BUREAU OF SHIPS GROUP  
TECHNICAL INSPECTION REPORT

OPERATION CROSSROADS.  
U.S.S. NIAGARA (APA87).  
TEST BAKER [U].

**USS NIAGARA (APA87)**

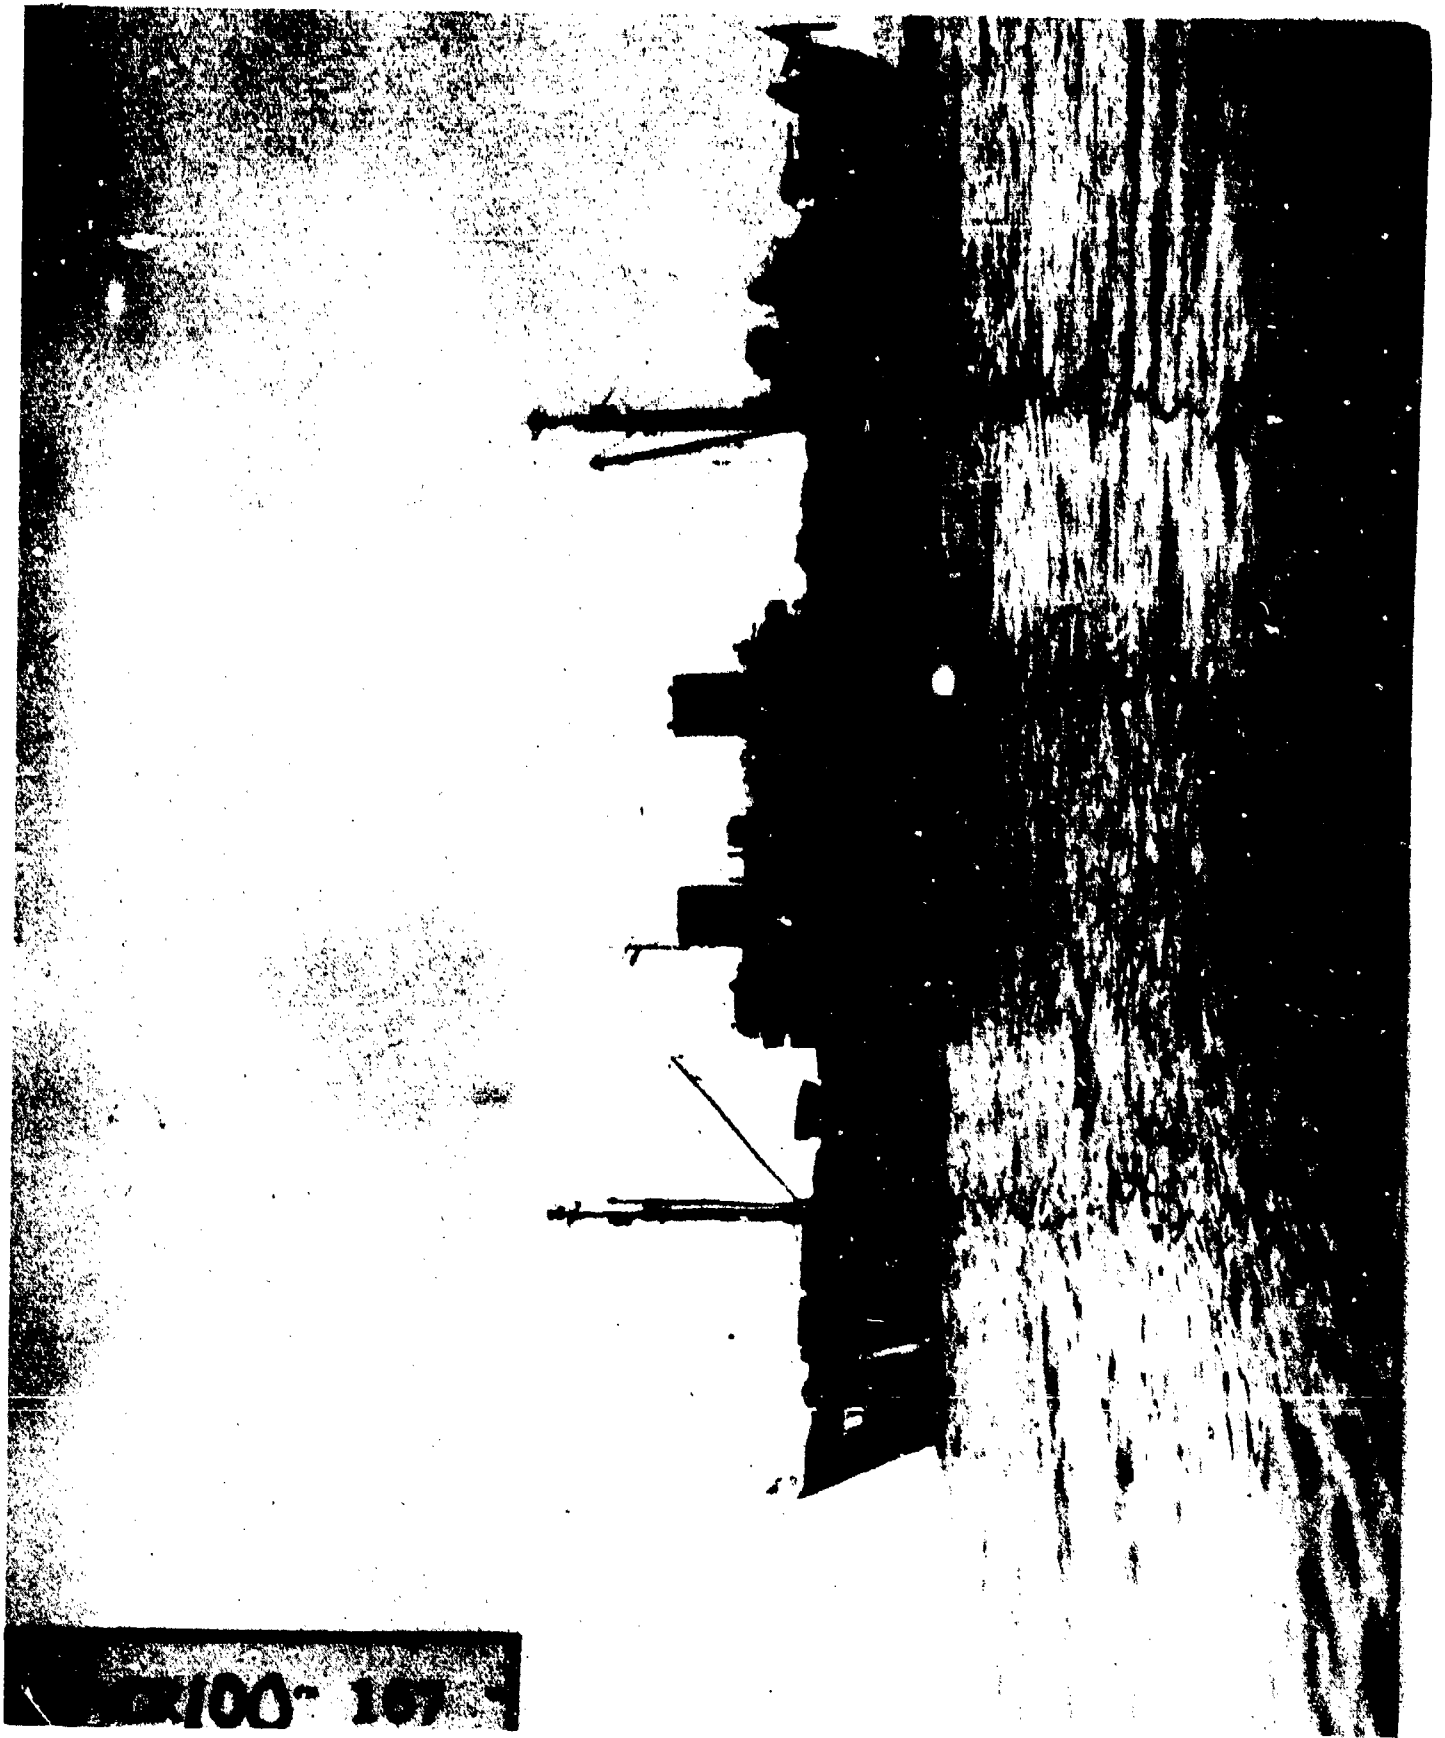
There is no damage. The only effect of the test is the displacement of several hatch cover panels. A general view of the ship after the test is on page 30.

AB-CR-100-167-2. View from off port beam after Test B.
