JOINT TASK FORCE ONE

ARMY GROUND GROUP  
(TASK GROUP 1.4)

FINAL REPORT  
OF  
ATOMIC BOMB TESTS

27 January 1946 to 30 September 1946

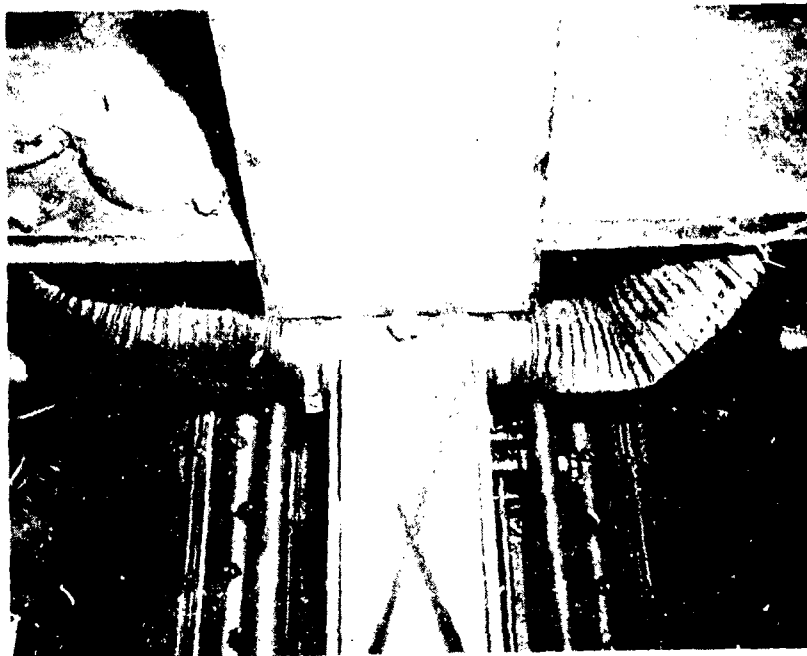
Fig. 117 - USS Nevada - Carriage, Motor, 90mm Gun, M36 - View after Test Able showing damage to engine air cleaner hoses.

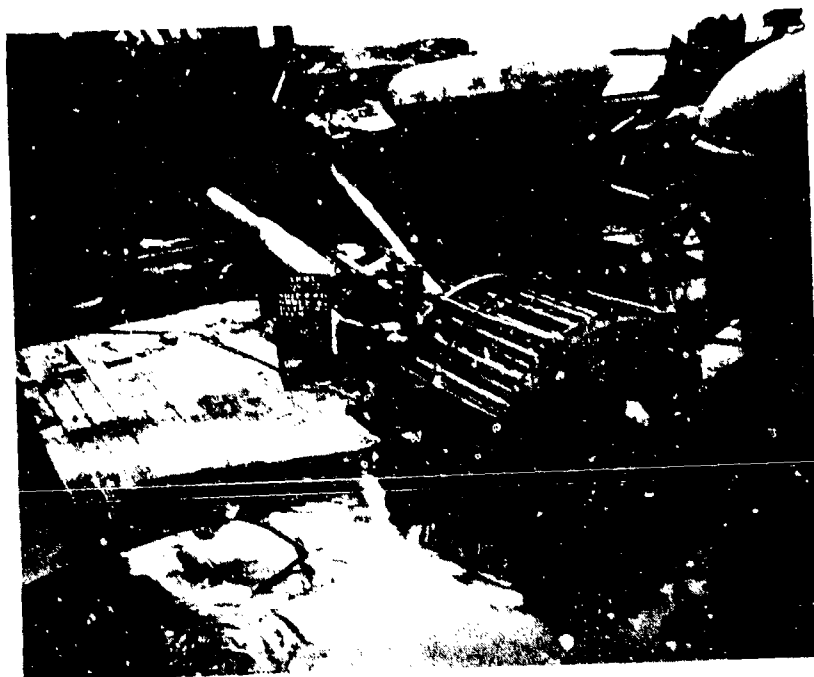
Fig. 197 - USS Nevada - Gun, 75mm, AC, M10 - Damage  
from Test Able. Note condition of the deck  
below the piece.

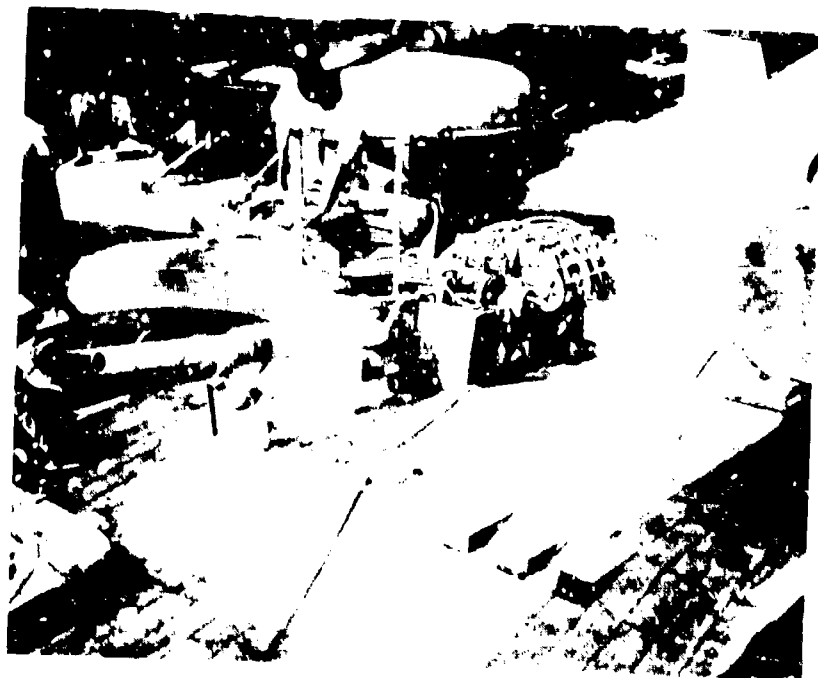
Fig. 198 - USS Nevada - Gun, 75 mm, AC, M10 - Damage from Test Able. Note condition of the deck below the piece.
