TECHNICAL INSPECTION REPORT

(6) OPERATION CROSSROADS,
U.S.S. ARDC 13,

TEST BAKER [U].

USS ARDC 13

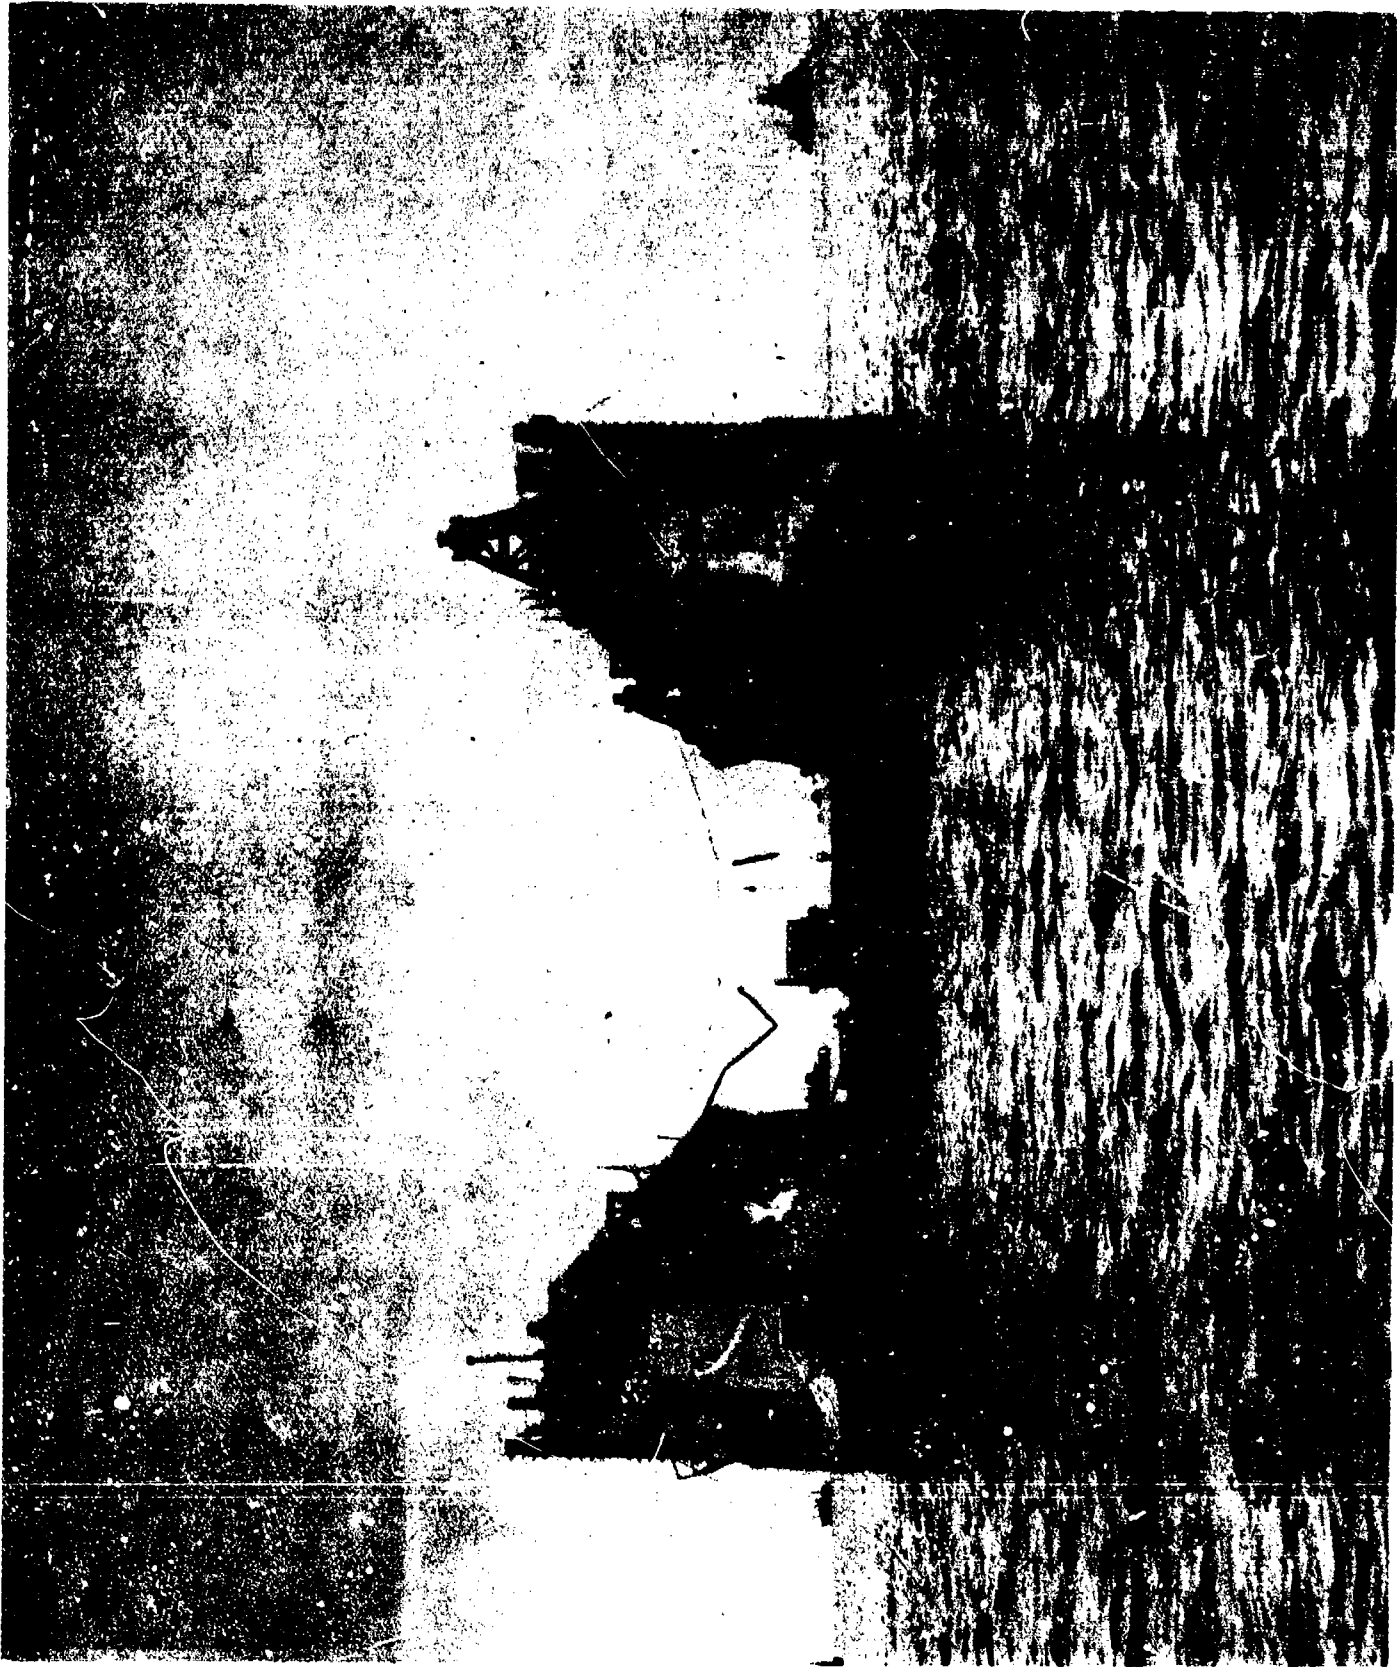
AB-CR-227-289-114. View from ahead after Test B.

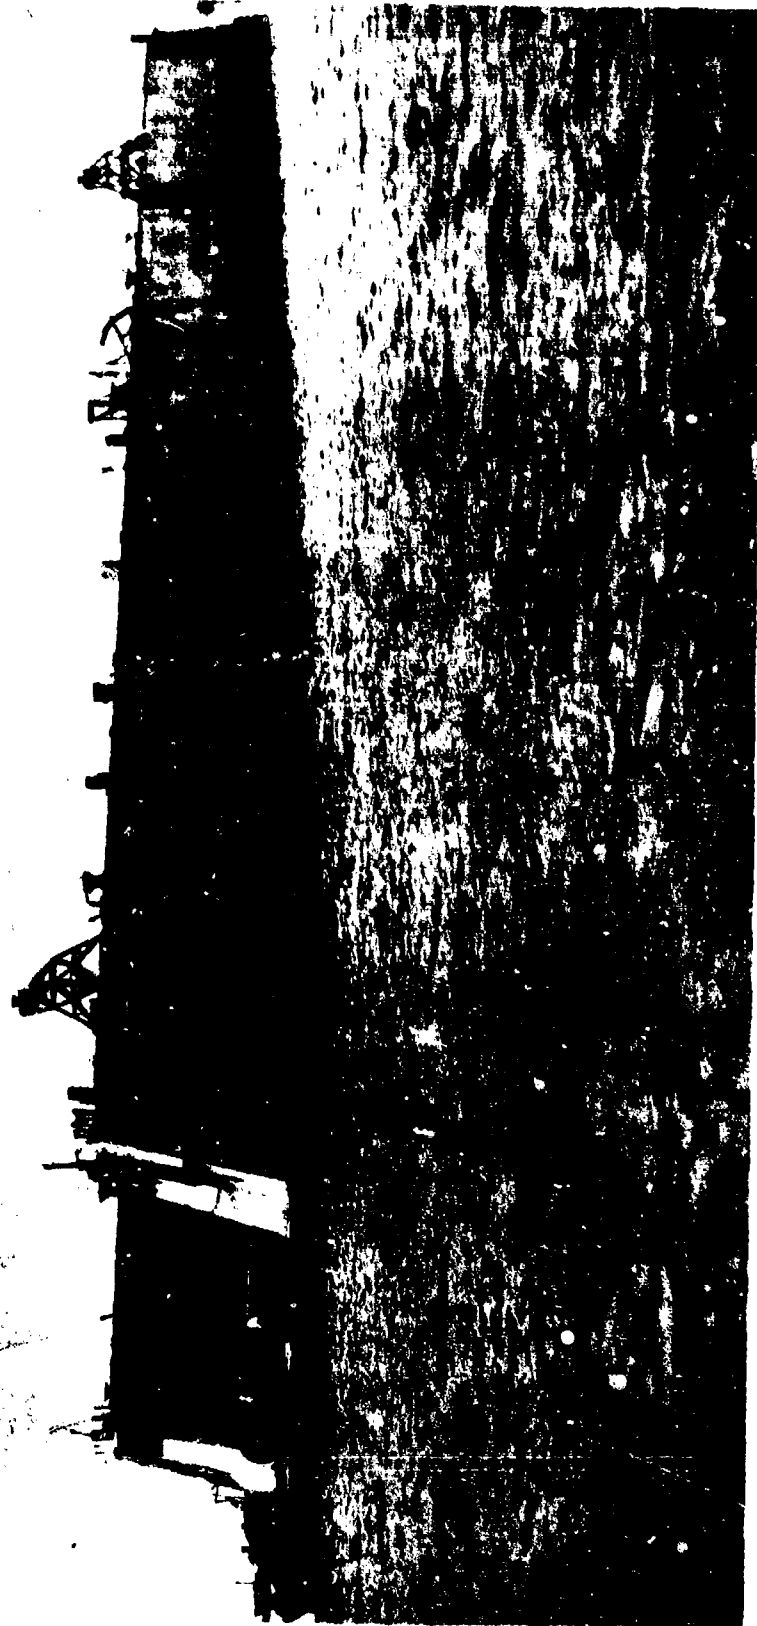
AB-CR-227-289-115. View from off port bow after Test B.

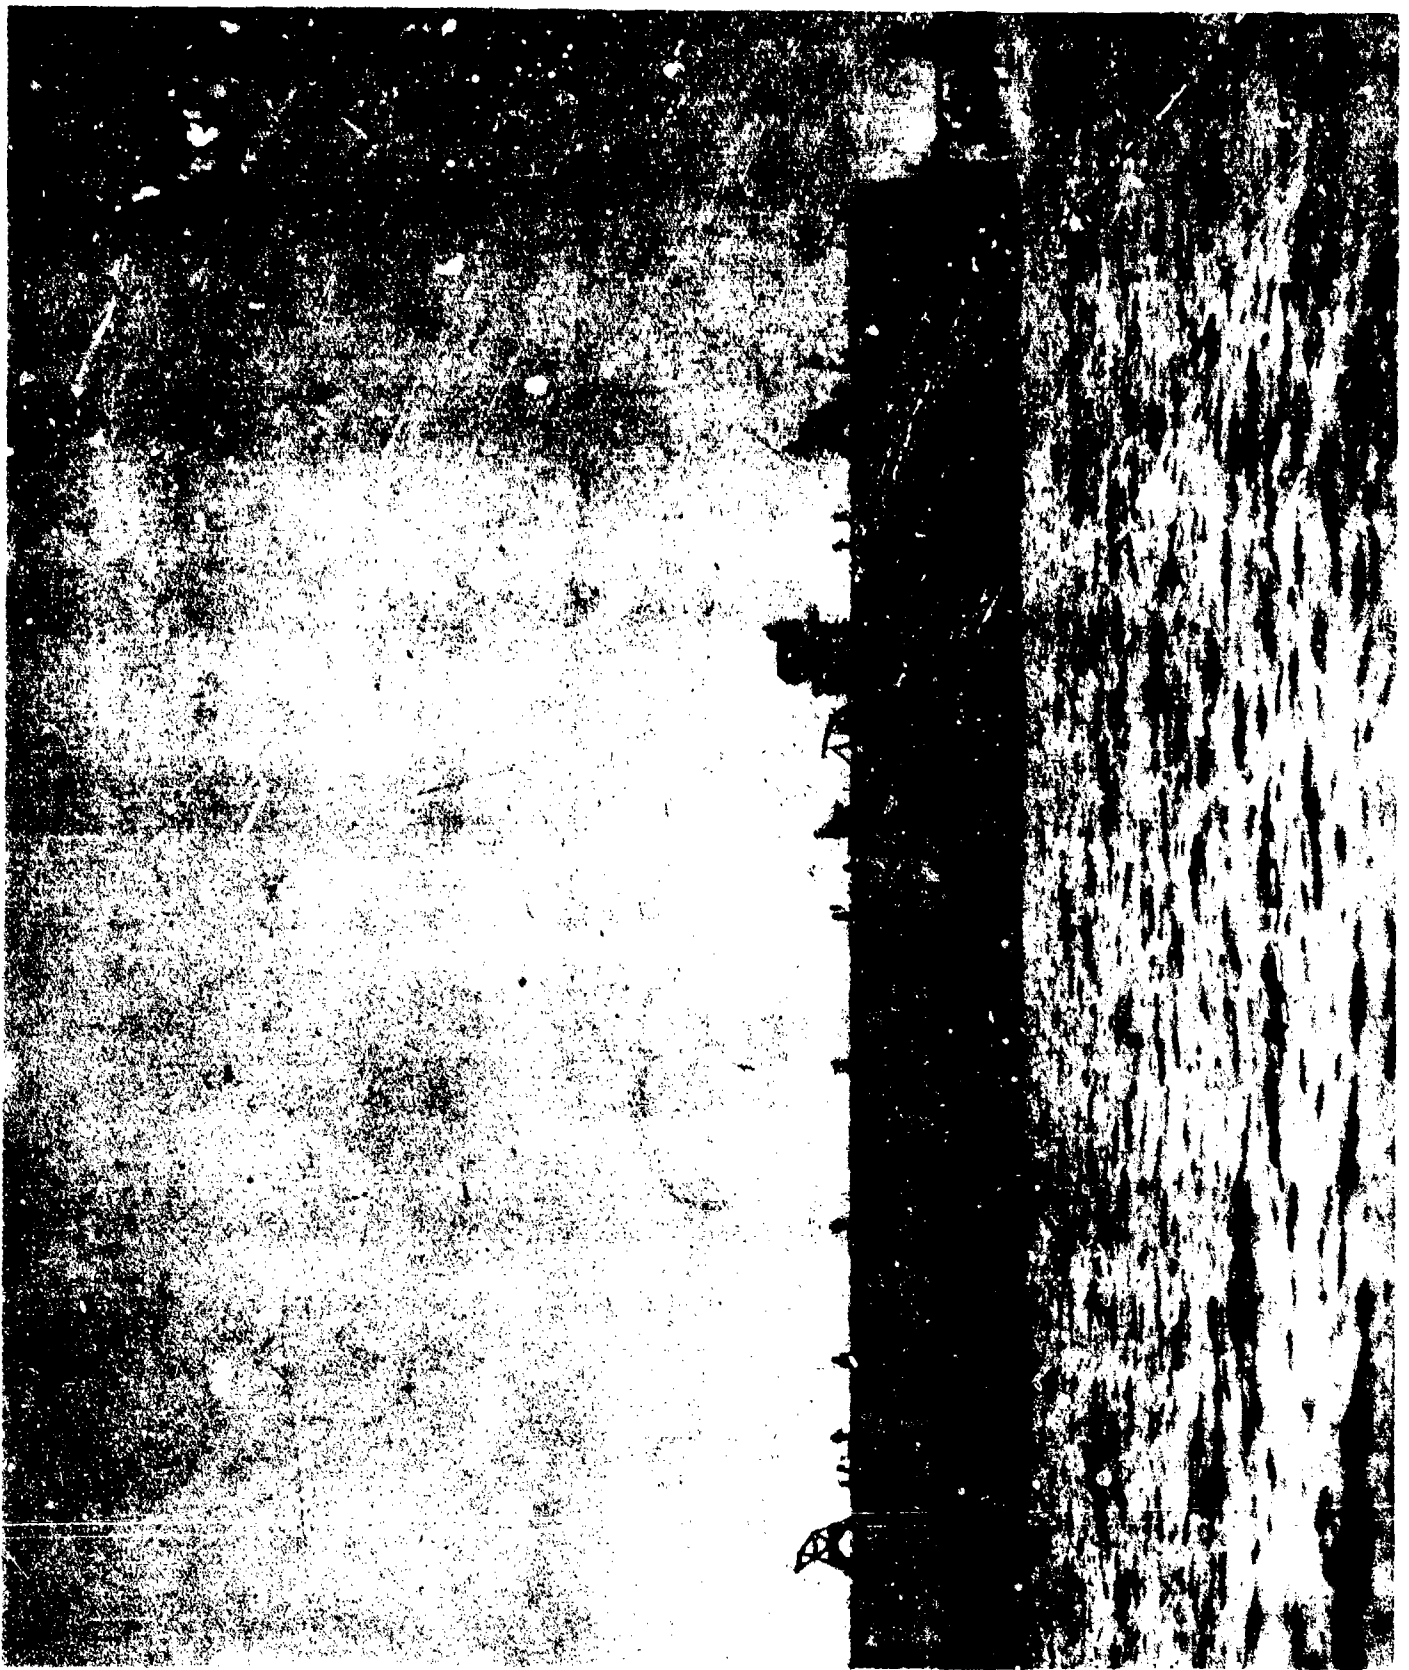
BB-CR-227-519-114. View from off port beam before Test B.

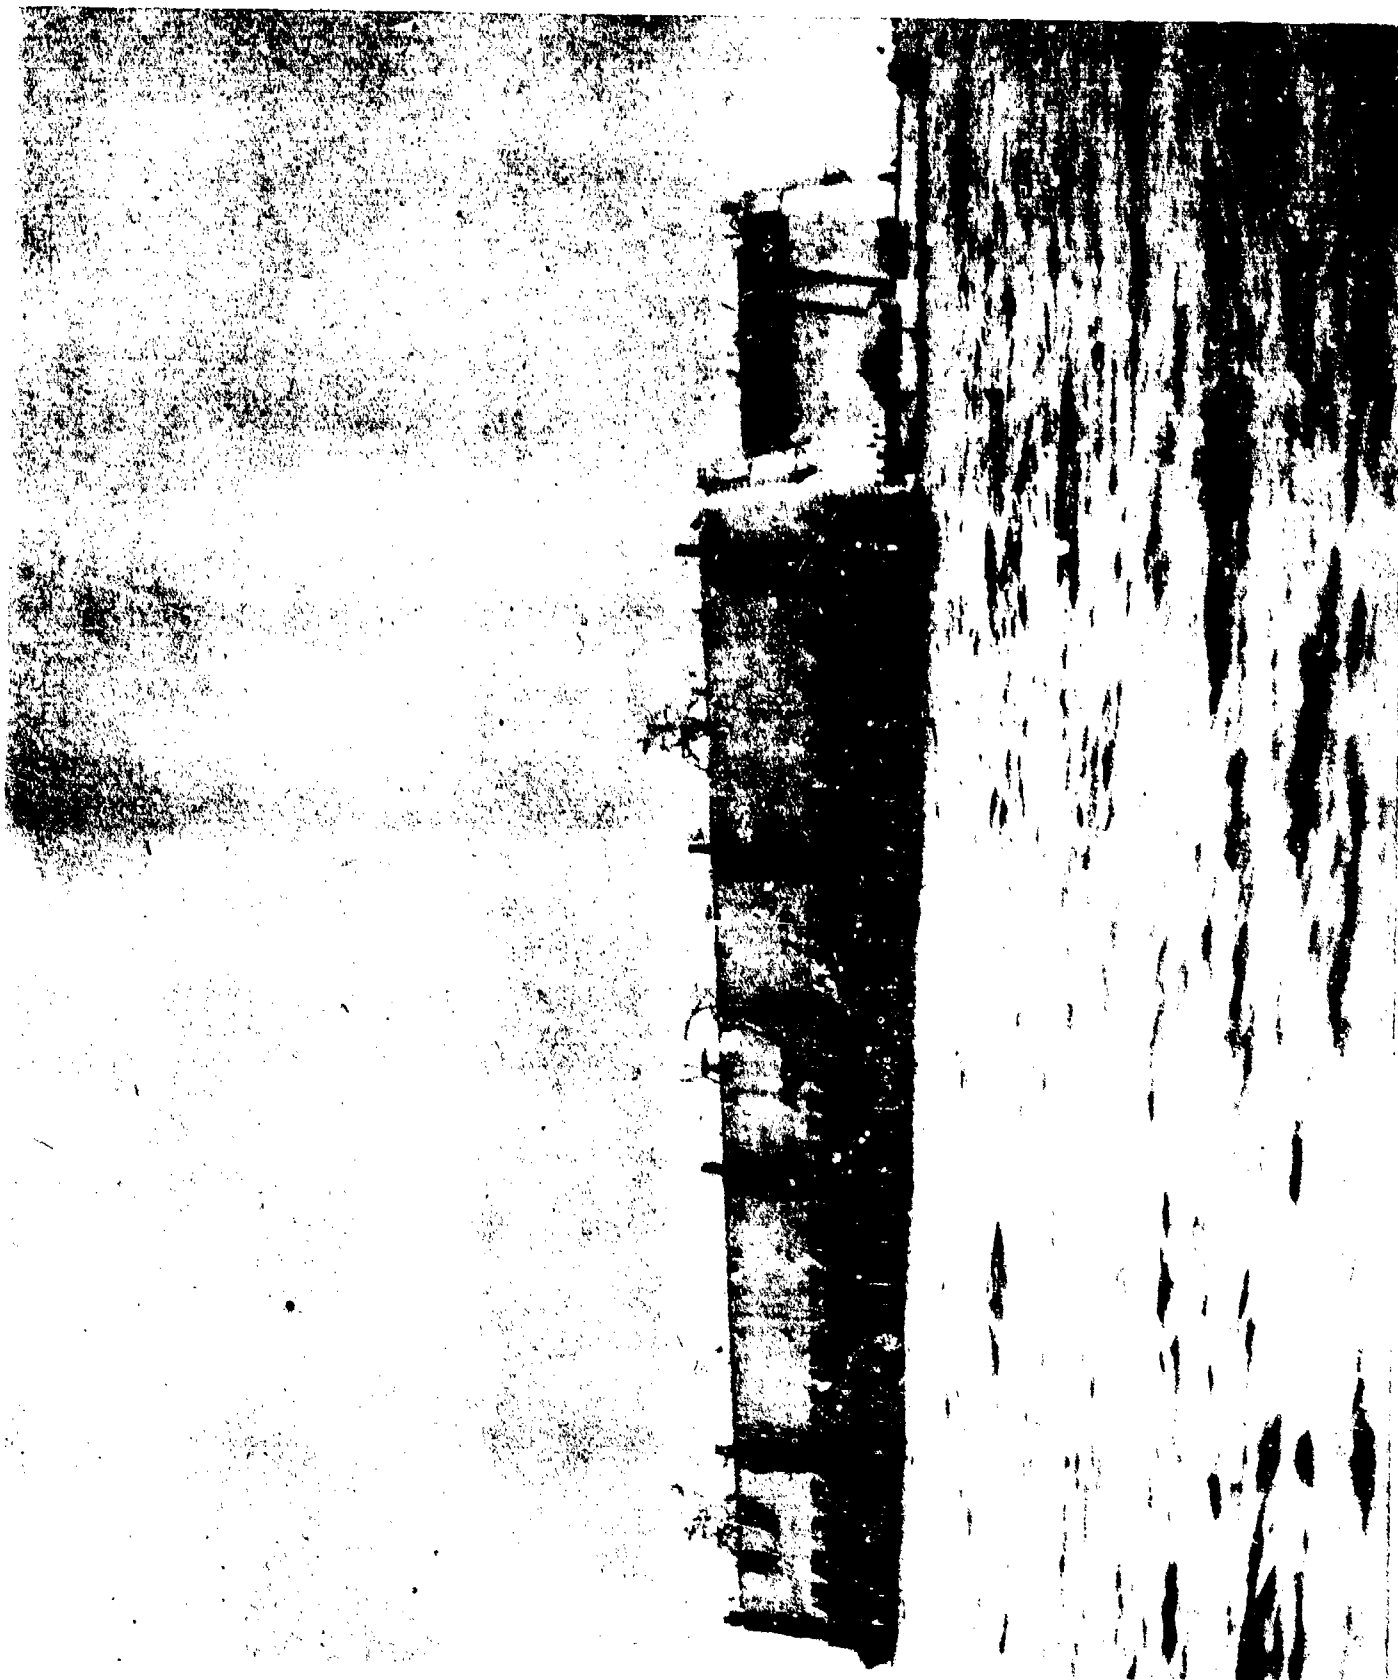
BB-CR-227-519-115. View from off port quarter before Test B.

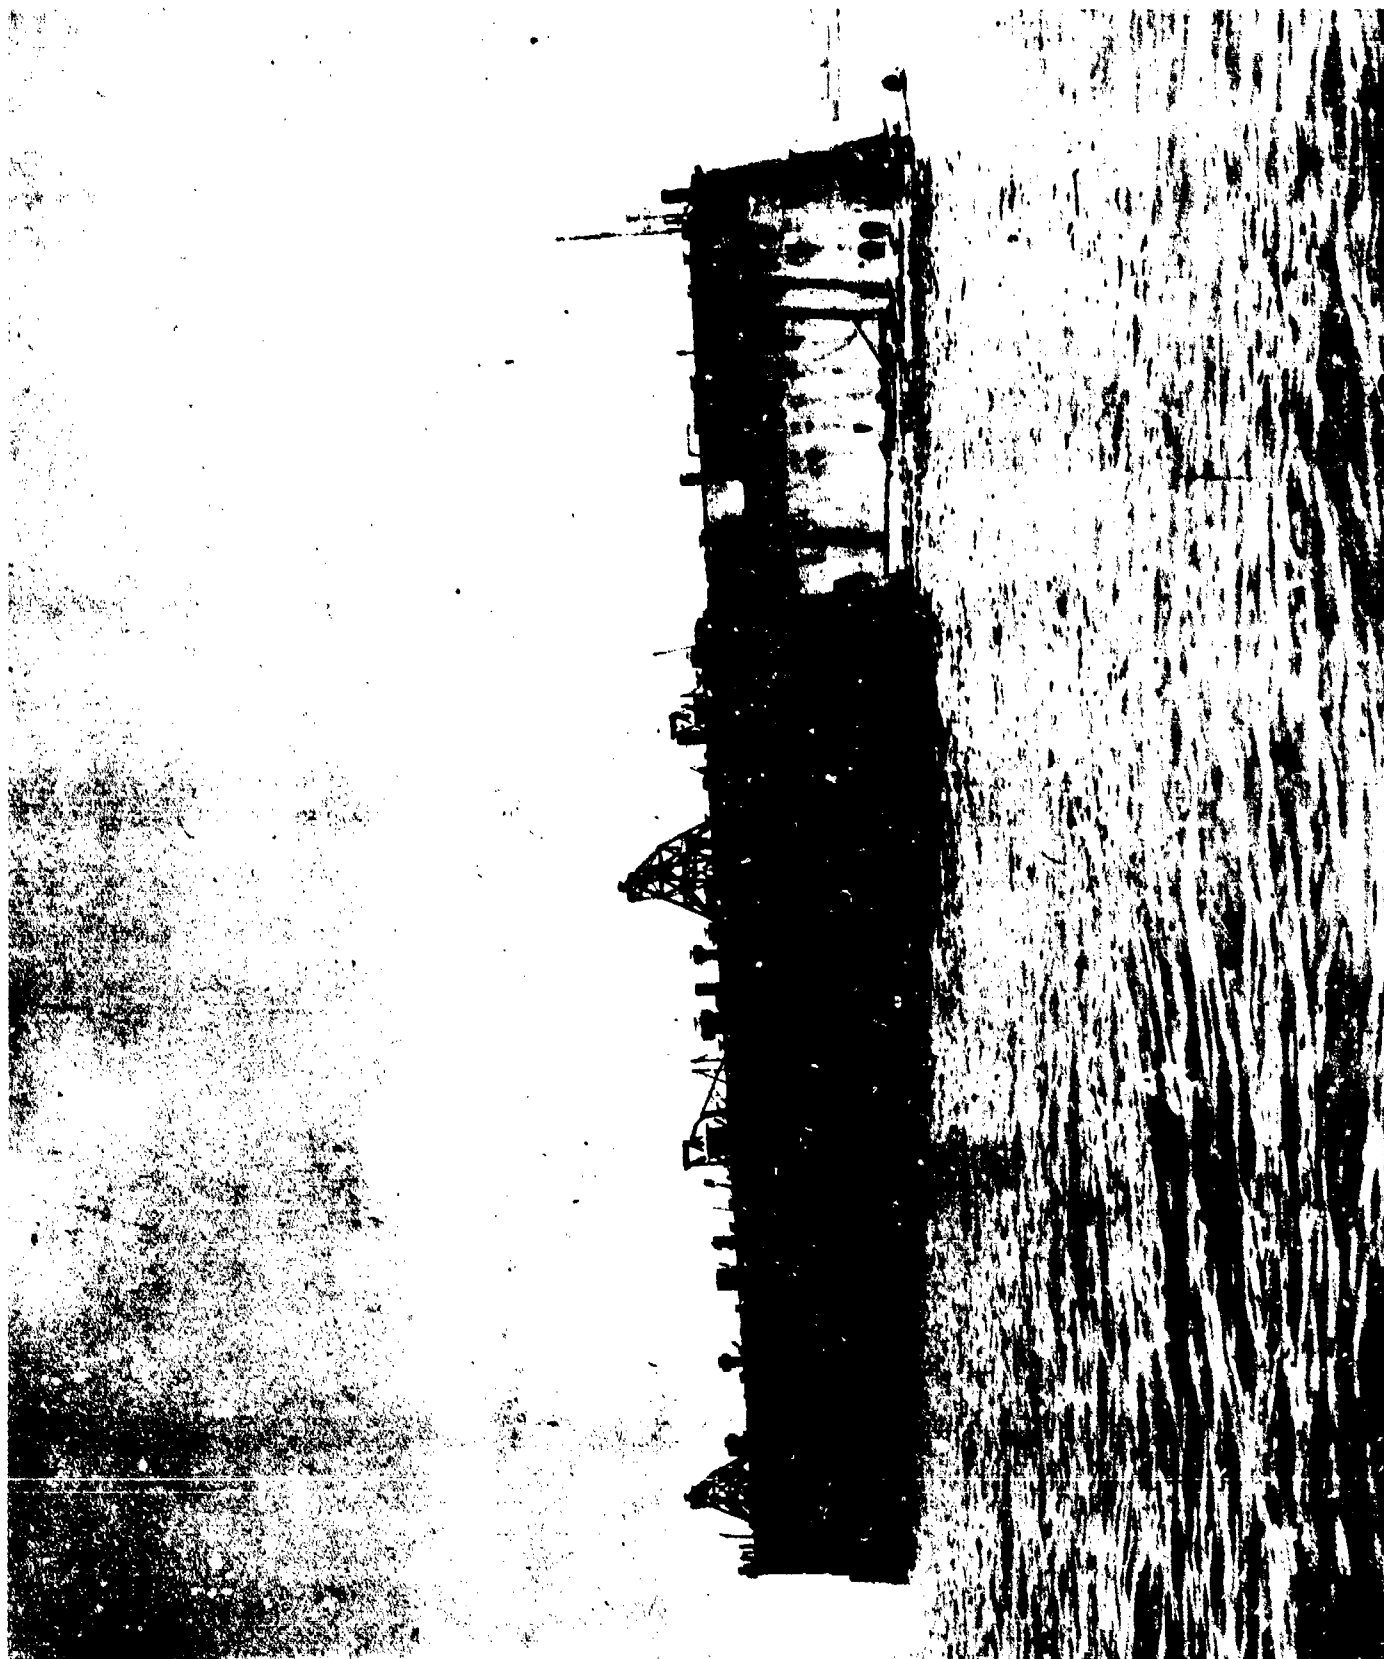
AB-CR-227-289-117. View from off port quarter after Test B.

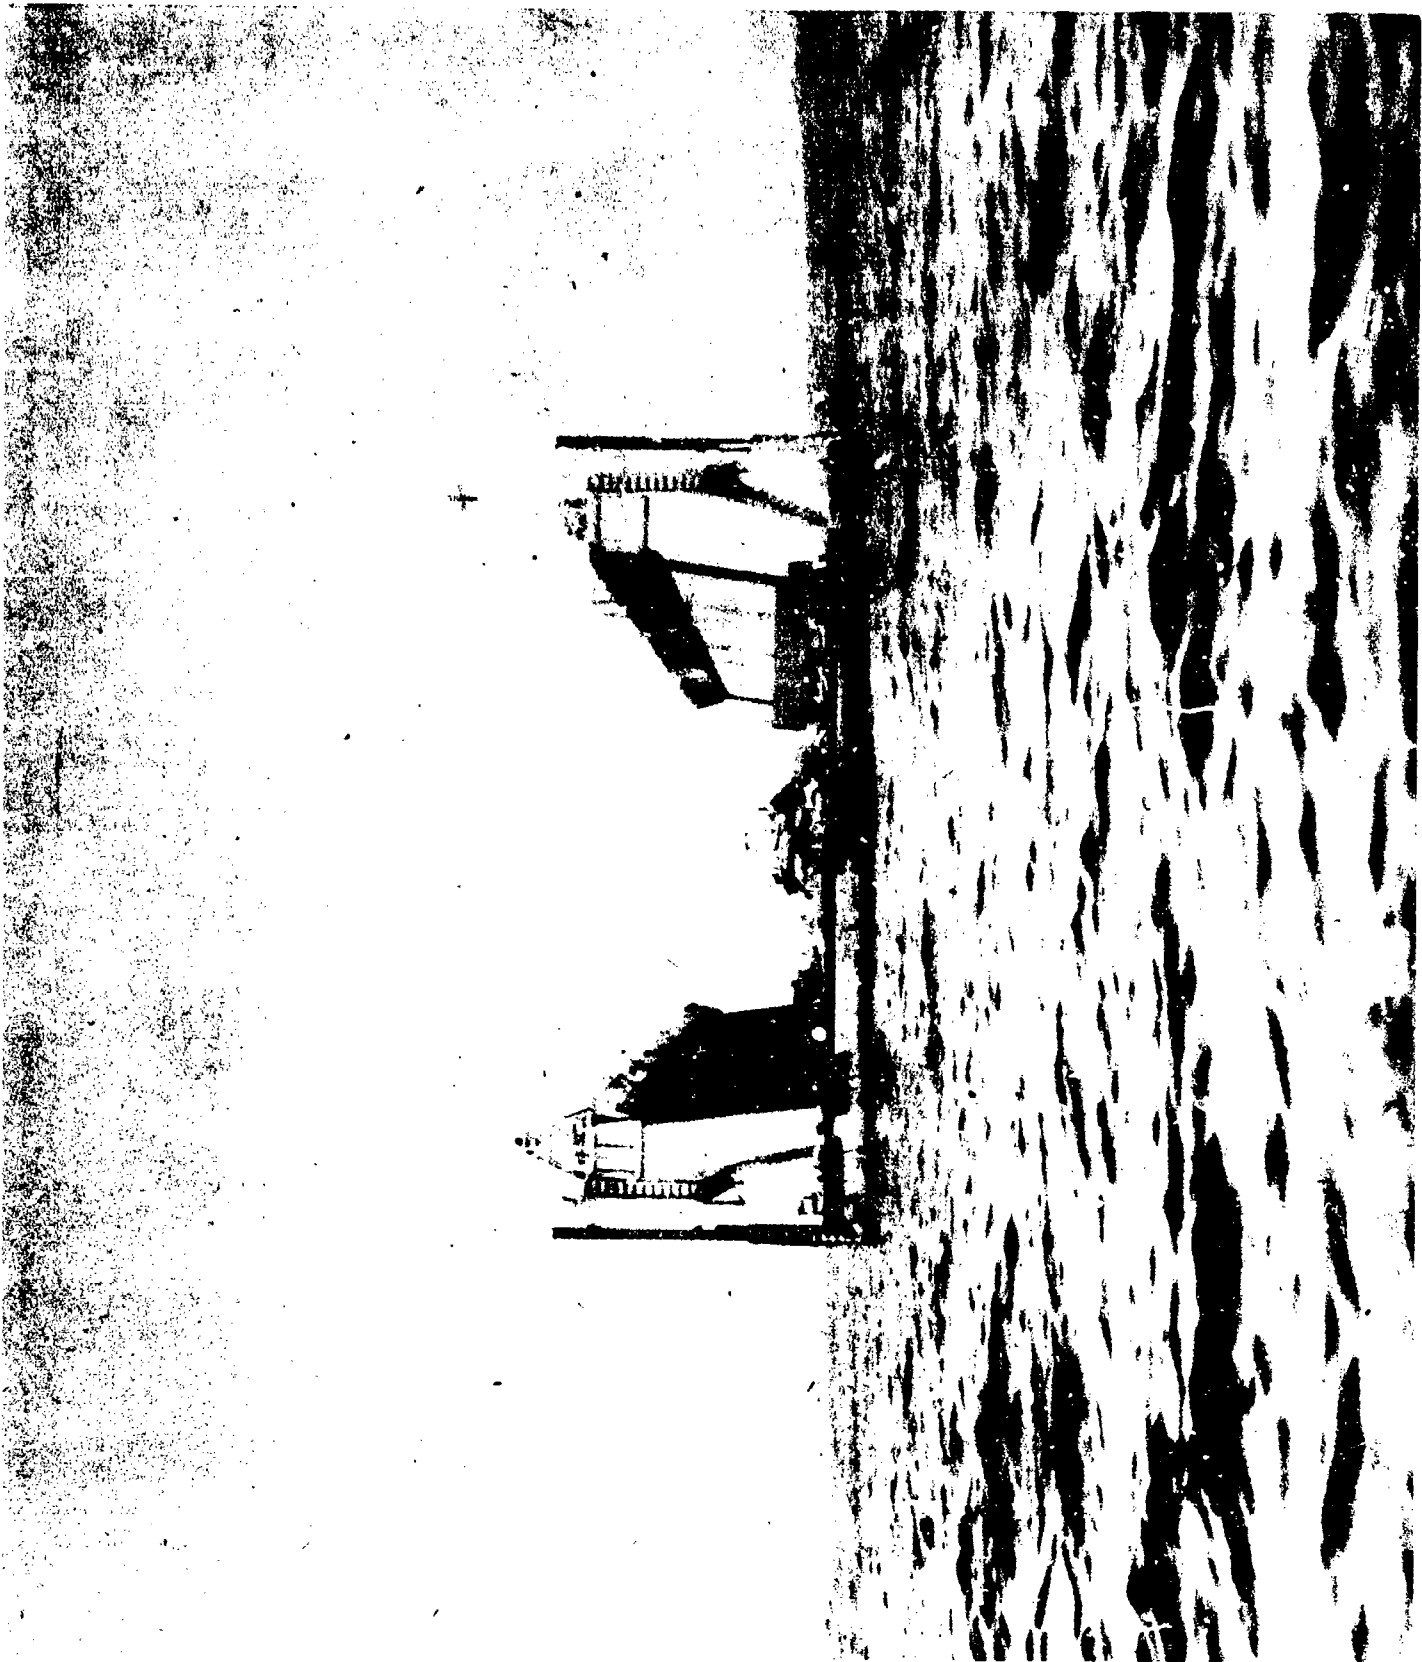
BB-CR-227-519-116. View from astern before Test B.

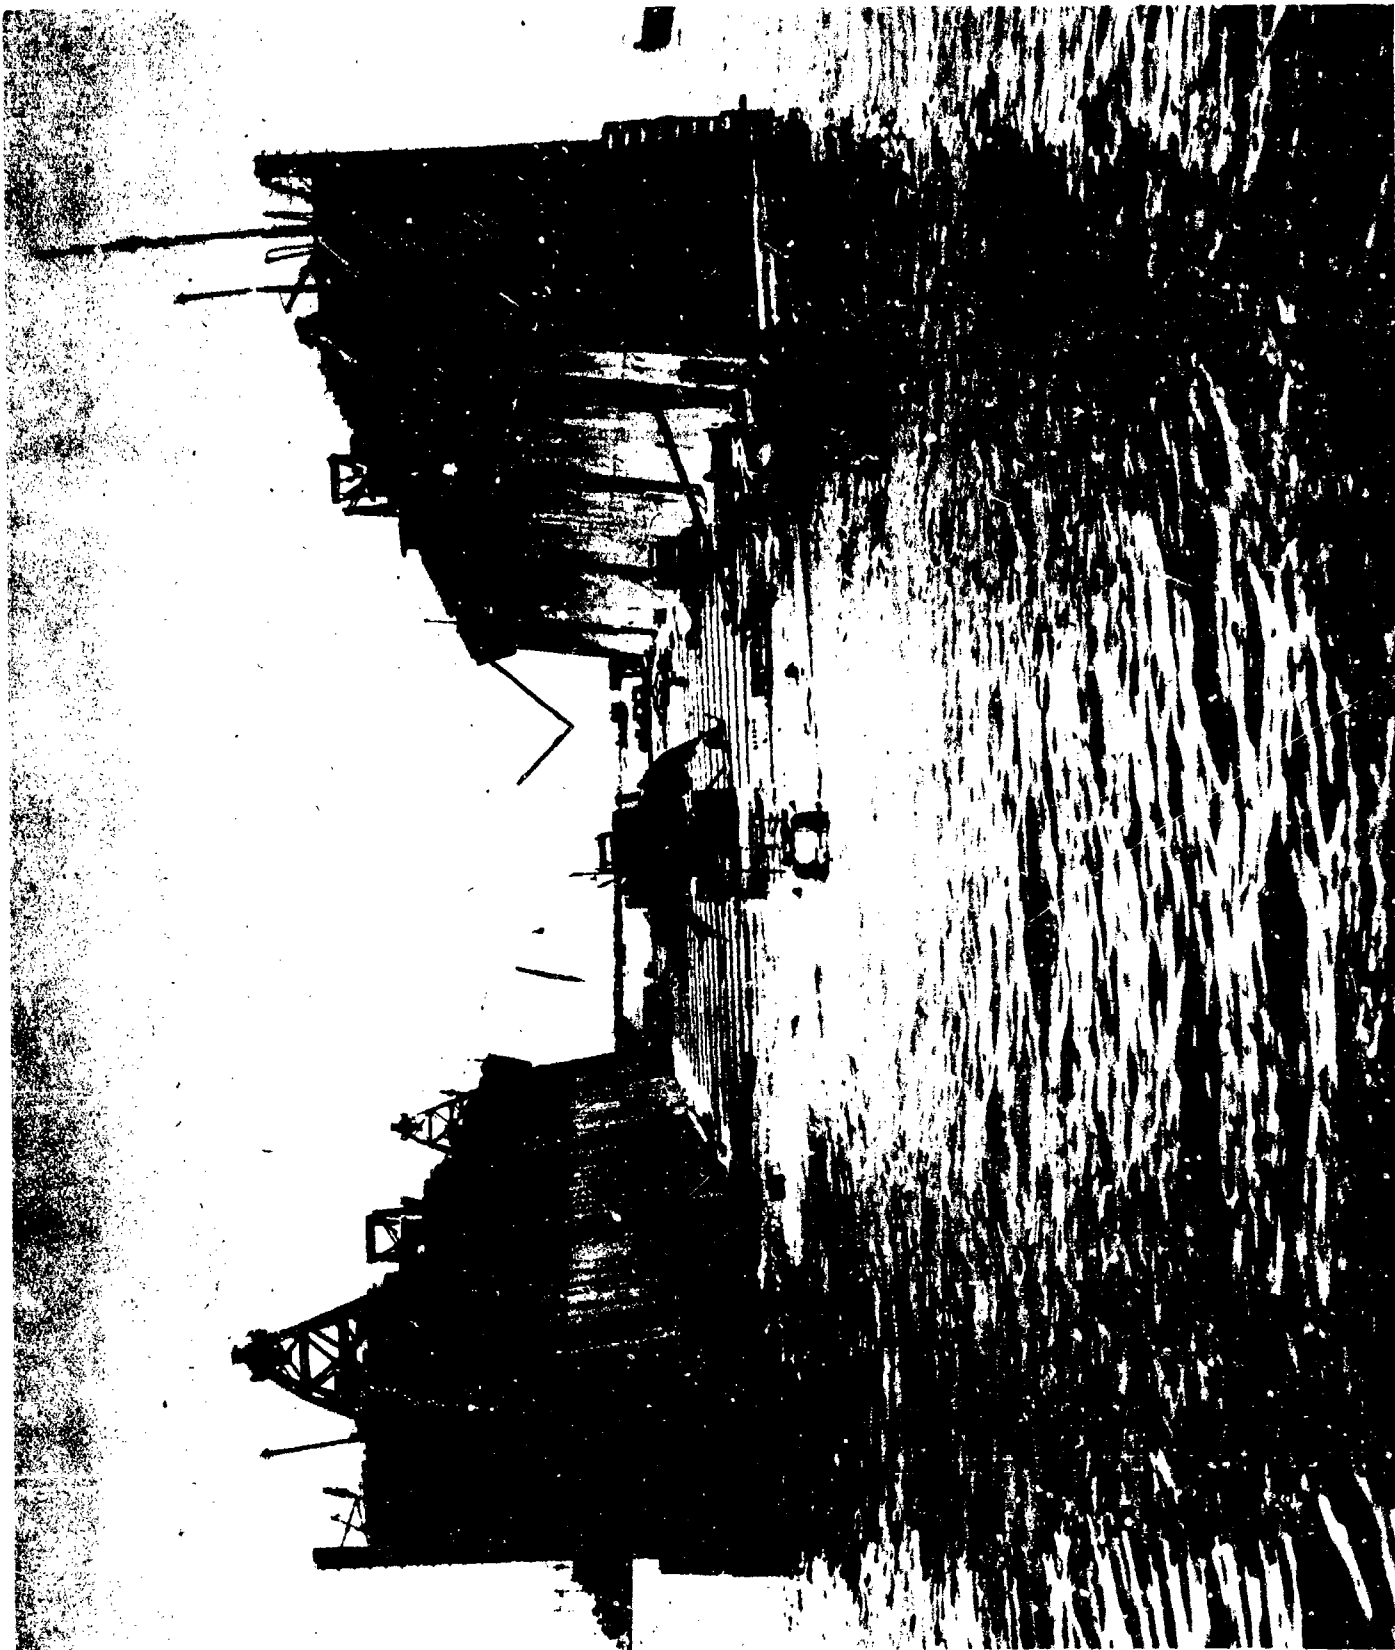
AB-CR-237-289-118. View from astern after Test B.

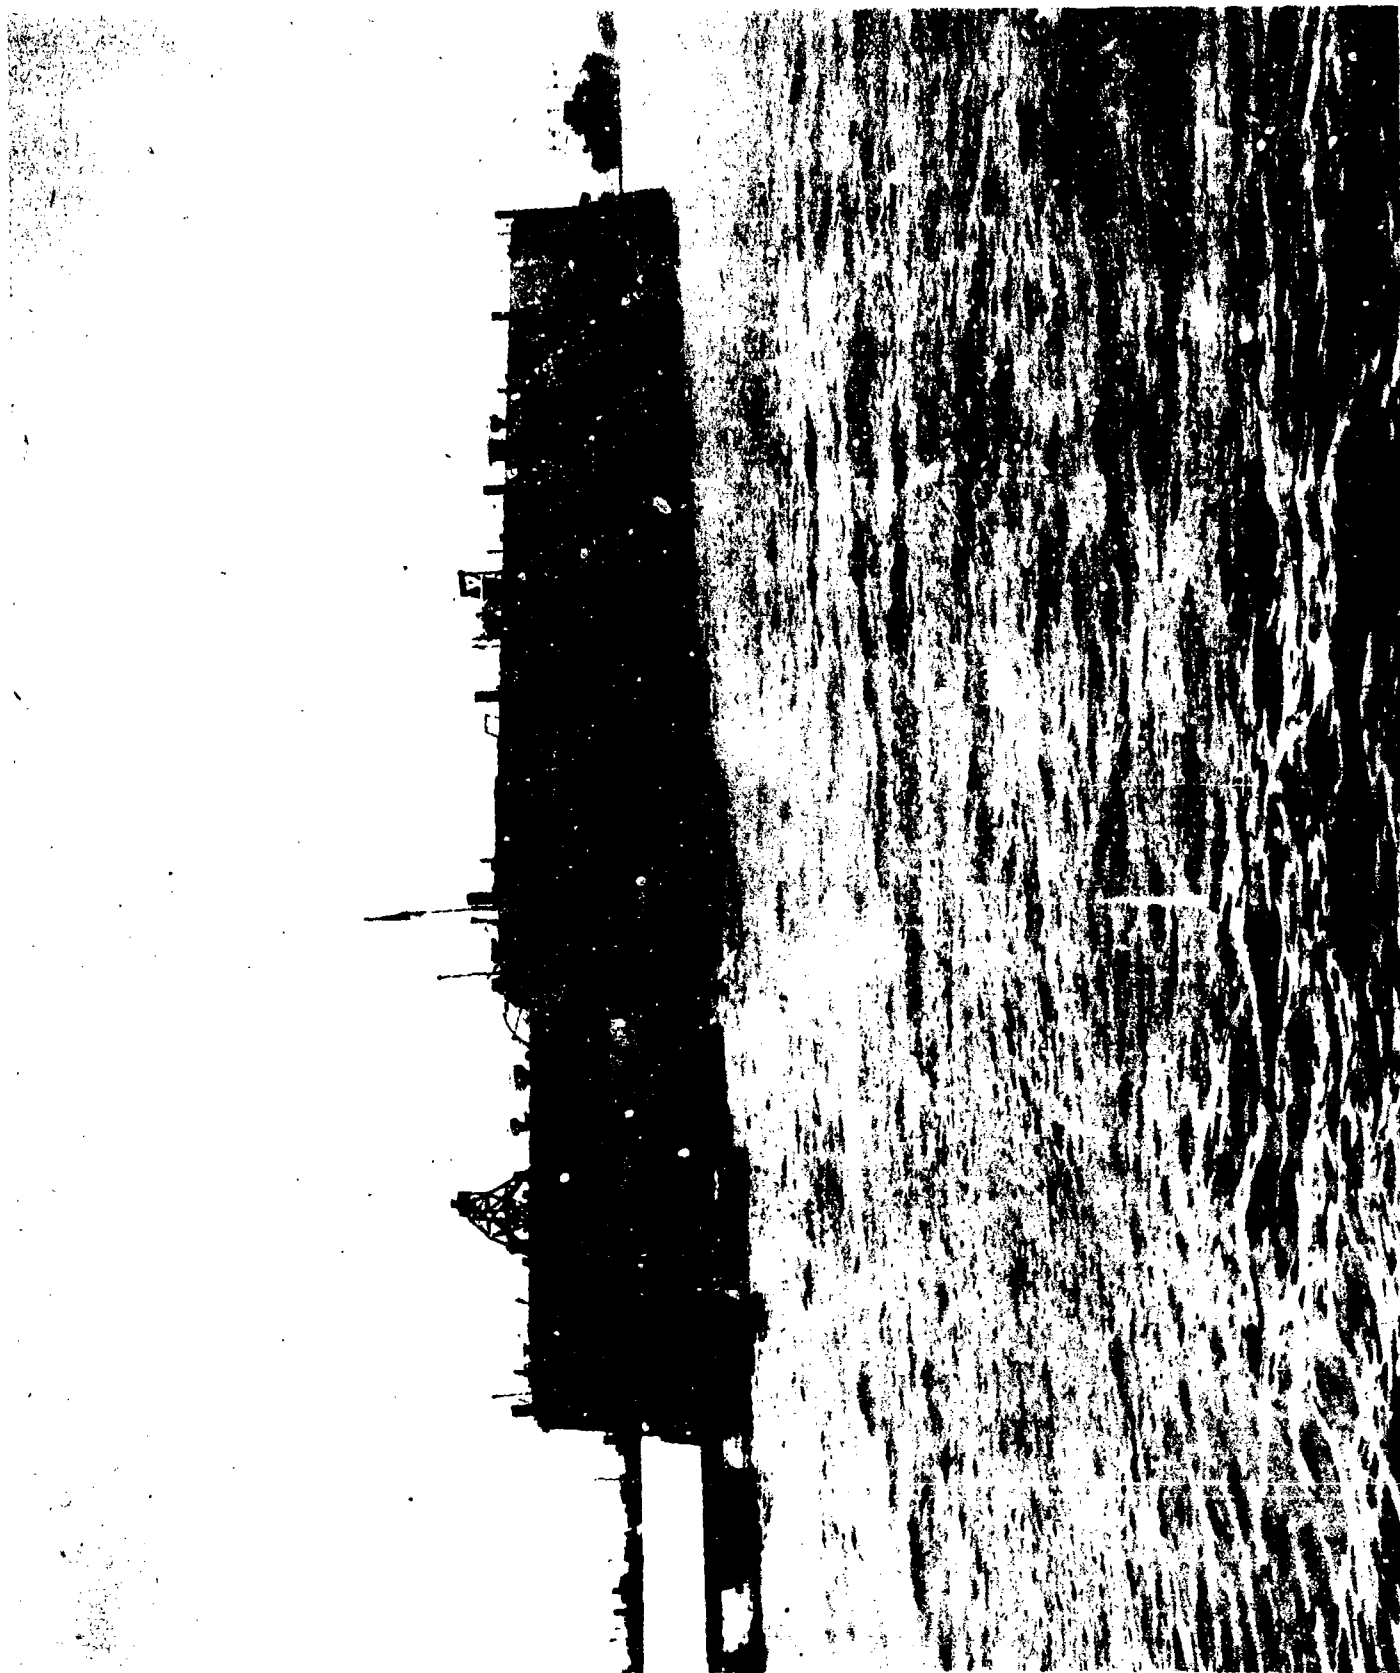
AB-CR-227-289-119. View from off starboard quarter after Test B.
