WTC-RESEARCH AND DEVELOPMENT REPORT

# A Facsimile Report

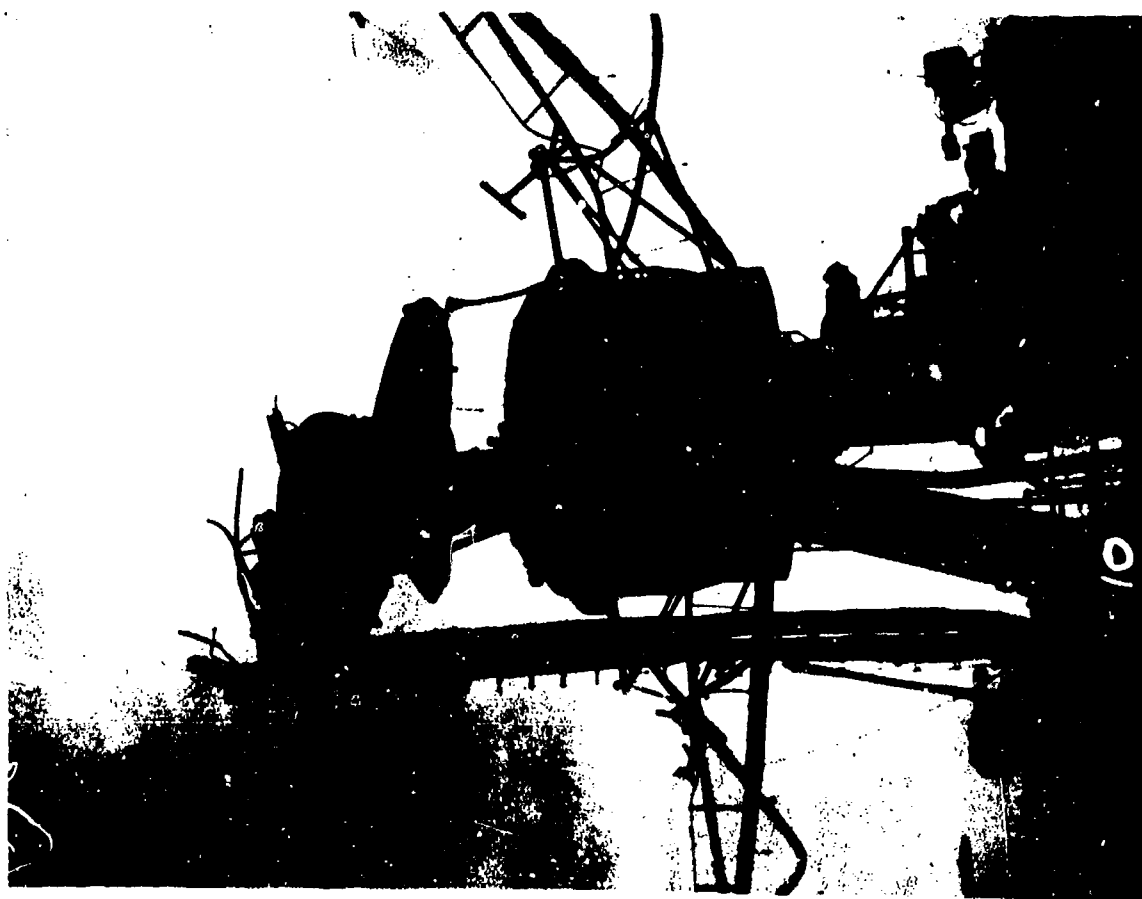
AA-CR-80-1897-10. U.S.S. NEVADA (BB36). Close-up of mainmast damage from port. Damage to pole mast indicates that mast bent considerably before failure. Note damage to yardarms also.

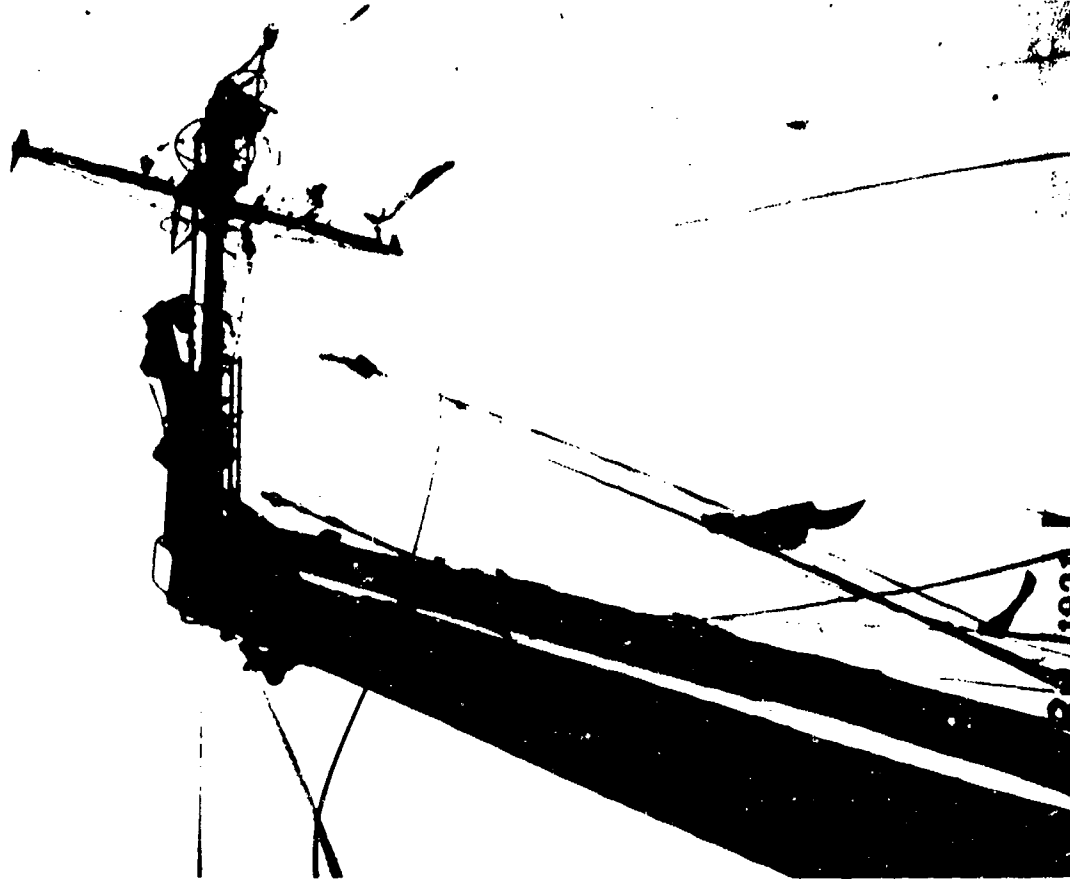
1. Masts and Spars. A detailed study of the behavior of masts and spars is the subject of a separate report. It appears that serious damage to masts and spars extended out to 800 yards on heavy ships and to 1100 yards on light vessels. Sporadic minor deflections occur in ships further removed. In Test A, four vessels were located about 600 yards (horizontal distance) from the burst. These were INDEPENDENCE (CVL22), NEVADA (BB36), ARKANSAS (BB33) and CRITTENDEN (APA77). The peak pressure experienced at this range was about 34 pounds per square inch and the wind velocity in the wave was momentarily about 700 miles per hour. INDEPENDENCE (CVL22) took the air blast over the port quarter. The cage-type mast structure supporting fire control equipment and radar is completely missing from the upper level of the island as shown in Photo 2040-6, page 27. Photo 196-151-23, page 28 shows the mast structure before test. NEVADA (BB36) also received the blast from the port quarter. The effect on topmasts is shown in Photo 1832-9, page 29. The masts and radar antennae all failed at discontinuities. A close-up view of the main topmast, Photo 1897-10, page 30, indicates that the mast bent considerably before parting from the platform. On ARKANSAS (BB33), which received the air blast on the starboard quarter, a similar condition resulted (Photo 1774-11, page 31). The main topmast has been torn from its connection to the director platform (Photo 1775-12, page 32). On the foremast, however, the radar pole mast is still connected to the radar platform although it is bent nearly double (Photo 2097-3, page 33). Signal yardarms are all bent forward. CRITTENDEN (APA77) was bow-on to the blast. Photo 227-49-116, page 34 indicates the effect of the air blast upon the pole masts. These are bent drastically aft but have not fractured. All three masts bent sharply at discontinuities or supports. (Photos 1921-10, 1922-8, and 1806-9; pages 35, 36 and 37).

AA-CR-82-1921-10. U.S.S. CRITTENDEN (APA77). Air blast damage to fore top mast.

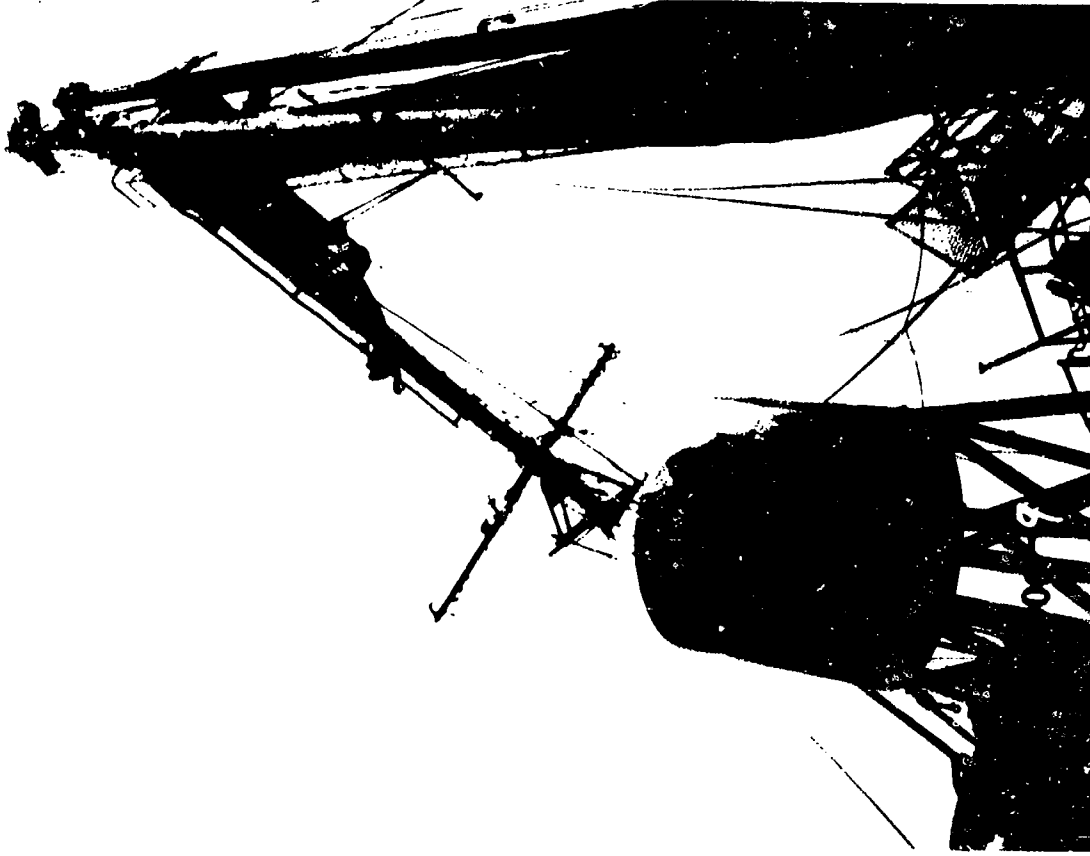
AA-CR-80-1906-9. U.S.S. CRITTENDEN (APA77). Air blast damage to main top mast, looking upward and aft. Note radar array fallen to house top.

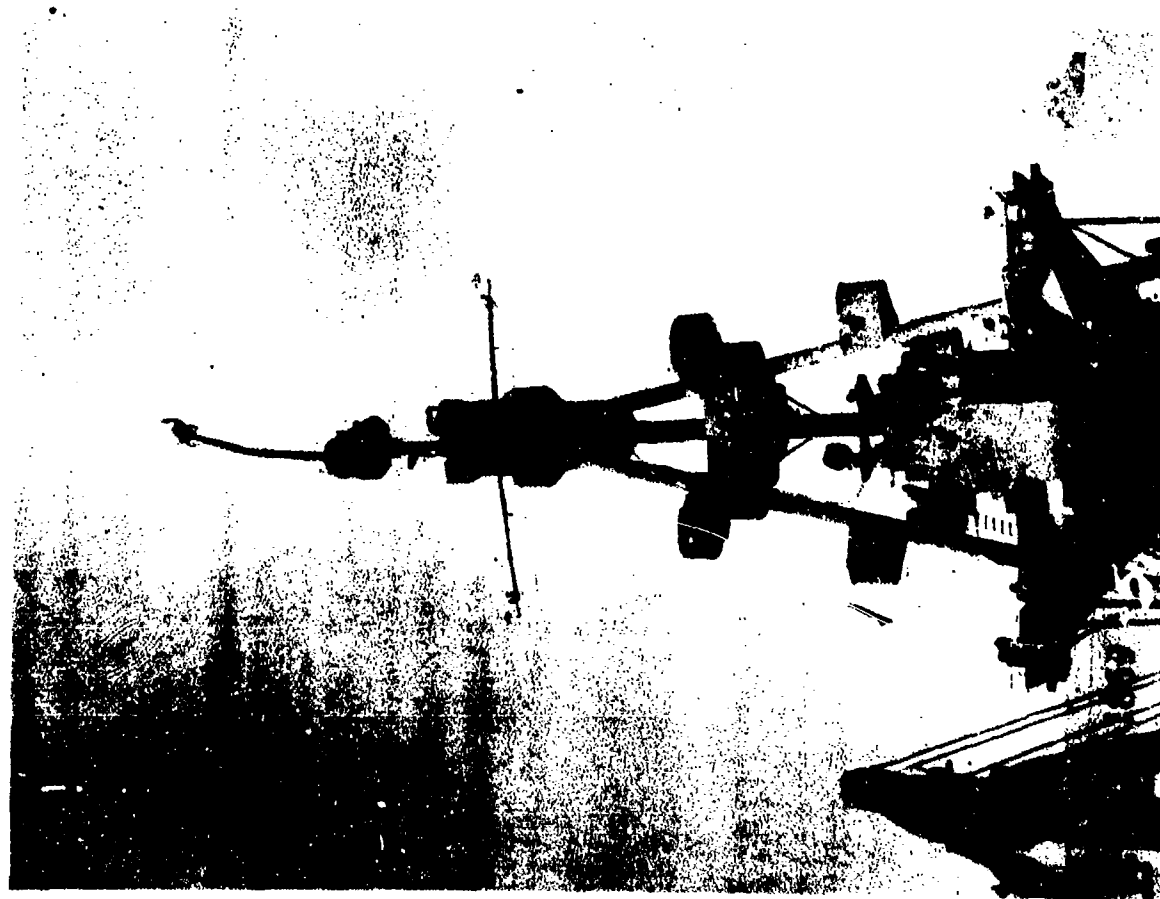
AA-CR-1869-5. U.S.S. SALT LAKE CITY (CA25). Air blast damage to foremast and radar polemast, looking forward from frame 74.

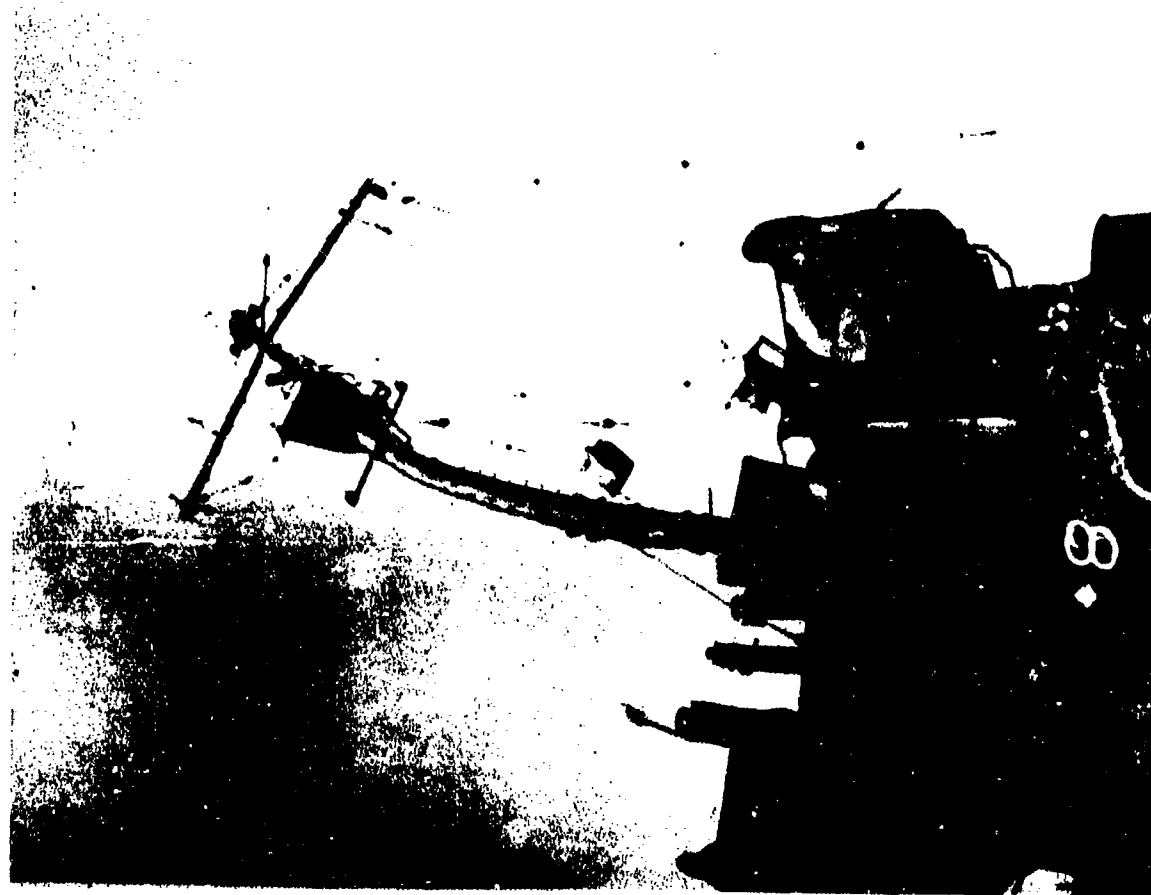
AA-CR-62-1868-8. U.S.S. SALT LAKE CITY (CA25). Air blast damage to radar mast and rigging on mainmast, looking forward from frame 94.

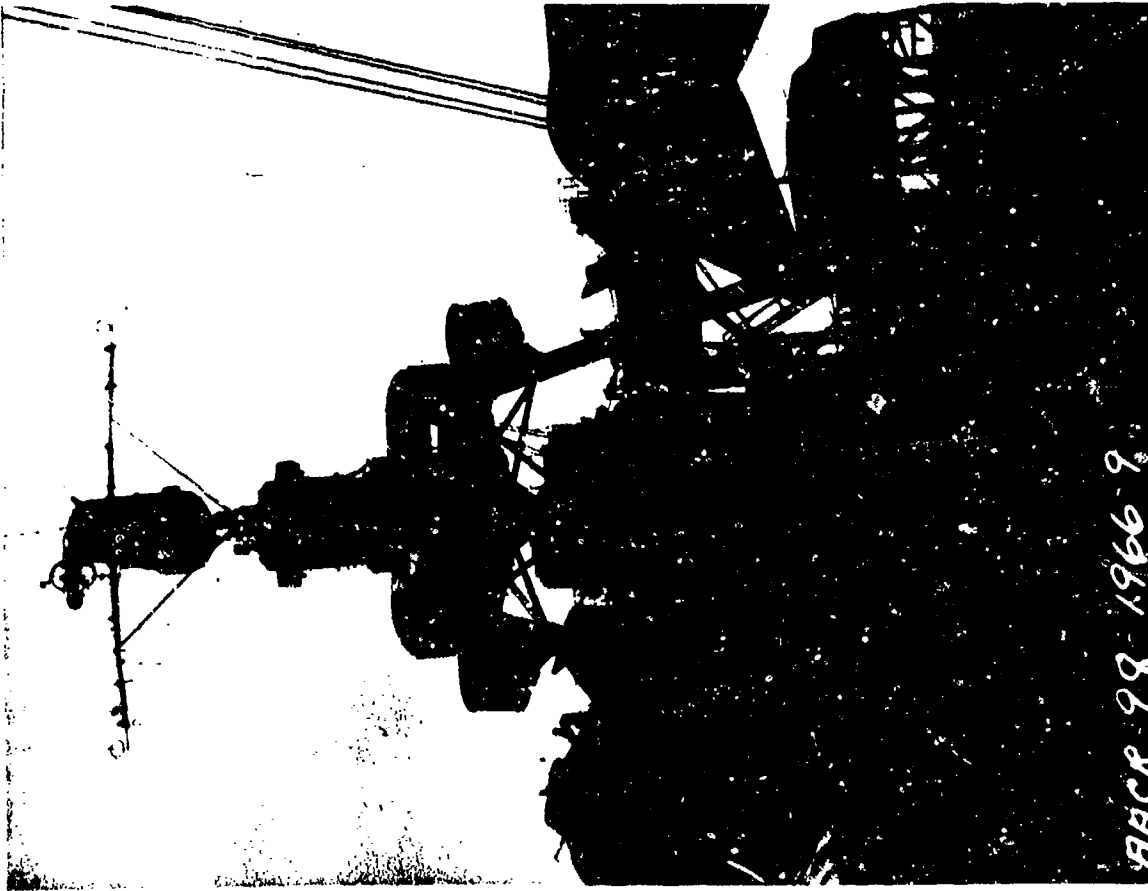
AA-CR-98-1966-9. U.S.S. PENSACOLA (CA24). View of after side of forward superstructure, showing damage to flat portions of platform shields.
