TECHNICAL INSPECTION REPORT

U.S.S. GILLIAM (APA57)

OPERATION CROSSROADS

BUREAU OF SHIPS GROUP
TECHNICAL INSPECTION REPORT

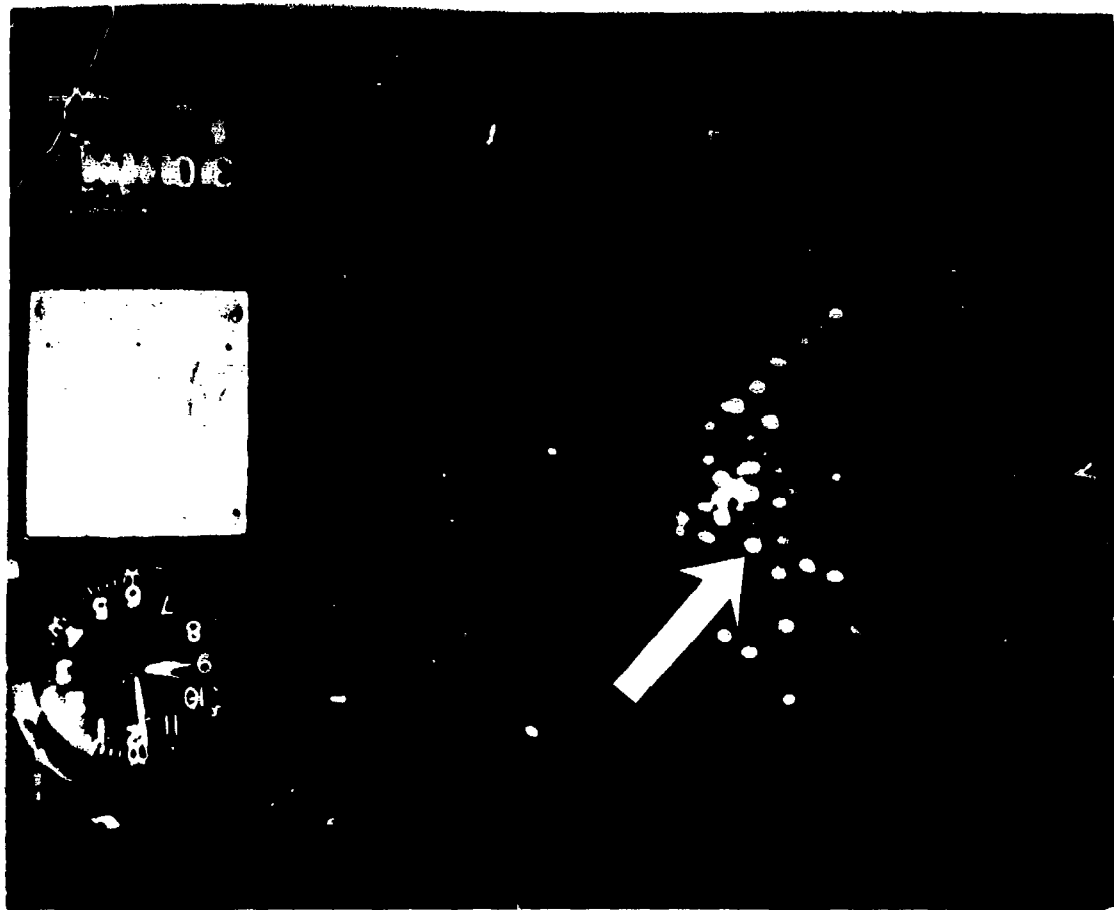
The GILLIAM was sunk. The time and manner of her sinking cannot be stated with certainty. The photo on page 12 shows the target array as seen on APQ #7 radar screen shortly before the burst. The arrow points to the position of the GILLIAM. In the photo on page 13, the GILLIAM appears to have broken into 3 pieces. The two extra images may be echos from large component units which were blown off the GILLIAM. The photo on page 14 shows the GILLIAM going down. She disappears from the radar screen 79 seconds after burst. Presumably the GILLIAM sinks shortly after the photo on page 16 was taken. No further image of the GILLIAM is obtained on the screen. A close scrutiny of the pictures taken by the 24 inch tower cameras on Bikini Island between 42 and 50 seconds after the blast reveal a darker spot in the general haze and smoke covering the array. (See photo on page 16). This spot orientates perfectly with the location of the stern of the GILLIAM just before the blast. Furthermore, it is shaped like the stern of an attack transport inclined upward at about 20 degrees. This spot persists for about four pictures or approximately twelve seconds before it disappears.

APQ #7 Radar Scope Picture #3011. View of target array before burst as seen on APQ #7 #1 radar scope located on Aomoen Island. Burst will occur at clock time of 0900:28. Arrow points to GILLIAM.

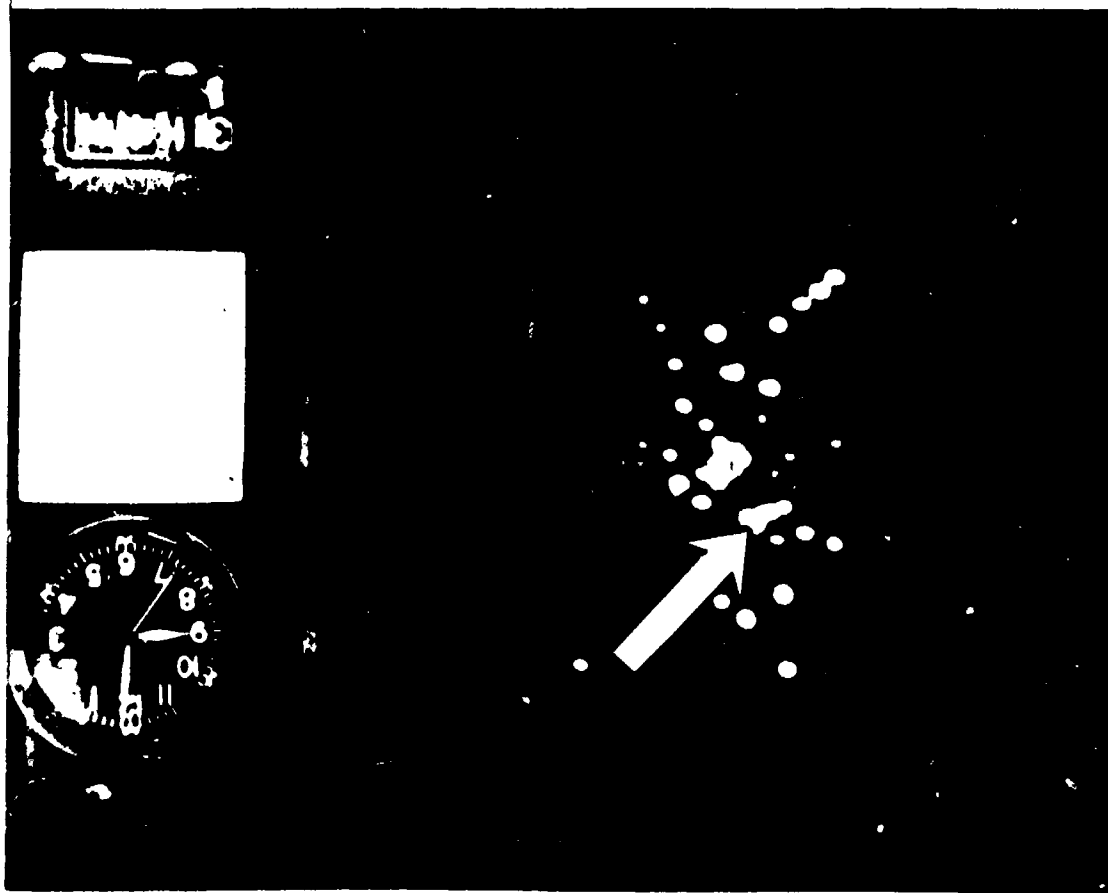
APQ #7 Radar Scope Picture #3141. Target array 8 1/2 seconds after burst. Note 3 plps in place of GILLIAM'S former spot.

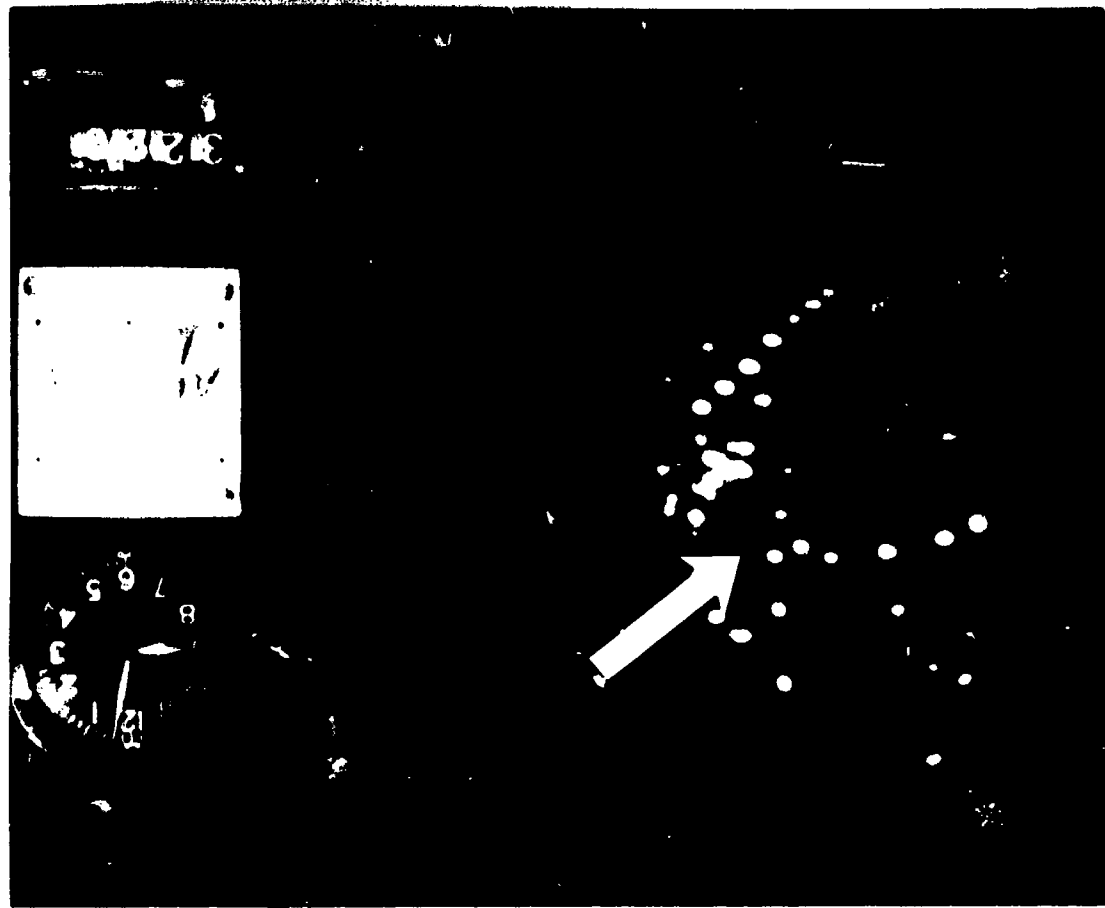
APQ #7 Radar Scope Picture #3220. GILLIAM going down.

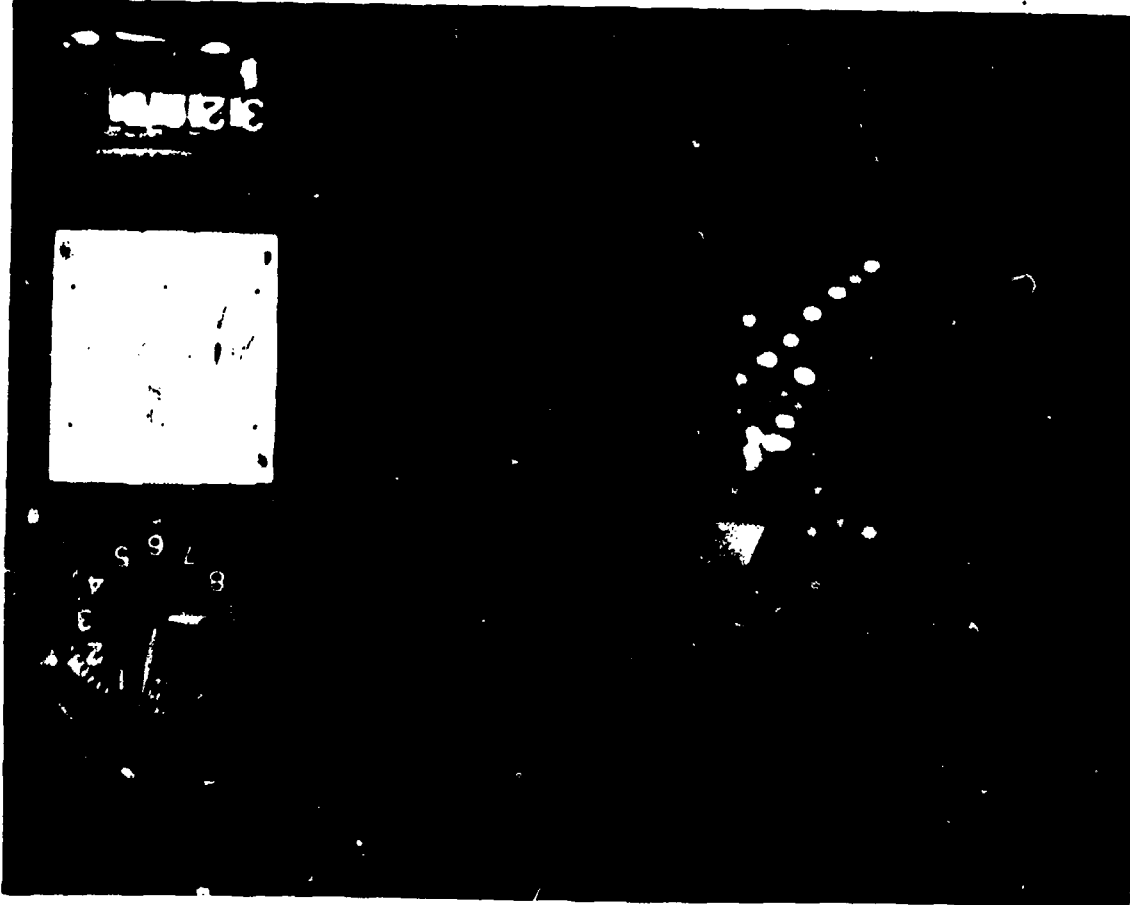
APQ #7 Radar Scope Picture #3225. GILLIAM has disappeared 79 seconds after burst.
