TECHNICAL REPORT
1583/68
of 1968
29 NOV 1965
DEFENSE ATOMIC
SUPPORT AGENCY

PAGE NO.
Ship Characteristics Sheet	3
Midship Section	4
Overall Summary of Damage	5
Hull Technical Inspection Report (Section I)	12
Machinery Technical Inspection Report (Section II)	18
Electrical Technical Inspection Report (Section III)	25
Photographic Section (Section IV)	34
Ship Measurement Data (Appendix)	54
Commanding Officers Report (Appendix)	55

USS BANNER (APA60)

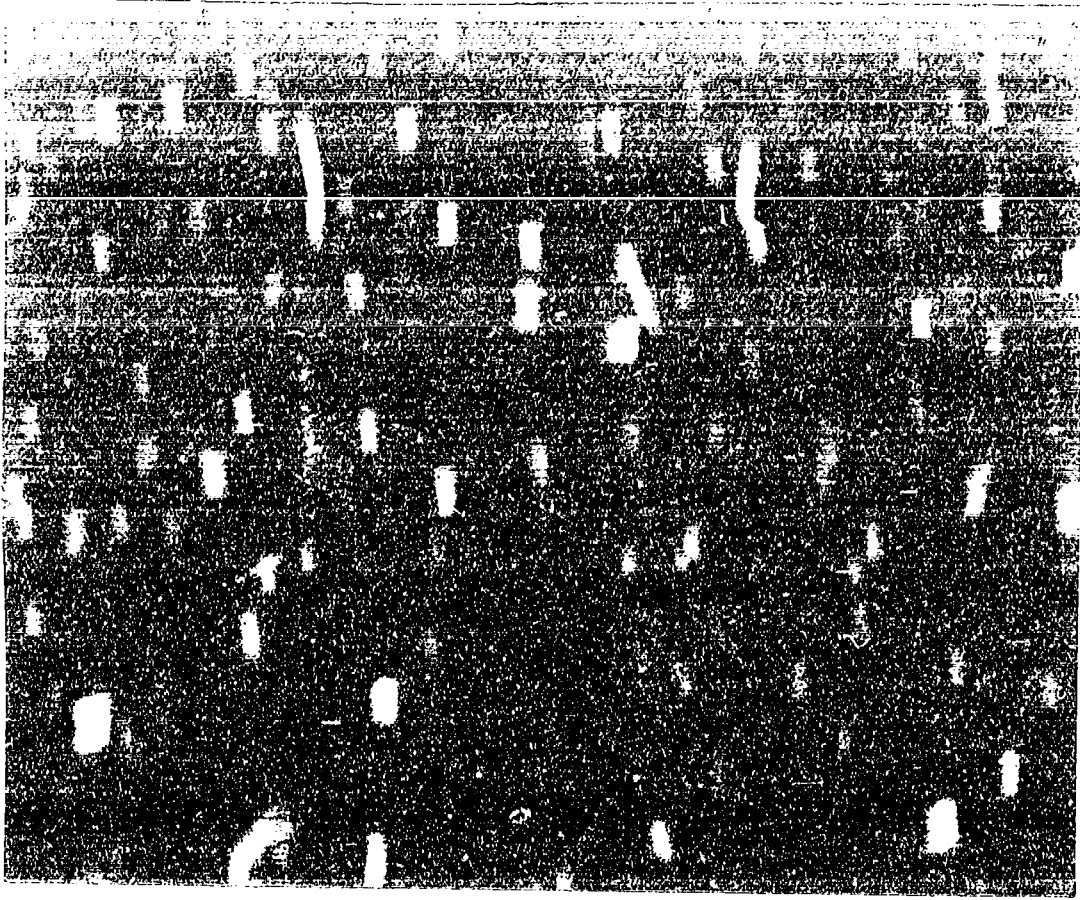
A fire was started by heat radiation in the starboard flagbag and damaged adjacent equipment.

A fire started by heat radiation destroyed the starboard lighting, searchlights, portable announcing equipment, and various electrical cables and junction boxes on the starboard signal bridge. (Photo, 1733-1; page 45). Signal lanterns were burned, exposed cables were scorched.

AA-CR-65-1733-1. Damage caused by fire in starboard flag bag.

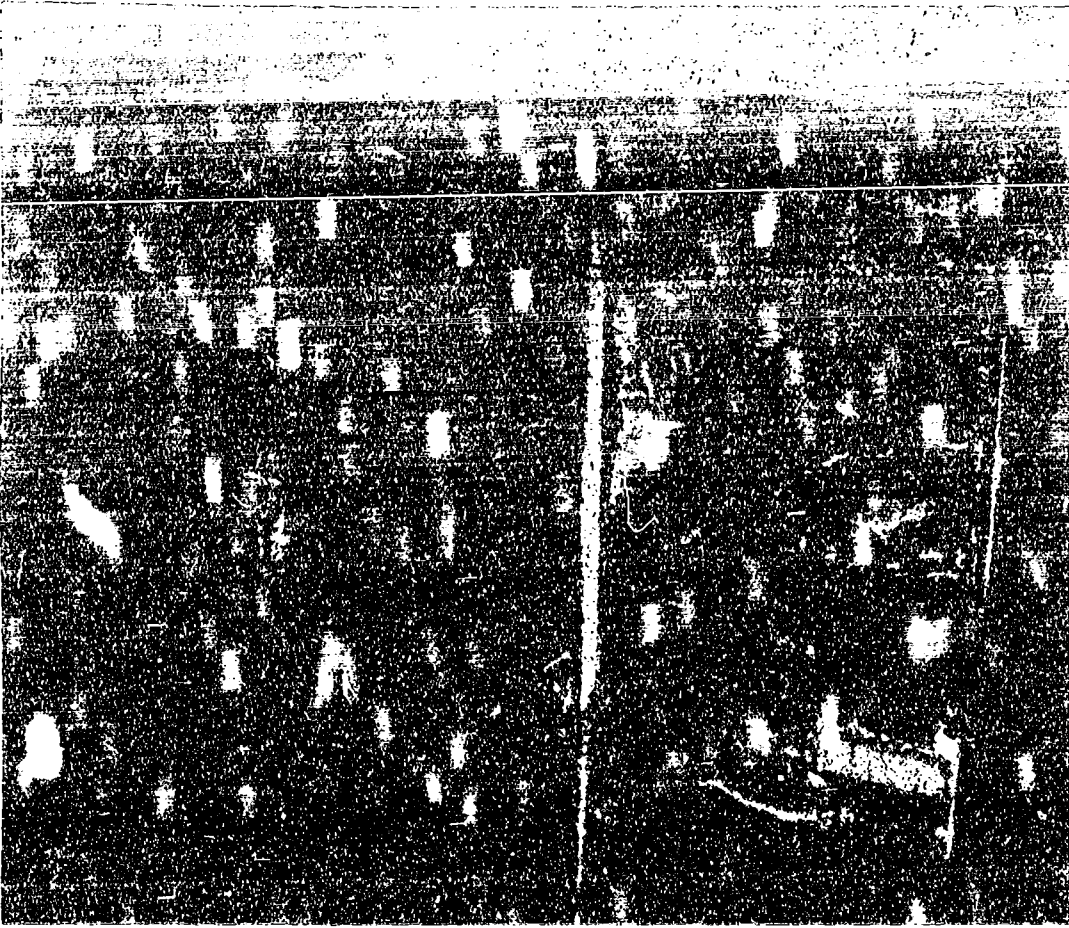
AA-CR-82-1830-1. Holes and dents in pontoons of after cargo hold.

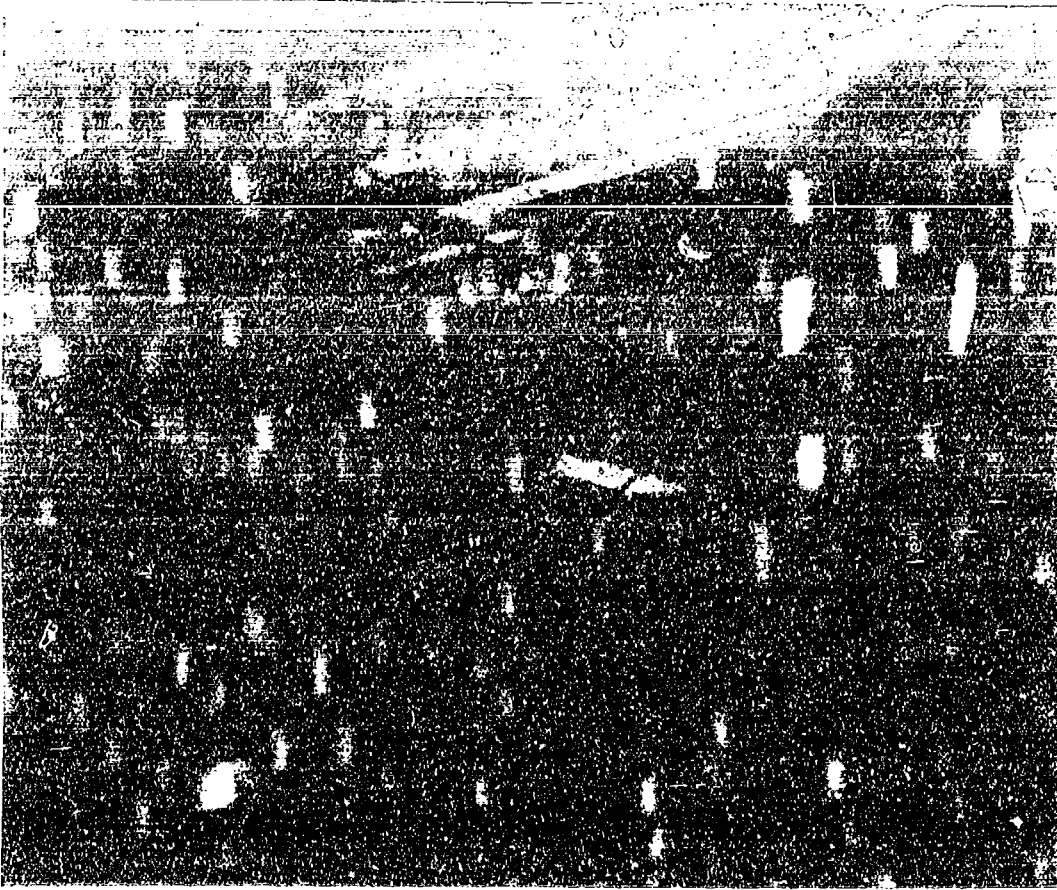
Upper deck main covers fell into main hold, and damaged covers at lower levels (photos 1812-11 and 1812-10, page 47). In the after hold the blast reached on the mainmast frame main covers, deflecting them until they dropped into the hold. Similar damage to main covers occurred in the forward hold. Many small markers were ripped or broken in bulkheads and mainmast. Pipe, stanchion supporting beams also dished or bent (photos 1812-10, 11 and 9, page 45, 46 and 50).

AA-CR-79-1814-11. Wreckage on main deck in forward hold.

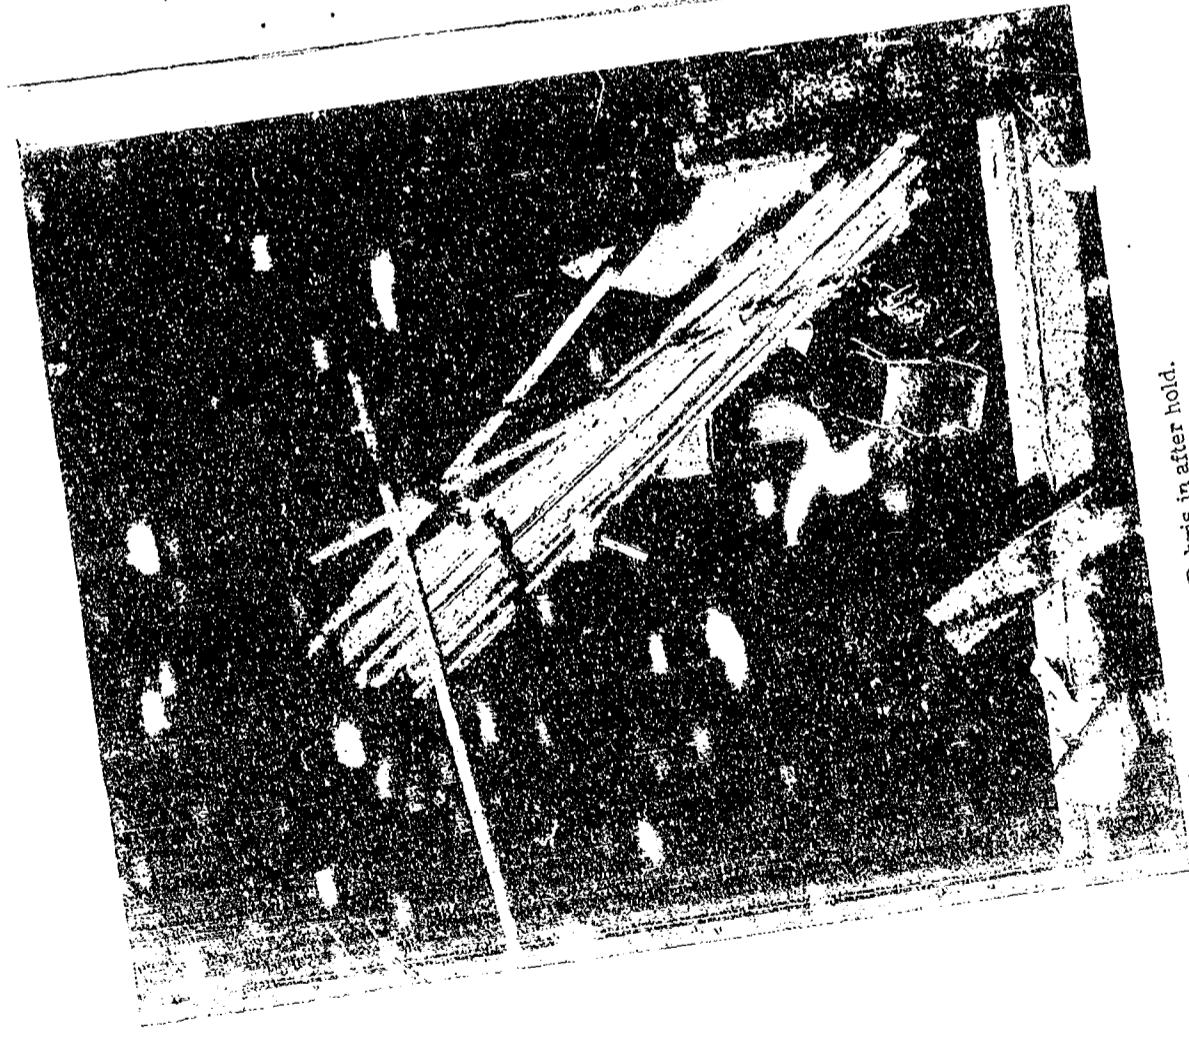
AA-CR-79-1814-8. Debris in after hold.
