AEC RESEARCH AND DEVELOPMENT REPORT

# A Facsimile Report

## DETAILED DESCRIPTION OF HULL DAMAGE

USS BARROW (APA61)

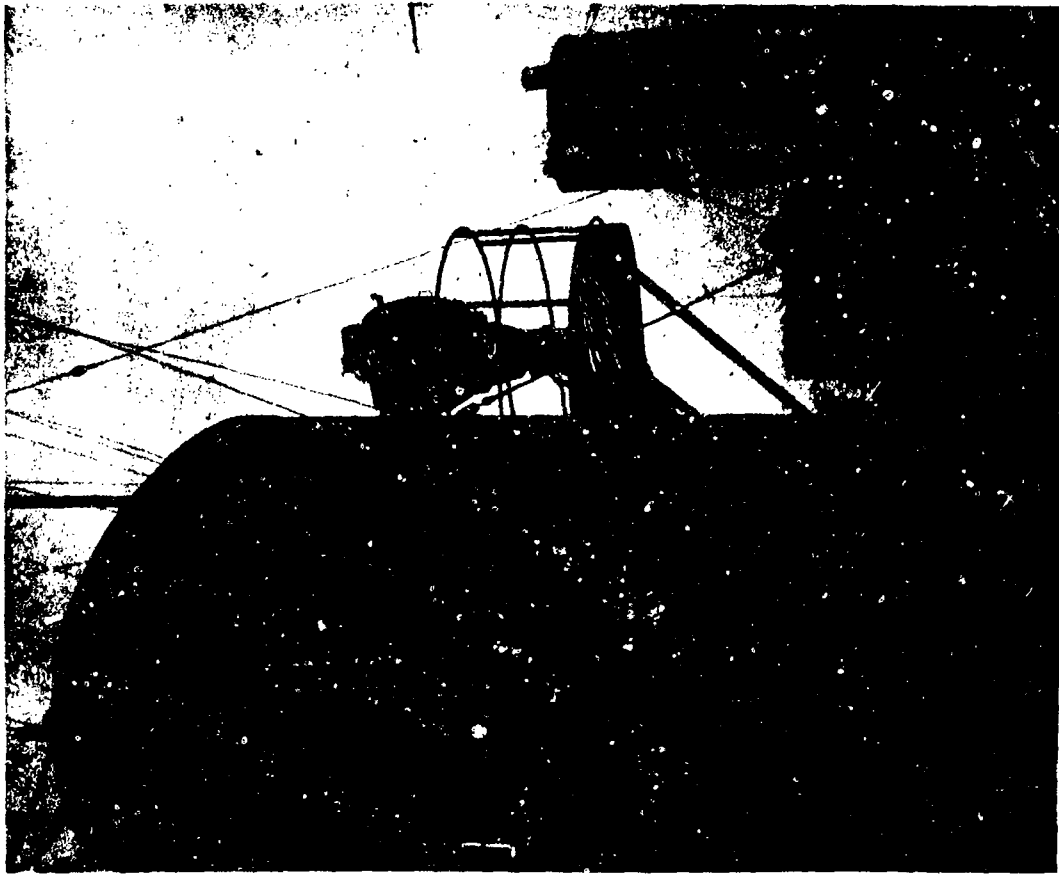
AA-CR-82-1913-3. Looking aft and inboard on port side of the signal bridge at slightly damaged flagbag and ladder to searchlight platform.
