# AEC RESEARCH AND DEVELOPMENT REPORT

#### GENERAL SUMMARY OF HULL DAMAGE

## DETAILED DESCRIPTION OF HULL DAMAGE

USS YO 180

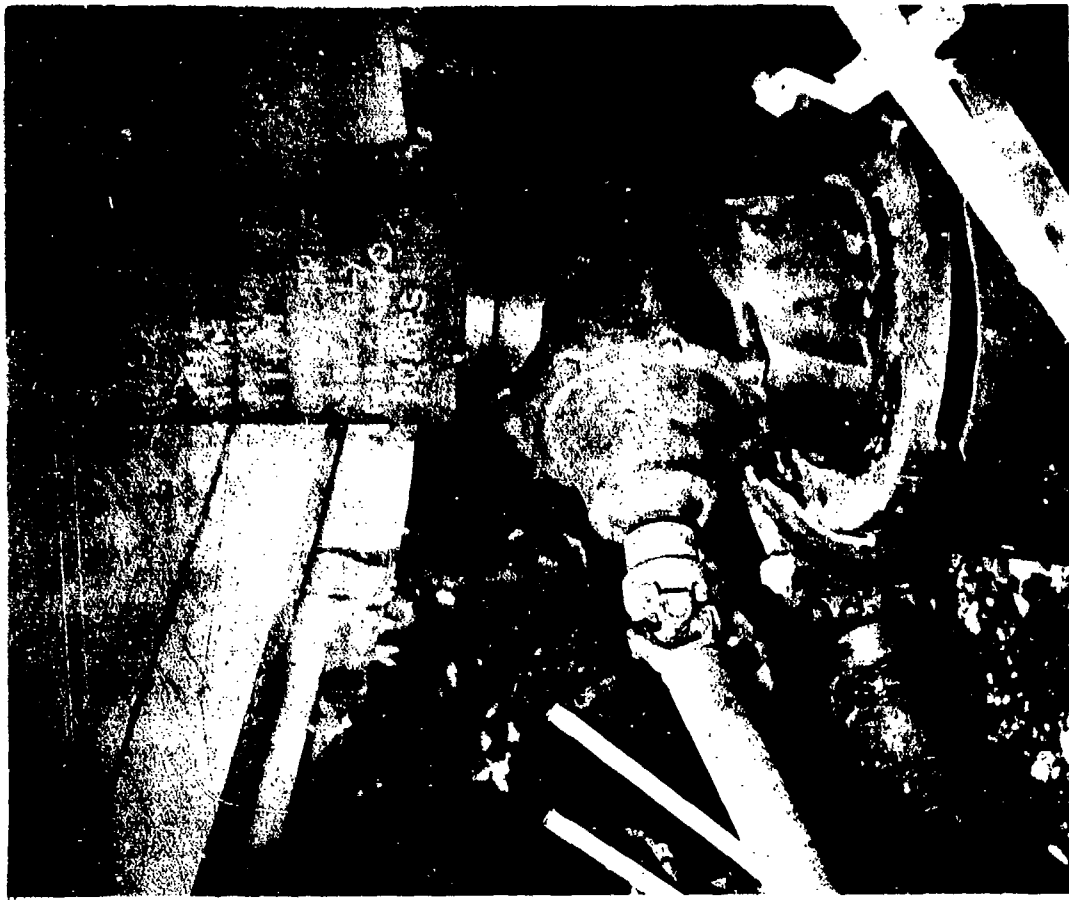
Equipment within the deck houses has been severely damaged by blast, by fire in the after superstructure, and by concrete or debris from falling structure. Pumping machinery in the midship deck house is out of commission (Photos 2161-1, 3, 2162-3, 4, pages 70, 71, 72, and 73). The steering engine can be operated by local control only. (Photo 2161-4, page 61). The ice machinery plant is inoperative.

Compartments above the main deck are uninhabitable. Blast has wrecked structure and equipment. Falling debris has further damaged equipment and in the after superstructure fire did additional damage (Photos 2161-1, 3, 2162-3, 4, 2161-4, pages 70, 71, 72, 73 and 81).

All pumps damaged and inoperable (See photo 2161-1, 3, pages 70 and 71).

AA-CR-88-2161-1. Damage to upper drive assembly for cargo pumps and overhead structure of deck house amidship.

AA-CR-88-2161-3. Damage to upper drive assembly for cargo pumps and overhead structure of deck house amidship.

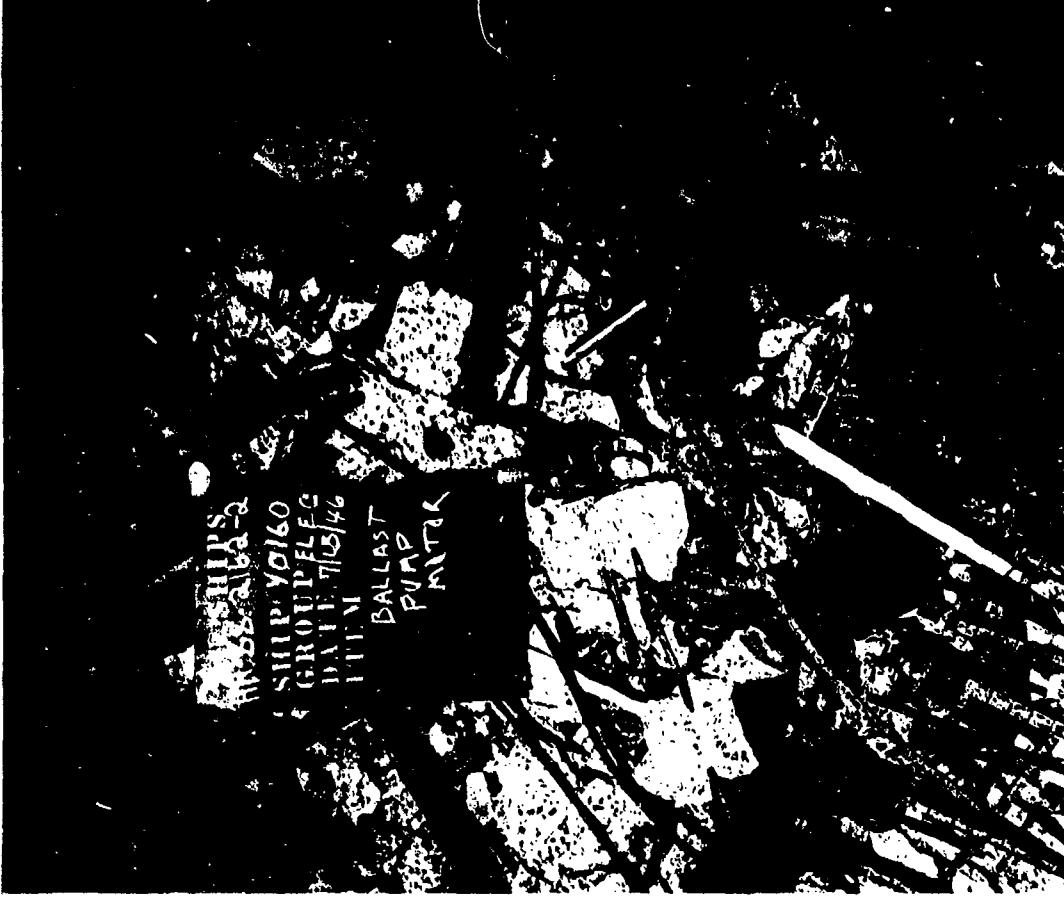
AA-CR-88-2162-3. Interior of deckhouse amidship showing damaged ballast pump motor and rubble from demolished overhead.

AA-CR-88-2162-4. Interior of deckhouse amidship showing damage to overhead bulkhead and ballast pump motor controller.
