22  
1st Part of Report  
No. AAEE/866/5

**AEROPLANE AND ARMAMENT  
EXPERIMENTAL ESTABLISHMENT**

SHACKLETON MK. 2 PHASE 3

NAVIGATION AND RADIO C.A. RELEASE TRIALS

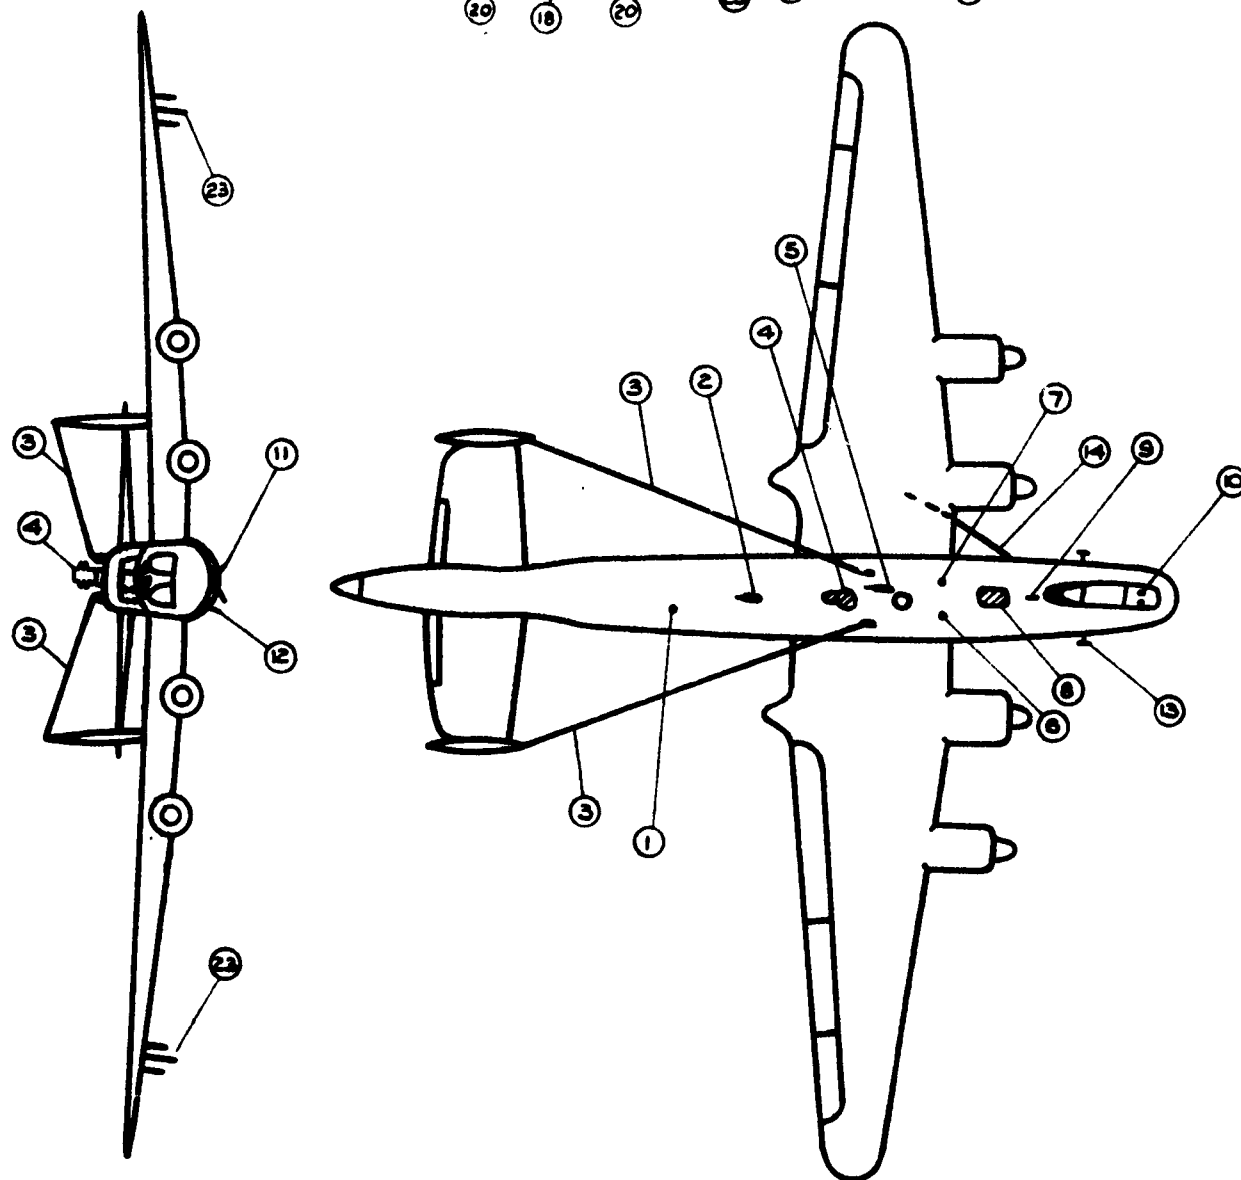
FIG. 1.

The installation of the transmitter/receiver and power unit is adequate. The aerials are in the same position relative to the fuselage as in the Mark 3 aircraft (see Figure 1) but the tail down attitude of the Mark 2 introduces unsatisfactory features. This might be expected in view of the recommendation in Radio Installation memorandum 115 that the aerials should be placed as high as possible on the aircraft. Spurious readings occur on the instrument whilst on the ground and for the first few feet after take-off. Therefore it is recommended that the radio altimeter readings are not used below 50 feet and that the zero control on the indicator be set to 7 feet regardless of the readings observed on the ground whilst the equipment is switched on.

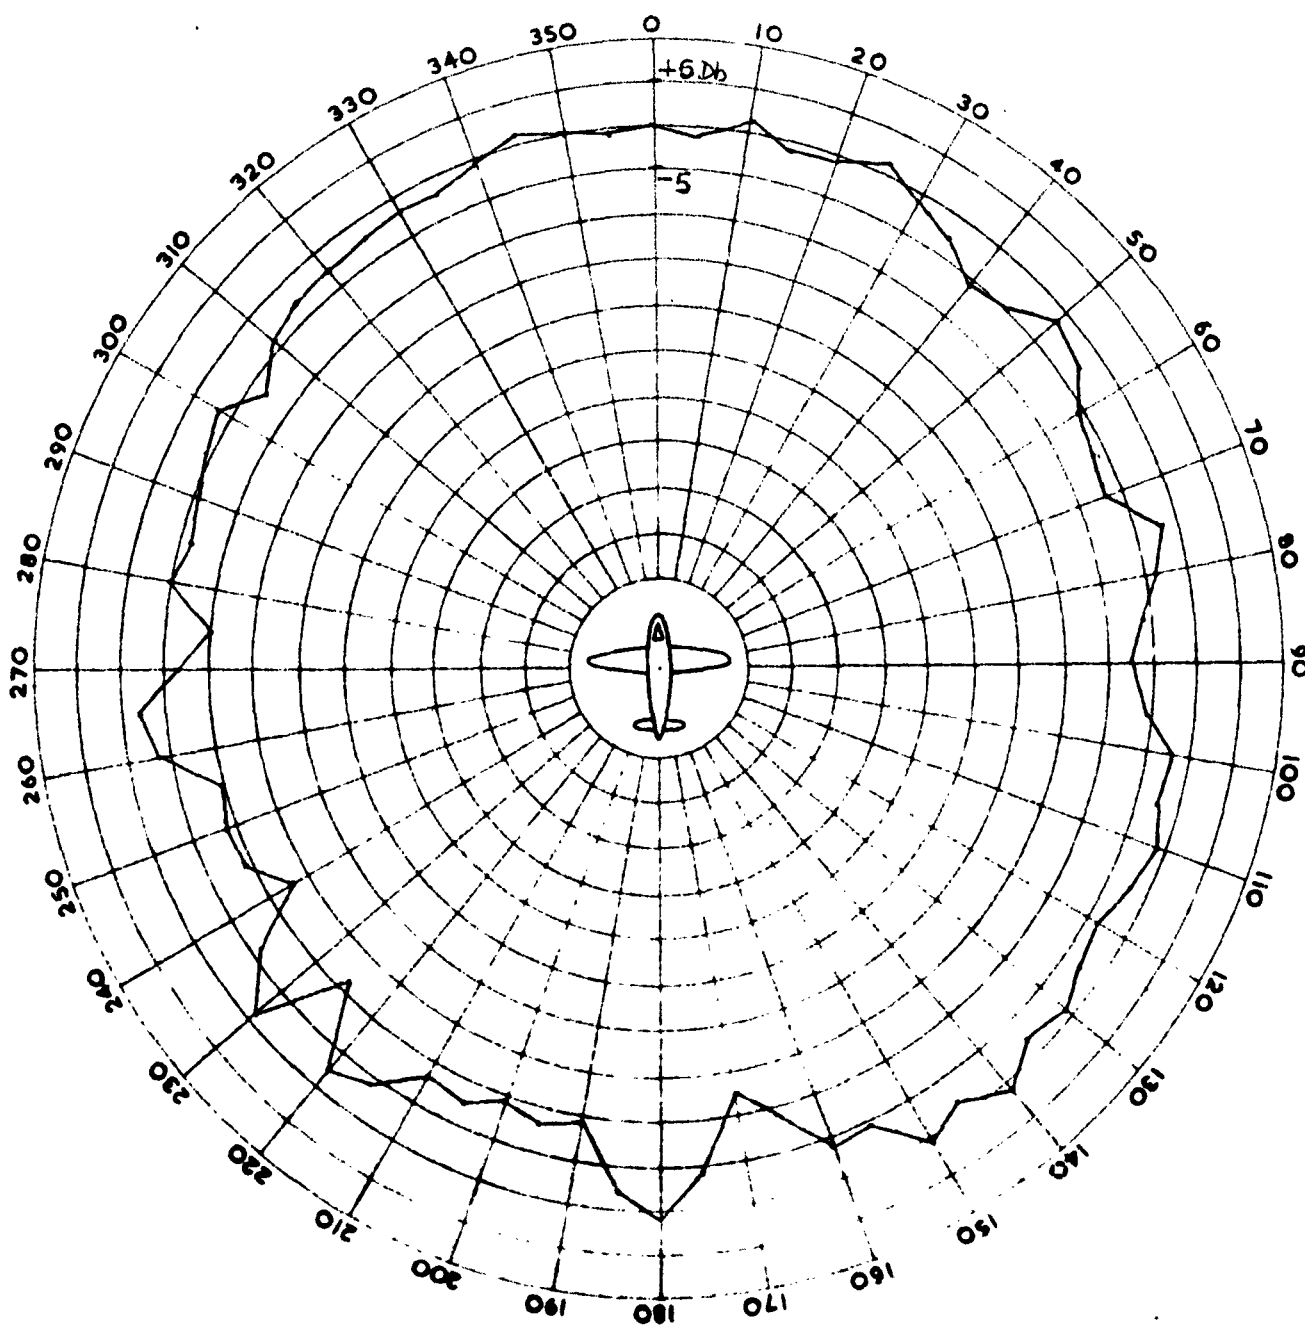
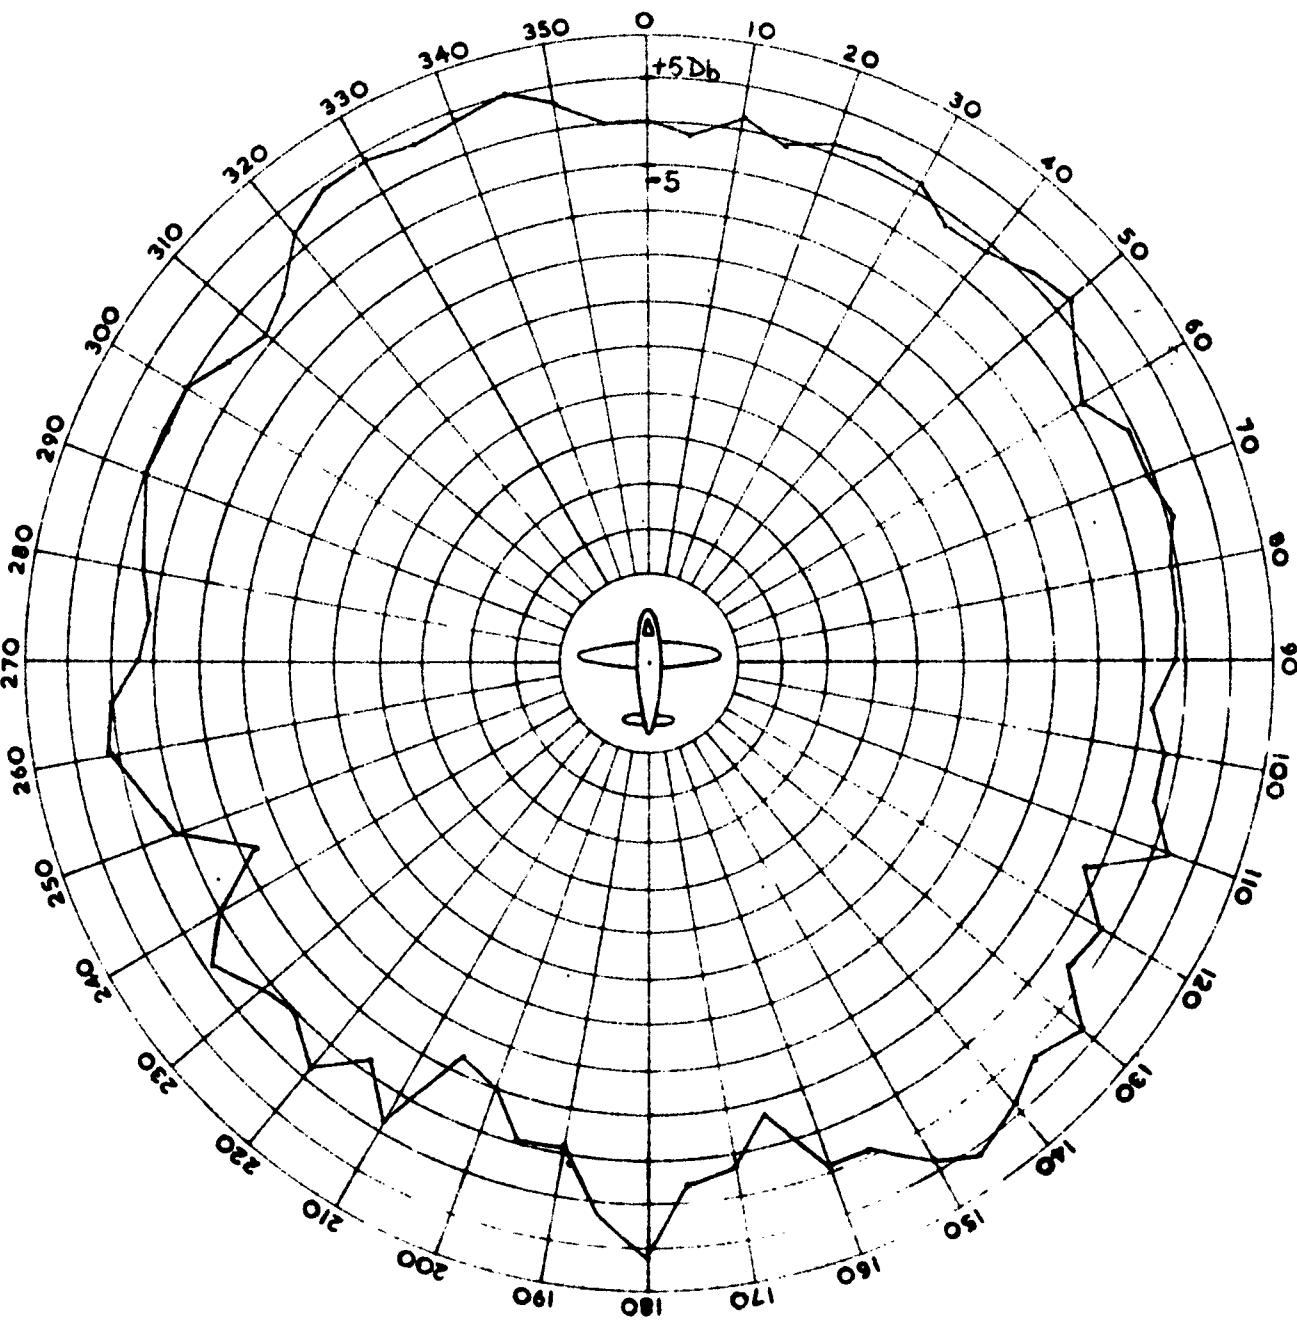
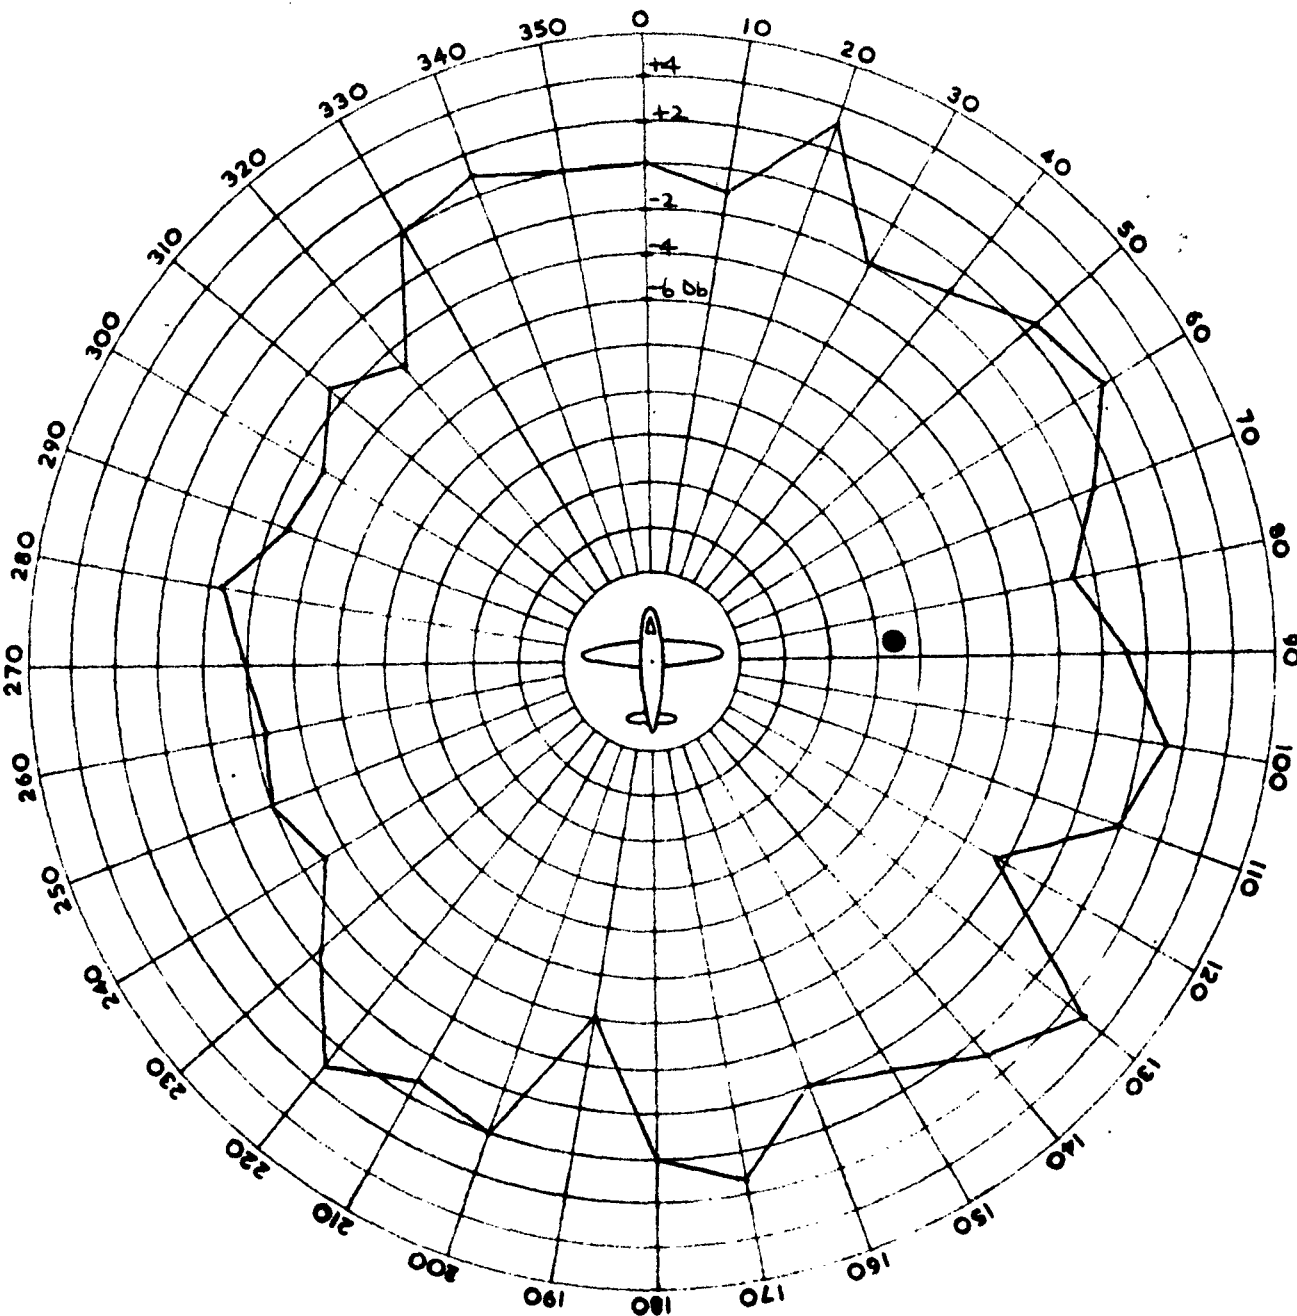
The installation of the Twin Sonobuoy 1C system is adequate including the new forward aerial. The radiation patterns of this aerial (Figures 7 - 10) indicate that its performance matches that of the existing aerial. It does not conform to Specification RAE/XRSP 3381 in that there are excursions in the pattern greater than 2 dB from the head on aspect, but acceptance of this is recommended in view of the practical results obtained. The Sonobuoy Homer and Homer/Violet Picture Switching Installations are analogous to the Phase 2 fit; the aerial installations continue to be unsatisfactory as exemplified by the failure of both aerials under moderate icing conditions in flight.

C.A. release is recommended for the sonics system except for the homer aeriels, but it is recommended that further investigations be made into the susceptibility of the sonics receivers to H.F. harmonic interference (see Appendix II). The homer aerial fault is well known and must be rectified without delay.
