# CATEGORY II TEST REPORT FOR WIND MEASURING SET AN/TMQ-15

CATEGORY II TEST REPORT FOR  
WIND MEASURING SET AN/TMQ-15

Weather Observing and  
Forecasting System 433L  
(Contract No. AF 19(626)-16)

Report No. WSC E-29

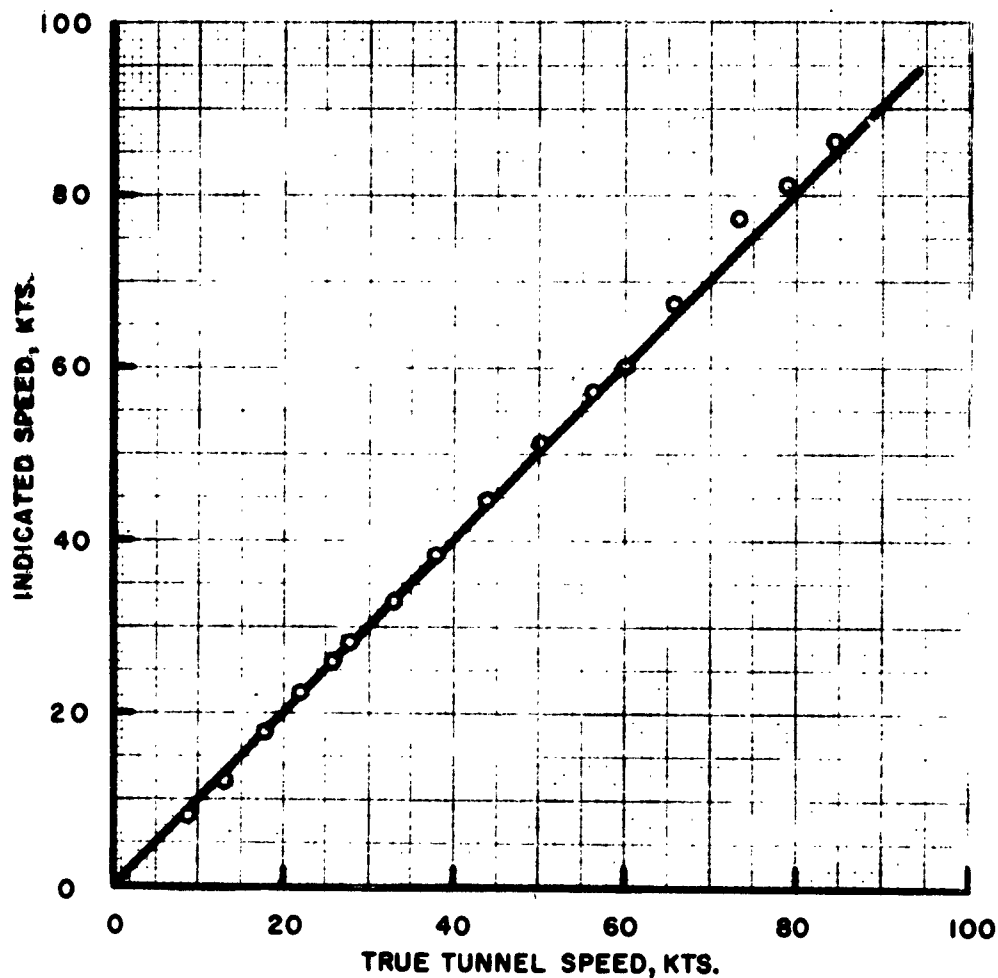
FIG. 4

6.3.1 From examining the curves of Figures 4, 5, and 6 no radical departure from the true value of air speed is observed. Difficulty was experienced in reading the AN/TMQ-15 Wind Speed Indicator and the Eput count (item of test equipment) from the wind speed transducer above 65 knots. It was observed that the AN/TMQ-15 Wind Speed Indicator was fluctuating approximately  $\pm 2$  knots; a similar phenomenon was also observed on the Eput meter. It was further noted that at 65 to 80 knots the anemometer cup assembly did not track smoothly in the horizontal plane. This is probably due to a slight dynamic unbalance in the anemometer cup assemblies which provided a wobbling of the shaft of the light chopper and, in turn, the production of unsteady pulses. This phenomenon explains the scatter in data shown in Fig. 8 at speeds above 65 knots.
