### DYNAMIC TEST OF AN AIRCRAFT LITTER INSTALLATION

One of a Series of Reports Pertaining to the  
Dynamic Crash Test of a U.S. Army H-21 Helicopter

March 1963

TRECOM Technical Report 63-3

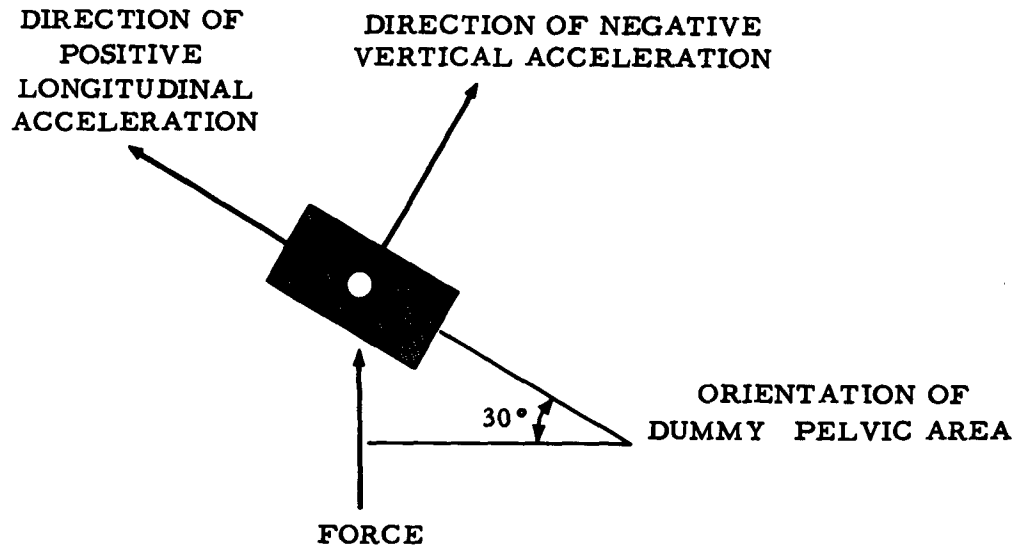
5. The contact of the bottom dummy with the floor of the aircraft resulted in oscillatory "longitudinal" acceleration as measured in the pelvic region of the dummy. A positive (forward) longitudinal acceleration of 50G is seen to have occurred at 0.21

second (Figure 17-5) in conjunction with the 50 (plus) G vertical acceleration. This positive acceleration was due to the orientation of the dummy and thus of the accelerometer at contact, allowing a negative "vertical" acceleration to be recorded as a positive "longitudinal" acceleration. A similar situation existed for the upper dummy, as seen in Figure 17-3. This action is illustrated in Figure 16.

Figure 16. Free-Body Diagram of the Upper Dummy Pelvic Region.

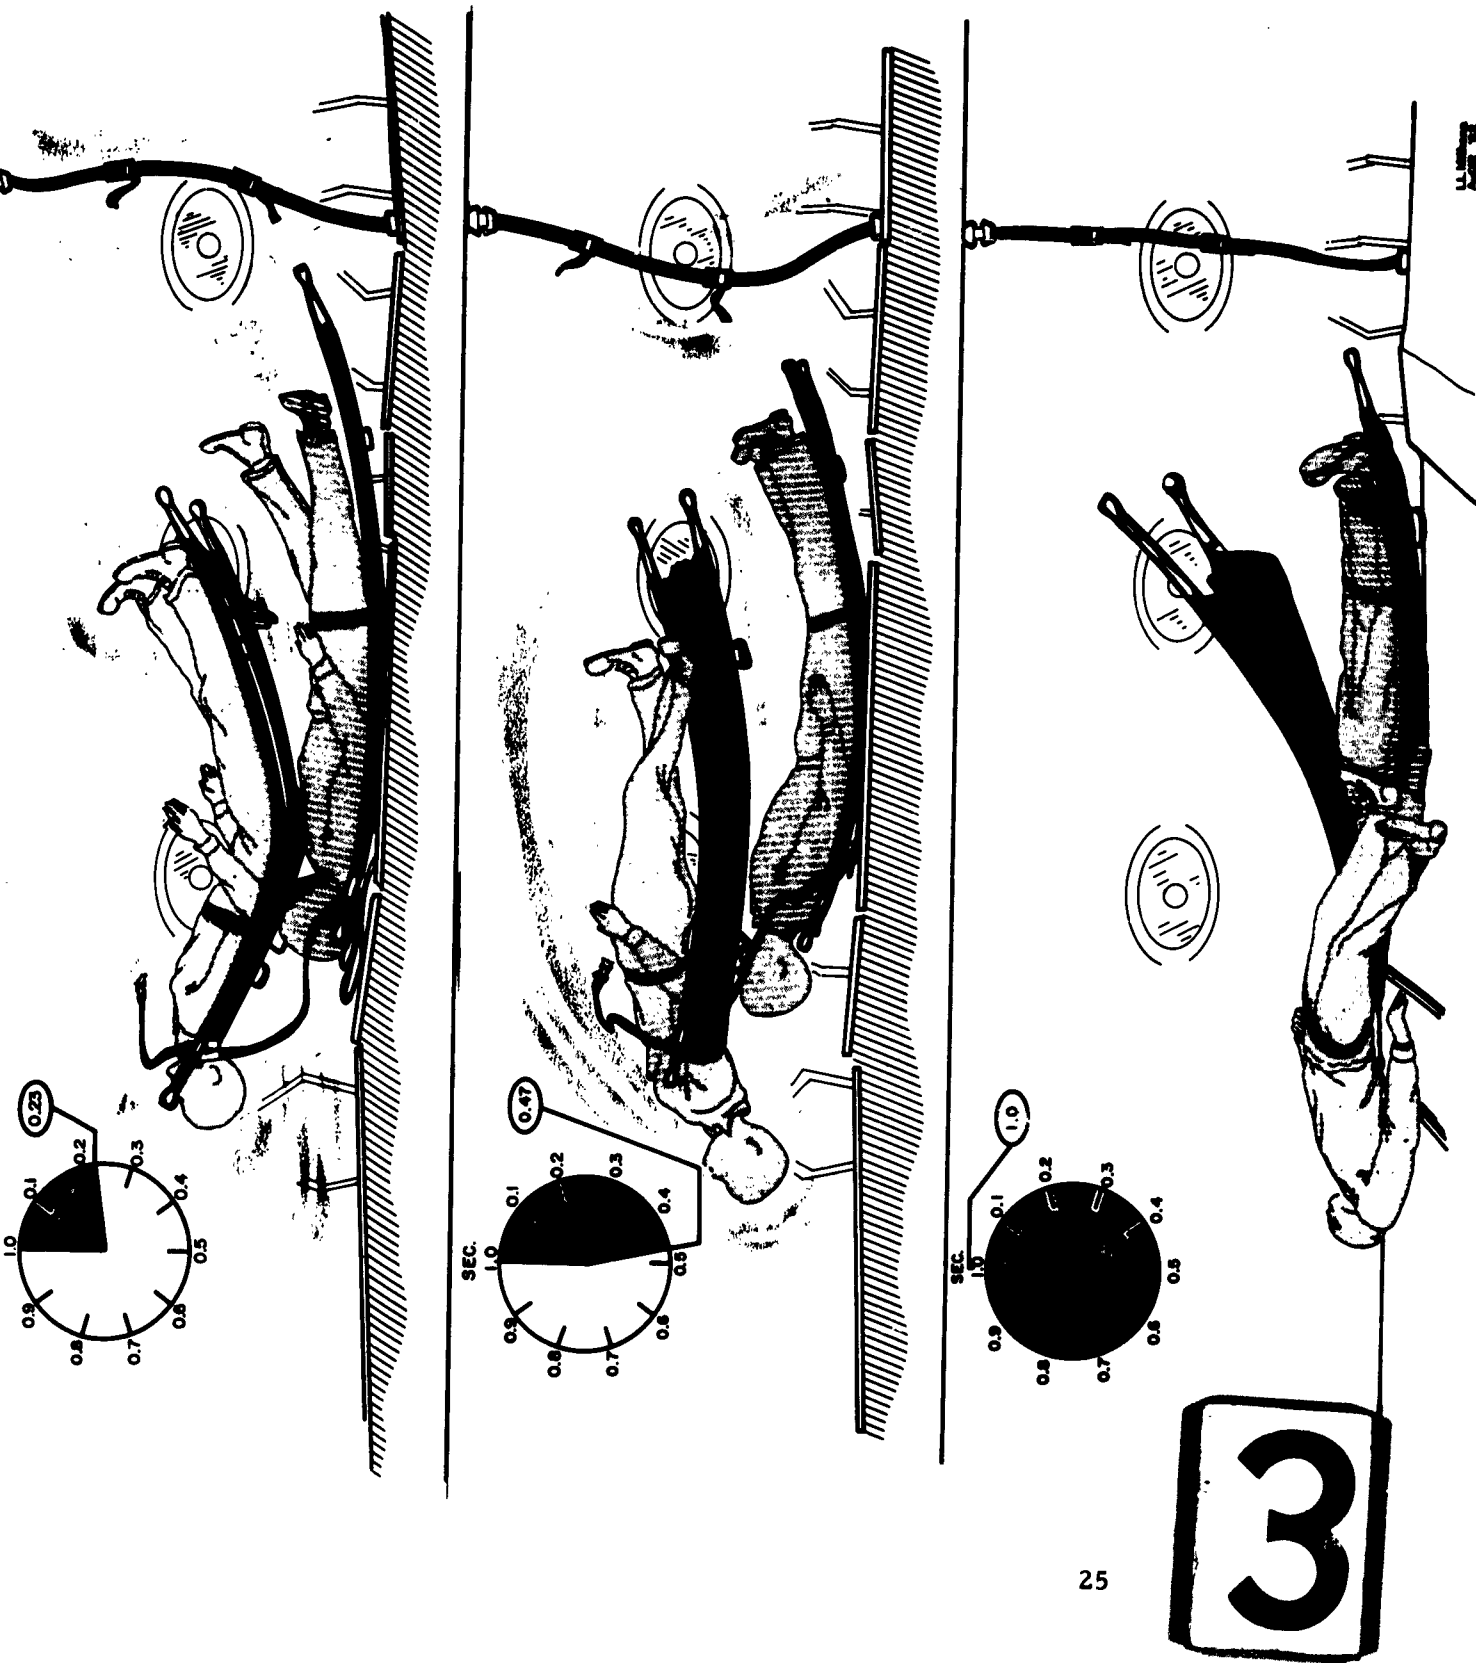
3. Both the upper and lower litters slipped out of the brackets attached to the rear support strap with subsequent reduction in load in the strap. The rear strap and its support system did not fail.

4. The forward litter strap reached a load of over 900 pounds at the time of separation of the rear litter handles from the rear strap. This load dropped to about 800 pounds at 0.21 second and then immediately dropped to zero as the support at the cabin ceiling failed.

6. The top litter patient impacted the lower dummy at 0.23 second, as shown in Figure 18. A "vertical" acceleration of 125G (see Figure 17-4) and a simultaneous longitudinal acceleration of 70G (Figure 17-3) were recorded. A positive vertical acceleration of 150G (Figure 17-6) was also recorded in the lower dummy. A positive acceleration in this instance implies that downward load has been applied as was obviously the case here.

Figure 18. Kinematic Drawing of Litter Restraint System During the Crash Impact Sequence.
