TECHNICAL REPORT 3058

MALFUNCTION INVESTIGATION  
OF  
CARTRIDGE, 81 - MILLIMETER: HE, M43A1  
AND  
M43A1B1, W/VARIOUS FUZES  
AND

CARTRIDGE, 81 - MILLIMETER: SMOKE, WP, M57A1,  
W/FUZE, TSQ, M77

FEBRUARY 1963

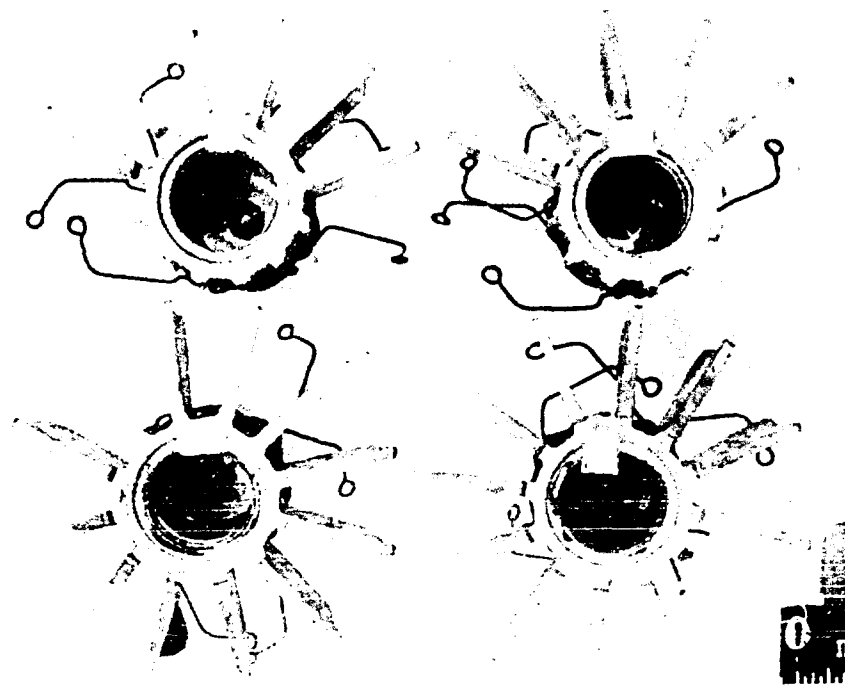
3. A photograph taken of a short round when it was ten feet from the muzzle of the weapon did not show broken fins, although broken fins were found when the round was recovered. Most rounds have their fins broken off upon impact (Figure 3 & 4). It is therefore concluded that the broken fins did not cause the five short-range rounds at Aberdeen.

(Table 1). The average velocity for 36 rounds was 465 fps, average pressure was 3,430 psi. The expected velocity for Charge 3, according to FT 81-AB-1, is 466 fps. Projectiles 4, 8, 12, and 14 fell substantially short of the intended range. The projectiles from Sample 4, 8, 12, and 14 were recovered and inspected. Sample 8 and 14 each were found to have had one fin blade broken off at the base (Figure 3). Six blades from Sample 4 and seven blades from Sample 12 were broken off in the same way (Figure 3). All samples had fallen into a soft, marshy area. Pictures of the four broken fin assemblies were taken. The consistent values found for pressures and velocities indicate that the ignition system and the propellant increments had not been affected by moisture. The broken fins found on all four short-range rounds were indicative of the probable cause of the malfunction. However, when the impact area was safe to enter, the fin assemblies from 11 projectiles which reached a range of 1,500 yards were recovered. It was found that 10 of the 11 assemblies had broken fin blades (Figure 4).

fired (Table 2). In addition, smear photographs were taken of each item approximately 10 feet from the muzzle. The average velocity for all 26 rounds was 464 fps and the average pressure was 3,375 psi. Projectile 19 fell substantially short of the intended range. When the fin assembly from this round was recovered it was found that some of the fins had broken off. However, examination of the photographs proved that the fins were intact when the projectile was leaving the tube.

Figure 3. Condition of Fin Assemblies Recovered from Short-Range Rounds  
(Test Round Numbers Are Indicated)
