COOPERATIVE MARINE PILING INVESTIGATION: PHASE I -  
PILE DRIVING AT COCO SOLO, CANAL ZONE

TN-473

29 April 1963

U. S. Naval Civil Engineering  
Laboratory  
Port Hueneme, California

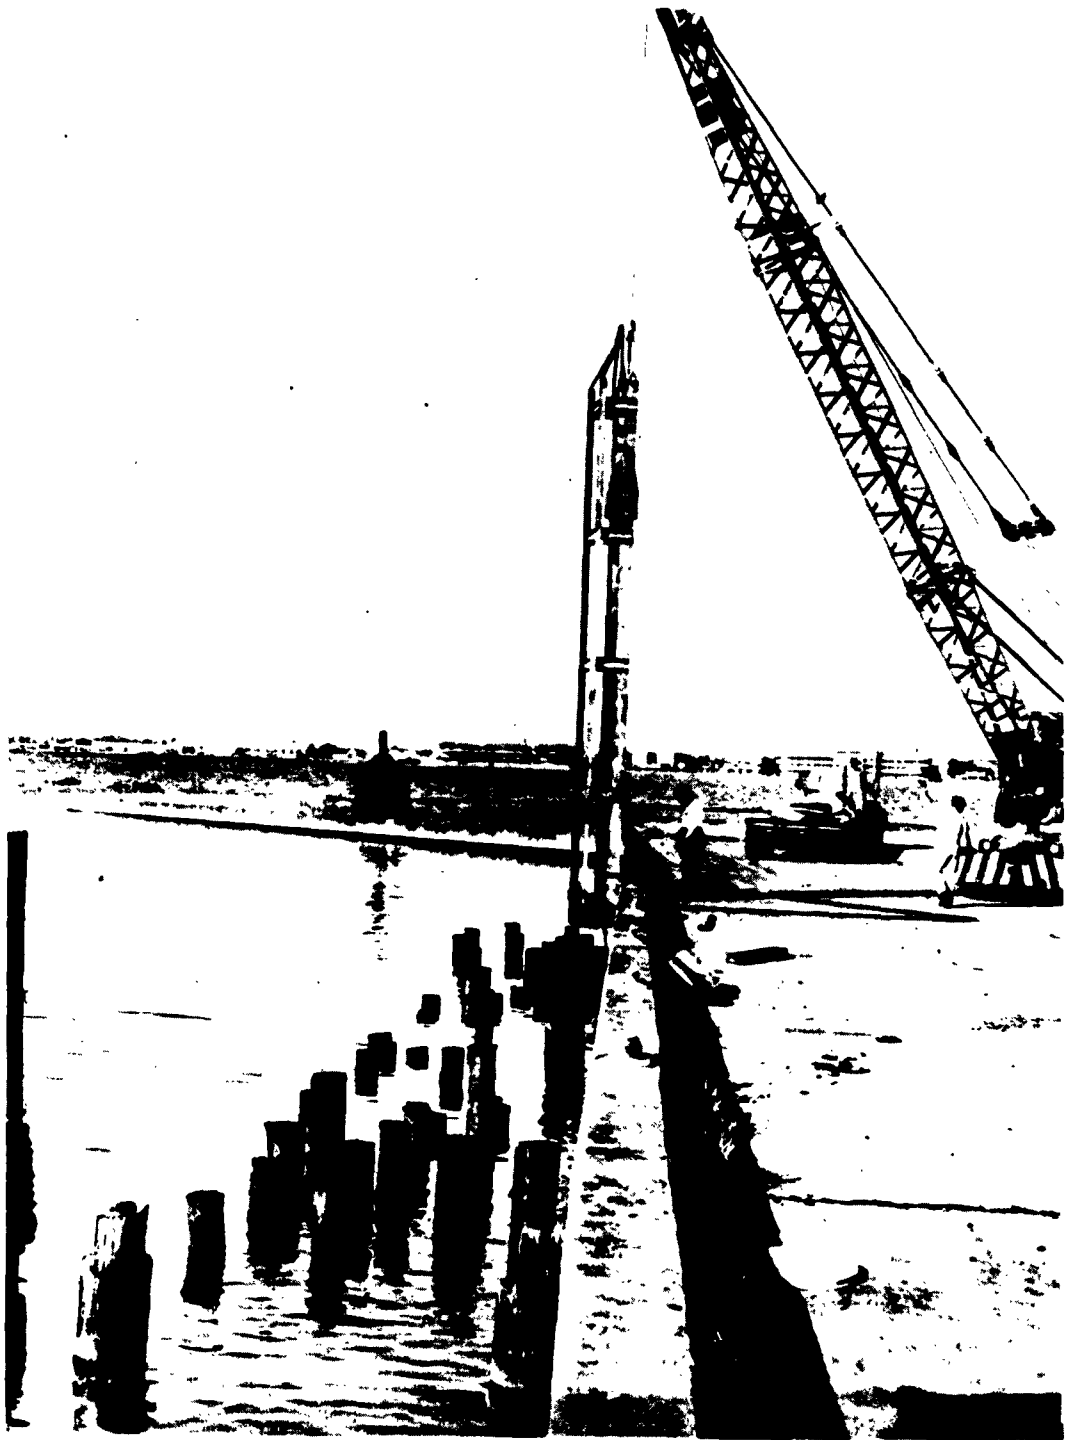
Figure 14. Appearance of area after pile driving was completed

built about 1954. These piles have been badly attacked by Limnoria and from one-third to one-half of the cross section of these piles is gone in the mid-tide zone. The photograph was taken at high tide so the borer damage is not visible.

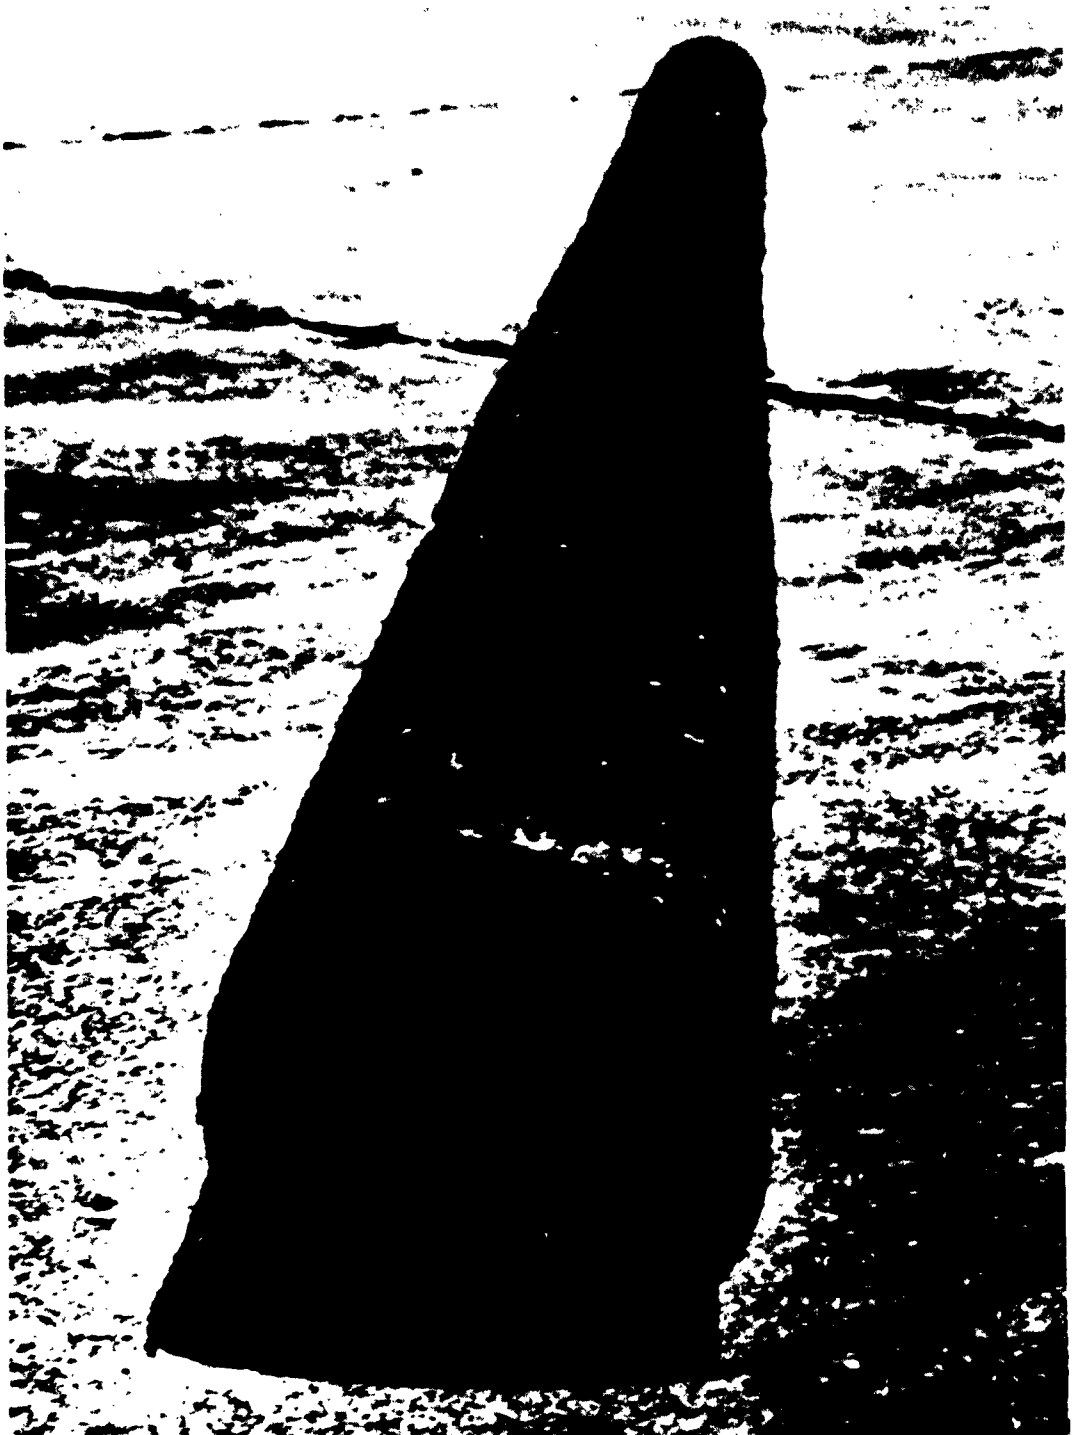
The System 1 Piles -- the Douglas Fir piles treated with ammoniacal copper arsenate followed by creosote -- were all badly checked, as shown in Figures 15, 16, 17, and 18. The crack shown in Figure 17 went all the way through the pile. The pile probably cracked during the drying operation after the initial impregnation with the aqueous solution because the inside surfaces appeared to be well treated with creosote.

Figure 16. End view of Group 1 pile showing typical cracking pattern

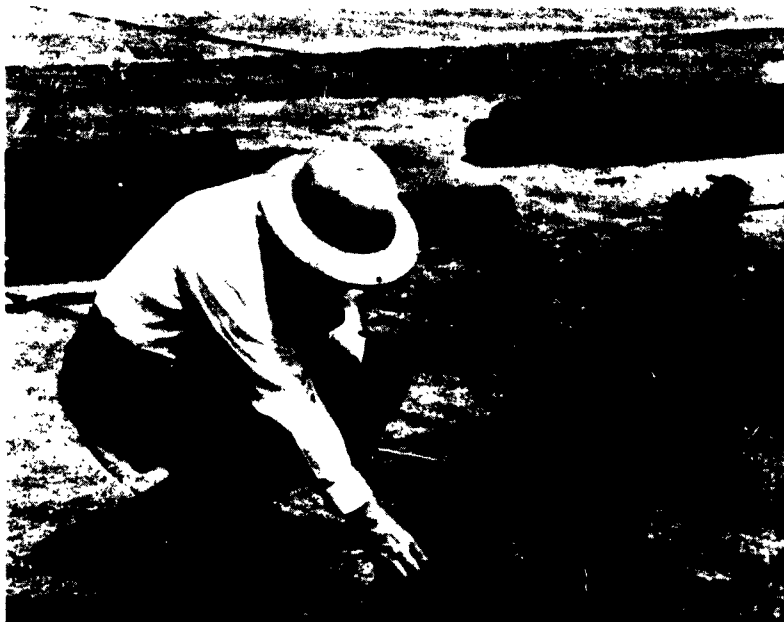
Figure 17. Pen being inserted into crack
