# DESIGN DIVISION TECHNICAL REPORT

**PHILADELPHIA NAVAL SHIPYARD**  
**PHILADELPHIA, PENNSYLVANIA**

COLLECTION OF LETTER REPORTS  
OF VIBRATION SURVEYS  
ISSUED DURING 1962

F. A. HEINZE  
AND  
D. S. BROGDEN

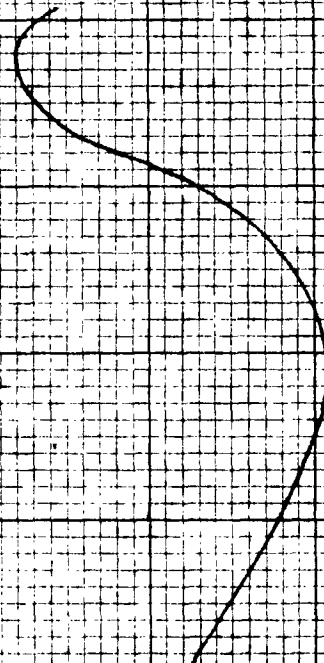
PHILADANVSHIRMD  
SHIP REPORT 2651-29  
SHEET 3 OF 3

5. The results of the survey are presented on *sheet (3) of (3)*. Two distinct first order (one vibration cycle per shaft revolution) critical speeds are present. The lower critical speed was 240 RPM with a displacement amplitude of  $\pm 8.7$  mils. The upper critical speed was 315 RPM with a displacement amplitude of  $\pm 14$  mils.

6. Based on measurements on a great many vessels, the New York Naval Shipyard Material Laboratory has established the tolerable limit of  $\pm 18$  to  $\pm 20$  mils (measured on the O2 level approximately frame 74) for first order athwartship vibration on this class vessel. Therefore the hull vibration amplitudes measured on this vessel are considered acceptable.

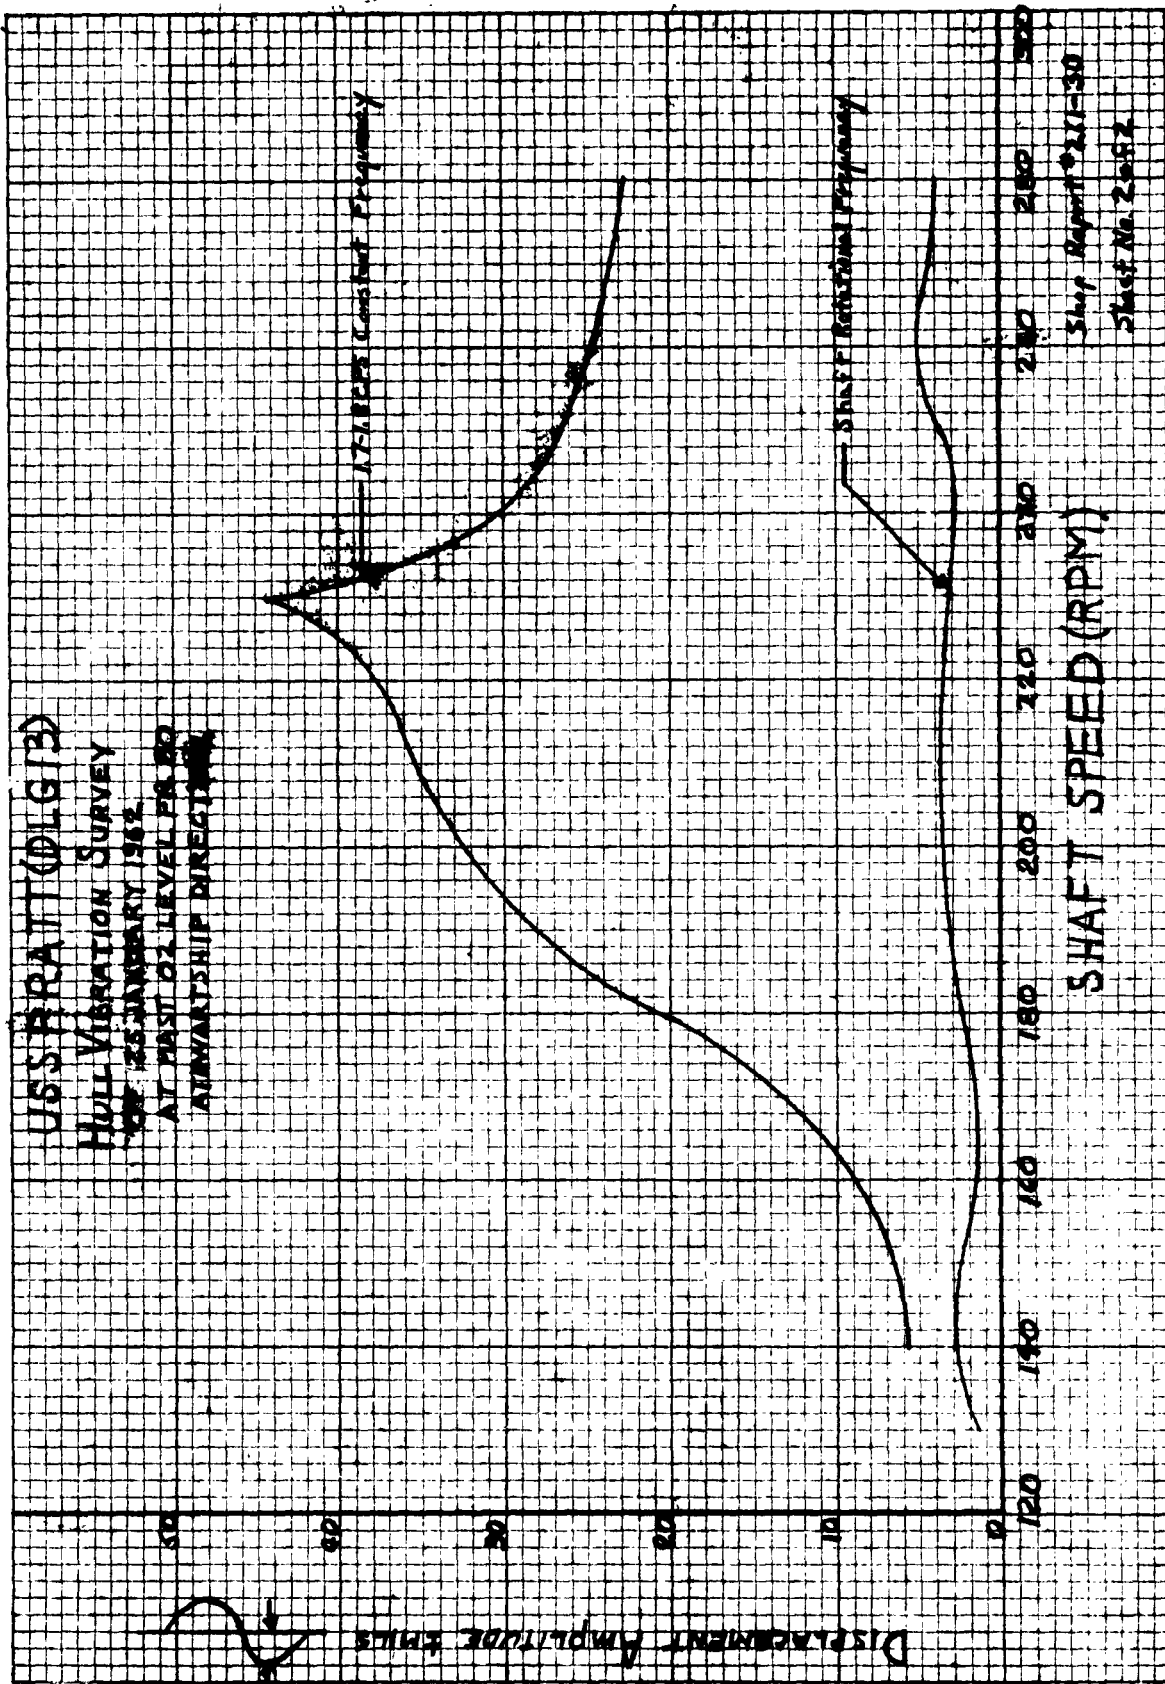
Ship Report # 211-30  
Sheet No. 2 of 2

3. The results of the survey are presented in graphical form on sheet 2 of 2 of this report. There does not appear to be any first order (one vibration cycle/shaft revolution) critical speed present. The maximum displacement amplitude of the first order vibration was  $\pm 5.0$  mils at 260 shaft RPM. Propeller blade frequency vibration (4th order) was observed from 130 to 250 RPM but never exceeded a displacement amplitude of  $\pm 0.5$  mils.

4. The most prevalent vibration observed throughout the speed range was a 1.7-1.8 cps constant frequency which is independent of shaft speed and most likely hydrodynamically excited. A critical occurred at 230 RPM with a displacement amplitude of  $\pm 44.6$  mils.

5. The hull vibration amplitudes measured on this vessel are considered to be acceptable.

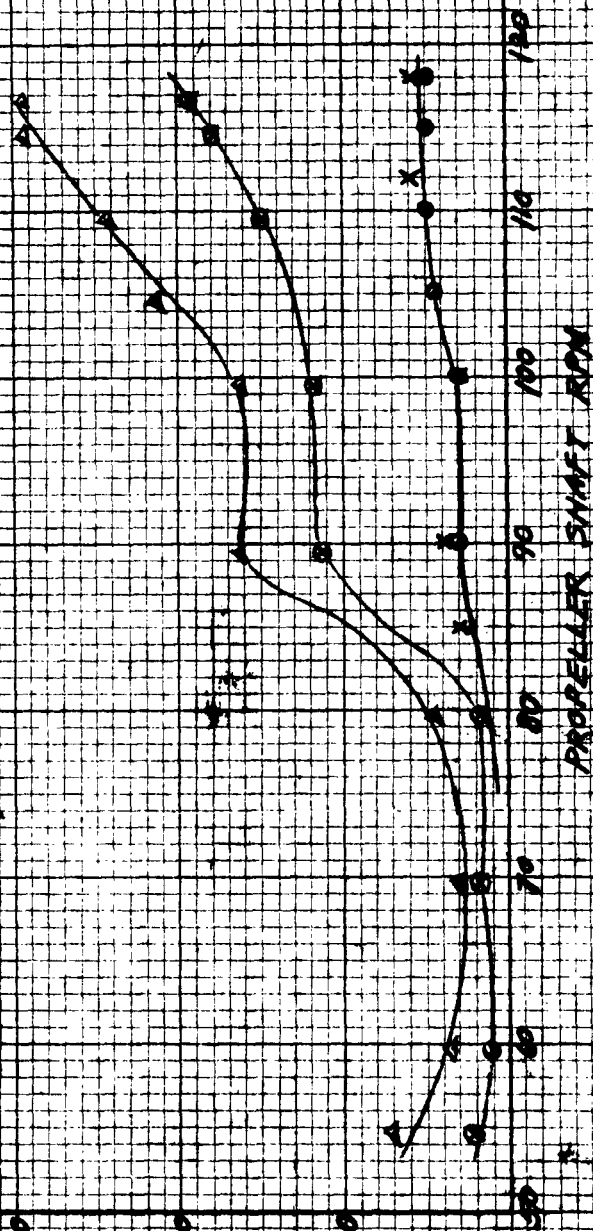
FIGURE 2

4. Results of the measurements at the towing pad, Frame 141, are plotted in figures 1 and 2 of enclosure (1). Data obtained on USS IWO JIMA (LPH-2) at 15,900 tons displacement on 10 January 1962 are plotted for comparison. It should be pointed out that vibration levels during hard turns are far from steady and the maximum amplitudes were found to vary considerably between various turns at the same rudder angle and speed. Therefore, the comparison between LPH-2 and LPH-3 in hard turns should not be given too much weight.

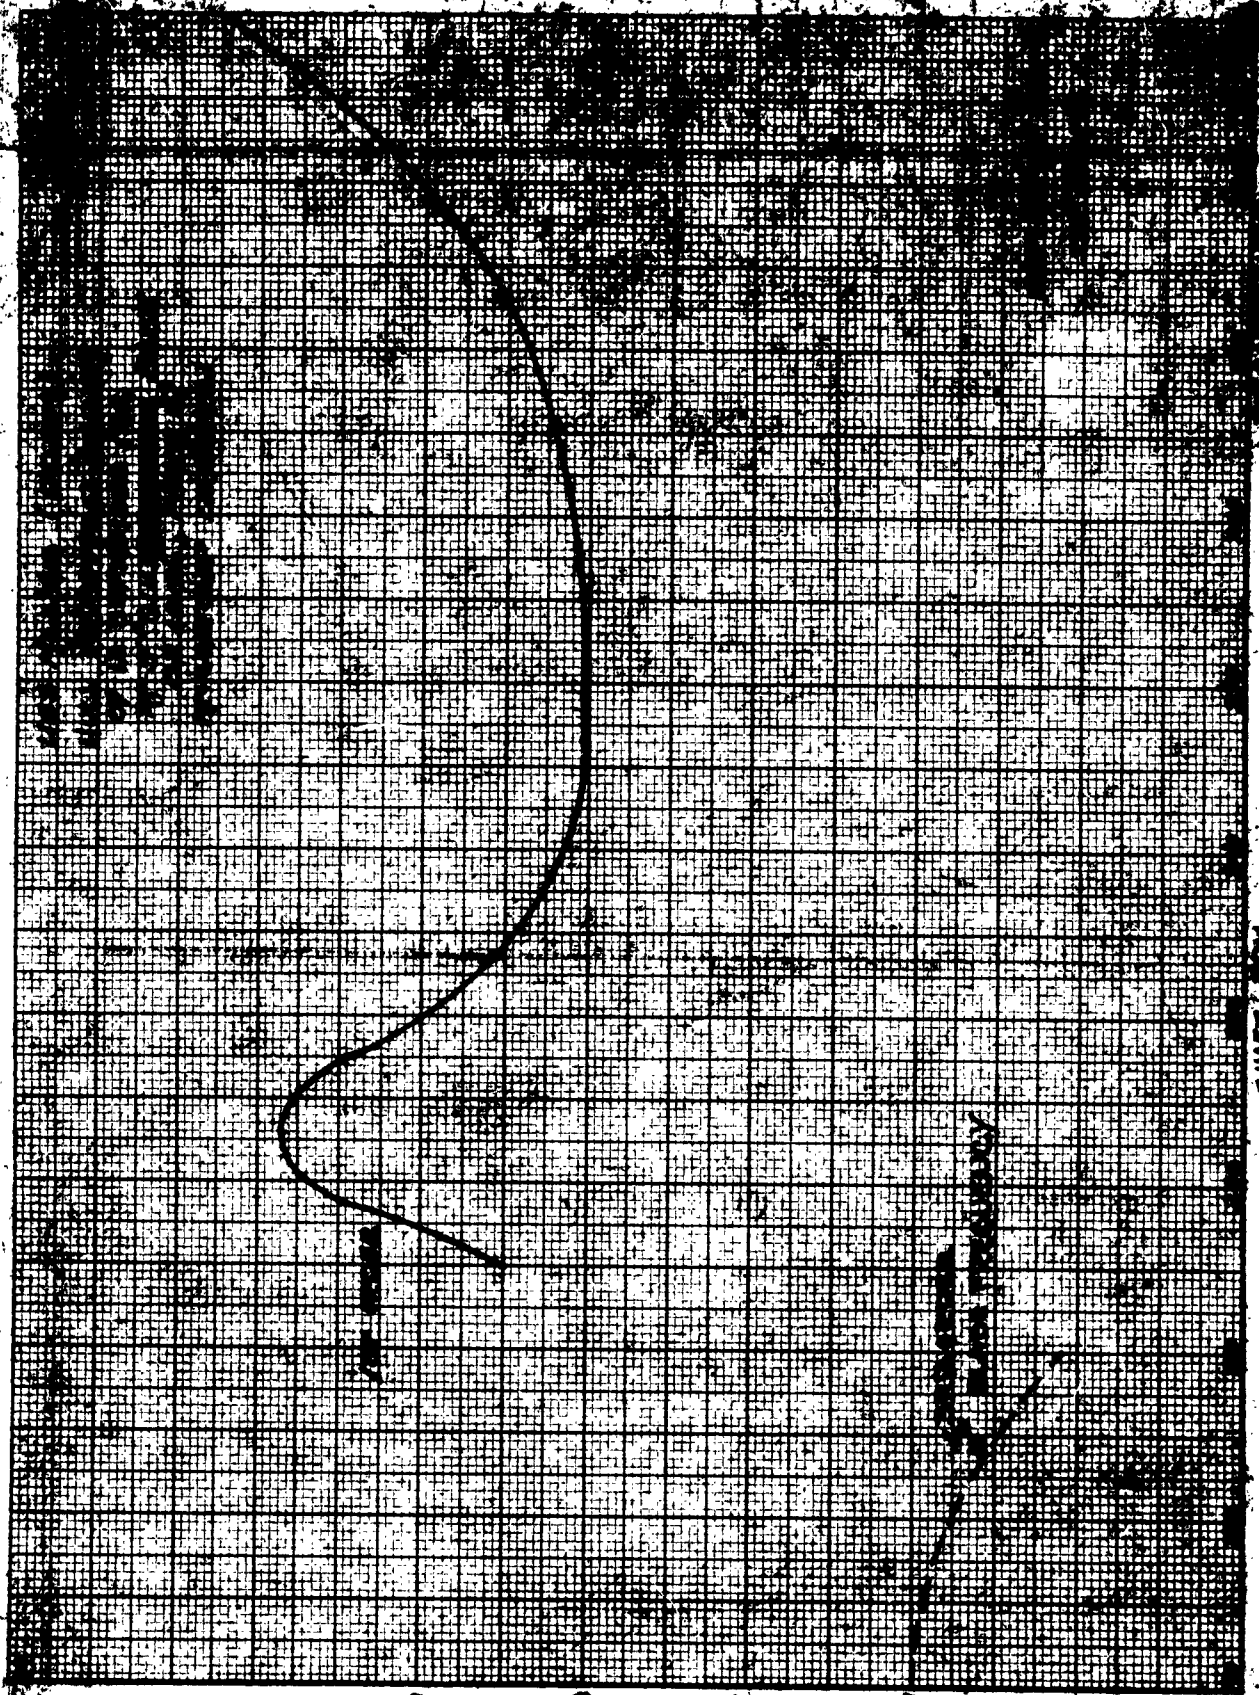
3. The results of the survey are presented in graphical form on sheet 2 of this report. A first order critical appears at 225 shaft RPM with a displacement amplitude of +11.6 Mils. The maximum displacement amplitude recorded was +12.5 Mils at 290 shaft RPM. This appears to be approaching the upper first order critical at a shaft speed above 290 shaft RPM. More extensive data could not be taken due to operational limitations. Propeller blade frequency vibration (3rd order) was observed from 190 to 210 shaft RPM. The maximum displacement amplitude was +4.0 Mils at 190 RPM.
