NUMBER D2-80092

UNCLASSIFIED TITLE Cryogenic Tanks Development -

(Dyna Soar)

MODEL NO. X-20A CONTRACT NO. AF33(657)-7132

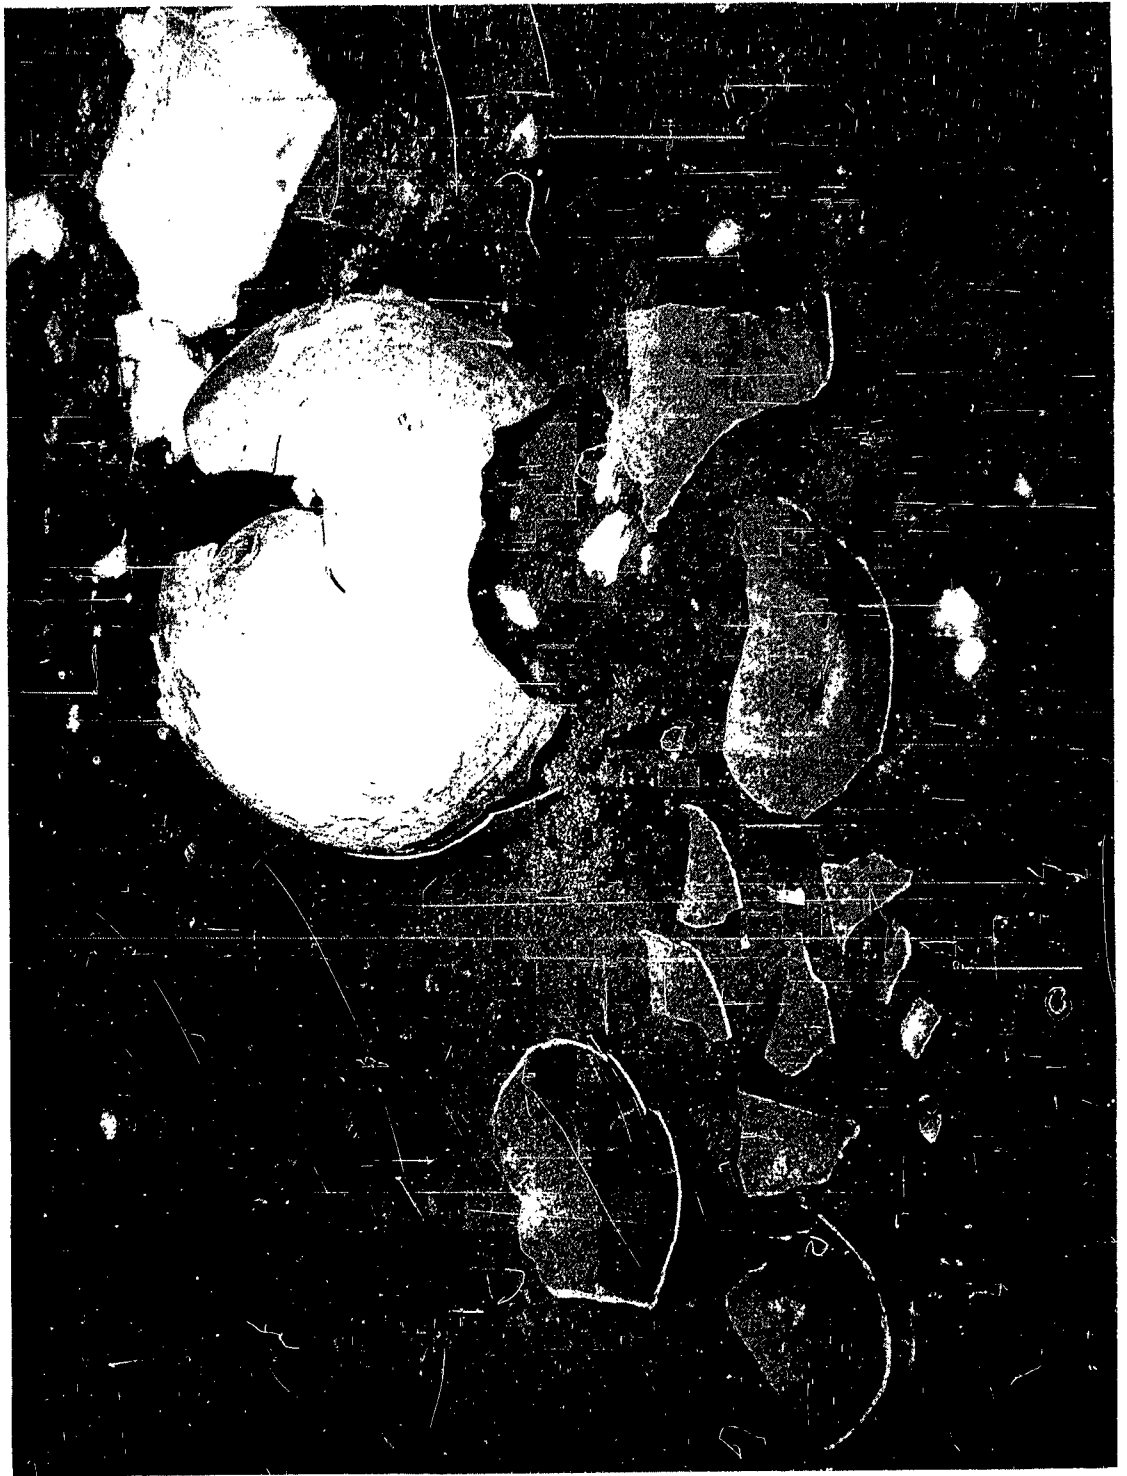
FIG. 1.10 TANK NO. 1 AFTER BURST

All three tanks were full of  $LH_2$  at the time of burst as indicated by temperature measurements and the nature of the burst itself. Very little scattering of tank fragments was in evidence (See Figures 1.10, 1.11, and 1.12).

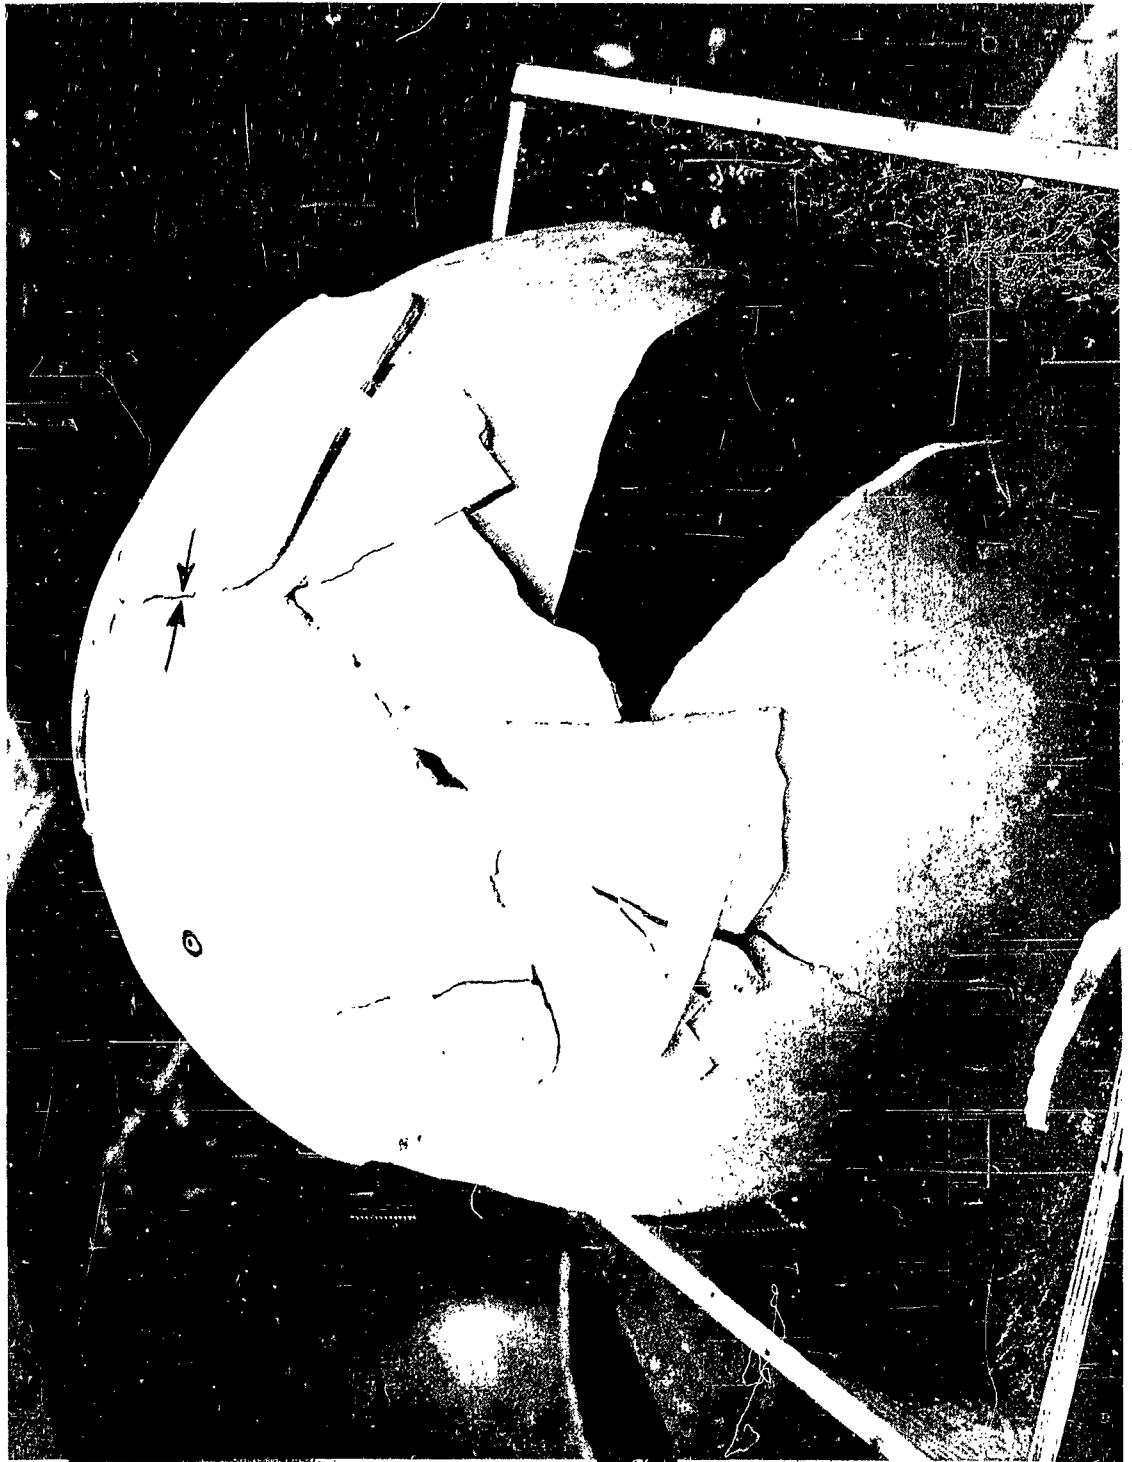
FIG. 1.13  
TEST TANK NO. 1 REASSEMBLED  
WITH FAILURE AREA NOTED

The tank failed in a ductile manner at an area of minimum wall thickness. No material defect was found at the point of origin of the failure. The pitting and intergranular attack on the inside of the tank did not contribute significantly to the failure but did influence the fracture path and the resultant breaking into numerous small pieces.

The broken pieces were re-assembled and the approximate point of origin determined. Figure 1.13 shows the parts re-assembled using the largest piece as a form. The center of the bottom is shown marked with a circle. The point of origin is marked with arrows.

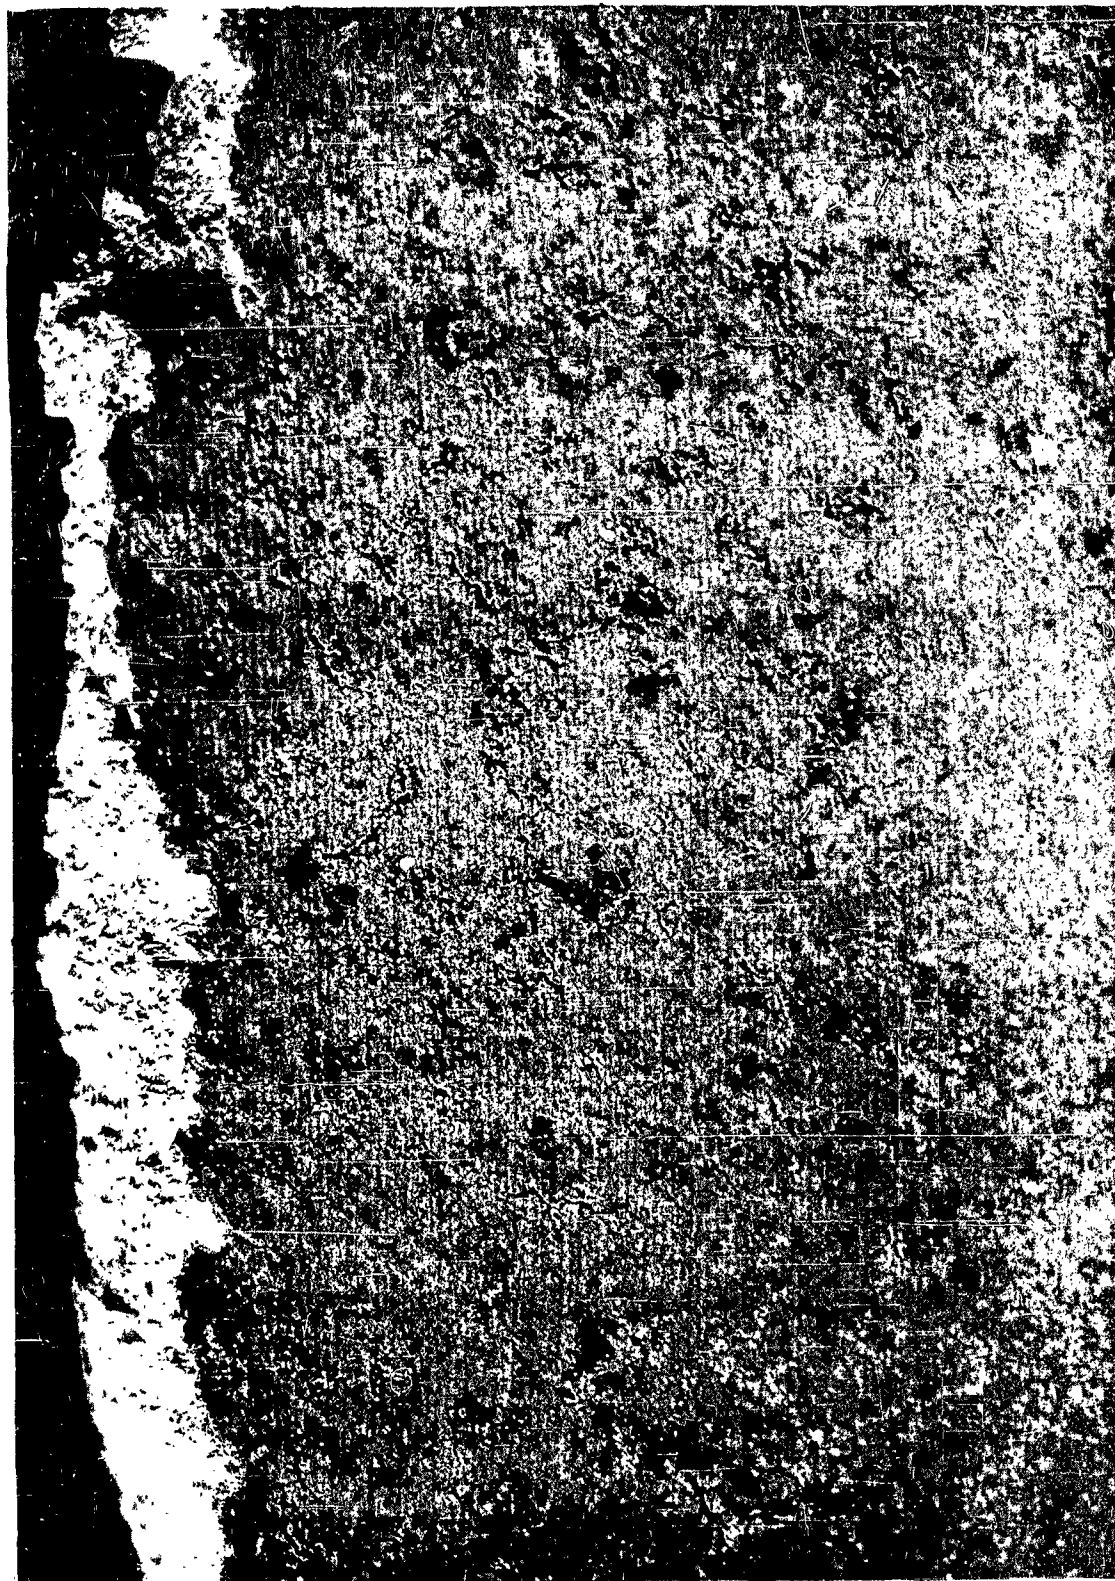
FIG. 1.14 5X WALL CROSS SECTION ~ TANK NO. 1

The interior surface contained a heavy coating of aluminum oxide and numerous corrosion pits. Examination at low magnification showed a network of fine cracks running from pit to pit. Figure 1.14 shows the interior surface. Figure 1.15 is a view showing the extent of the intergranular attack on the interior surface. The intergranular network on the interior surface had an average depth of .005" and was general. This in effect is a decrease of 5% in effective wall thickness. Had this network been absent the tank could be expected to withstand a somewhat higher burst pressure. The cracks shown in Figure 1.14 are the opening up of this area during general yielding of the tank prior to failure. Along the fracture face at the side of the photo it will be seen that the fracture followed these cracks from one dark corrosion pit to the next. The fact that the tank failed at full calculated stress would verify that this network of cracks did not contribute significantly to the failure. However, if a tank with similar intergranular attack was subjected to either sustained or cyclic loading, the notch effect could lead to early failure. This type of surface is definitely unsatisfactory for pressure vessels. The Structural Materials Group recommended a cleaning sequence prior to heat treatment which was followed on the third tank of this series. The interior of this tank was bright after heat treatment. The material was checked microscopically after burst test to verify the absence of intergranular attack.

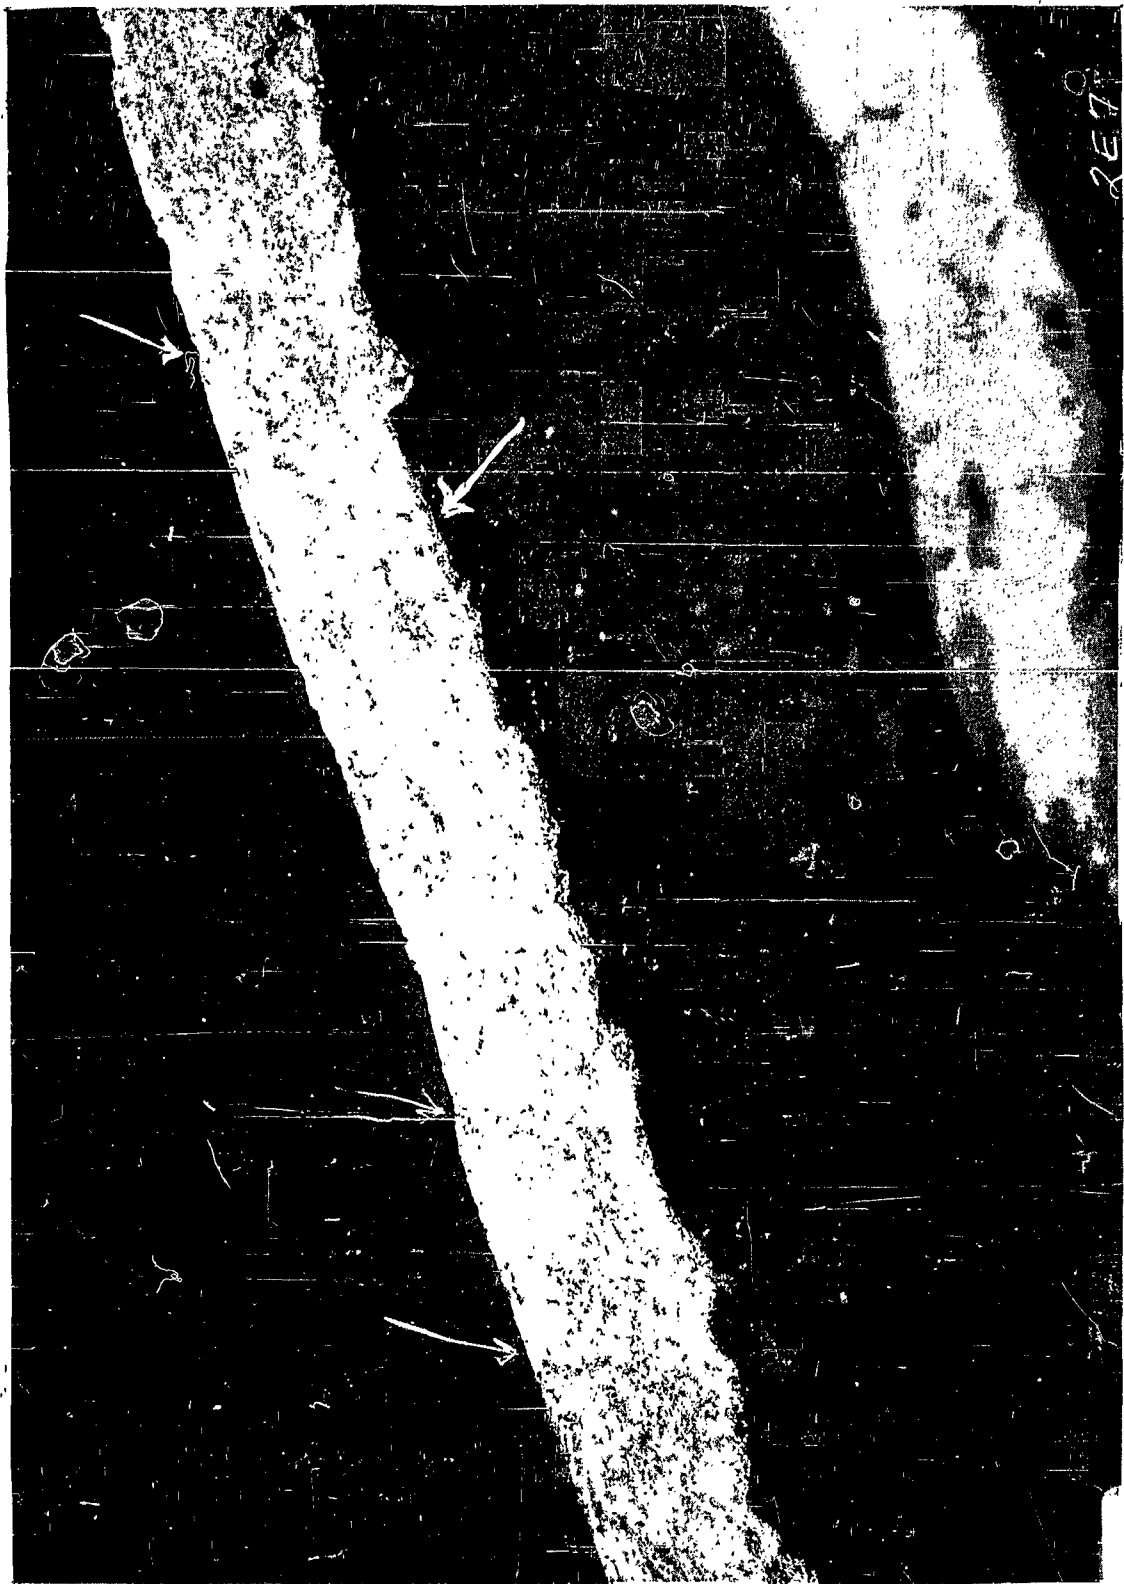
FIG. 1.16 6X VIEW AT POINT OF FRACTURE ~ TANK NO. 1

The point of origin of the failure was approximately 10° up from the bottom of the tank (or 6.5" down from the girth weld). Figure 1.16 shows the fracture face at the point of origin. The arrows indicate the location of growth rings or hesitation points in the growth. Beyond the outer arrows, growth was catastrophic. Critical crack length (area of slow growth) was .100" at the surface and .200" at the center of the wall thickness.

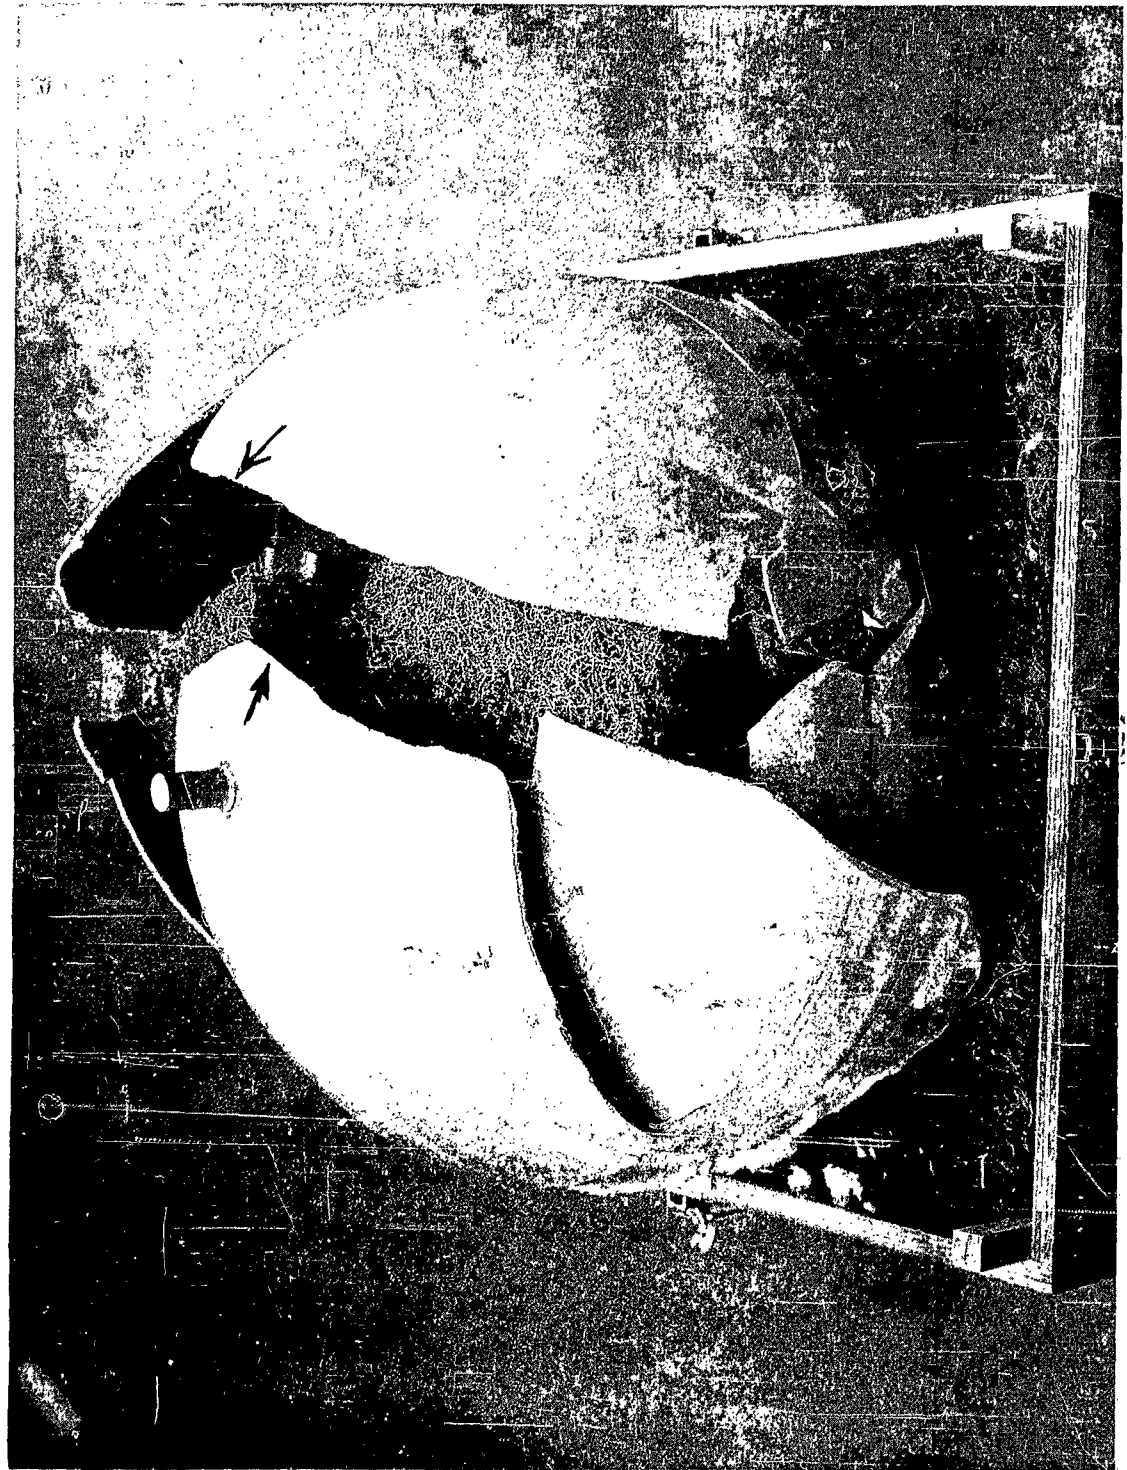
FIG. 1.17  
TEST TANK NO. 2 REASSEMBLED WITH FAILURE AREA NOTED

The tank failed in a ductile manner in an area where minimum wall thickness was combined with a change in contour. No material defect was found at the point of origin of the failure. Both surfaces of the tank were free of oxide coating. There was no intergranular attack found on either surface.

Figure 1.17 shows the broken tank after reconstruction. The point of origin was found to be 2.5" from the center of the boss. From this point in toward the boss the shell thickness increased abruptly. Thickness at the origin of failure was .108".

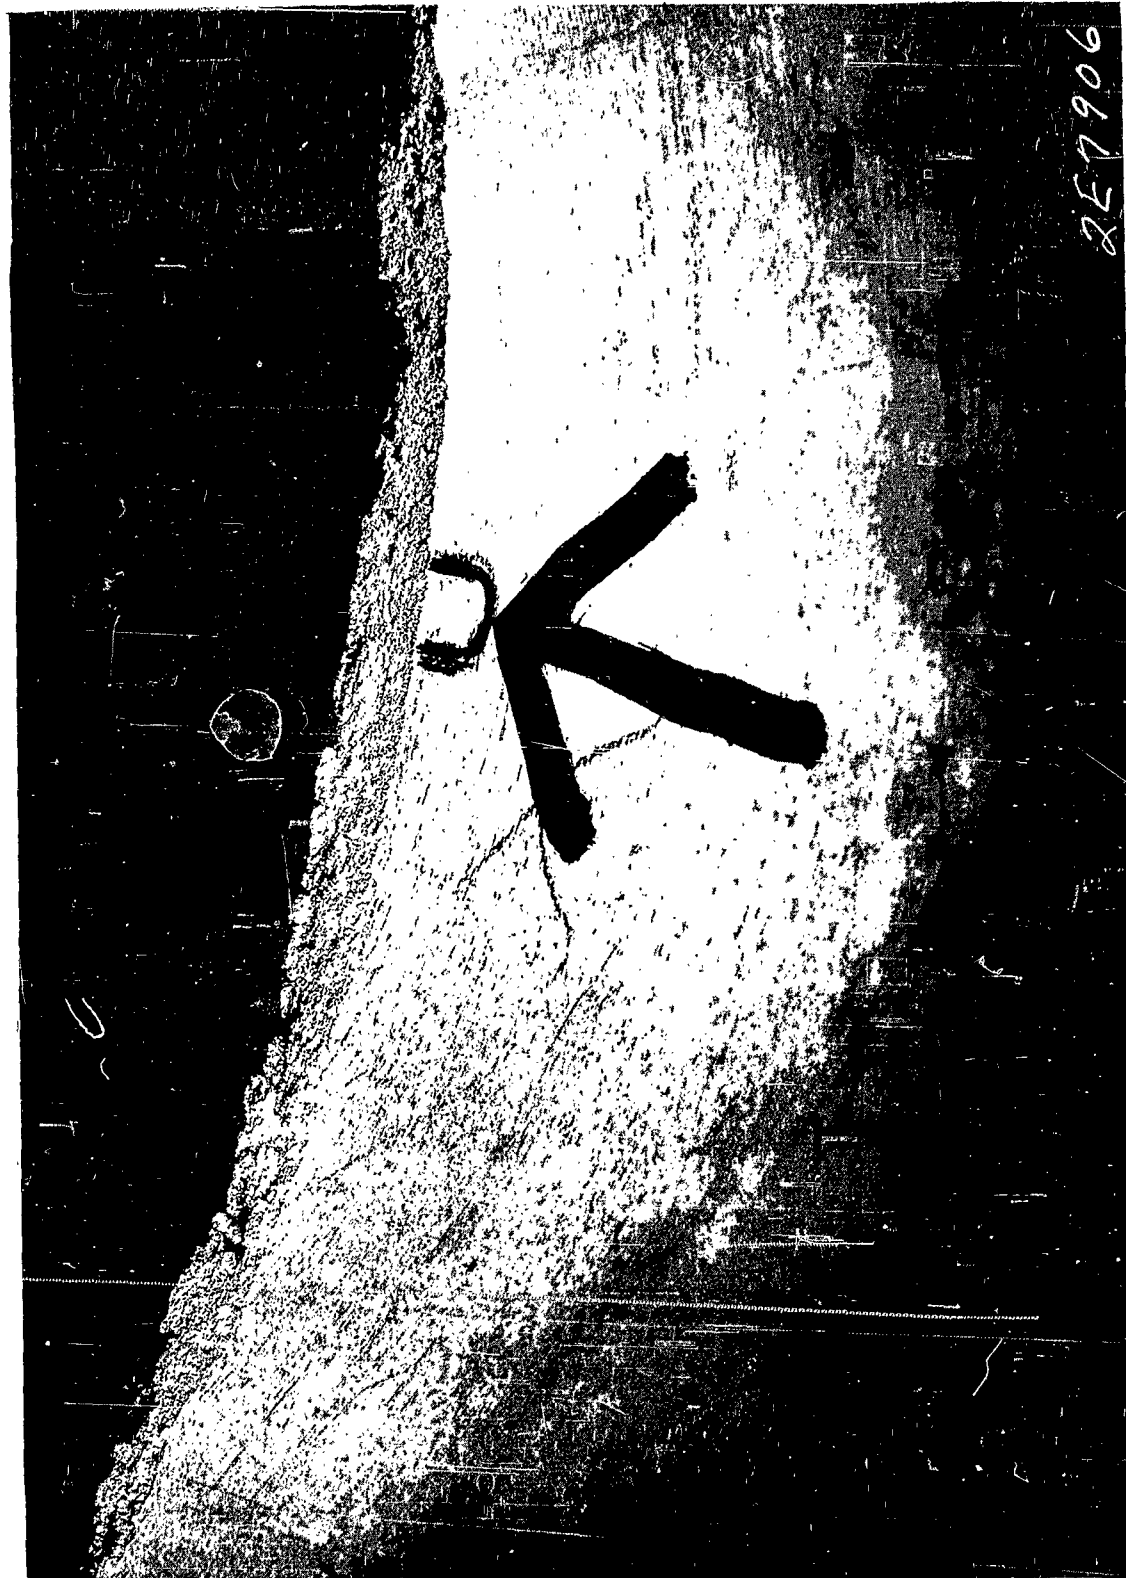
FIG 1.18 4X OUTER SHELL VIEW ~ TANK NO. 2

The outside contour in this region was a uniform sphere. The increase in wall thickness around the boss resulted in a flattening of the interior contour. It was at this change of contour that the failure originated. Critical crack length (area of slow growth) was .100" at the surface and .200" at the center of the wall thickness. Figure 1.18 shows the fracture with the point of origin bracketed.

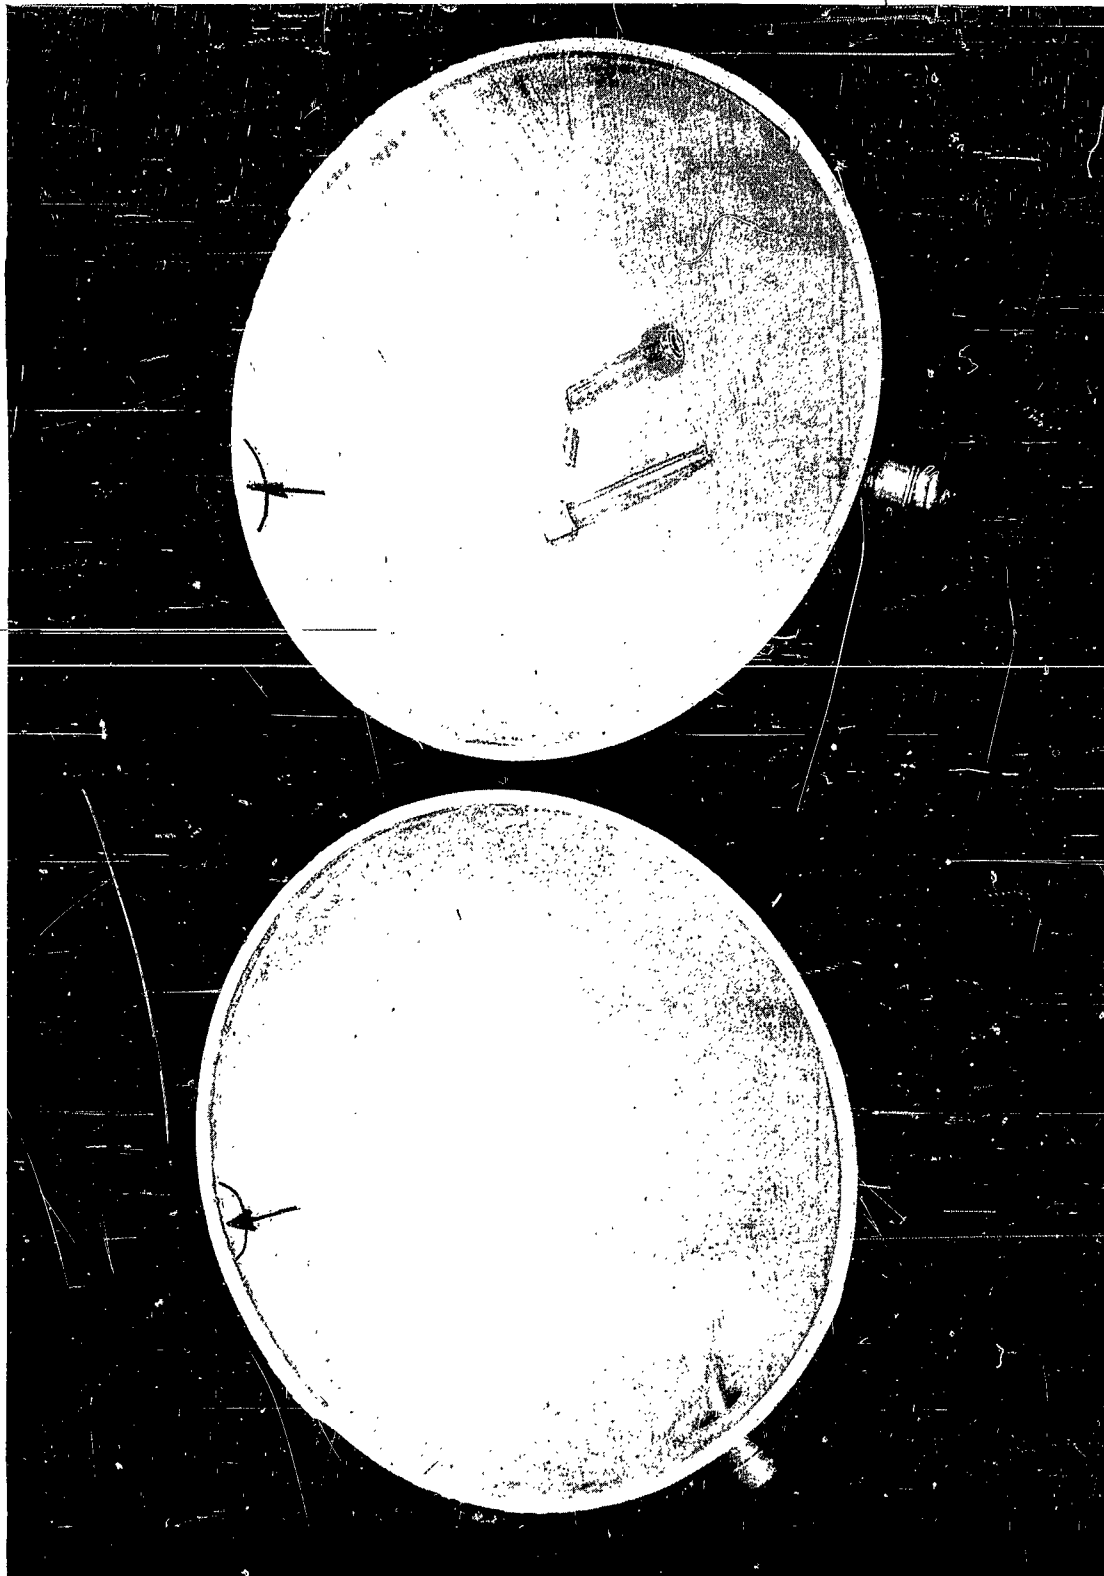
FIG 2.6  
LN<sub>2</sub> TANK INNER SHELL  
AFTER BURST

Burst occurred as a mild detonation due to two factors. (1) There was no fragmentation, and (2) the burst energy was absorbed by the immersion liquid. Figure 2.6 is a photo of the test specimen after failure. As is noted, the failure occurred as a clean circumferential break adjacent to the girth weld neatly separating the tank into halves.

The following data is based on information provided in reference 2.3.3 by the Materials and Process Unit. The failure occurred along the girth weld. The arrows in Figure 2.6 and 2.7 indicate the origin of failure which corresponded with a deep, sharp weld undercut on the outer surface of the tank. Figure 2.8 is a cross section through the weld showing the .0055" deep undercut with a root radius of .012". This undercut was evident on both sides of the weld and varied in depth from .005" to .006".

In conclusion it can be stated that the notch effects at the weld undercut and the underbead drop-through acted as stress risers and caused failure in that zone.

Production tanks will not have "as welded" joints in the shells, nor will such obvious stress raiser be tolerated.

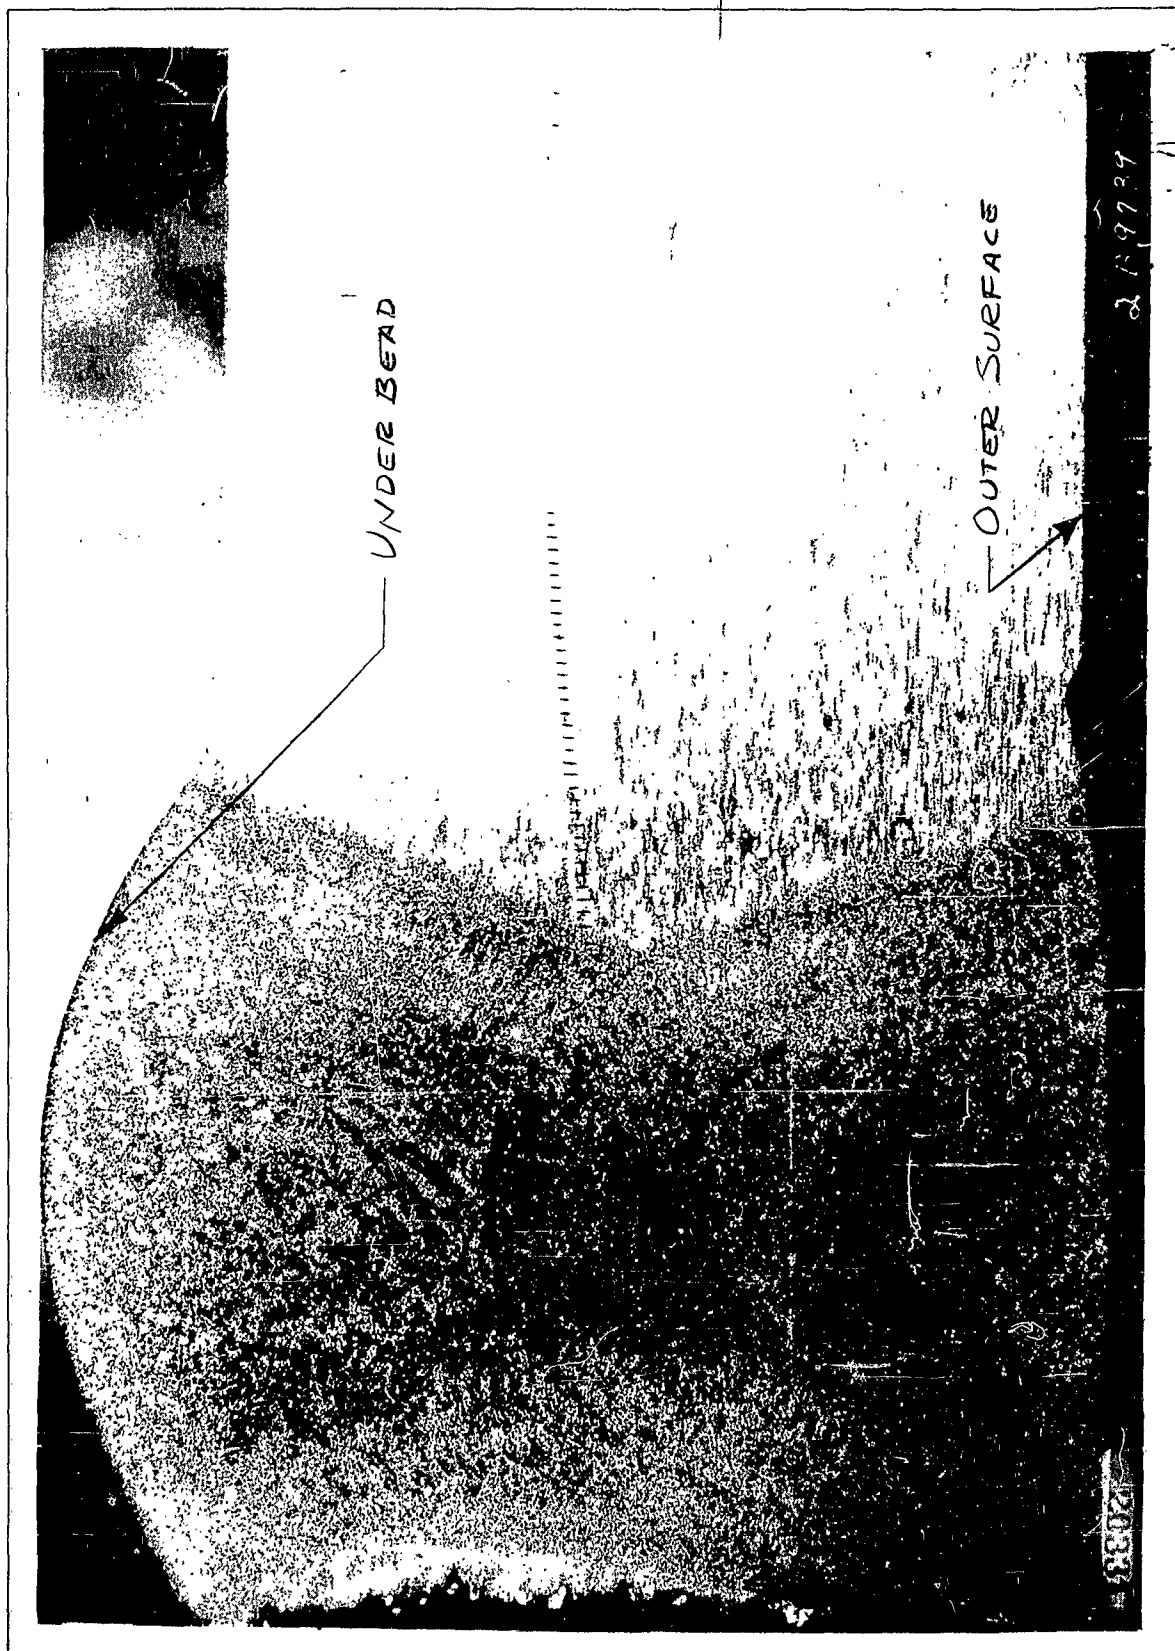
FIG. 2.8  
GIRTH WELD CROSS  
SECTION (5X)

The radius of the weld underbead drop-through is .028". The weld itself was found to be of uniform quality with no porosity or slag
