00Y-TR- 63-20

JUNE 1963

## AIRMUNITIONS TEST REPORT

SERVICE AND SHELF LIFE OF  
EXPLOSIVE SWITCH P/N 1186 FOR  
T3019E5 ARMING PROGRAMMER  
IM99A MISSILE

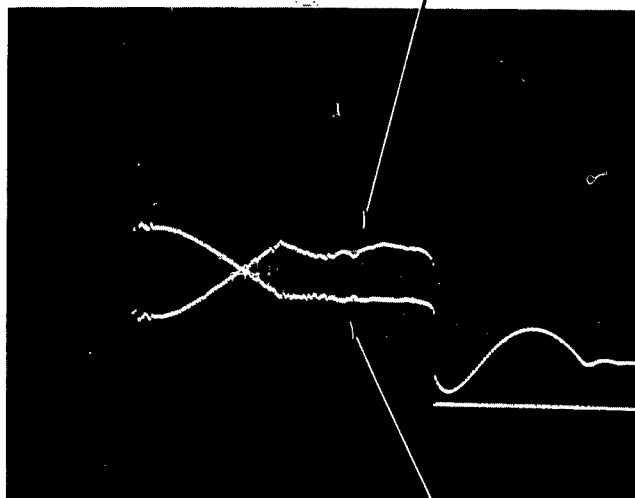
FIGURE 5. Typical Firing Trace - 40°F.

A fire pulse was observed for each switch indicating that the bridge wire had broken. Most fire pulses were recorded by camera. A few pulses were not recorded due to equipment failure. All traces obtained were similar in appearance (Figure 5). Table 1 contains a tabulated record of the firing voltage, firing current, ignition delay and energy input level for each switch.

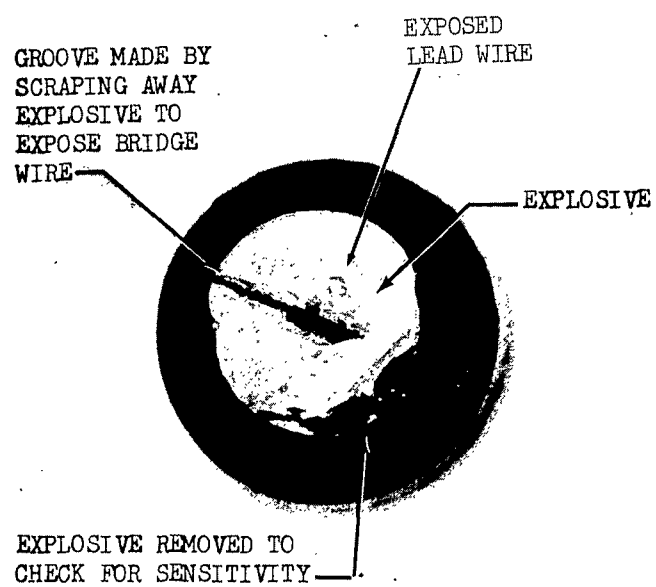
FIGURE 7. Explosive Film Intact After Switch Received Fire Pulse.

The second switch was filed from the top. The potted end of the lead wires with a thin film of explosive was obtained intact (Figure 7). The explosive was scraped away between the lead wire ends revealing that the bridge wire between the lead wires was missing. A tiny portion of the explosive was removed and checked for ignitability by contact with the flame from a match. The explosive detonated with an audible report indicating that it was still sensitive to heat.

As the one sample was filed down from the top, the lead wires were visible. One lead wire was observed to have been inserted in a folded (accordian) like position. The cross section of this wire at various depths from the top of the switch toward the bridge, was not round but rectangular as would be obtained from filing the side of the wire. This folding caused the two lead wires to almost touch at several points. It is conceivable that lead wires inserted in this manner could touch each other, effectively shorting out the bridge. It is not likely that the switches malfunctioned in this way, since the resistance of the bridge circuit was normal for the two switches (5.06 ohm and 7.62 ohm). Also, the bridge wire was not found under the explosive.

Two possible causes for failure of the switch are:

1. The explosive immediately around the bridge wire was melted away from the bridge or desensitized from the application of stray voltages or test voltages less than that required for detonation.
2. The bridge wire and explosive were not in intimate contact at the time of manufacture.

It is recommended that the service life be extended to 54 months from the date of manufacture.
