OPERATIONAL TEST AND EVALUATION  
NOISE SUPPRESSOR SYSTEM TYPE A/S32A-5

HEADQUARTERS  
TACTICAL AIR COMMAND  
United States Air Force  
Langley Air Force Base, Virginia

TAC-TR-61-15  
June 1963

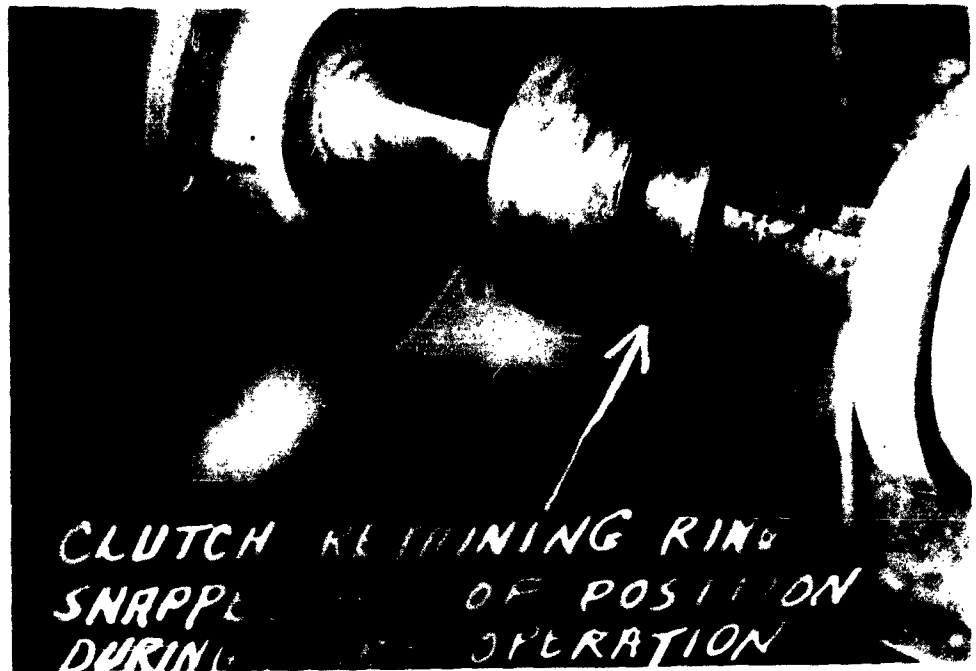
b. Problems were experienced with the unit as early as March 1962. An inspection of the unit revealed that the internal acoustical liner was distorted and in some areas was deteriorating (see Figure 1 in Annex A). The baffles on the rear of the suppressor were also showing signs of warping. While running a J75 engine, the inner wall acoustical panel started to buckle. It was found that the inner wall had separated and pulled out the wall retaining bolts (see Figure 2 in Annex A). Special jacks were fabricated to support the lining and 37 man-hours were expended welding it back in place. The fillet was welded solid and in such a manner as to prevent overlap facing into the direction of thrust. During another run, the fire guard noted that the water supply to the suppressor was depleted. It was found that the water pump coupling retainer ring had come loose causing the pump to be disconnected from the power source. Figure 3 in Annex A is an illustration of the pump coupling.

FIGURE 3. Water pump coupling
