OPERATIONAL TEST AND EVALUATION

SILVER ZINC BATTERY CELL REPLACEMENT

TAC-TR-61-73  
June 1963

Operational Test and Evaluation  
Silver-Zinc Battery Cell Replacement,

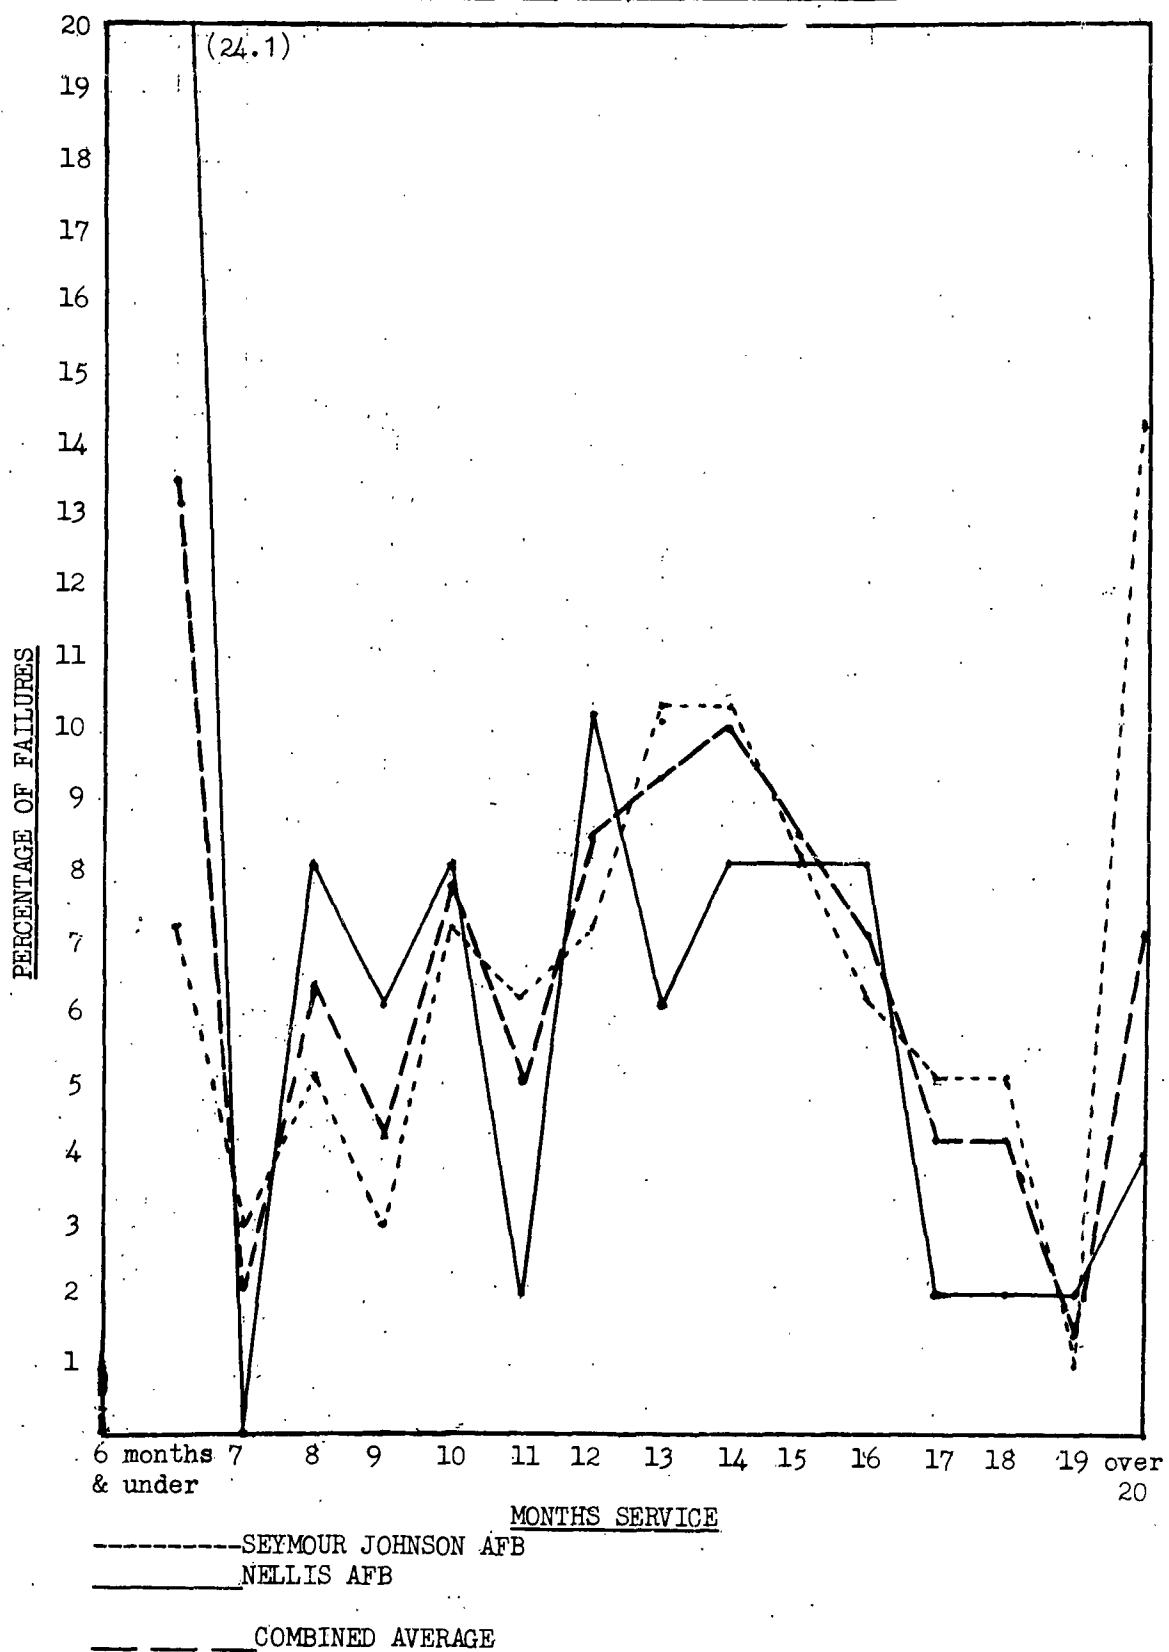
ANNEX A

f. In analyzing the test results from the two bases, significant differences were noted in the failure pattern; 24.1% of the batteries failed at Nellis AFB with six months or less service compared to only 7.1% at Seymour Johnson AFB. 81.9% of the batteries failed with 15 months or less service at Nellis AFB compared to 68.3% at Seymour Johnson AFB. The net result was an average of 3.93 more months service at Seymour Johnson AFB than at Nellis AFB before the first failure occurred. The reasons for this wide difference could not be specifically determined. The higher average temperature at Nellis AFB is believed to be a contributing factor to the higher failure rate. The use of the individual cell discharging at Seymour Johnson AFB is possibly a contributing factor to the lower failure rate. Further analysis of the failures revealed no wide differences in failure patterns when related to calendar months. Surprisingly, most of the failures at both bases occurred during the months of March, April and May. The percentage of the total batteries in the test group that first failed in each age group is shown in Annex A. A comparison of the percentages at the two test bases is shown as well as the overall percentage.

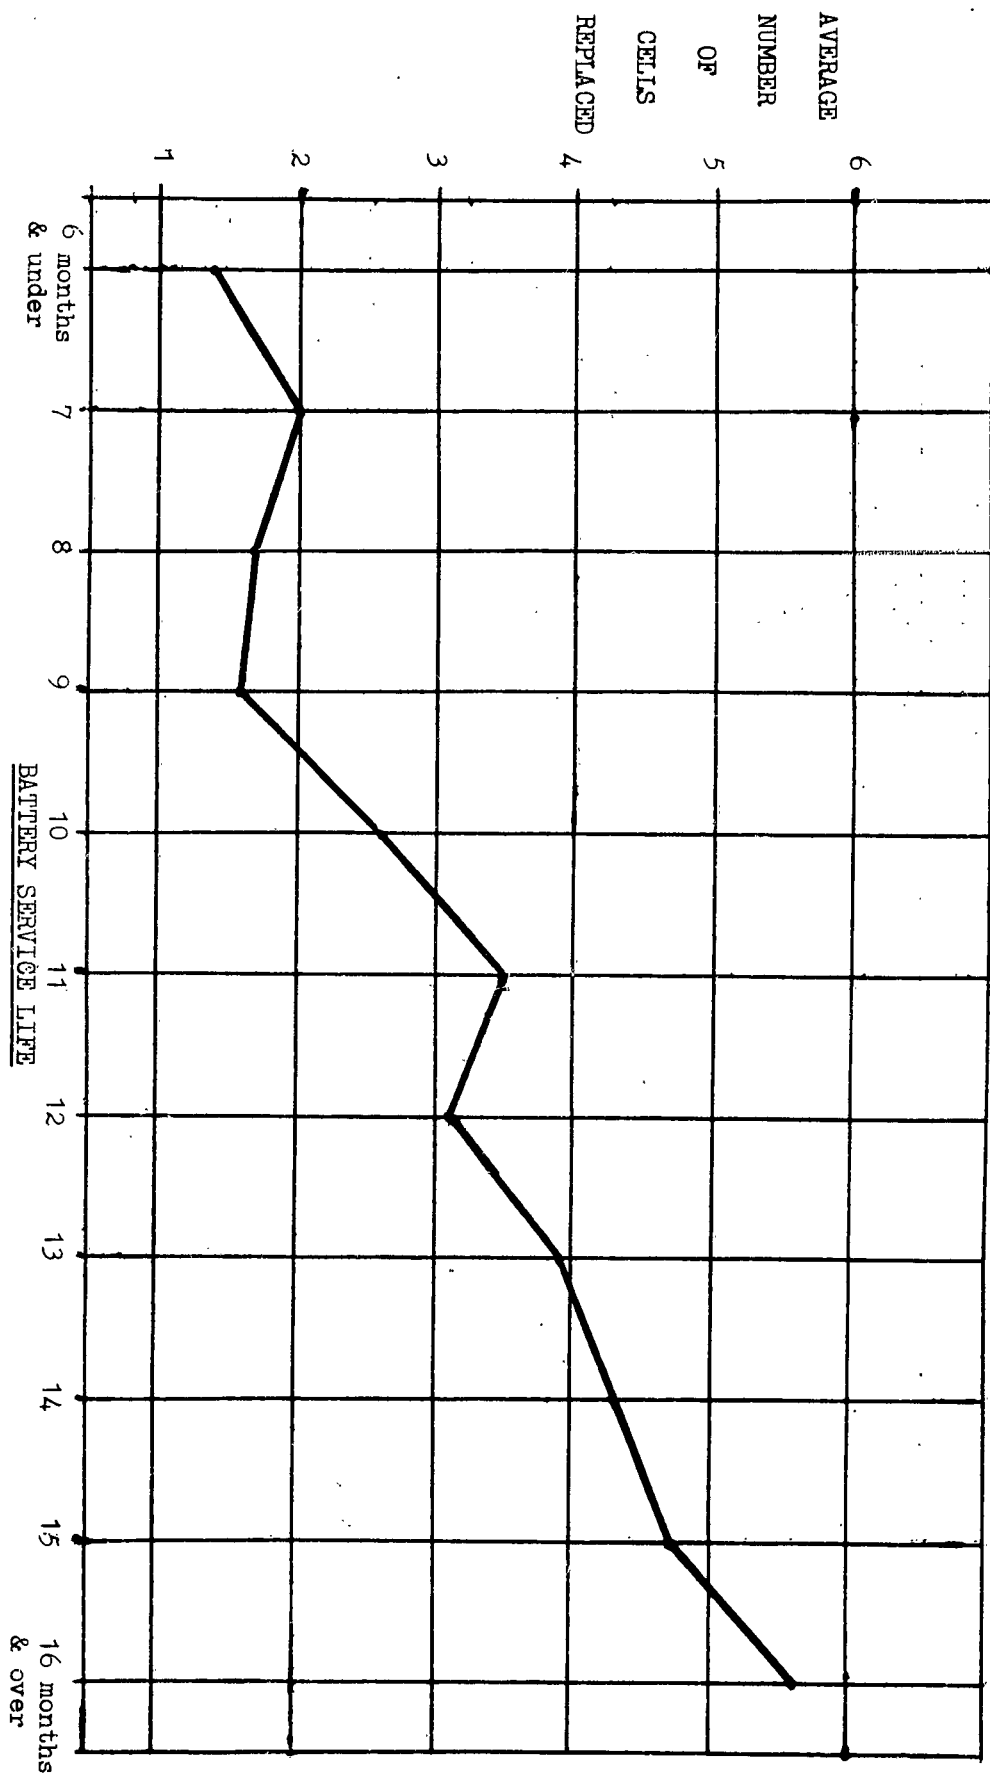
ANNEX B

g. The number of cells that fail in a battery is a factor which must be considered when determining at what service life batteries should no longer be repaired. It was found that batteries failing with six months or less service required replacement of an average of 1.4 cells. This ranged up to 5.6 cells for batteries having over 15 months service. Annex B shows the average number of cells replaced in batteries by age group. The number of cells in each age group is accumulative to show the increase in cells replaced as service life increased.
