TECHNICAL REPORT 3086

INVESTIGATION  
OF THE  
CAUSE OF AN EXCESSIVE DUD RATE  
OF  
CARTRIDGE, 40 MM, HE: M406, LOT MA-10-3

WILLIAM CARLDON

JULY 1963

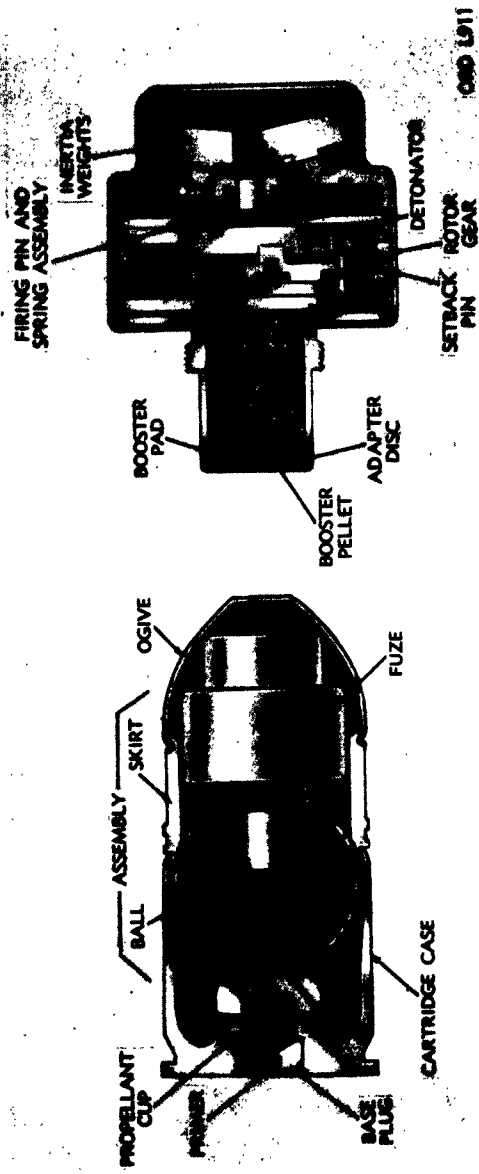
FIGURE 1. CROSS SECTION, CARTRIDGE 40MM HE, M406  
CROSS SECTION FUZE PD M551

The purpose of this investigation was to determine the cause of a reported excessive dud rate of Cartridge, 40MM, HE: M406, Lot No. MA-10-63, with M551 Fuze, Lot No. MHR-20-3 (Figure 1). The malfunction occurred 13 August 1962. During a training exercise of L Company, 3rd Battalion, 4th Marine Regiment, six rounds of 75 fired failed to function. Malfunction Investigation File (MIF) Number A-127-62 was assigned and was forwarded to Picatinny Arsenal by the U.S. Army Ammunition Procurement and Supply Agency.

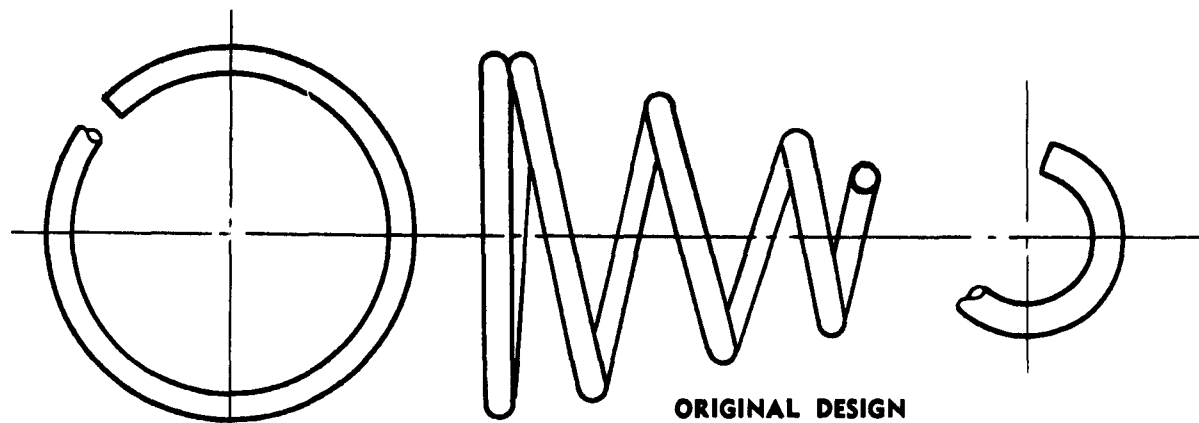
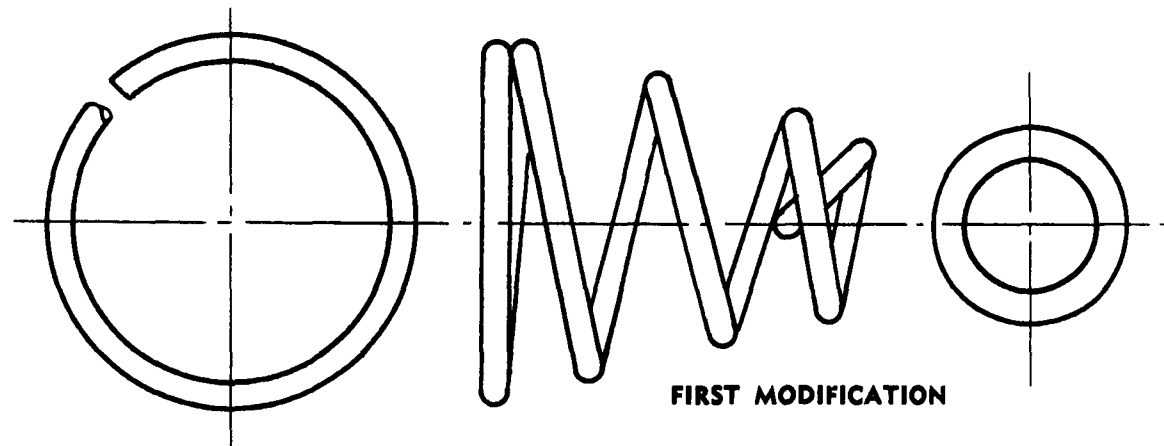
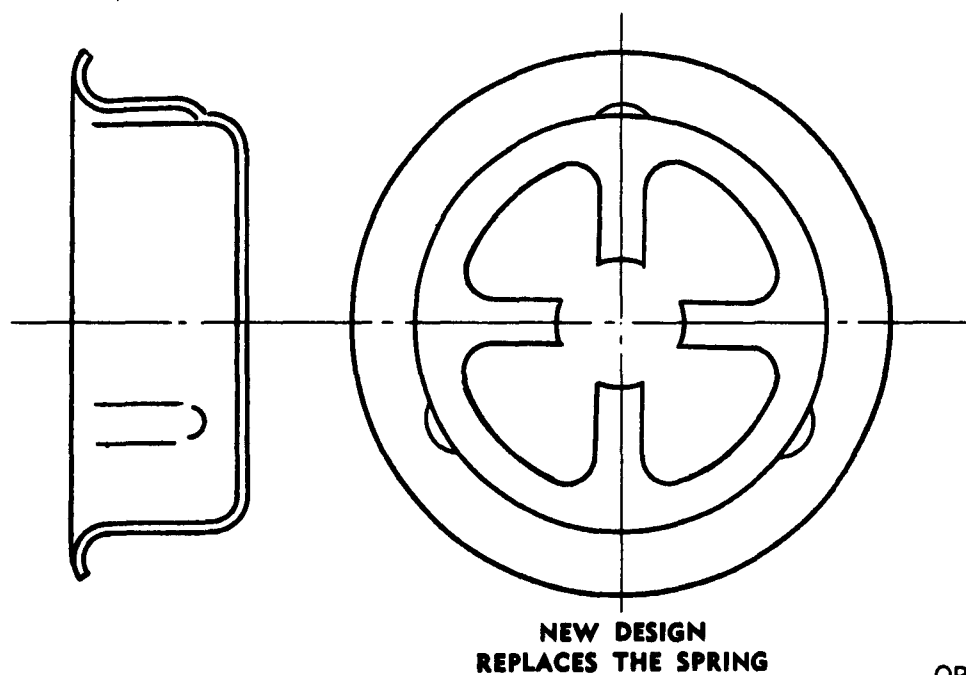
FIGURE 3. SET BACK PIN SPRING AND RETAINER

Set Back Pin re-entry was due to failure of the Set Back Spring to lock the pin when it was fully retracted and prevent it from re-entering the hole in the upper spacer plate -- preventing movement of the rotor to the ARMED position.

1. The Set Back Pin was redesigned and the Set Back Pin Spring was changed to a Set Back Retainer (Figures 3-5).
2. Additional mass was added to the hammerweights.
3. The upper and lower Plate Dowels were removed and incorporated on the Verge Shaft.
