U.S. NAVAL APPLIED SCIENCE LABORATORY
NAVAL BASE
BROOKLYN I, NEW YORK

REPORT OF INSPECTION AND PROGRESS
IN
APPLICATION OF STELLITE 6B OVERLAYS OF
HIGH POINT (PC(H)-1)

Lab. Project 9300-17, Technical Memorandum #4

5 FEB 1964

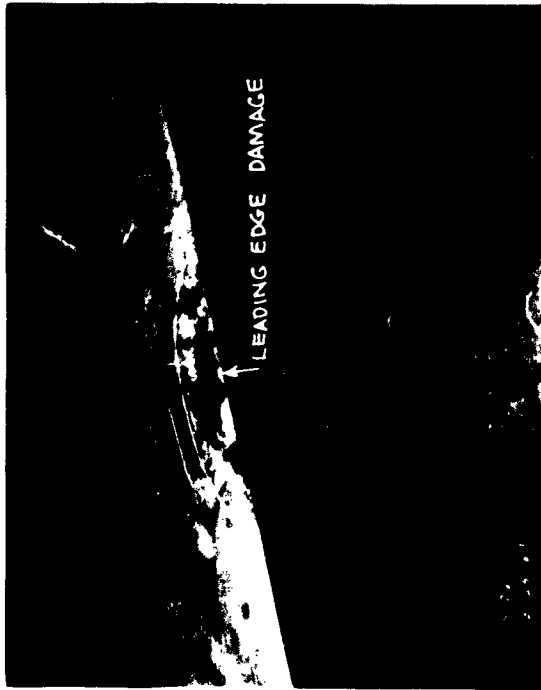
PHOTO No. L-19527-65

(6) The adhesive strength of the polyurethane coating was low, resulting in peeling at the sea water inlets, enclosures (3)B, and (4)D, and at the foil leading edge, enclosure (7)A.

LEADING EDGE DAMAGE

COATING
EROSION DAMAGE

Conditions of Aft Foil, Amidships, Forward Area, and Port Macelle
and Foil (Outboard. Forward, Underside)

- A - Aft foil, amidships, leading edge coating damage
- B - Aft foil and port nacelle, forward, underside
Enclosure (7)
