**STATIC TEST PROGRAM FOR CH-47A HELICOPTER**

**TECHNICAL DOCUMENTARY REPORT No. RTD-TDR-63-1230**

**DECEMBER 1963**

**AIR FORCE FLIGHT DYNAMICS LABORATORY  
RESEARCH AND TECHNOLOGY DIVISION  
AIR FORCE SYSTEMS COMMAND  
WRIGHT-PATTERSON AIR FORCE BASE, OHIO**

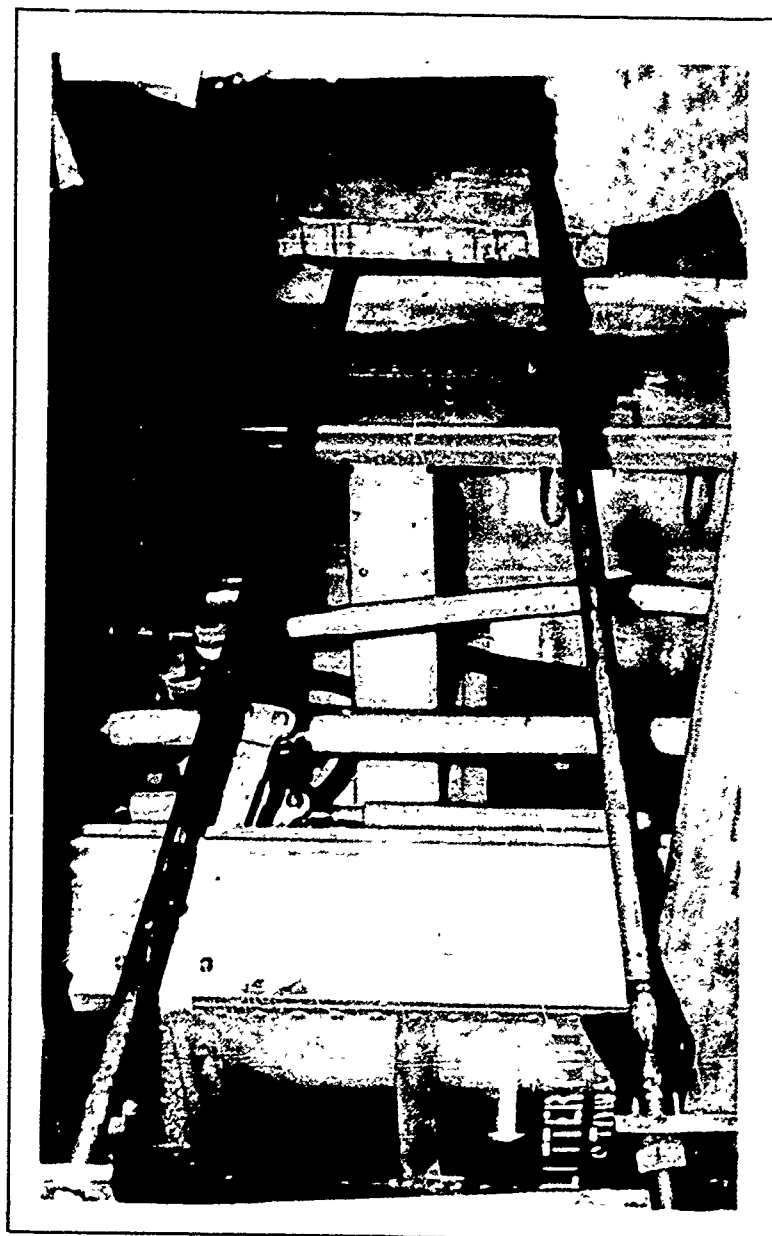
During the test of flight control system condition No. 11, a failure occurred at 94 percent DUL. The 114C1013-8 push-pull rod failed in compression. The boost pressure at the time of failure was 1500 psi. A similar rod was tested with a boost pressure of 2250 psi. The rod failed in compression at 85 percent DUL. A new rod was designed with a greater wall thickness and retested. The system satisfactorily supported 100 percent DUL with the new rod (114C1013-33). (Figures 11 and 12.)

Figure 11. Failure of 114C1013-8 Link Assembly at 85 percent DUL

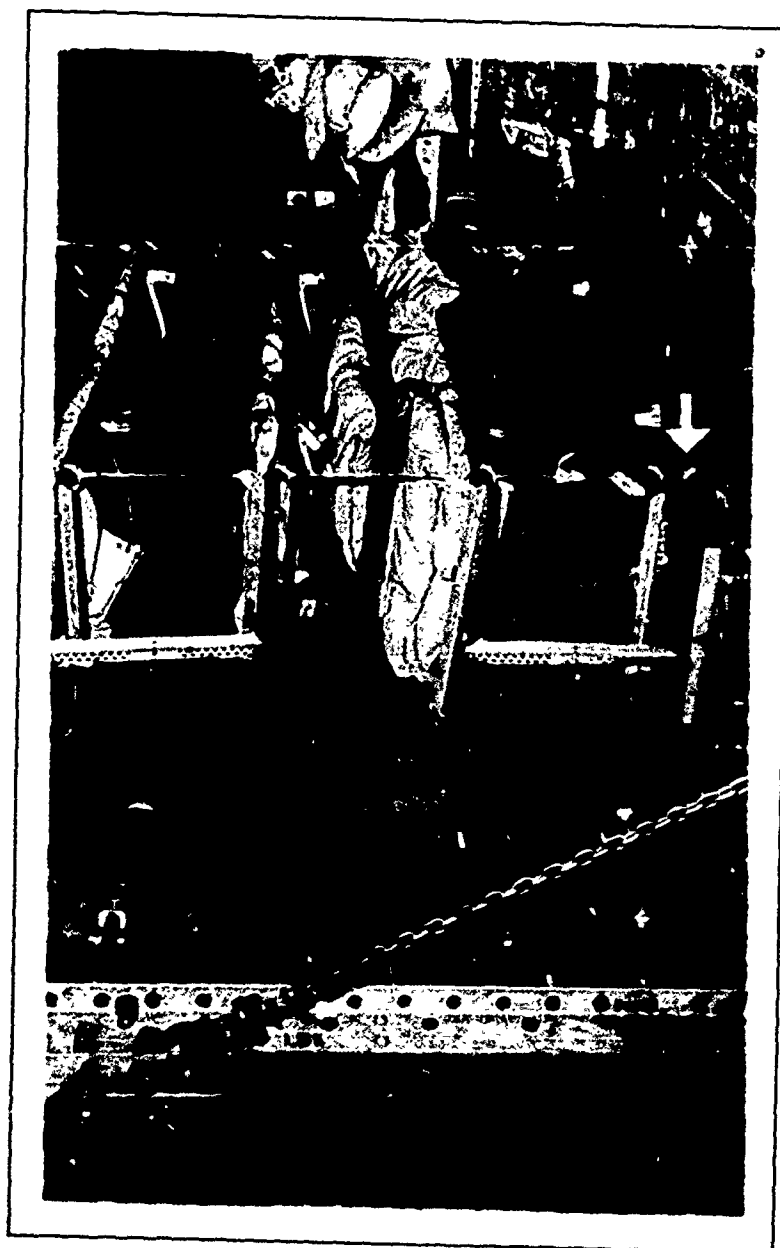
Figure 18. Test Set-Up (Failure at Arrow)

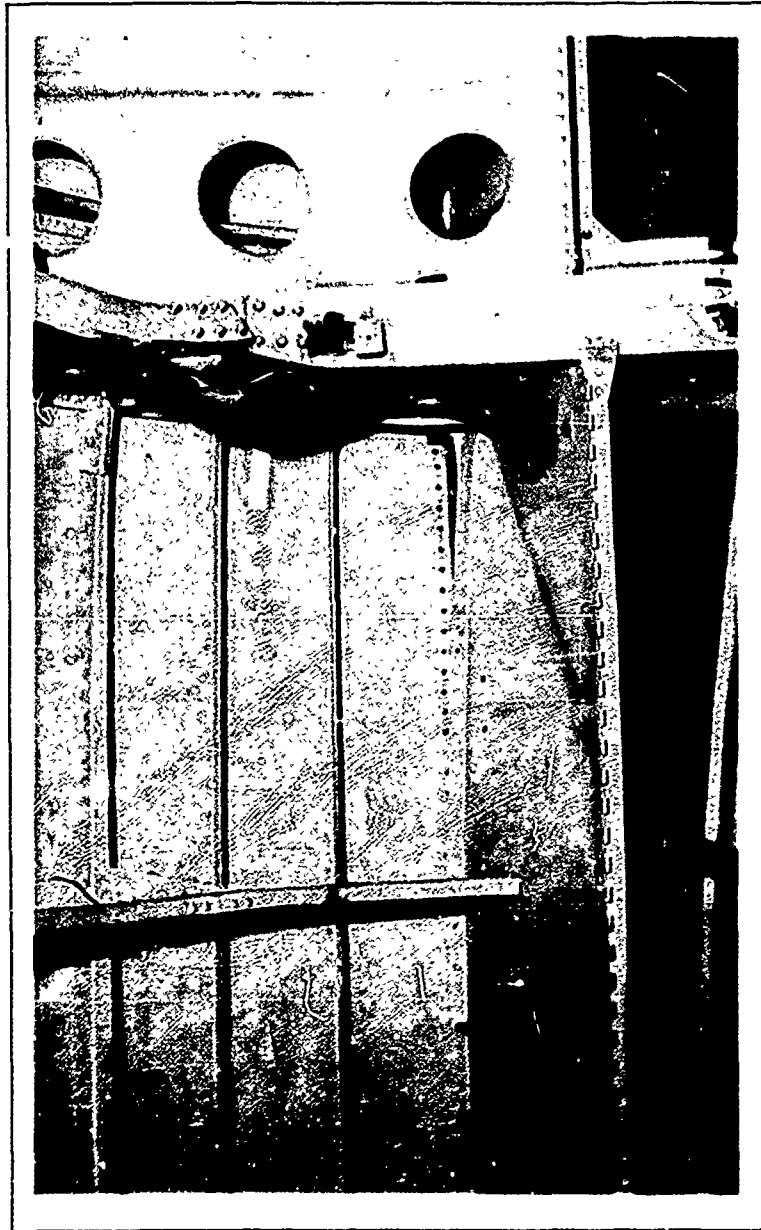
Figure 23. Condition 3B 140 percent DUL--Failure of Frames 555,575.5 and 594 and Rivet Scar in Beaded Web Which Attaches to Longeron 114S3356-17 (View Looking Up)

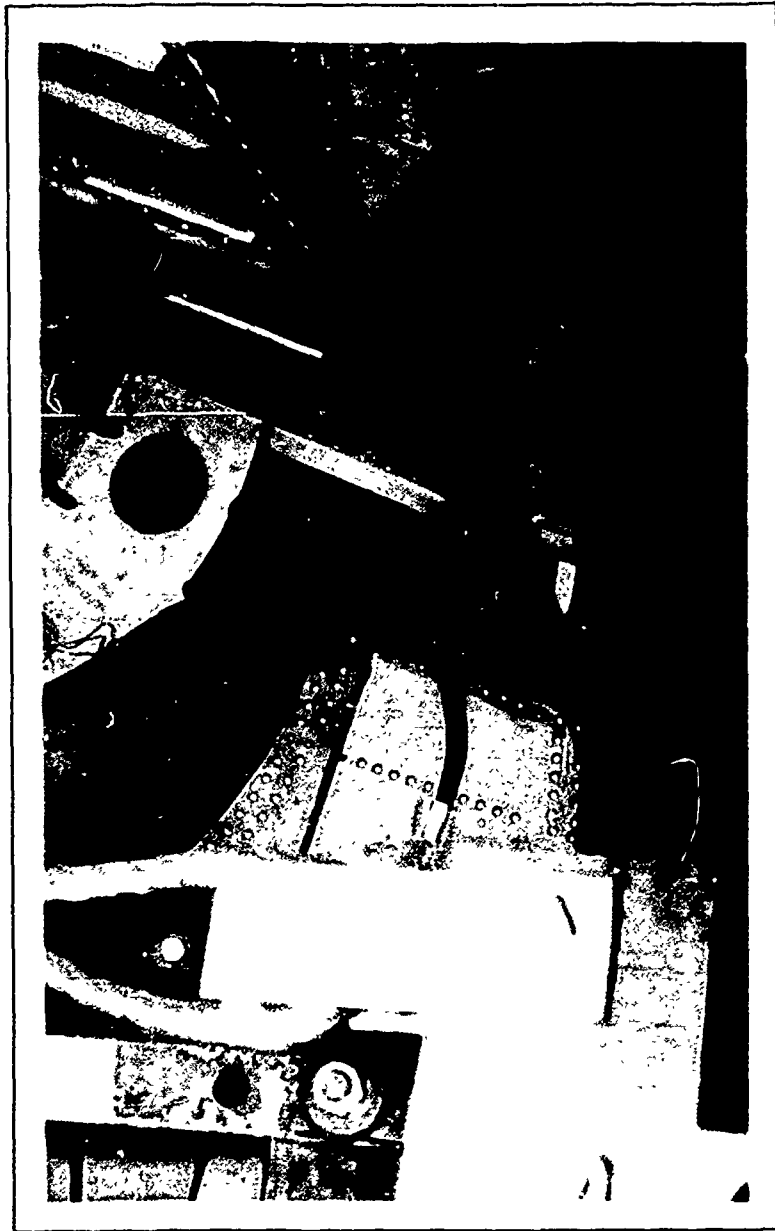
Figure 24. Condition 3B 140 percent FUL--Failure of Beaded Web Which Attaches to Longer 114S3356-17 (View Looking Aft)

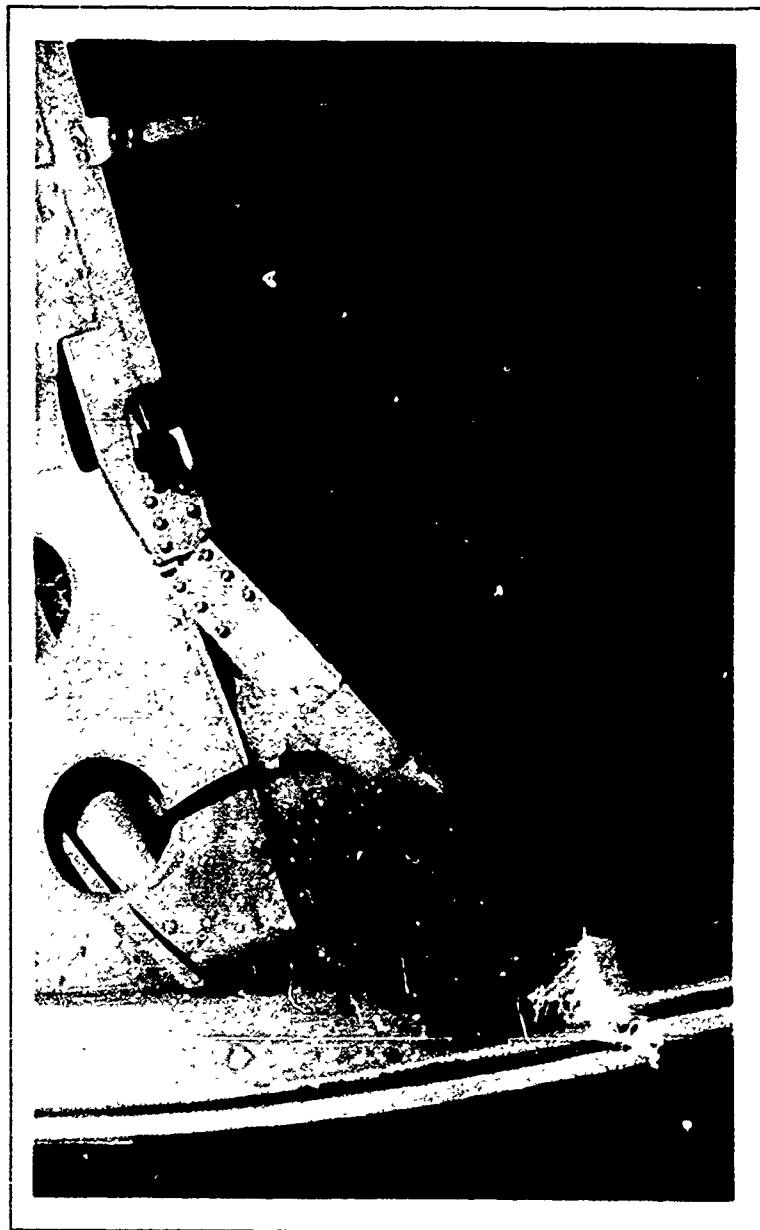
Figure 26. Condition 3B 140 percent DUL--Failure of Frame 594 (View Looking Up)

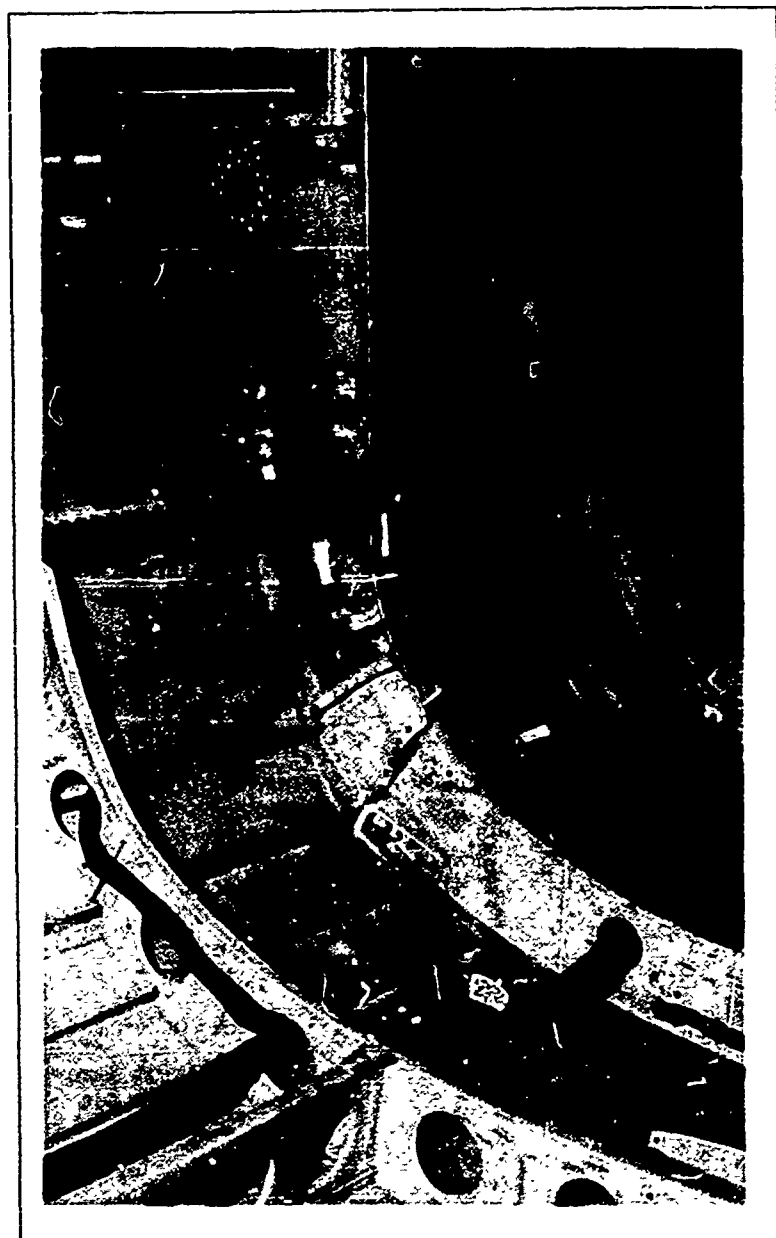
Figure 27. Condition 3B 140 percent DUL.--Failure of Frame 534 (View Looking Forward)

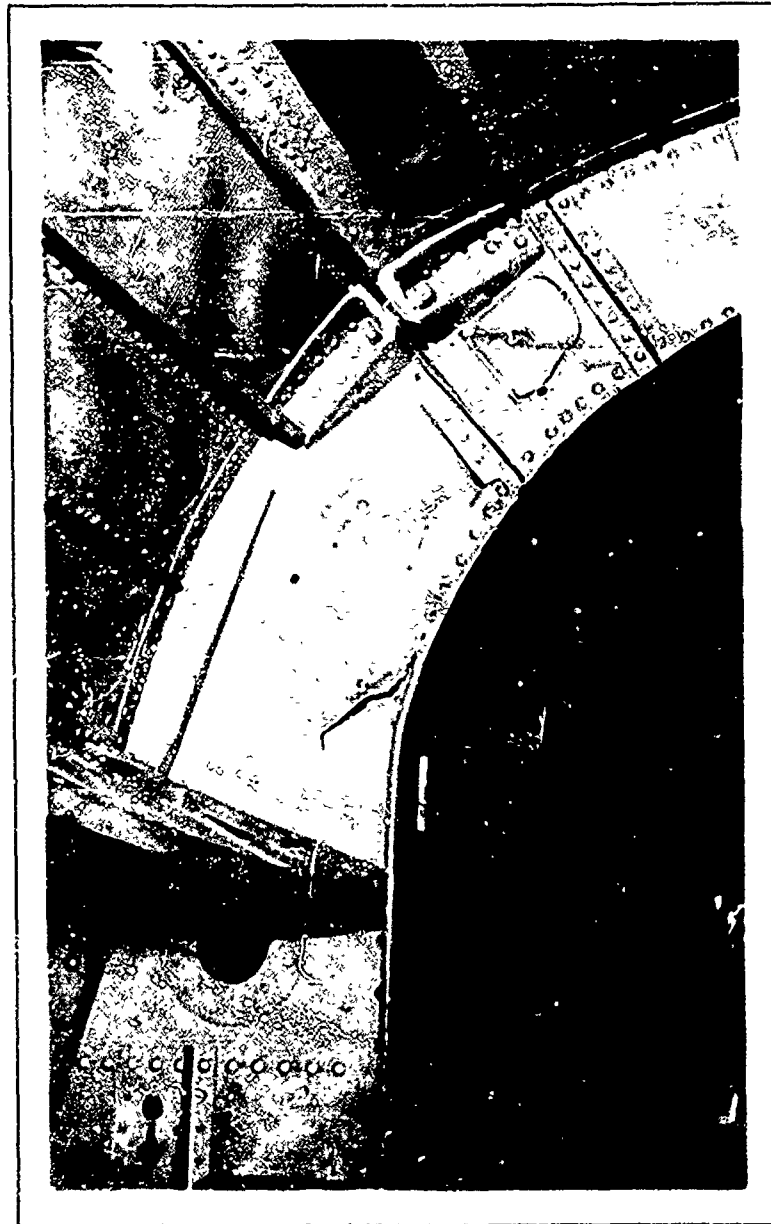
Figure 28. Condition 3B 140 percent DUL--Failure of Frame 534 (View Looking Aft)

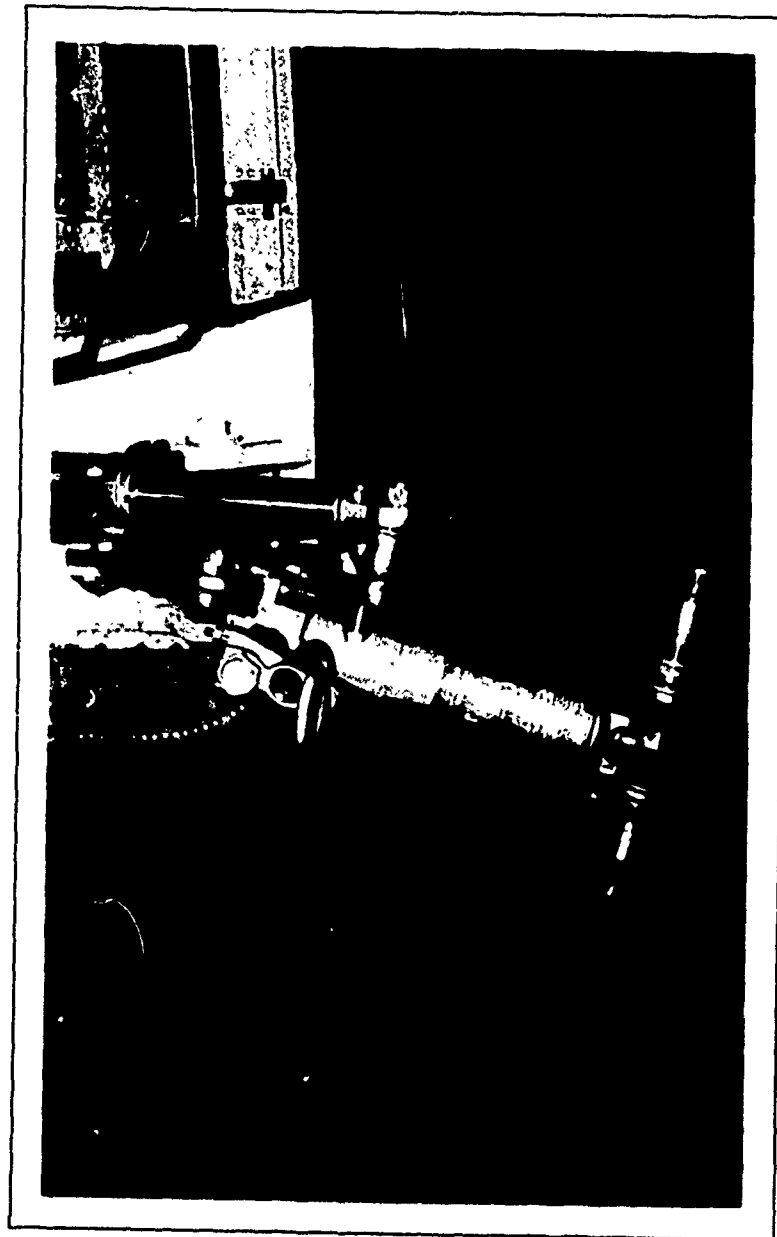
The aft landing gear condition Vc was retested with a new shear web installed. The drag link on the main gear forging (Part No. 114L 2029-1) failed at 127 percent DUL. (Figures 30, 31, and 32). The new web installation was permanently wrinkled (Figure 33).

Figure 30. Condition VC---Failure of Aft Gear at 127 percent DUL

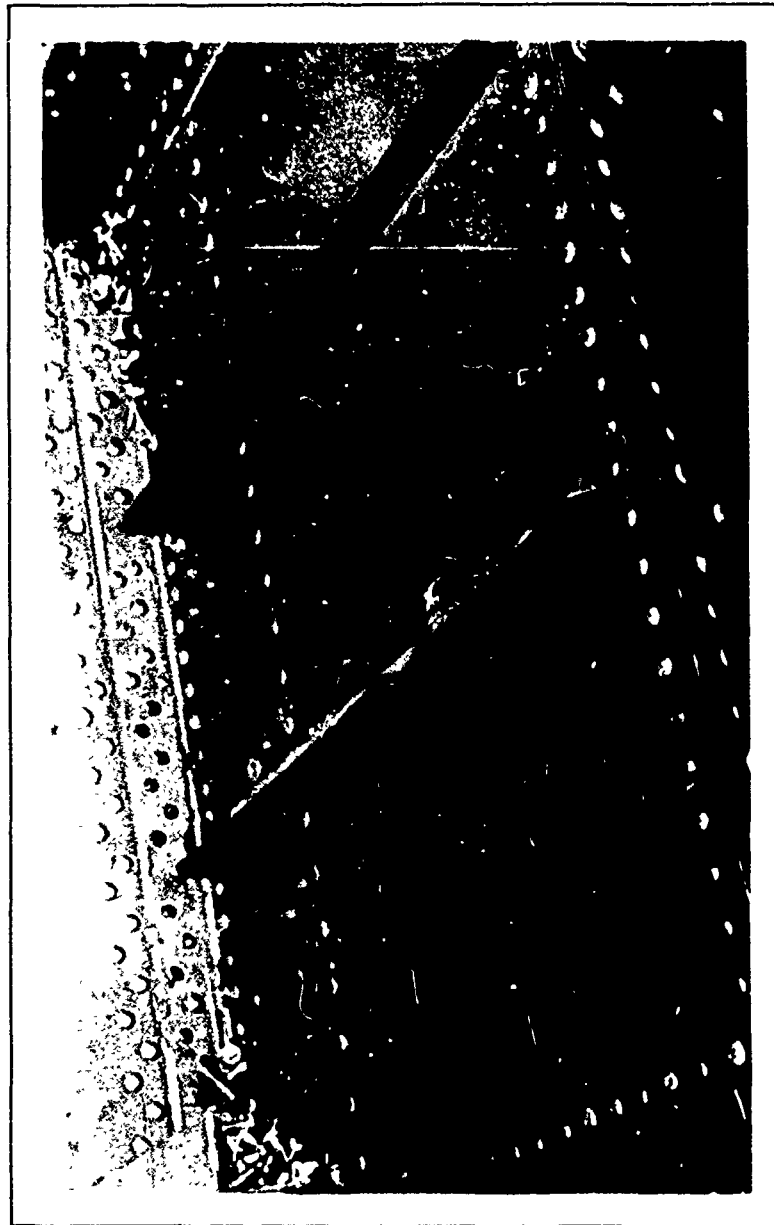
Figure 33. Wrinkles in New Web Installation
