**CH-21A HELICOPTER AIRFRAME DEFORMATION
UNDER A DYNAMIC CRASH CONDITION**

One of a Series of Reports
Pertaining to the Dynamic Crash Test of a U. S. Army CH-21A Helicopter

January 1964

TRECOM Technical Report 63-77

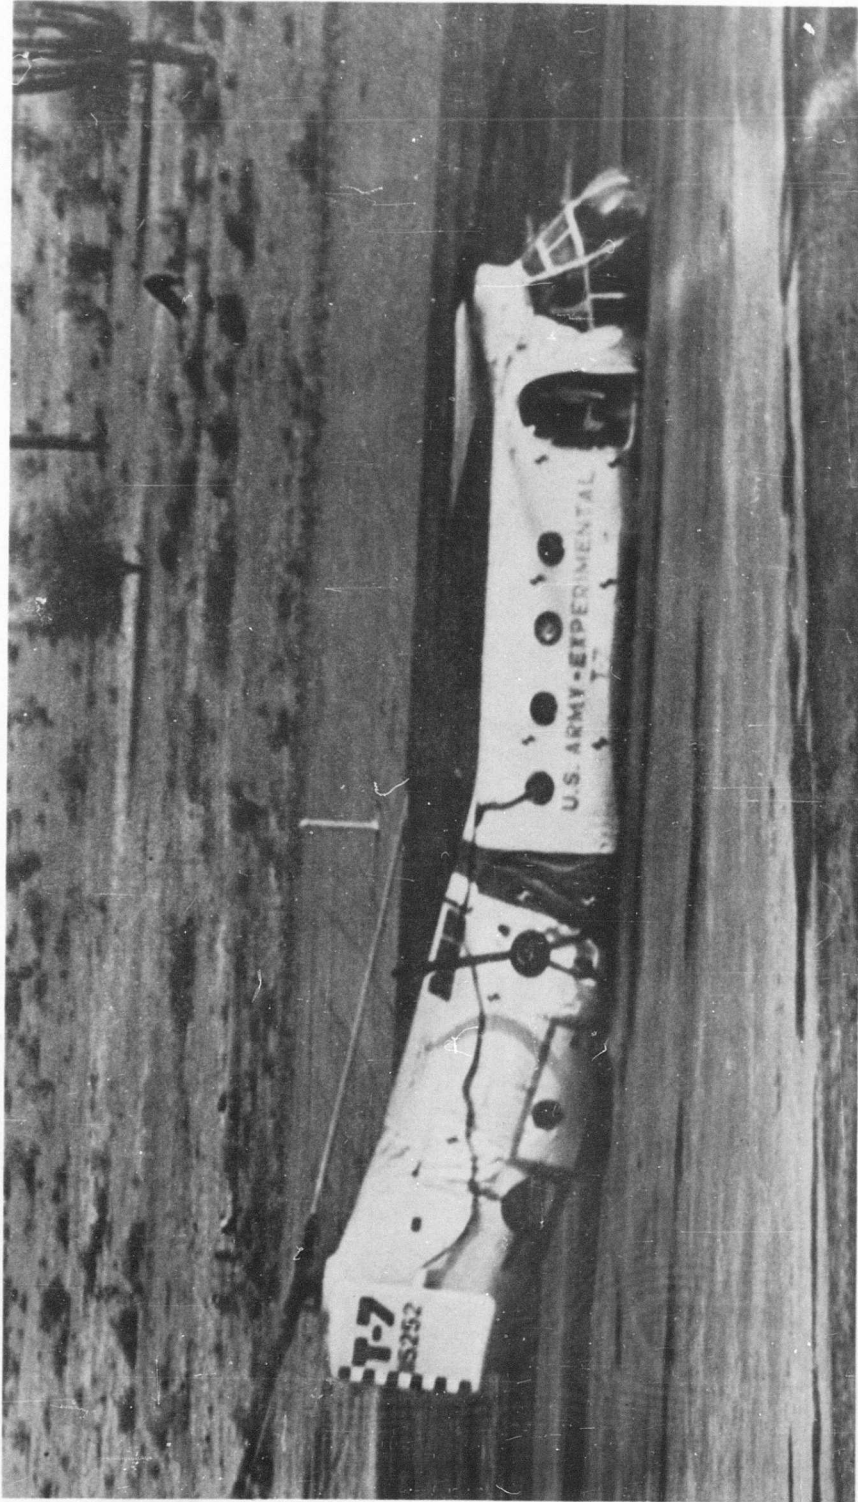
Figure 5. Test Vehicle 0. 240 Second After Initial Impact.

Notice that the landing gear have failed, and that the lower fuselage is crushing due to impact. Also, notice the skin wrinkles in the dark band just forward of the main landing gear and in the tail section just above the engine compartment access door as well as the skin wrinkles below the forward rotor between the door and the cockpit. (U. S. Army Photograph)

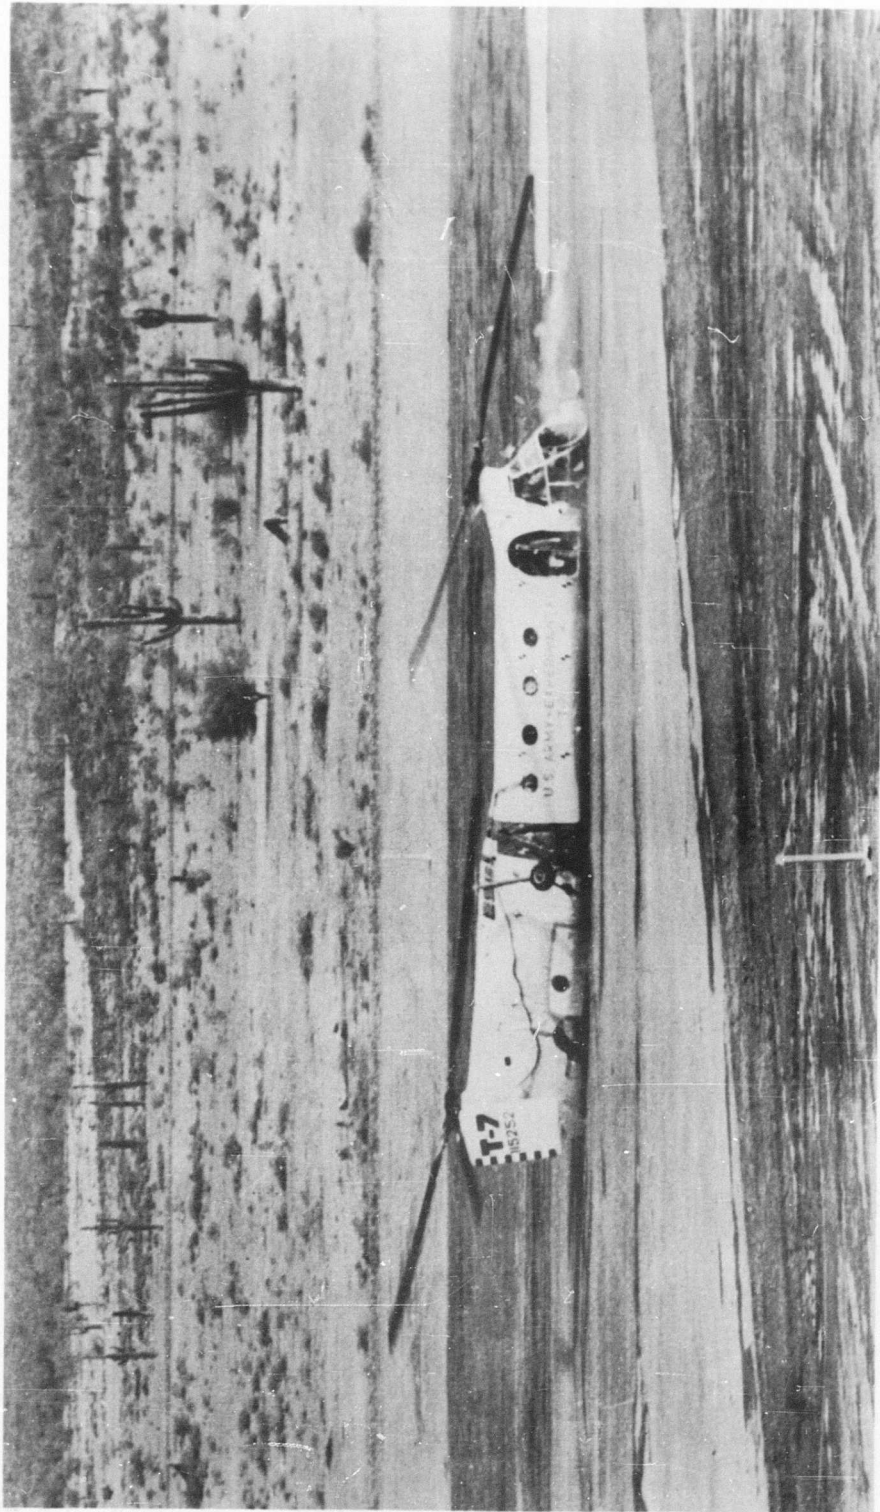
Figure 6. Test Vehicle 0.331 Second After Initial Impact.

Notice that the tail of the fuselage has bent downward until the entire bottom surface of the fuselage is in contact with the ground. It will also be noted that the fuselage is beginning to tear in the dark band just ahead of the main landing gear near the top of the fuselage. (U. S. Army Photograph)

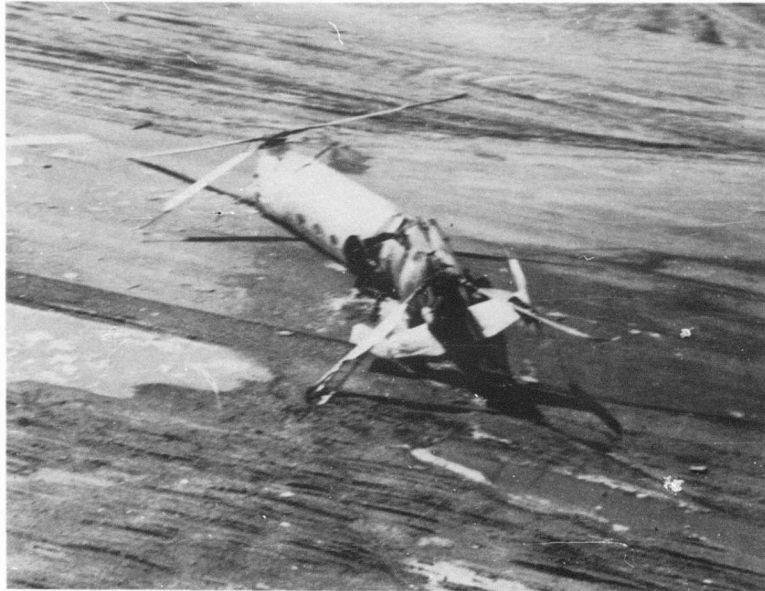
Figure 8. Attitude of Test Vehicle After the Crash. Notice how the aircraft turned to the right and the tail section bent to the left.

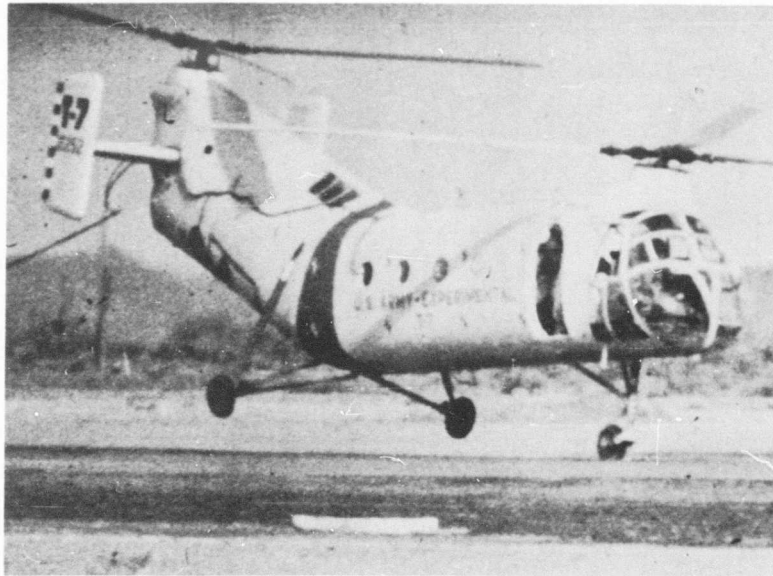
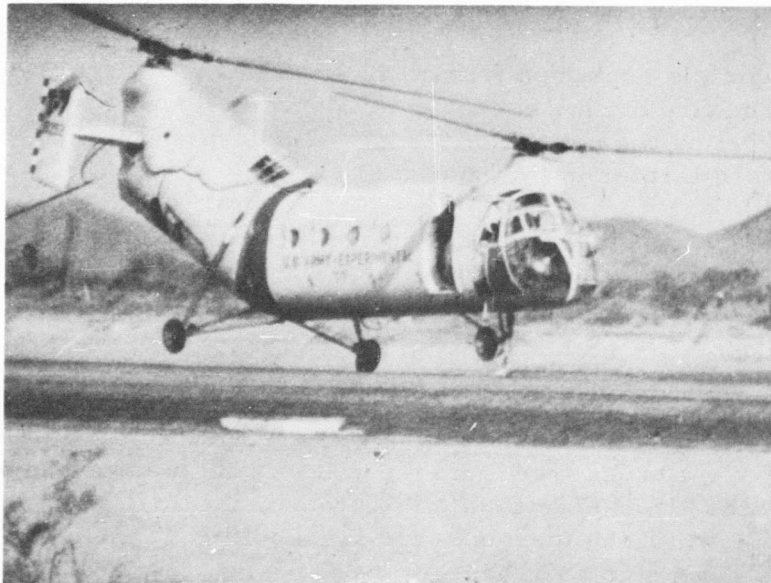
The nose wheel broke away from the oleo strut, and then the nose landing gear oleo strut broke free from the aircraft at its attachment to the fuselage. As the aircraft settled to the ground, the nose wheel bounced up into the bottom of the fuselage, and the oleo strut assembly folded aft so that both were trapped beneath the forward section of the cargo compartment (Figures 9, 10, and 11).

Figure 9. Sequence Photo of Nose Landing Gear Failure.

Figure 10. Sequence Photo of Nose Landing Gear Failure.

Figure 11. Sequence Photo of Nose Landing Gear Failure.

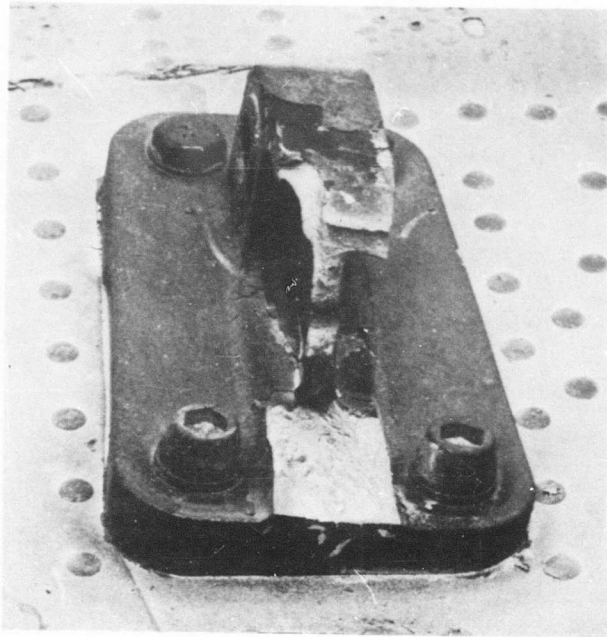
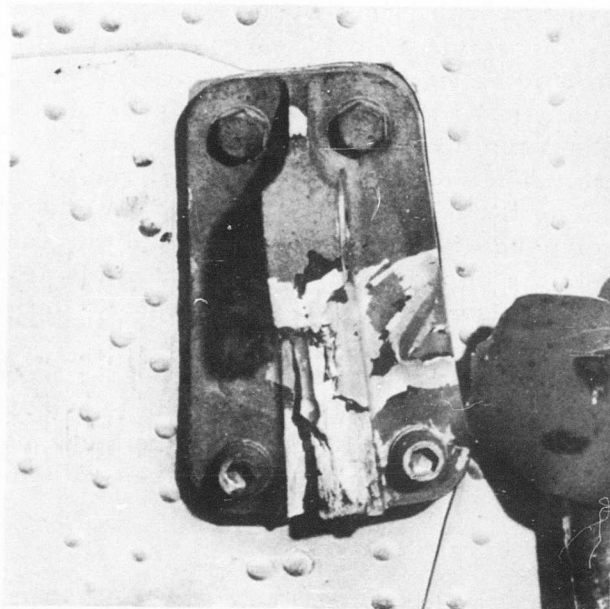
Both main landing gear support fittings, parts numbers 4251048-1 left side and 4251048-2 right side, failed (Figures 12 and 13). Study of high-speed motion picture film revealed that prior to the fitting failure, the main landing gear oleo struts were not compressed any appreciable amount; they acted as solid compression members. Impact forces were transmitted directly to the support fittings, causing their immediate failure. The oleo struts were then free to rotate about their lower attach point as the fuselage continued downward toward impact. The upper ends glanced off the fuselage skin and moved upward and outward relative to the support fittings without doing any major damage to the fuselage structure.

Figure 12. Main Landing Gear Support Fitting, Right Side.

Figure 13. Main Landing Gear Support Fitting, Left Side.

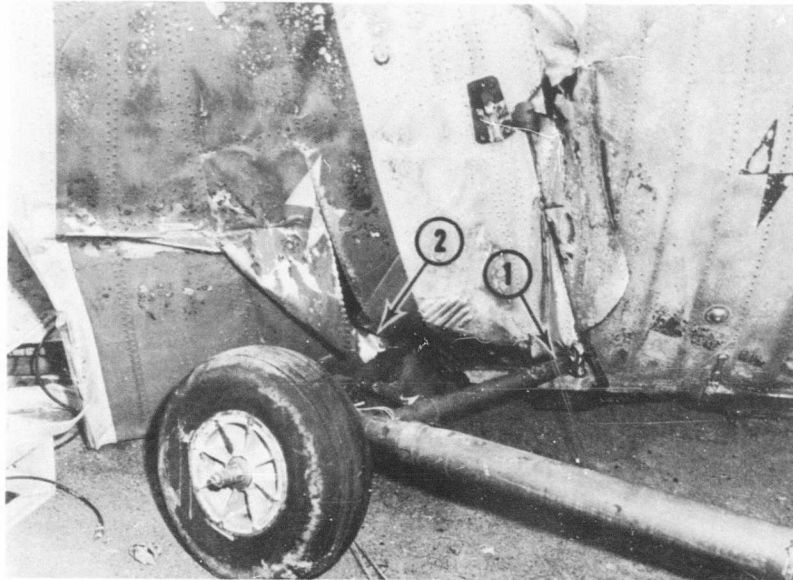
Figure 14. Left Main Landing Gear.

As the aircraft continued to settle and contacted the runway, the main landing gear V-brace assemblies punctured the lower fuselage, doing serious damage to the lower fuel tank structure and ripping the inverter from its mounts in the plenum chamber (Figures 14 and 15).

The rear V-brace (arrow 1) ripped through the fuselage and tore the inverter from its mounting in the plenum chamber. The forward V-brace (arrow 2) smashed upward into the main fuel cell.

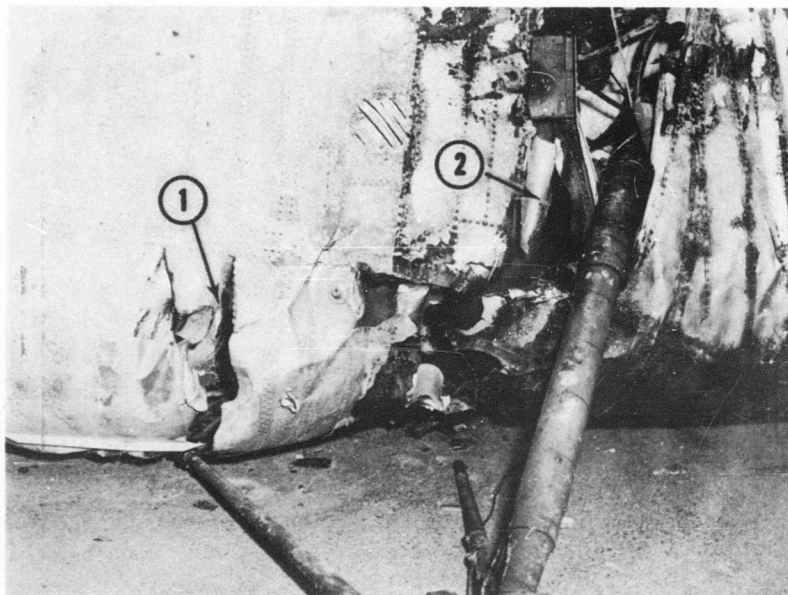
Figure 15. Right Main Landing Gear.

Notice the damage to the lower fuselage structure done by the V-brace assembly (arrow 1). Also notice the jagged hole in the main fuel cell just aft of the landing gear oleo strut (arrow 2).

The fuel tank structure was extensively damaged. The top of the tank was the only part which remained intact. Figure 15 shows the beginning of a tear at the upper right side of the front of the tank. This tear extended all the way around under the fuel tank at the forward edge, to the top of the left side. The left side of the tank and the front of the tank were buckled due to the crushing of the bottom of the aircraft by impact. The bottom of the tank was torn and punctured to such an extent that it was virtually destroyed.

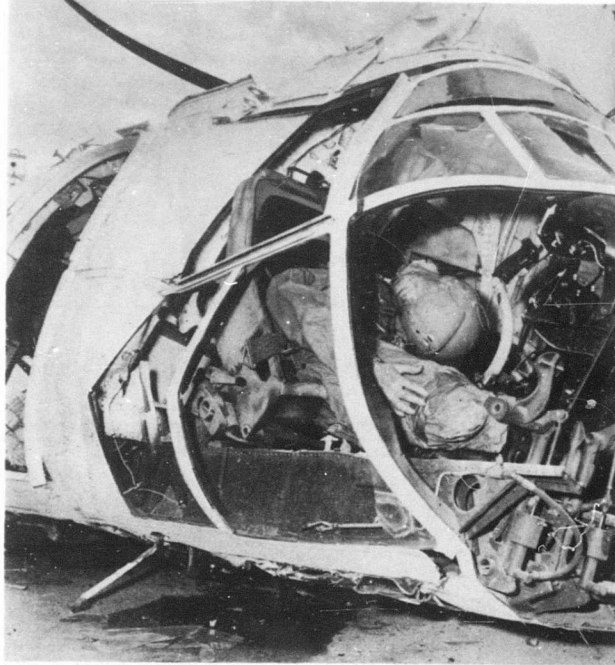
Figure 16. Right Side of Cockpit Following Crash.

The primary structure in the cockpit area remained essentially intact. The floor sustained only minor damage, which was apparently caused by the failure of the pilot's seat and its subsequent impact with the floor. The main floor beams did not fracture when the fuselage substructure crushed, but permanent deformation did occur.

Note the deformation of the window frame structure and the pilot's seat extending partly out one window. Also notice the window frame structure resting on the instrument console.

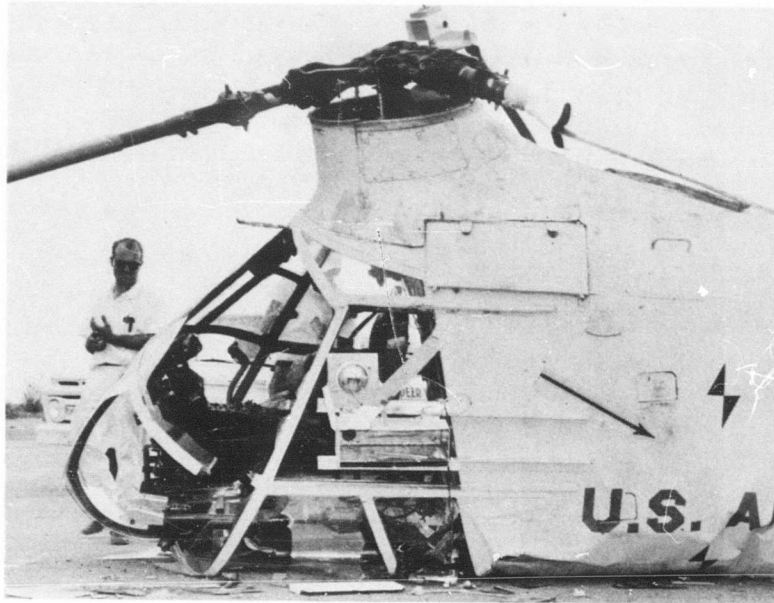
The bulkhead behind the pilot's seat, fuselage station 97.036, partially collapsed due to the high compressive load imposed upon it by the forward rotor transmission. The partial failure of this bulkhead allowed the transmission and rotor head to move downward and forward, causing collapse of the cockpit window frame structure, which then struck the instrument console (Figure 16). All the cockpit windows were broken. The partial failure of the station 97.036 bulkhead also resulted in buckling of fuselage skin aft of this station (Figure 17).

Figure 17. Left Side of Cockpit Following Crash. Notice the deformation of window frame structure and the skin wrinkles aft of the cockpit (arrow).

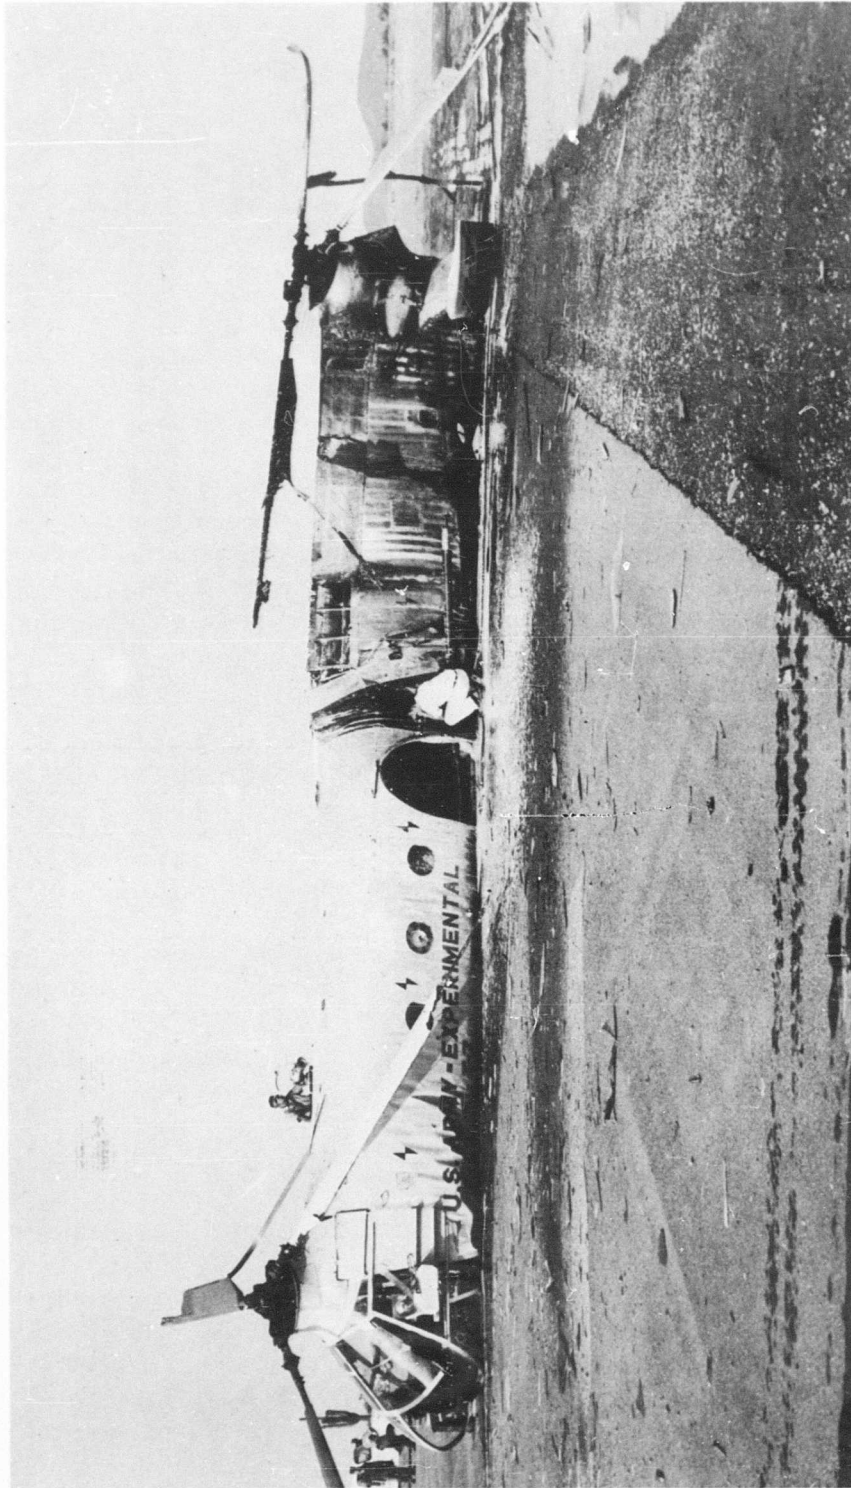
Figure 18. Overall View of Left Side of Aircraft Wreckage.

The entire cargo compartment lower body, including fuselage skin, floor support structure, and lower sections of body frames, was crushed by impact. Because the aircraft impacted with a slight left roll (Figure 4), the lower fuselage sustained more damage on the left side than on the right side.

The break in the fuselage extended from beneath the fuel tank on the bottom of the aircraft, up the right side, and over the top of the aircraft. The fuselage structure beneath the fuel tank and plenum chamber was badly mangled by a combination of impact, sliding, and puncturing by the main landing gear V-brace assemblies. The V-braces punctured the fuselage on both sides of the aircraft.

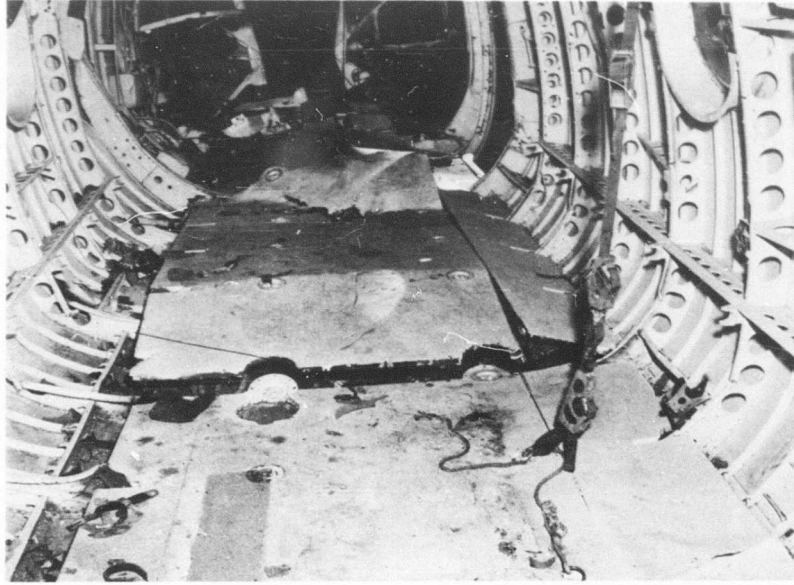
Figure 20. Overall View of Passenger Compartment Floor. This view is toward front of aircraft, after removal of experimental equipment.

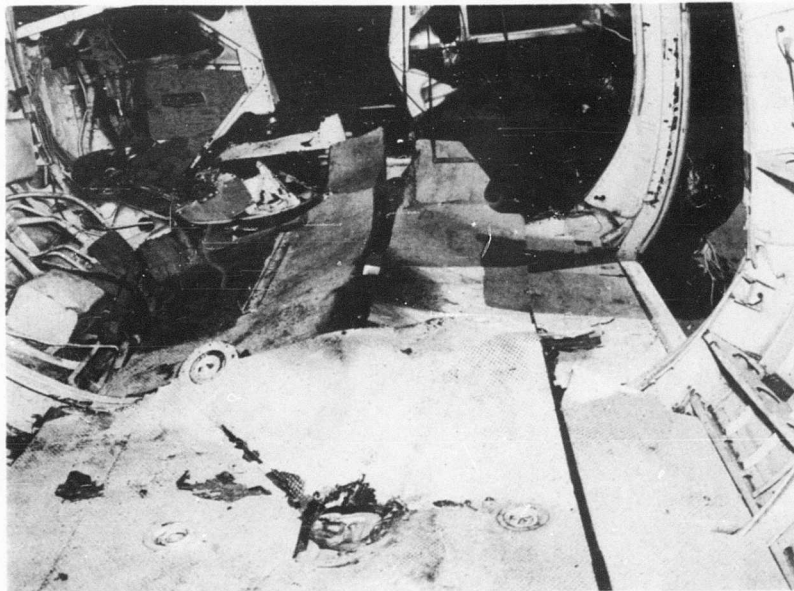
Figure 21. Severe Buckling of Passenger Compartment Floor, Fuselage Station 100 to Fuselage Station 160. This deformation was caused by the collapsed nose landing gear which was trapped beneath the fuselage.

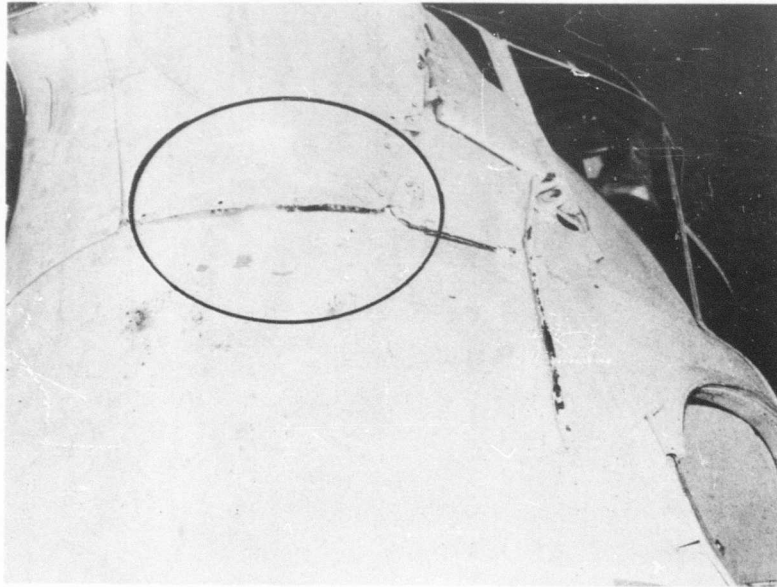
The forward displacement of the forward rotor transmission and rotor head assembly caused the failure of a row of fasteners at the junction of the fuselage station 119.50 bulkhead and the upper fuselage skin at the aft edge of the right side cowling assembly, part number 2258020-7. The tearout of this row of fasteners progressed outboard into a tear of the fuselage skin panel immediately outboard of the cowling assembly. The upper fuselage skin aft of the fastener failure was buckled due to the tensile load which was applied by the forward displacement of the rotor head.

Figure 22. Upper Fuselage Aft of Forward Rotor Head.
This photograph shows the separation of the cowling and the skin panel on the upper fuselage skin aft of the forward rotor head, fuselage station 119.50.

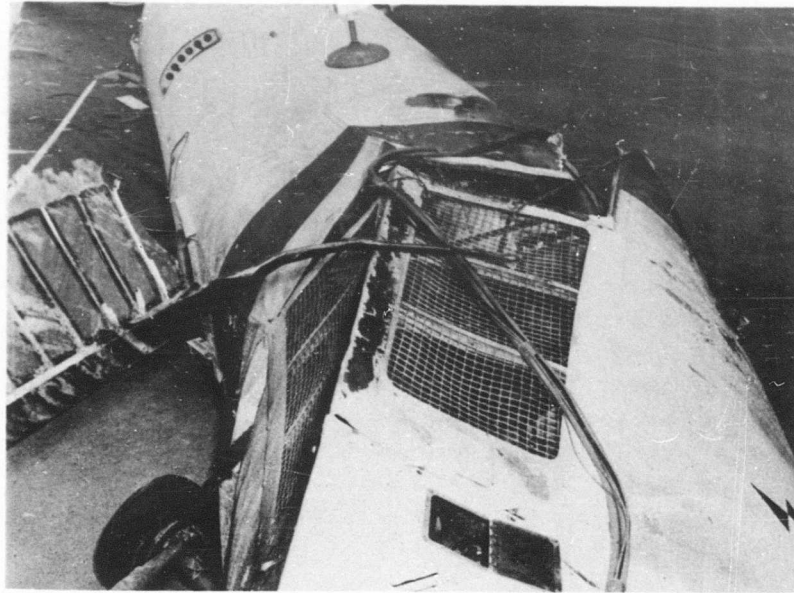
Figure 24. Fuselage Failure, Top View.
View looking forward showing the continuation of the fuselage rupture over the top of the fuselage. Notice the angular deflection of the entire tail section.

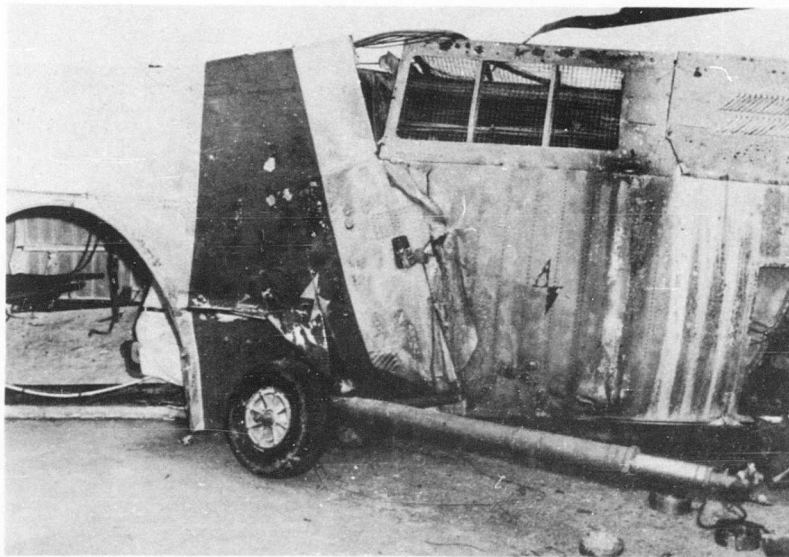
Figure 25. Fuselage Damage, Left Side, Opposite Fuselage Break.
This photograph shows the structural failures opposite the ruptured fuselage skin.
