# FRANKFORD ARSENAL

EXAMINATION OF ROTATING BANDS FROM 155MM  
PROJECTILE, HE, M107, FIRED WITH PROPELLANT CHARGE XM119

Test Report T64-3-1

October 1963

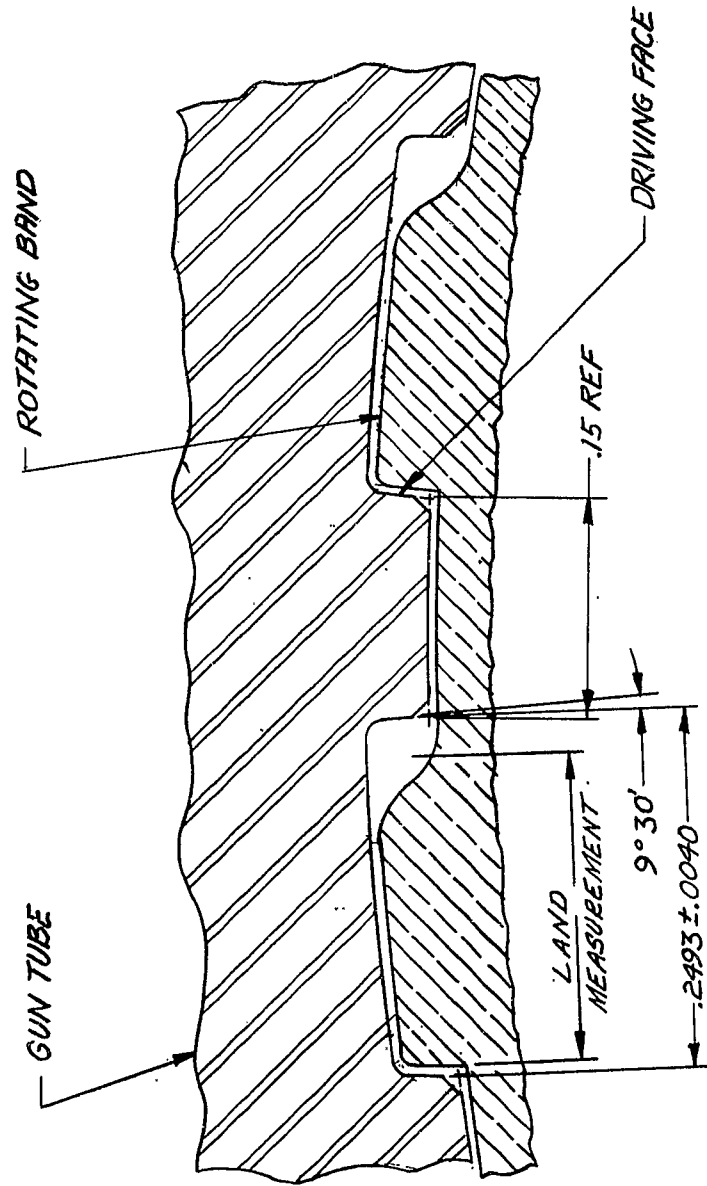
Figure 2. 155mm M107 Rotating Band Wear with Propelling Charge XM119

are given in table IV. Because of the erosion of the nondriving face, it was not possible to accurately measure the band land width. The measurements were taken as shown on figure 2 and the actual percent of band shear or wear is somewhat greater than that shown by the measurements. On three of the four rounds fired at service pressure, the band wear was 19% with one round of 31%. On three of the four rounds fired at excess pressure, the wear was 38% with one round of 47%. From a new tube, two definite wear levels are evident, proportional to pressure and velocity and fairly consistent with an occasional outlier. The wear level (17-36%) from the worn tube is comparable to that of the new tube; however, the variation of the wear level is greater for the worn tube which is expected due to the worn condition of the tube.

Although considerable wear is evident, sufficient working metal was left to satisfactorily impart full spin to the projectile and because of the consistency of the wear, the wear did not adversely effect either the velocity uniformity or range dispersion of the shell (PE range .20% at 18,000 meters). The rotating bands of four recovered T387E1 projectiles fired at 120% of rated maximum pressure were measured for comparison with M107 and the wear of the T387E1 was 3 to 5%. Diametrical measurements of the band do not appear to be too meaningful or significant. Band land and groove diameters are shown in tables II and III. They exceeded the maximum rifling diameters, although the excess cannot be related to excessive band gap. A possible explanation may be that of elastic deformation of the shell body due to the engraving pressure. Similar measurements of the T387E1 shell were generally within dimensional limits, however, the T387E1 band is supported by the solid base section thus minimizing, if not eliminating, elastic deformation of the shell body.

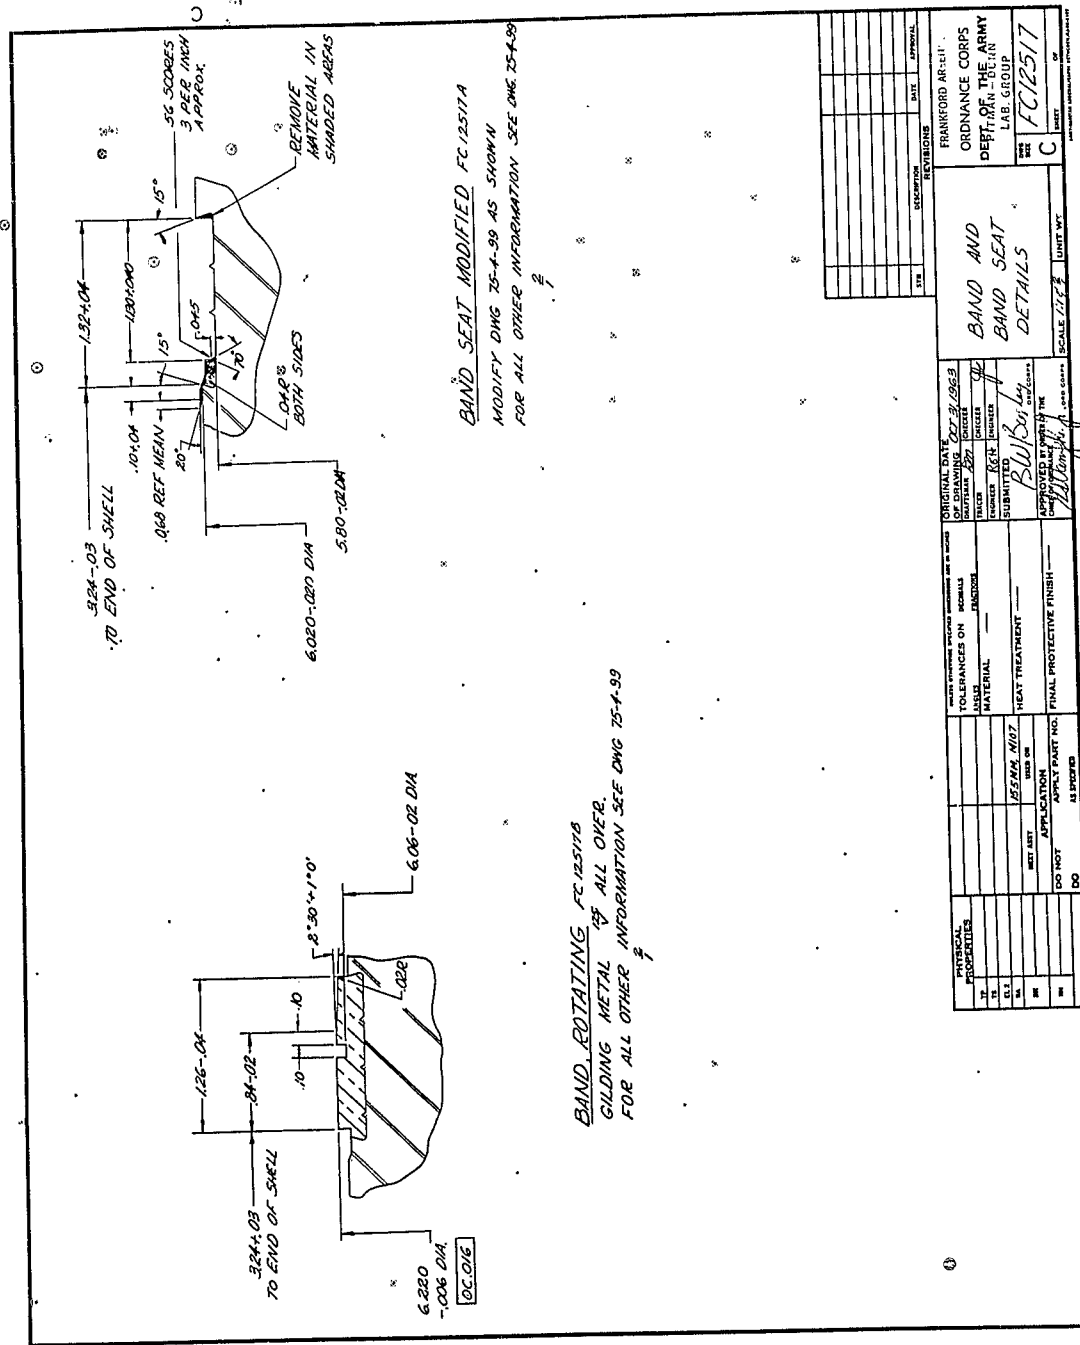
Figure 4. Band and Band Seat Details

Finally, the band seat profile was examined for its ability to retain the band. The edges of the band seat are not undercut and due to the large relief groove behind the band, the depth at the rear of the seat is only about .070" or one-half that of the forward edge of the seat (.140"). Therefore, band retention is primarily dependent upon the strength and tightness of the band.

The above is the most probable cause of band failure except for failure of the band in hoop tension, and could probably be overcome by proper application of the bands. However, if the problem is serious enough to warrant rebanding, then it is recommended that the seat profile be modified to include 15° undercuts of the edges and widened to increase the depth of the rear edge of the seat to a minimum of 85% of the depth of the forward edge. A proposed band seat and band profile is given in figure 4.
