TERMINAL BALLISTIC TARGET ANALYSIS AND STUDY  
OF TARGET VULNERABILITY TO VERY HIGH SPEED IMPACT

Technical Documentary Report No. ATL-TDR-64-51  
August 1964 Project No. 5841  
Task No. 02

Directorate of Armament Development  
Det 4, Research and Technology Division  
Air Force Systems Command  
Eglin Air Force Base, Florida

(Prepared under Contract No. AF 08(635)-3641 by the Hayes  
International Corporation, Birmingham, Alabama)

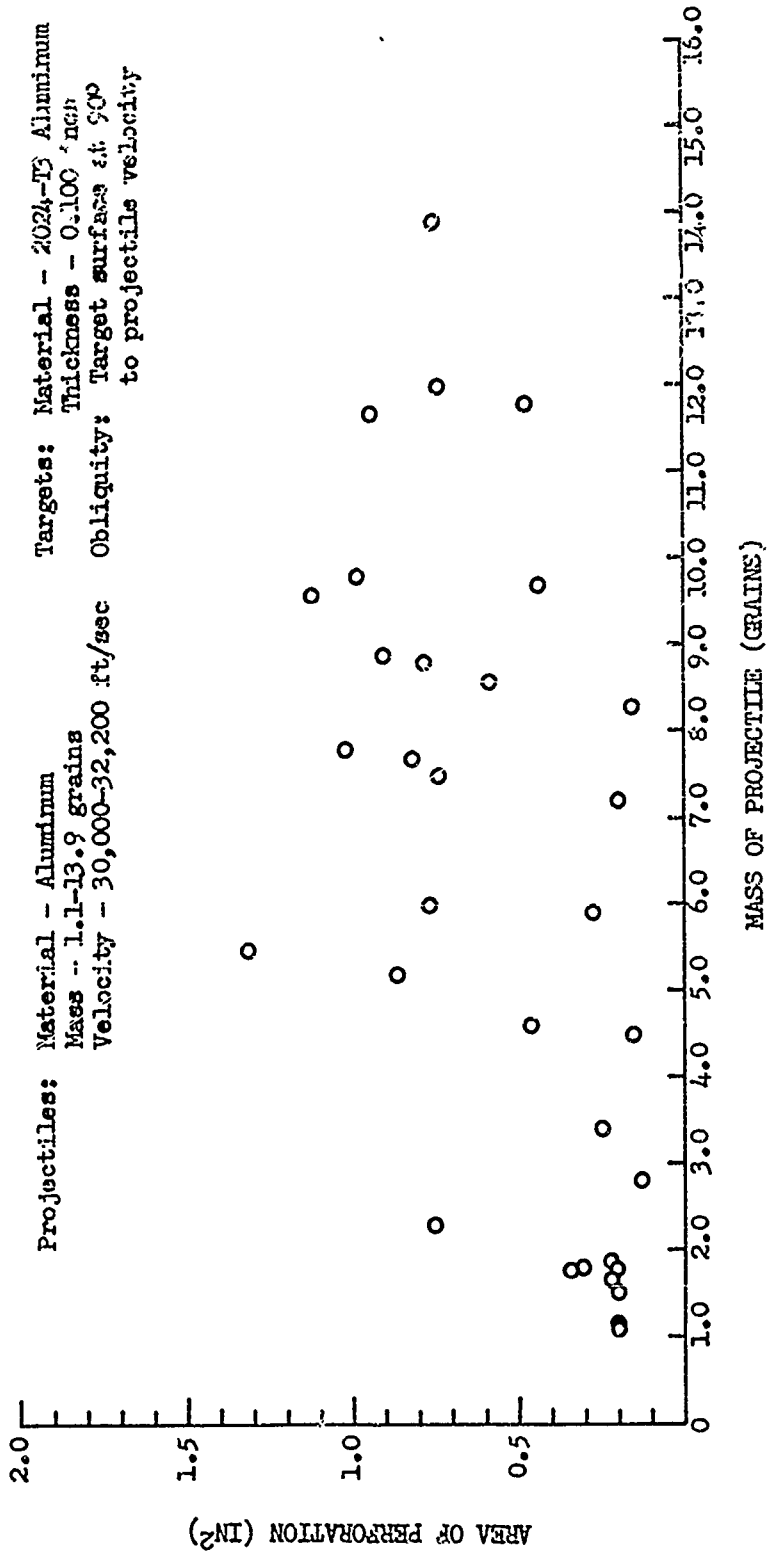
Damage to the first panel of each target was determined by measuring the dimensions of the perforations produced by projectiles of known mass and velocity. From the dimensions, the areas of the perforations were calculated. These data are summarized in Table 2. Perforation area is plotted as a function of projectile mass in Figure 13. The data show

FIGURE 13 PERFORATION AREA AS A FUNCTION OF PROJECTILE MASS FOR THIN ALUMINUM TARGETS

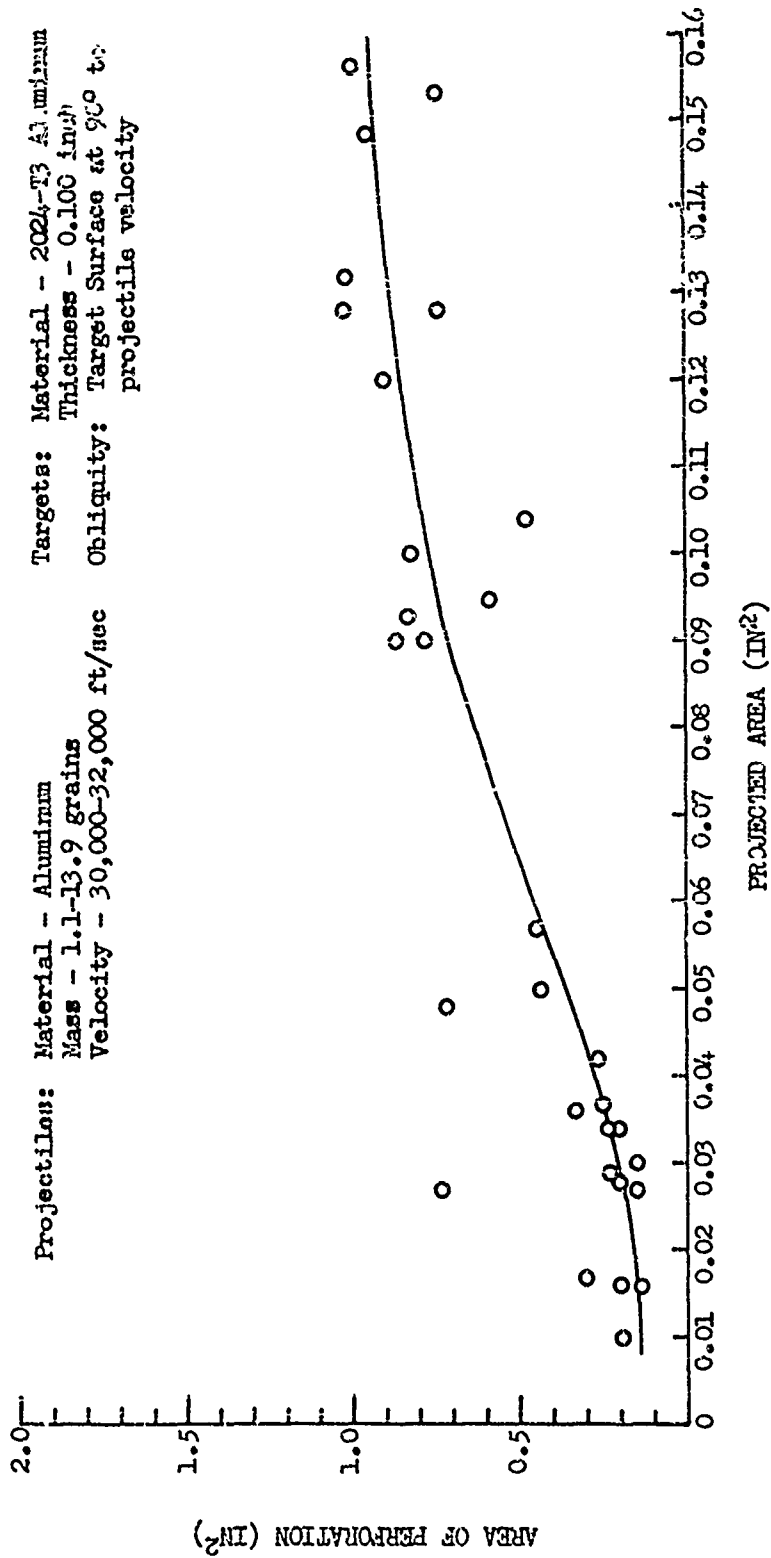
considerable scatter. Perforation area plotted as a function of the projected area of the impacting projectile produces a smoother relationship as shown in Figure 14. Consequently, the damage to thin 2024-T3 aluminum targets appears to depend primarily on the projected area of the projectile.

FIGURE 14. PERFORATION AREA AS A FUNCTION OF PROJECTED AREA OF PROJECTILE FOR THIN ALUMINUM TARGETS
