REPORT NO. ST35438R-63  
TASK NO. RAE20P031  
PROBLEM NO: 031-AE22-33  
DATE 1 Aug 1963

# NAVAL AIR TEST CENTER TECHNICAL REPORT

THIRD INTERIM REPORT

(6) TEST FLIGHT OF PILOTS' FLASHBLINDNESS  
HELMETS, GOGGLES, GLASSES, AND ASSOCIATED SYSTEMS.

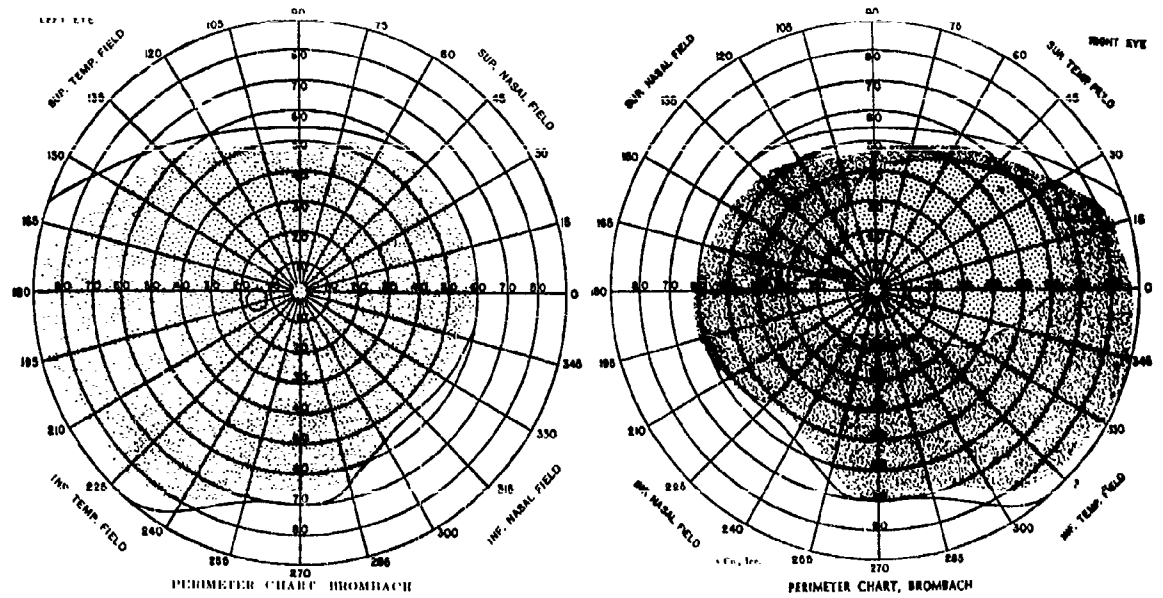
Figure 5  
Composite Perimeter Chart

16. Perimeter tests revealed a marked reduction of peripheral vision with the EMG, as indicated in the composite perimeter charts (figure 5). The over-all reduction of the nasal fields and the asymmetrical reduction of the right superior nasal field was consistent for all subjects. These reductions of nasal fields were caused by the 1 in. separation between the goggle lenses across the bridge of the nose and by the motor release lever over part of the right lens. Repeated perimeter tests on any given subject showed minor jagged deviations in outline in the temporal fields, caused by shutter interference. The variations in superior and inferior fields were probably caused by the shutters in the lenses. Other quadrants of reduced vision varied with subjects. The differences of facial anatomy, particularly the nasal contours, accounted for the variation between subjects. Flight tests of the goggles were restricted to dual control aircraft because of the severe reduction of peripheral vision. The EMG are unacceptable because of the reduction they create in the wearer's field of vision.

18. Evaluations of instrument, console, and control visibility conducted in the cockpits of various aircraft verified the laboratory EMG perimeter studies. All tests were conducted with the seat adjusted so as to align the subject's optic axes with the design eye plane. The reduction of visual fields by the EMG caused most subjects to assume a head down position to see the essential flight instruments. This position was both uncomfortable and unsafe.
