EFFECTS OF AIRFRAME GEOMETRY  
ON DOWNWASH PROBLEMS OF  
TANDEM DUCTED-PROPELLER  
VTOL AIRCRAFT

DATE Jan. 1964 REPORT NO. 179T80-6

Prepared Under Navy,  
Bureau of Naval Weapons  
Contract N0w61-0926-c

R. R. Pruyn  
R. R. Pruyn,  
Manager, Research Engineering

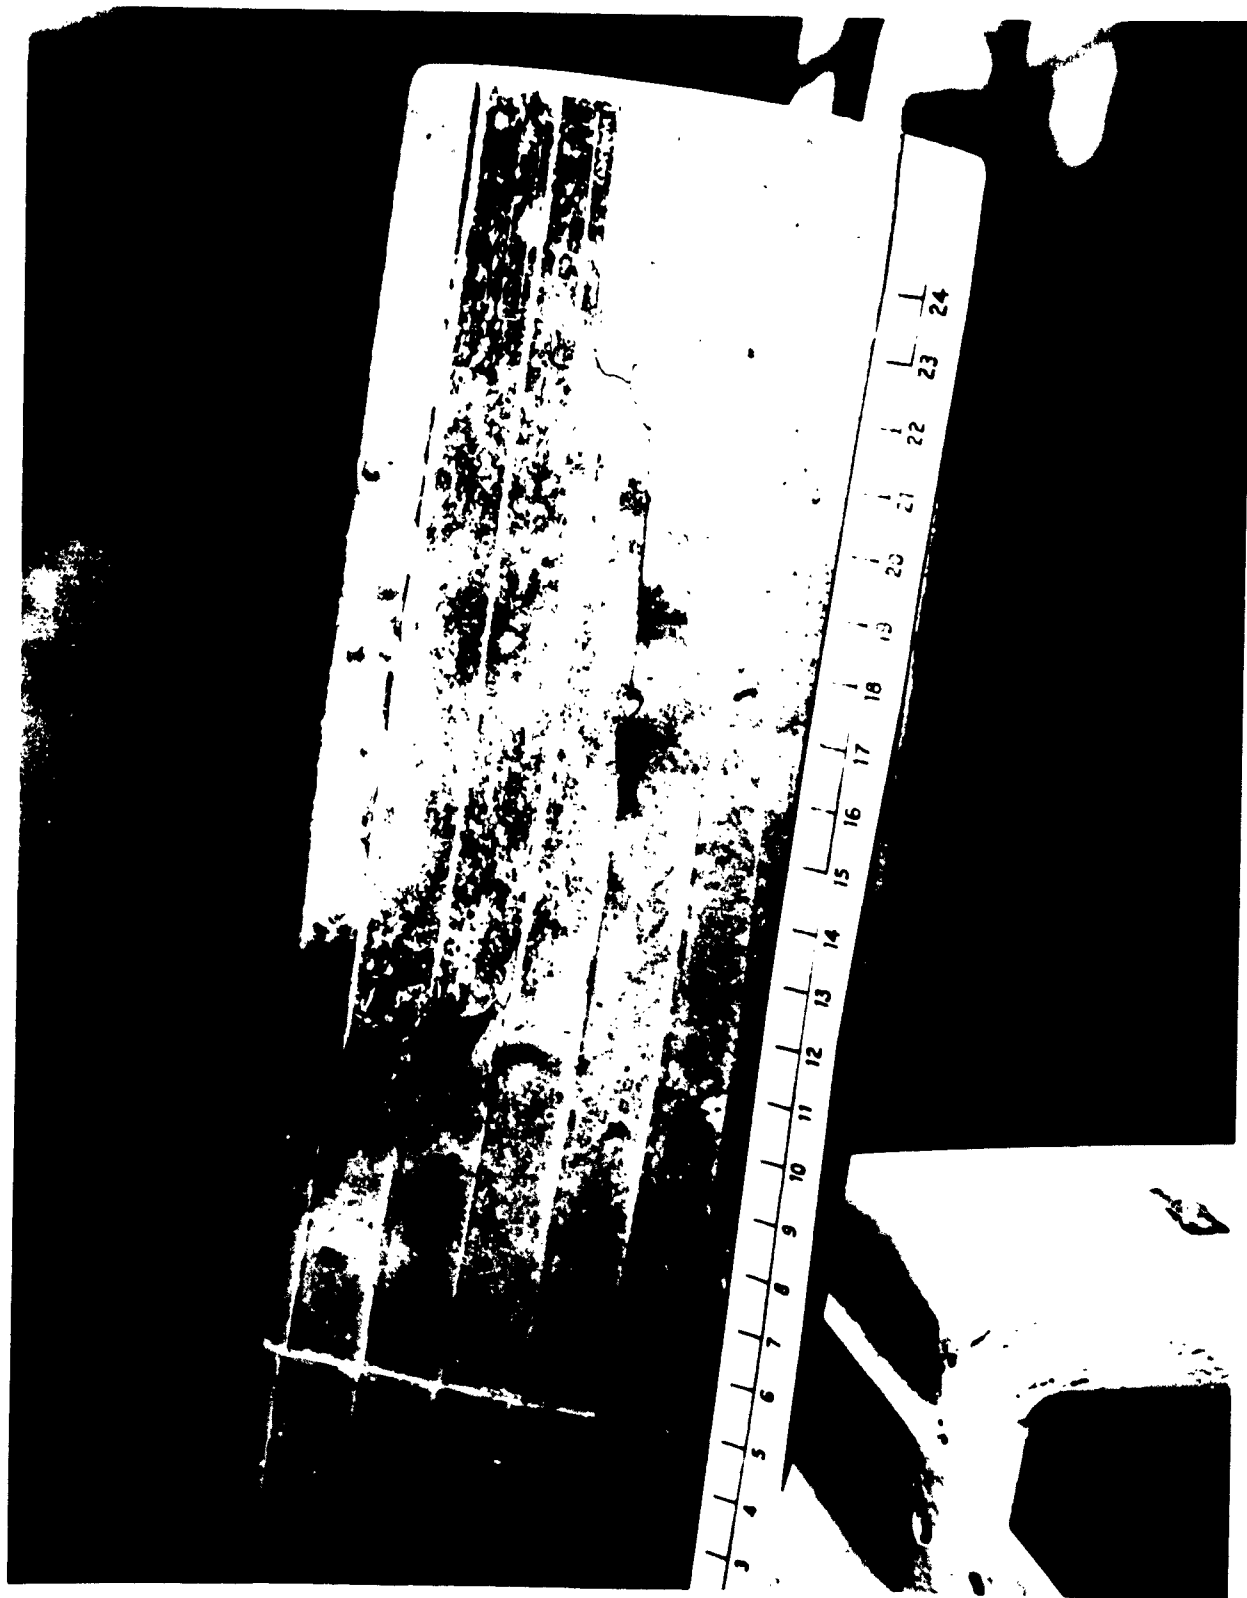
FIGURE 40. BOTTOM SURFACE OF AFT PROPELLER BLADE SHOWING FAILURE OF NEOPRENE ABRASIVE COVERING AFTER FIVE MINUTES OF MAXIMUM POWER OPERATION OVER SAND

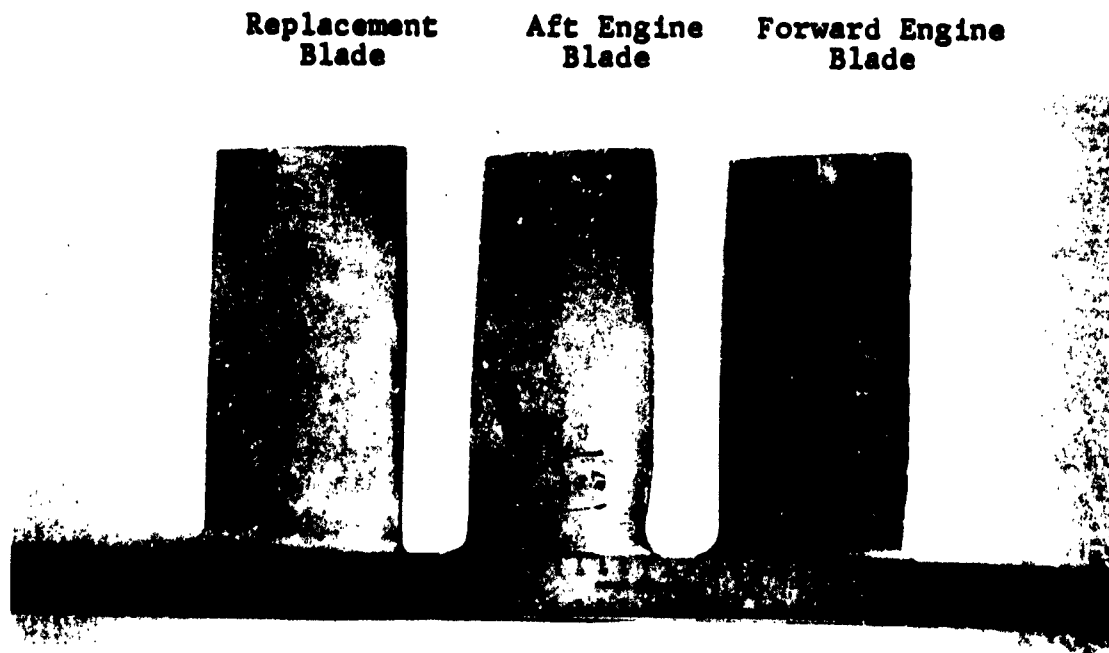
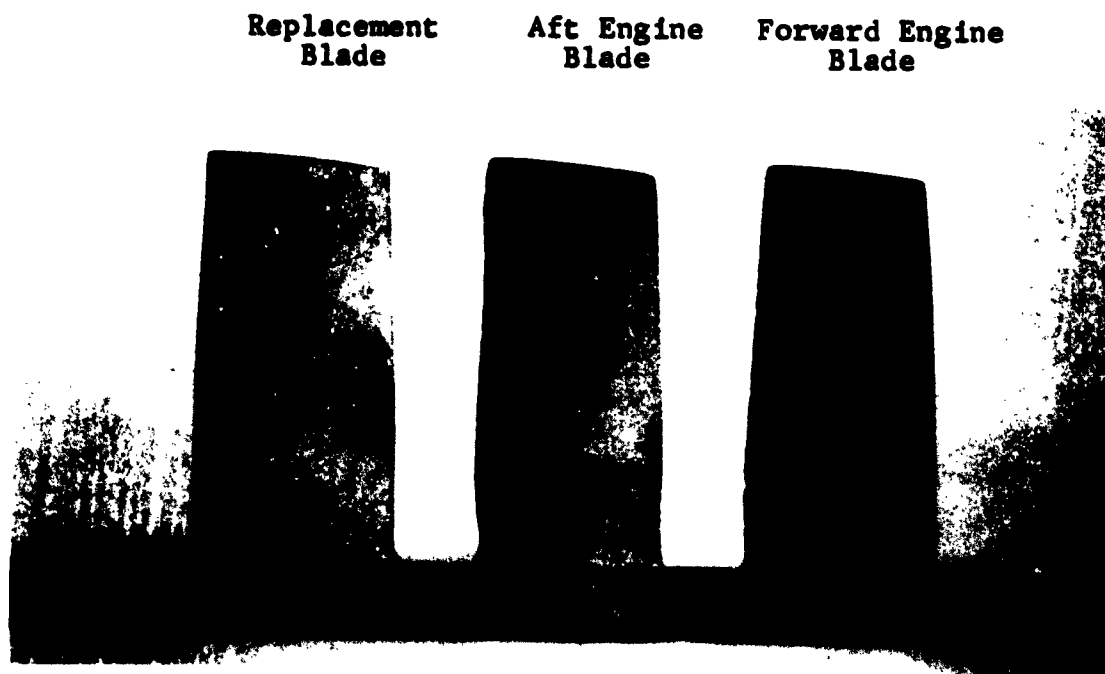
a) Downstream Side Of Blades

b) Upstream Side Of Blades

FIGURE 43. COMPARISON OF FIRST STAGE COMPRESSOR BLADES OF T-53 ENGINES SHOWING DAMAGE DUE TO SAND INGESTION
