Technical Note N-622

TSUNAMI DAMAGE AT KODIAK, ALASKA, AND CRESCENT CITY,  
CALIFORNIA, FROM ALASKAN EARTHQUAKE OF 27 MARCH 1964

U. S. NAVAL CIVIL ENGINEERING LABORATORY  
Port Hueneme, California

ABSTRACT

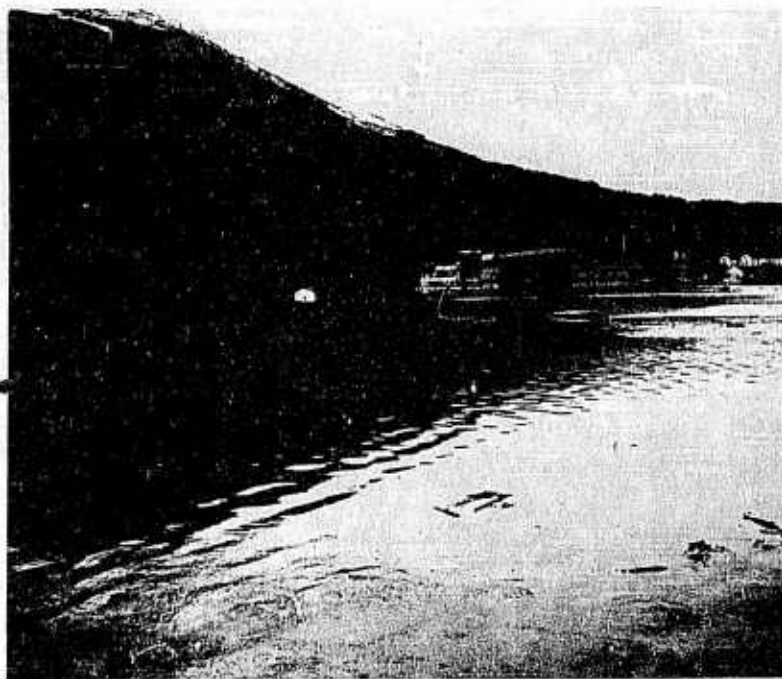
**Fig. 4** View of first tsunami wave which crested at 16 ft above the old MLLW deluged the seaplane ramp leading from Old Woman's Bay. The two PV2 aircraft in front of Hanger #3 were saved by moving them to higher ground.  
(Photo by PIO, Kodiak NAVSTA)

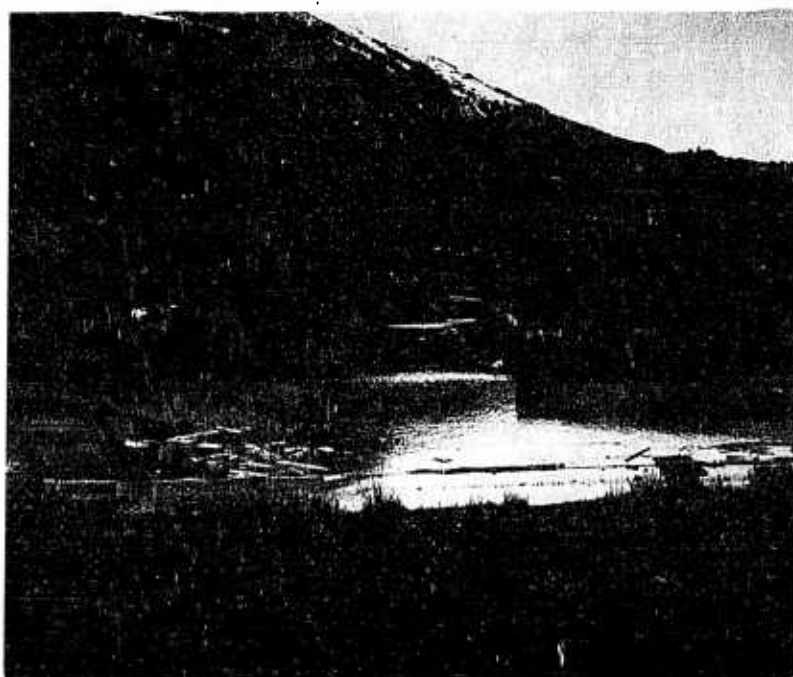
**Fig. 5** Debris and ice cakes are deposited on the seaplane taxiways after recession of first crest. Damage to the Stations three hangers is placed at more than \$1 million dollars. (Photo by PIO, Kodiak NAVSTA)

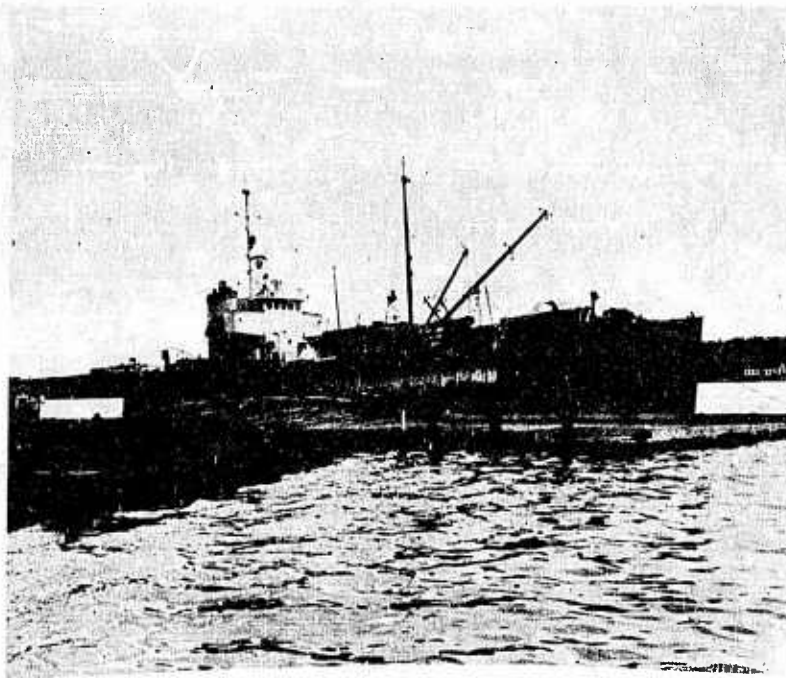
The Cargo Dock, Structure No. 454, which was in a deteriorated condition, was completely damaged by the tsunami. Prior to the earthquake all ship and cargo supplies were loaded and unloaded at this dock. The tsunami-induced motion of moored ships raised the bollards and damaged some fendering (Figure 6). A more extensive analysis of failure to fenders by moored ships is reported by O'Brien (1963) in an analysis of damage to Apra Harbor, Guam, during Typhoon Karen. There it was found that the fender damage was due to thrashing by vessels moored alongside. All occupied fenders there suffered damage. The 5-1/2-foot tectonic settlements of NAVSTA enables the high tides to nearly inundate the Cargo Dock.

Figure 6. Cargo Pier deck nearly inundated by high tide after tectonic settlement of NAVSTA. Tsunami-induced motion of moored ships raised bollards.

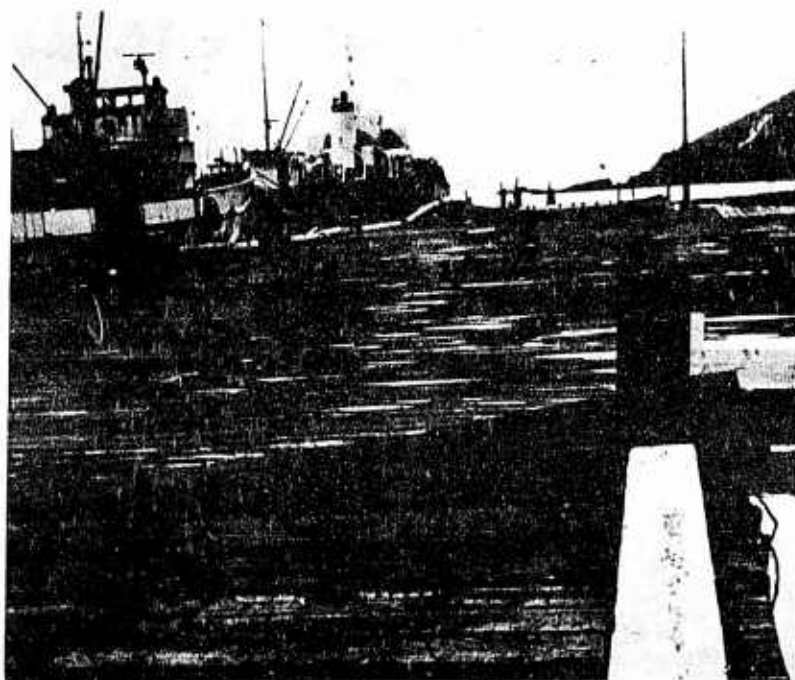
Figure 7. Local elevation of Cargo Pier deck caused when tsunami-extracted piles did not return to augered pile holes in rocky bottom.

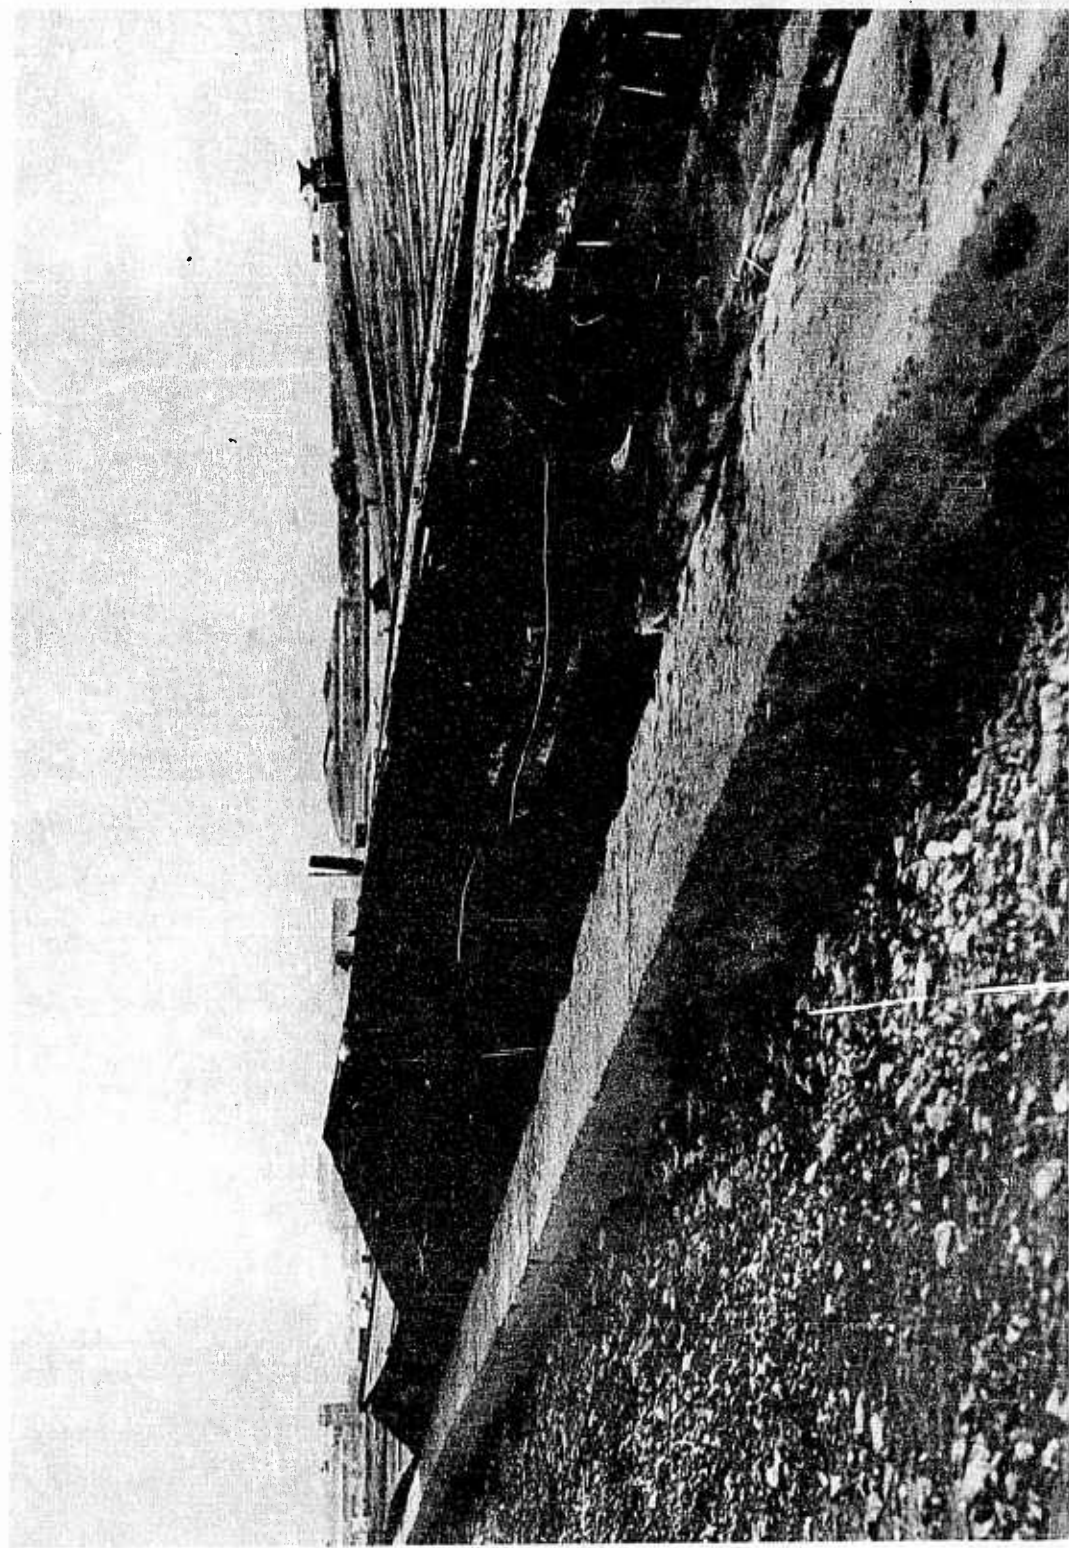
The elevated waters lifted (buoyed) sections of the pier decking off the piling and moved it laterally. This shifting caused failure of many framing and bracing members. Several piles were pulled from their pile-holes along with the elevated decking. The reason is that great difficulty is experienced upon driving piles in the rocky bottom, and in some instances, the pile-holes have to be augered. When the water receded, the buoyed decking and extracted piles did not return to their original positions (Figures 7 and 8). This resulted in differential elevations of several feet in the decking. The Marginal Pier suffered minor damage such as that on the approach (Figure 9) where a moored barge under tsunami action loosened a bollard and some decking.

Figure 8. Waviness of Cargo Pier deck resulted when decking buoyed by tsunami failed to return to original location. (Photo by PIO, NAVSTA)

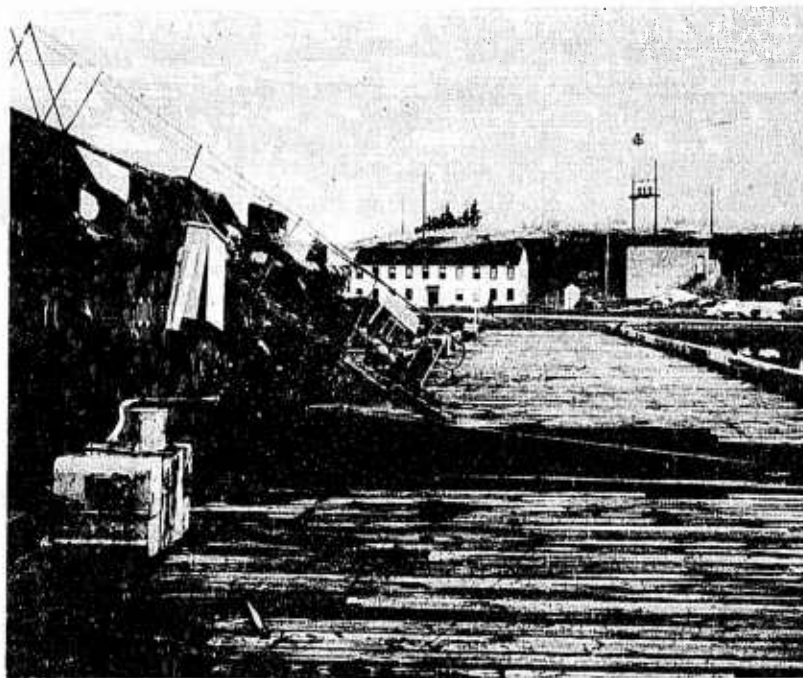
Figure 9. Moored barge under tsunami action pulled decking and bollard loose from marginal pier.

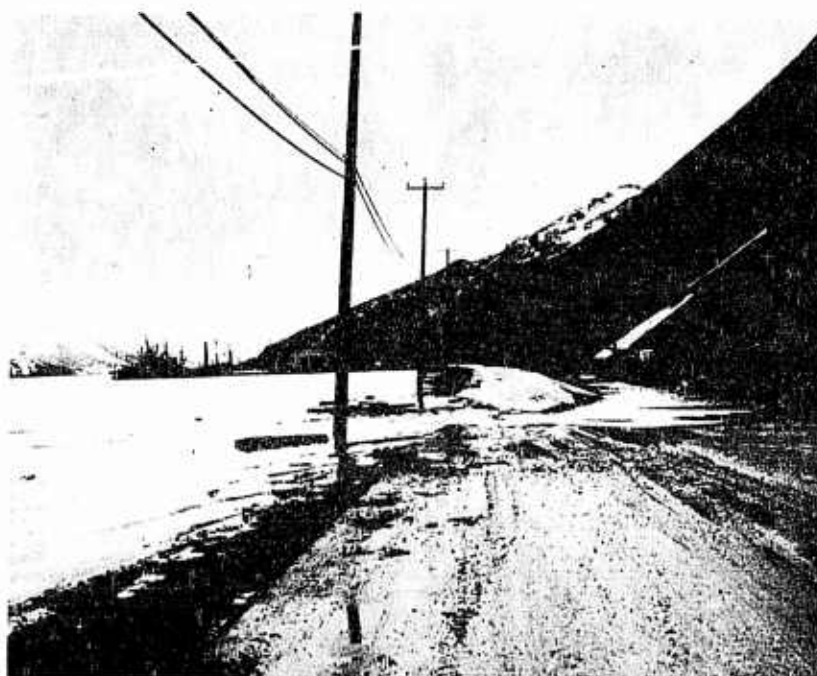
The two bridges and Chiniak Road between the Naval Station and Holiday Beach were washed out causing loss of vehicular contact with the NAVRADSTA (Figure 10). The power line in the swamp flat 4 miles to the south was damaged. NAVRADSTA (T), Buskin Lake, and NAVRADSTA (R), Holiday Beach, stand on high ground and were not damaged. The Holiday Beach barracks cracked open along a line separating the mess hall and the dormitory area.

Figure 10. Kodiak Island subsidence of 5-1/2 feet allows high tide to wash over road to NRS(R) Holiday Beach. Cargo Pier in background.

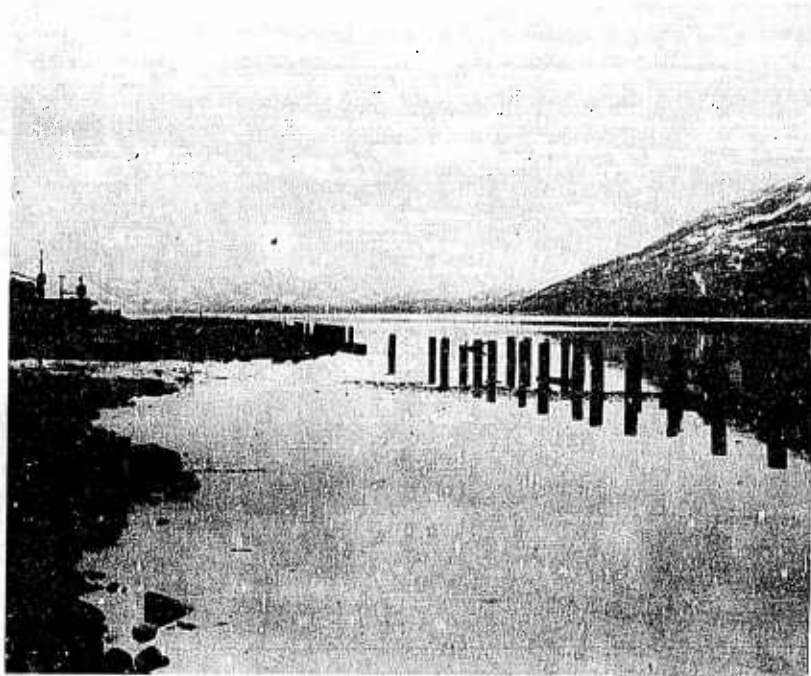
Two small waterfront structures, the Hobby Shop and Engine Generator (TACAN) Building, located on the edge of Old Woman's Bay were completely swept away except for the foundation pilings (Figure 11). Lack of adequate ties between floor beams and piling made the structure vulnerable to water uplift and lateral forces.

Figure 11. Piling is all that remains of the Hobby Shop and Engine Generator (TACAN) Buildings on edge of Old Women's Bay. Fuel Pier in background.

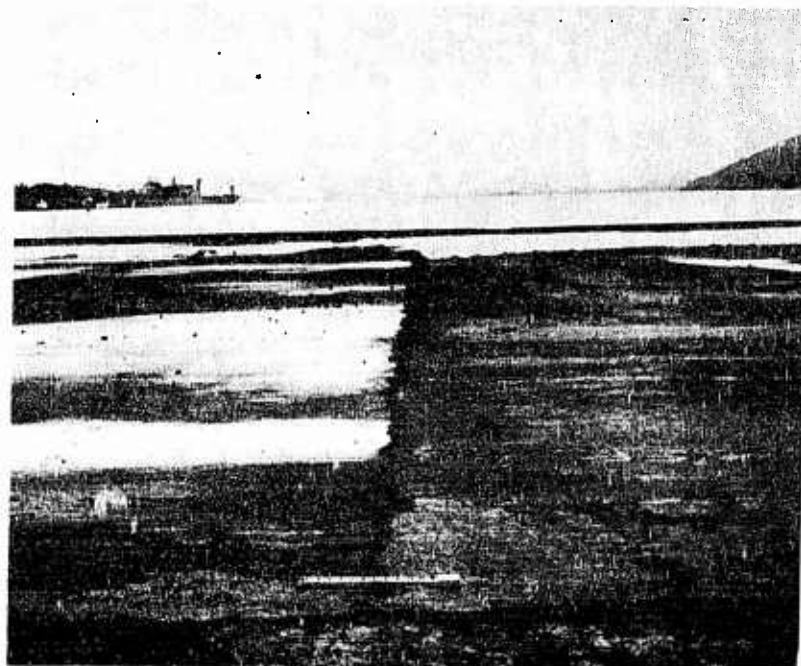
The asphalt pavement covering the taxiways between the hangars and seaplane ramps were cracked under the seismic action (Figure 12). In the hangar there was differential settlement between the pile-supported columns and fill-supported hangar deck (Figure 13) and settlement between the hangar deck and hangar structural footings around the perimeter of the hangar. The hangars were constructed on approximately 15-20 feet of glacial till fill which was consolidated under the tectonic shock and loading action of the subsequent tsunami waves. This subsidence was further accompanied by ripple and surface erosion near the hangars. The differential settlement of several inches between the slabs and hangar door footing produced an obstacle step for aircraft entering and leaving the hangar. Some of the hangars suffered slight bracing deformation and broken glass from subsidence.

Figure 12. Seismic action produced 1" cracks in asphalt pavement of taxiway. Fuel Pier in background.

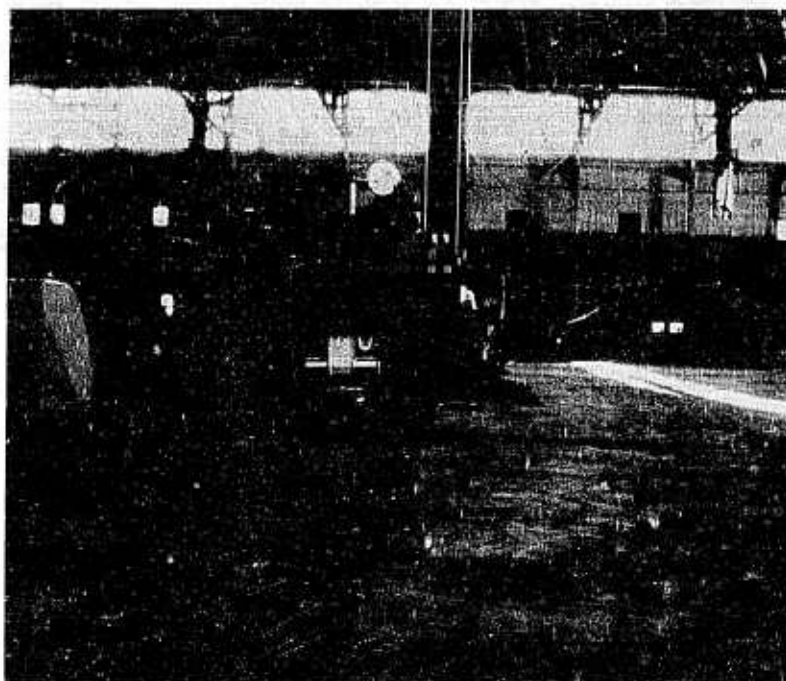
Figure 13. Hangar decks had differential settlement up to 1 foot under four to six feet of flooding. Columns on piles did not settle.

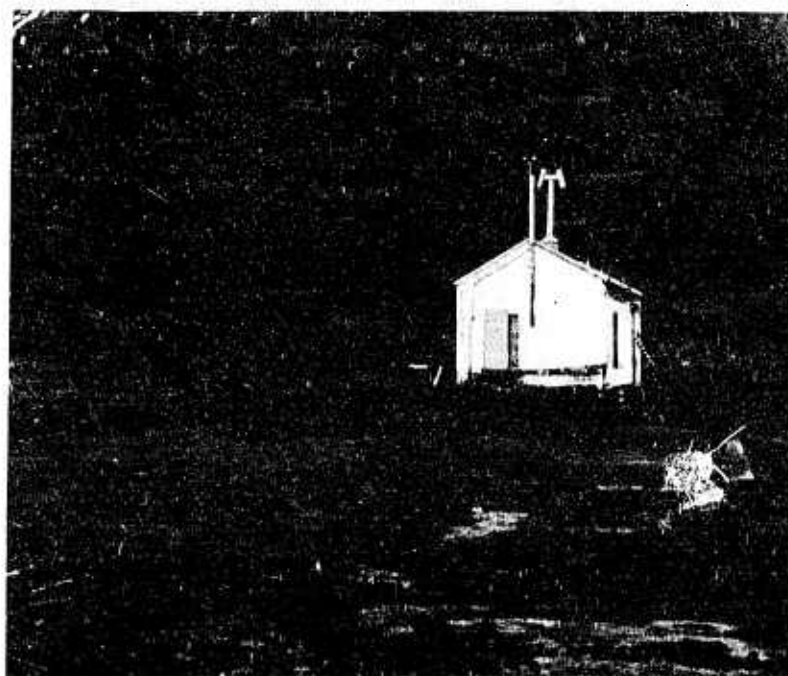
Figure 14. Little white house on end of taxiway was held in place by three hold down cables to roof. Water in foreground left by high tide.

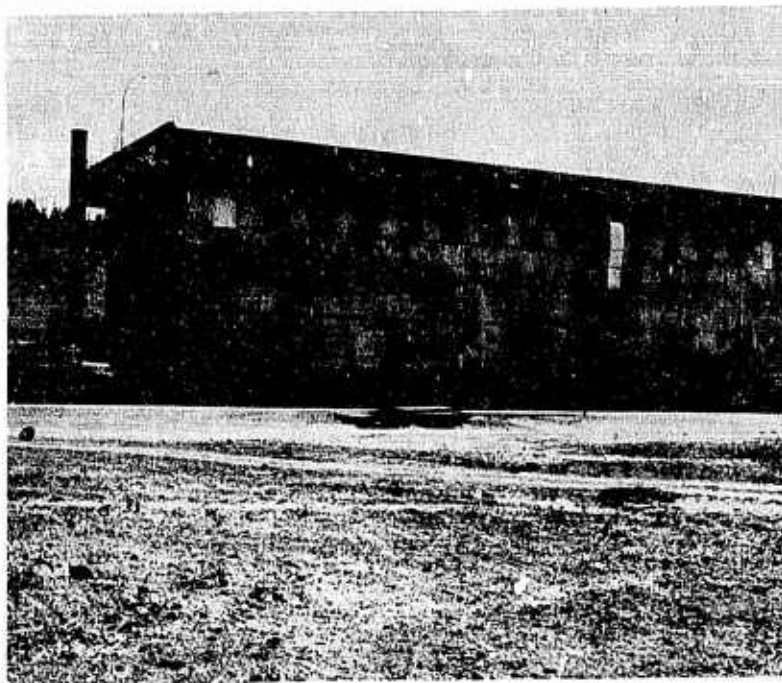
Figure 15. Power plant repeatedly flooded. Note black oil-slick level. Generator flat not flooded. Boilers and auxiliary flats were pumped dry.

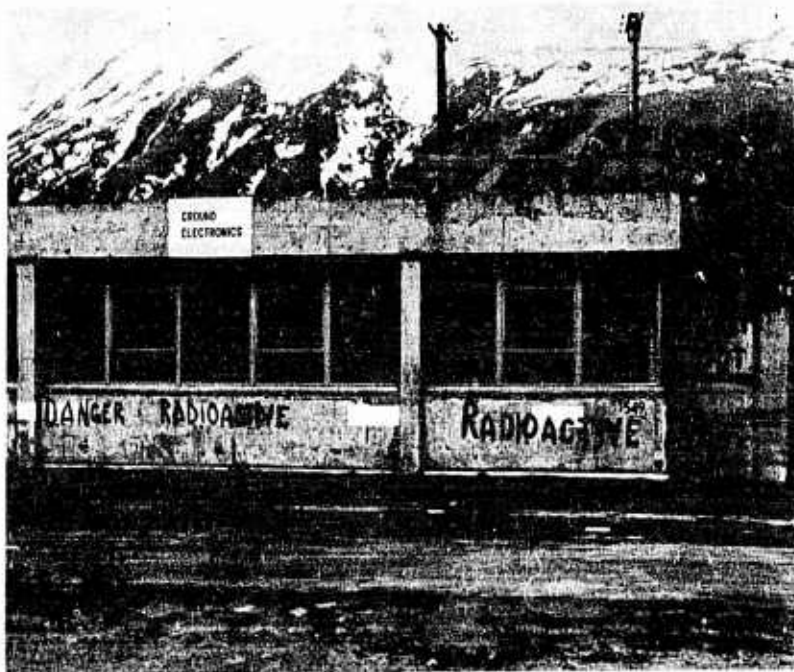
Figure 16. Low-level radioactivity from wave-damaged electronic tubes and radioisotopes in Ground Electronics Building was detected and posted.

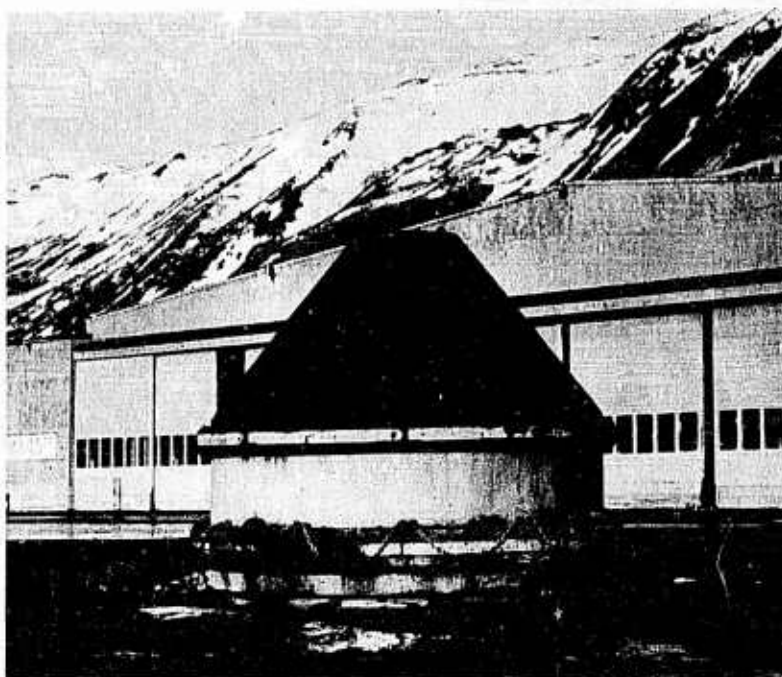
Near the Crash Boat Harbor, sea shells brought in from the harbor by the tsunami were found deposited on land 10 to 15 feet above MLLW. Adjacent to the supply building a 16-foot-diameter mooring buoy (Figure 17A) was washed ashore after being torn from its offshore anchorage. The magnitude of the force on the buoy when submerged is estimated in Figure 17B. This estimate indicates that where the buoy is fully submerged, as it was by the tsunami, the added load is approximately 36 times the load from an assumed mooring chain while neutrally floating. This would seem enough to tear the mooring from its anchorage.

Figure 17A. Mooring buoy weighing over 10 tons now rests on the Station taxiway. Third tsunami wave cresting at 24 ft. above old MLLW drove this buoy inshore.

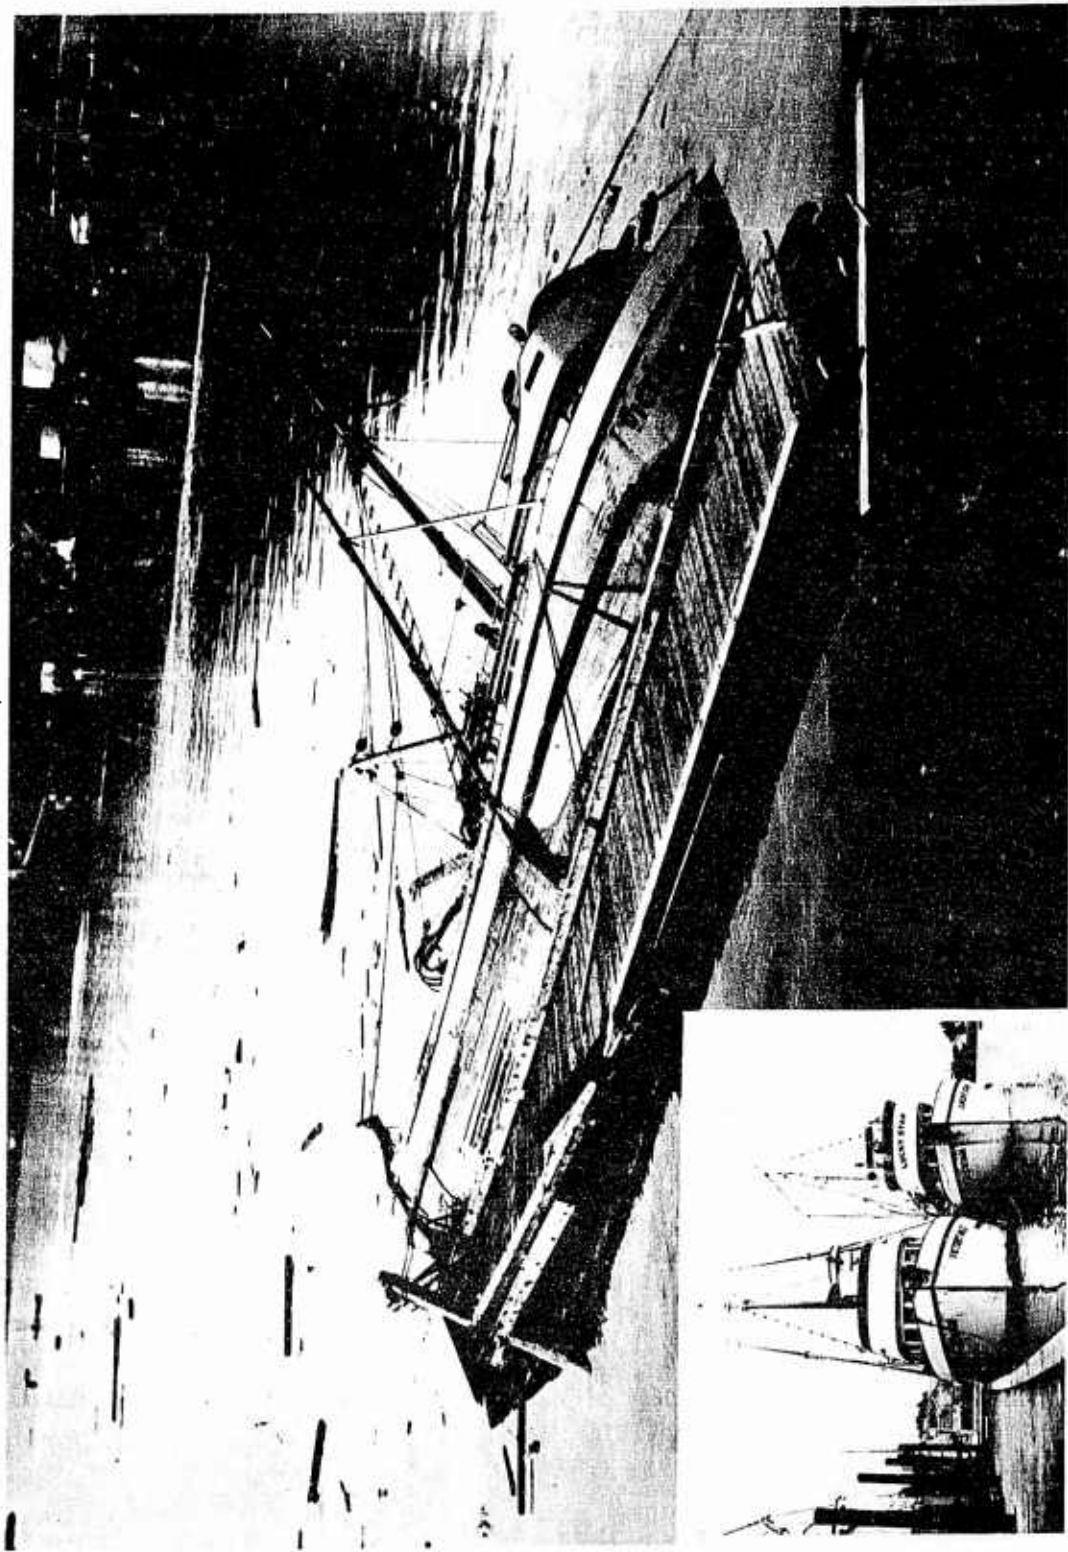
Seventy-seven of the total of 160 crab and salmon boats were missing or fearfully mauled (Table I), two of the canneries were swept away, and the others were unable to operate for 1 or 2 months. An example of boat damage is shown in Figure 23 which also shows a ruined portion of the harbor dock shown in Figure 24.

**Figure 23.** The view in the lower photo insert shows the Victory Maid and the Lucky Star of the Kodiak's fishing fleet resting serenely hours before the earthquake. The Lucky Star, which was declared a complete loss was not as lucky as her companion the Victory Maid, which is lying to port following the Alaskan Good Friday tsunami. (Photos by PIO, Kodiak NAVSTA)

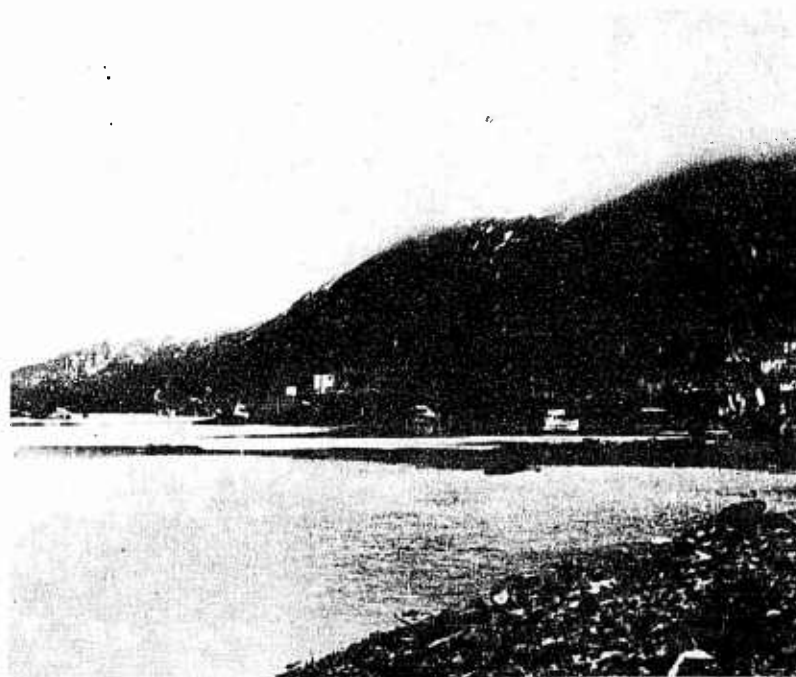
Figure 25. View of harbor after four successive waves filled and emptied the harbor demolishing the piers and sweeping away the fishing boats.

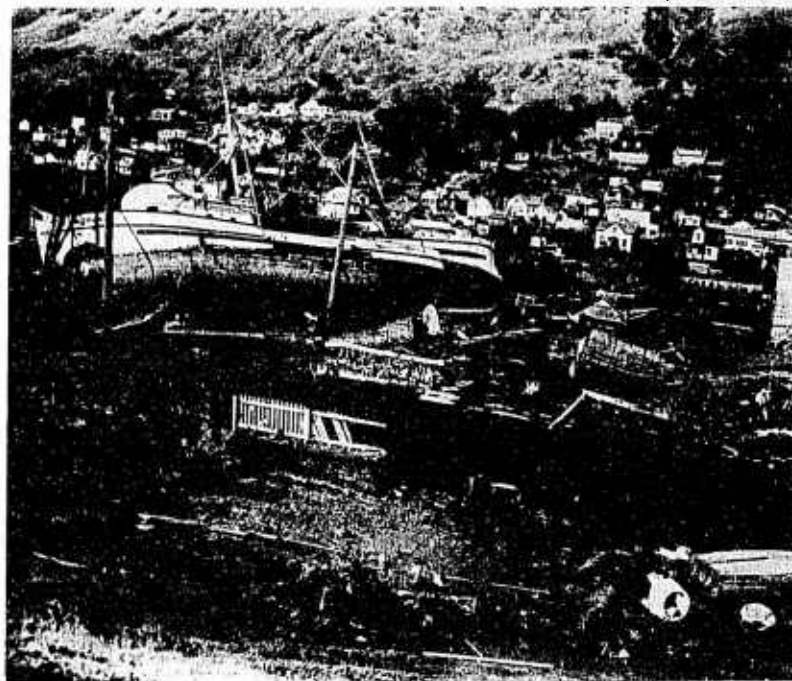
Figure 26. Arrows point to reinforcing rods from foundation of bowling alley at edge of harbor. Buildings were removed by ship impact and buoyancy force

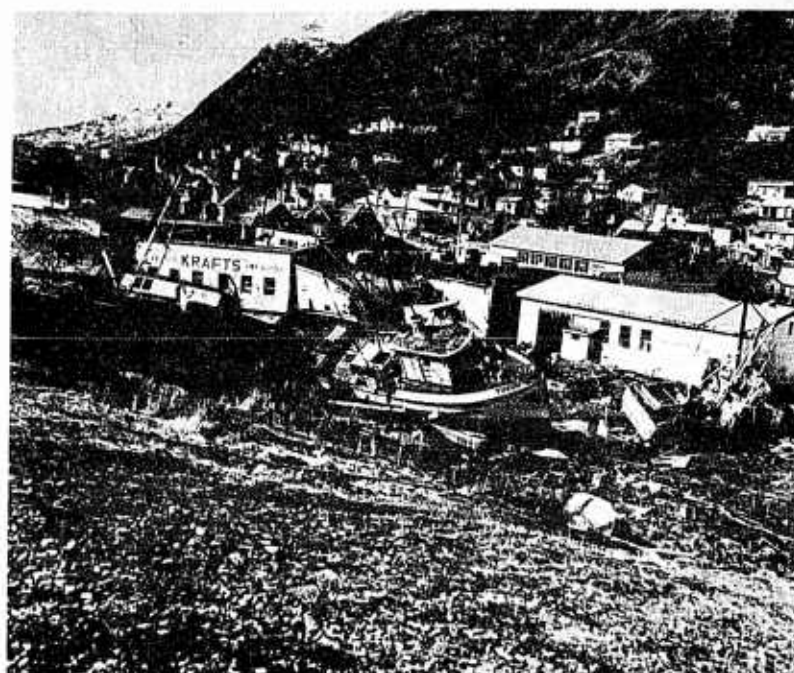
Figure 27. Fishing boats buoyed-in more than one-half mile on tsunami waves are scrambled together with city buildings.

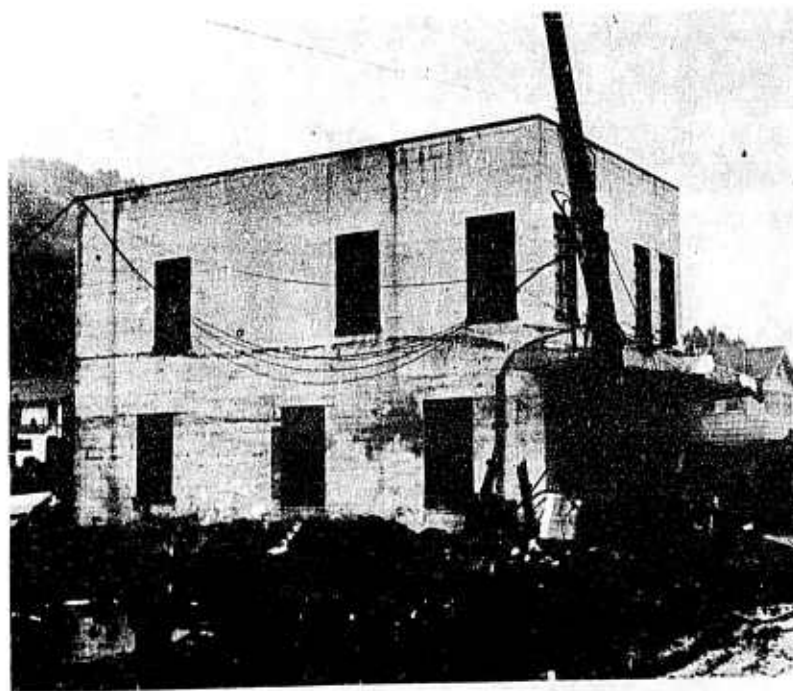
Figure 29. Canopy and utility pole acting as a fender and dolphin helped save concrete block building. Six foot and ten foot high water marks visible.

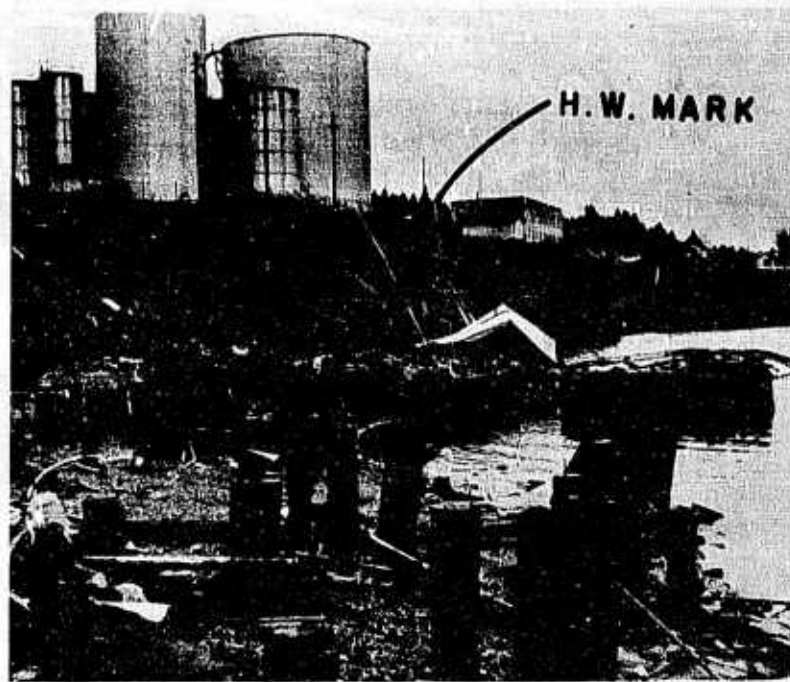
Figure 30. Skeleton-like timber piling marks former site of cannery. Steel drift-pins point direction in which cannery was swept away by second wave.

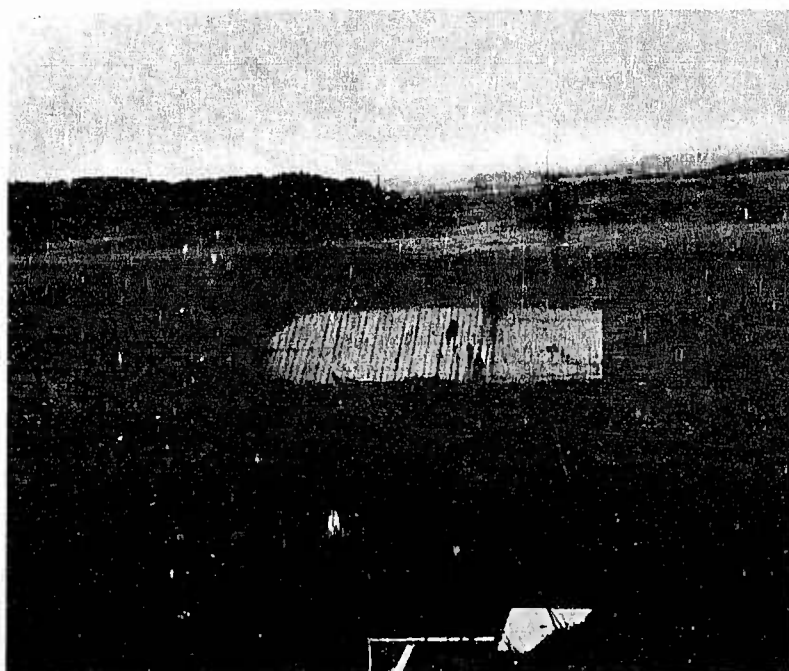
Figure 31. Cannery was displaced one mile by tsunami waves. Rubble-rock breakwater settled 3 feet in addition to 5-1/2 feet subsidence.

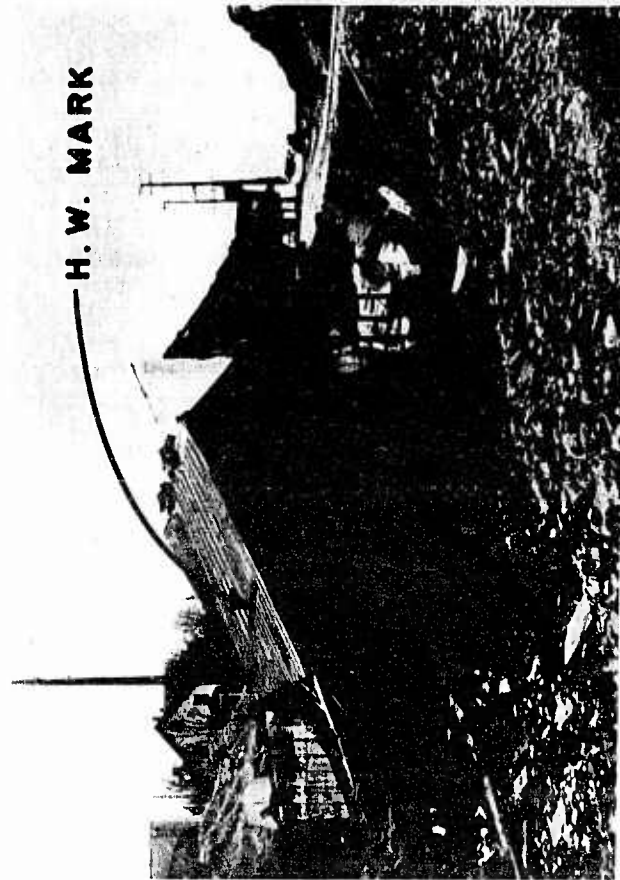
Figure 32. Transit shed type building did not survive well under tsunami deluge. High water mark is on roof of this welding shop.

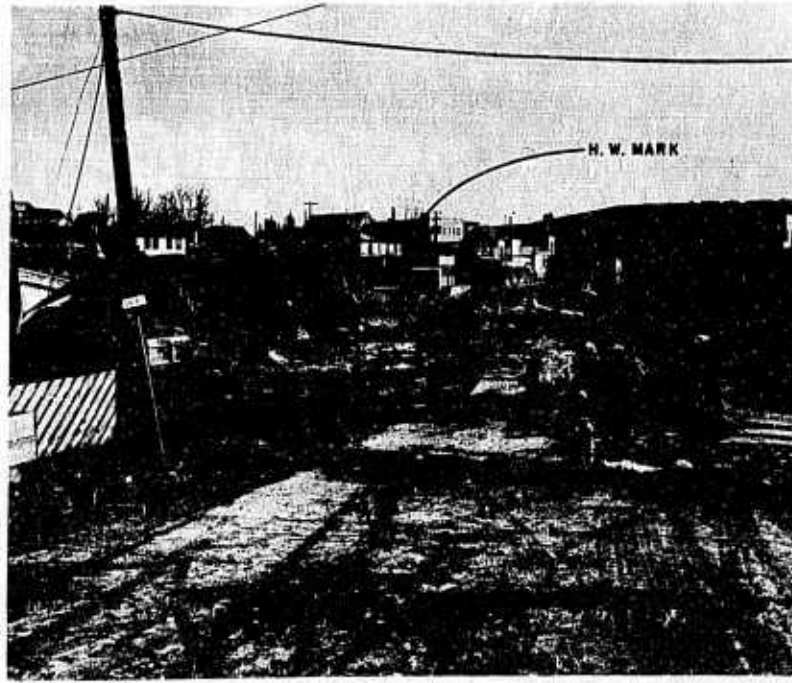
Figure 33. View of the main street shows erosion under roads and sidewalks (middle of photo) caused by tsunami wave inundation. (PIO, Kodiak NAVSTA)

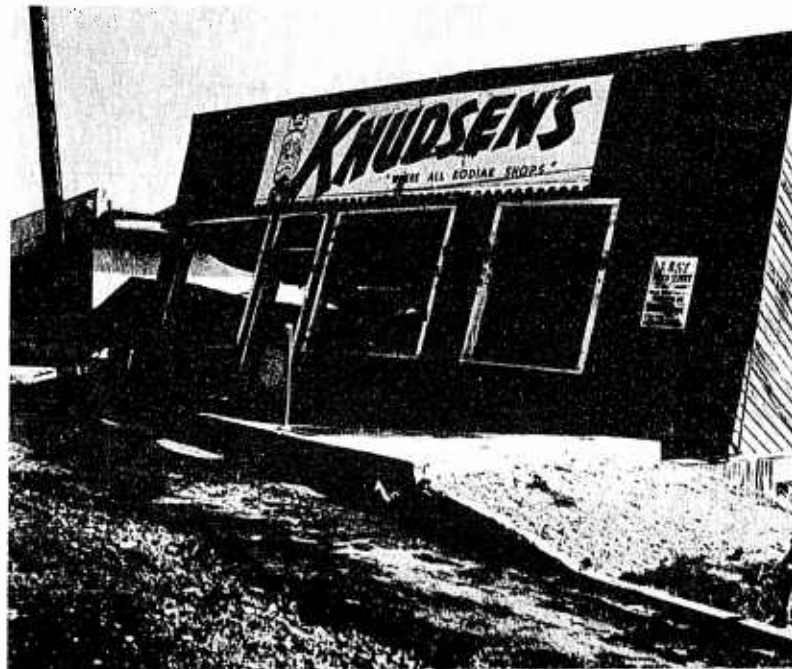
Figure 34. Haberdashery was washed right off its foundation and rested with its rear portion in the harbor.

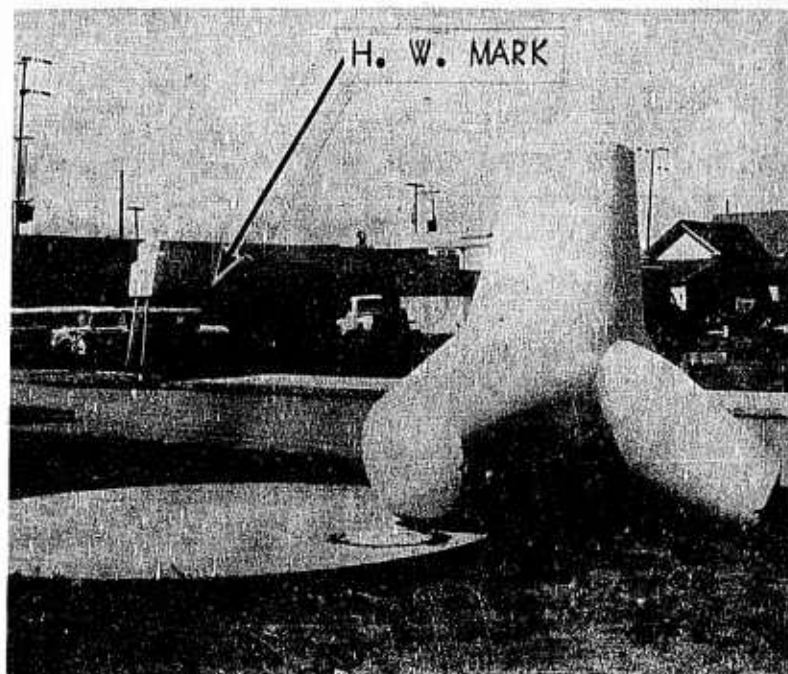
Figure 37A. 25 ton tetrapod monument at Front Street and US 101 was moved from base by water forces and log impact.

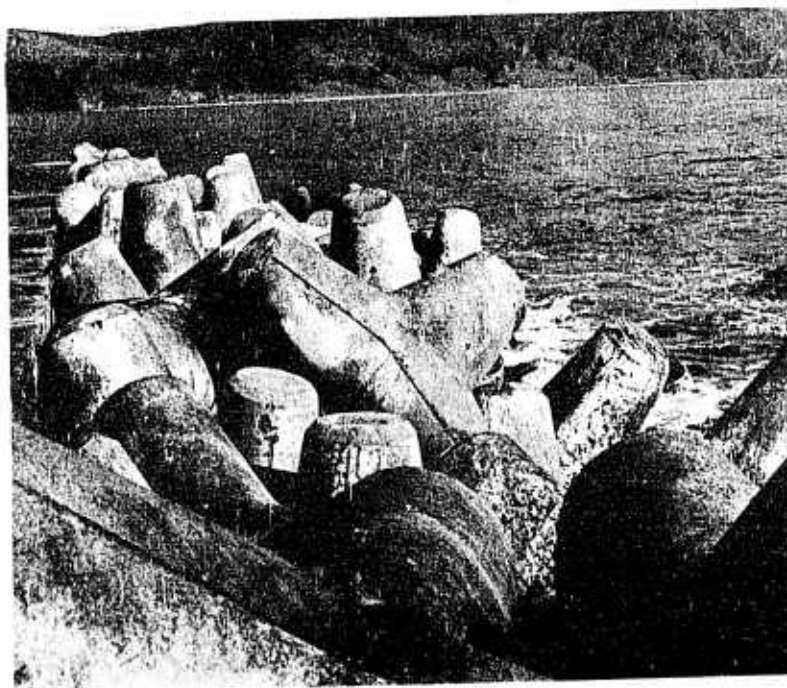
Figure 39. Tetrapods on outer harbor breakwater stayed in place when submerged by the tsunami wave.

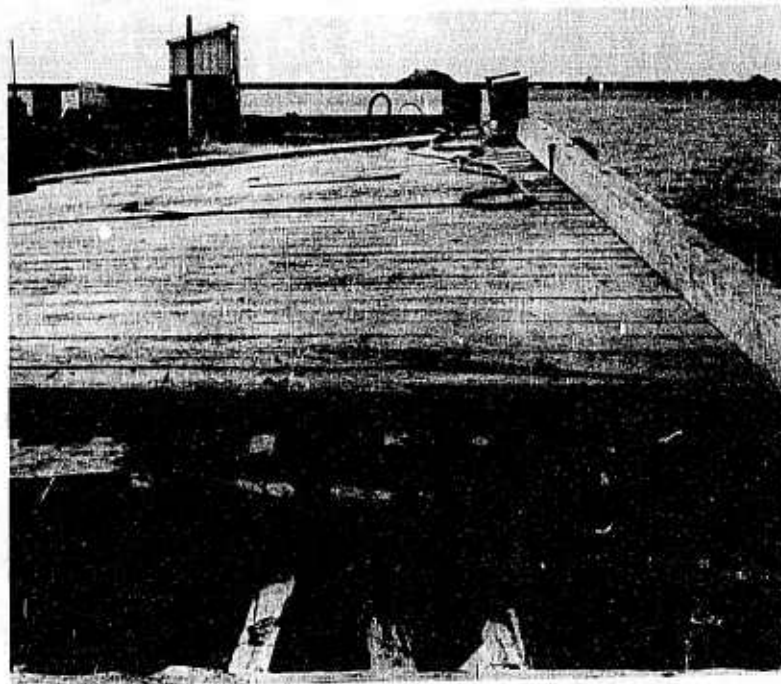
Figure 46. Tide shack on Citizens Dock was fully submerged. Decking is elevated towards one of bollards mooring a lumber barge.

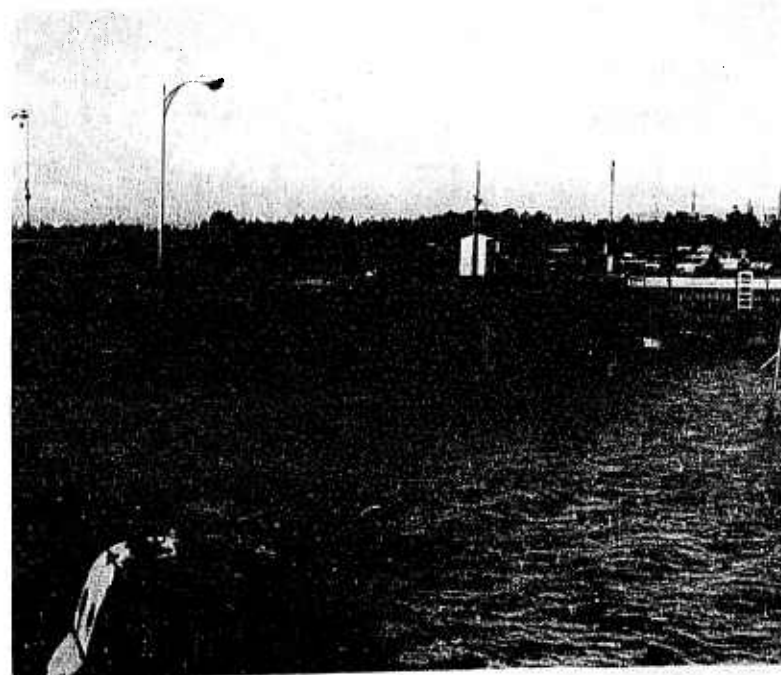
Figure 47. Snake-like approach to Citizens Dock deflected when piling snapped off. The small boat docks occupying this area have disappeared.

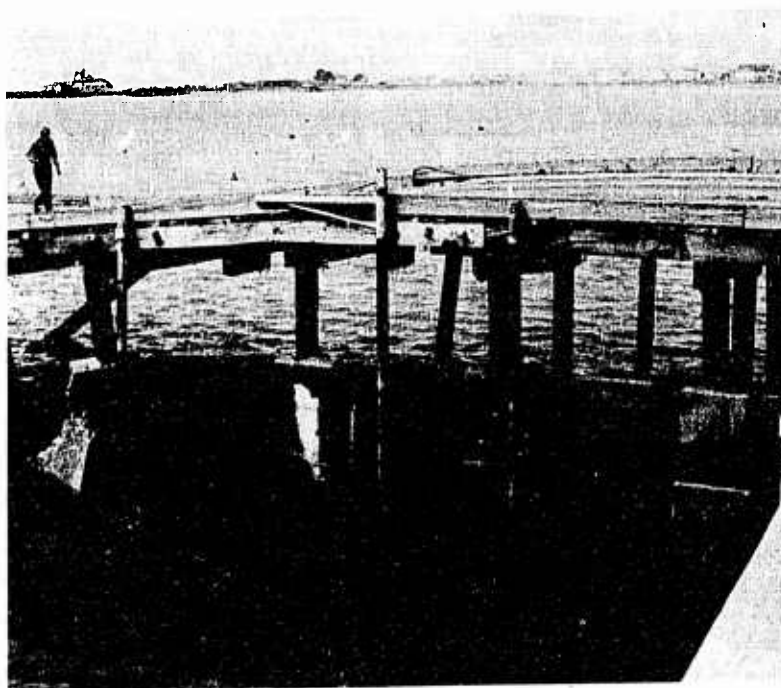
Figure 48. Concrete wave barrier under Citizens Dock approach was broken by log impact and water forces as the harbor filled and emptied. Encased piling was removed with the wall.

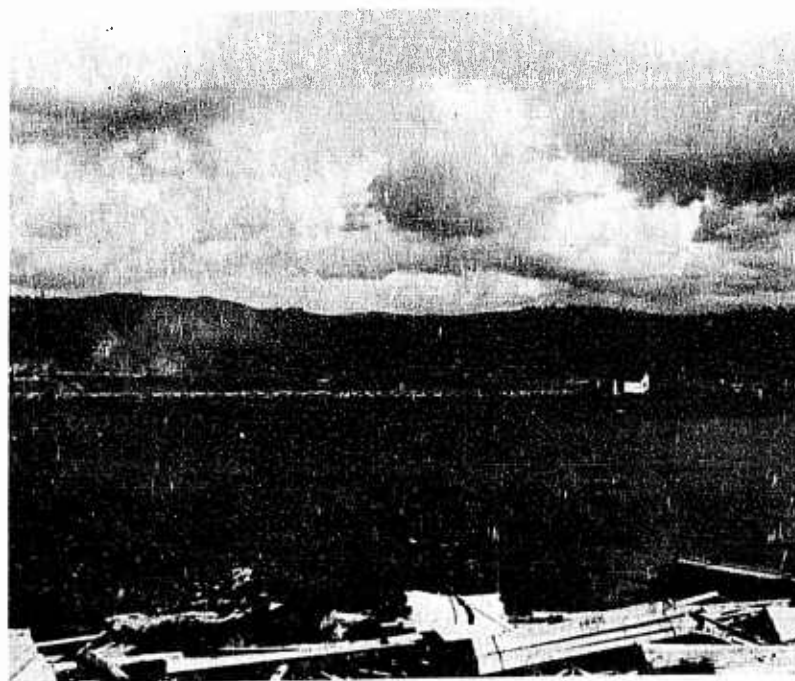
Figure 49. Dutton Dock unharmed when submerged 5 to 6 feet under largest tsunami wave. Lumber debris in foreground is from dock.

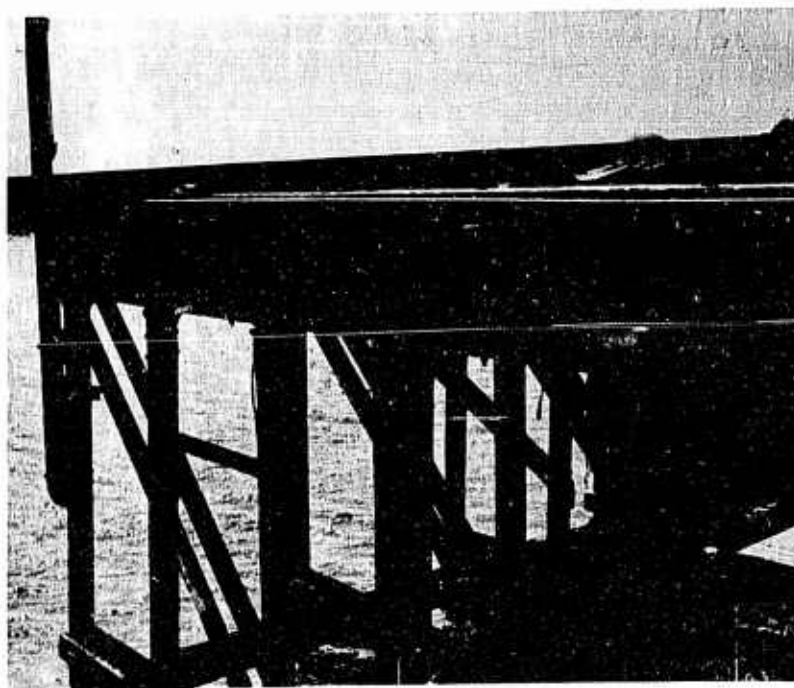
Figure 50. Steel straps, bolted connections, and abundant cross bracing helped Dutton Dock survive virtually without a scratch.

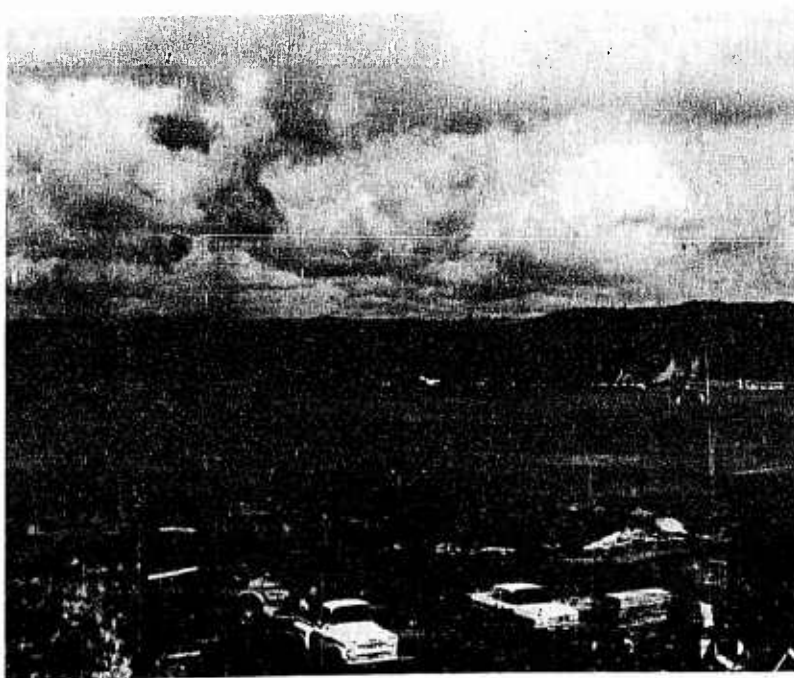
Figure 51. The abandoned and dilapidated Sause Dock was further damaged by the seismic sea waves.

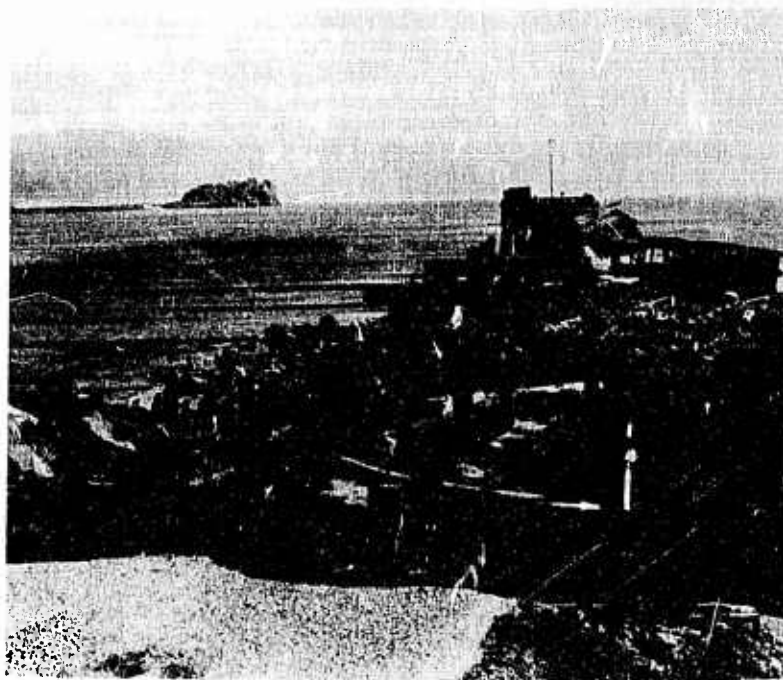
Figure 52. Decking of the Sause Dock sprawls to one side. Drift pins are still embedded in pile tops. Piles and pile caps have survived fairly well.

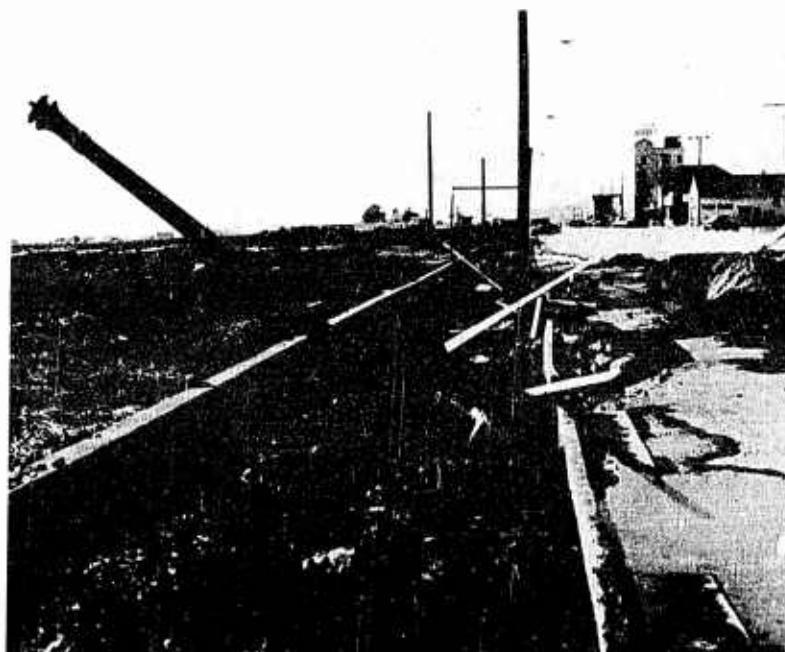
Figure 53. Erosion causes pole tippage, misalignment of curbing, fragmentation of black top road, and exposure of sea wall.
