Technical Note N-622

TSUNAMI DAMAGE AT KODIAK, ALASKA, AND CRESCENT CITY,  
CALIFORNIA, FROM ALASKAN EARTHQUAKE OF 27 MARCH 1964

U. S. NAVAL CIVIL ENGINEERING LABORATORY  
Port Hueneme, California

ABSTRACT

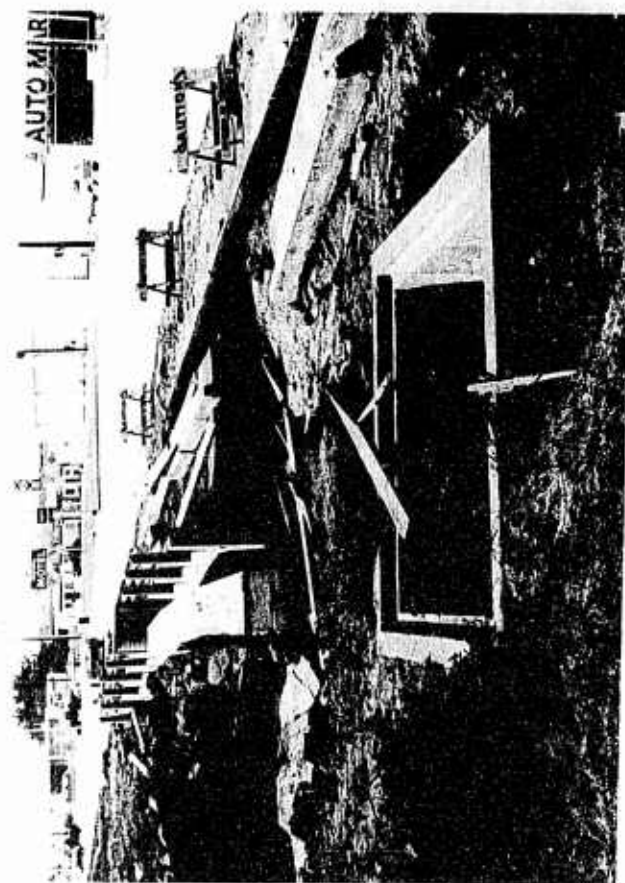
Figure 54. Erosion bares Elk River concrete box culvert and undercuts Highway 101. Steel beam tidal barrier on left normally protects bridge from logs.

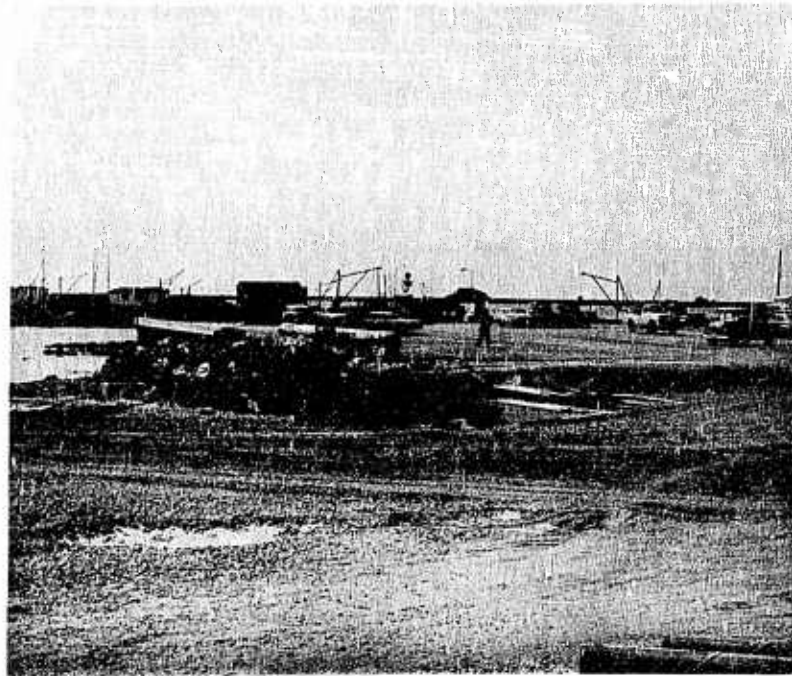
**Problem:** Find intensity of boundary shear pressure,  $\tau$ , from recession of tsunami wave at Crescent City Citizens Dock parking lot.

Figure 55 Scour at Citizens Dock Parking Lot

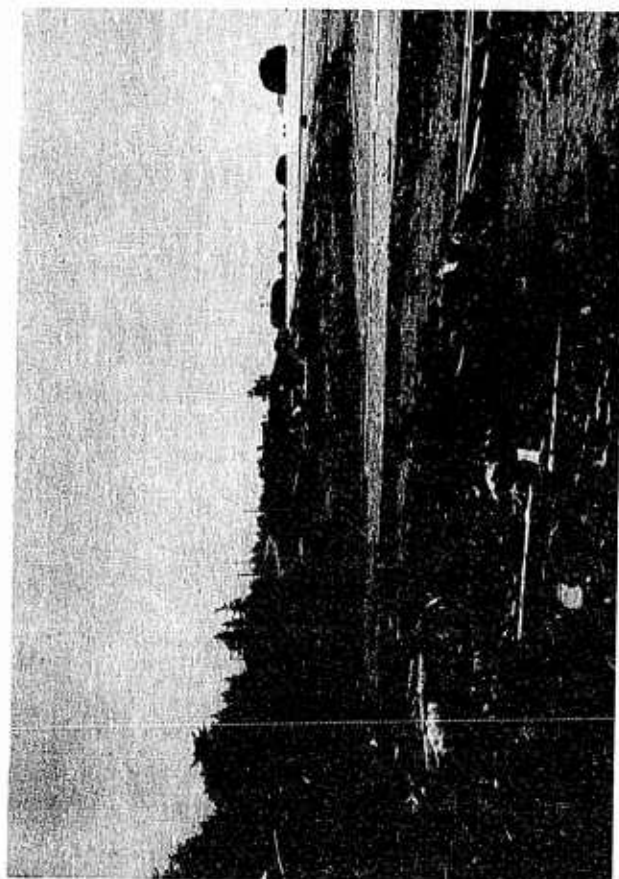
Figure 56. Waterfront logs were being driven into walls and glass windows with the force of a battering ram.

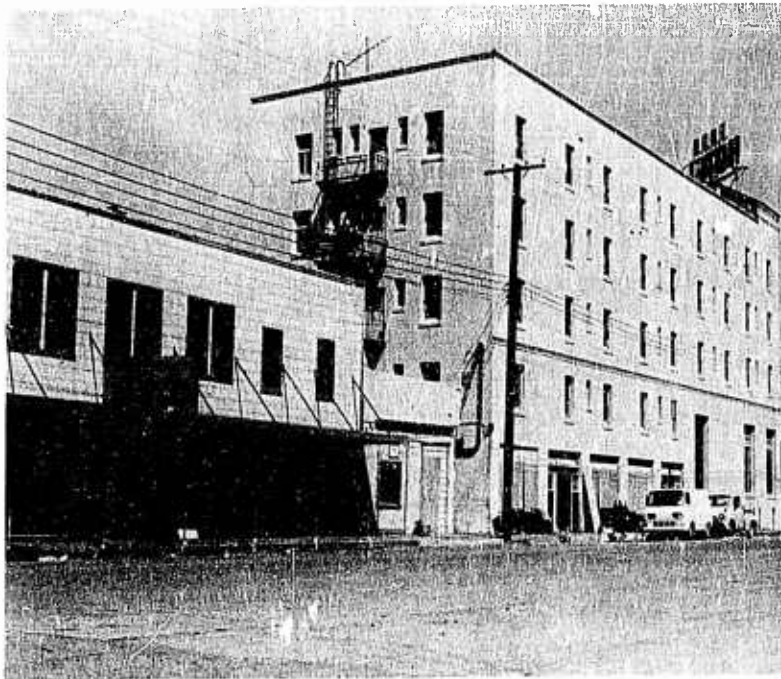
Figure 57. Plywood now boards windows along Front Street broken by floating debris carried on 4- to 6-foot inundation.

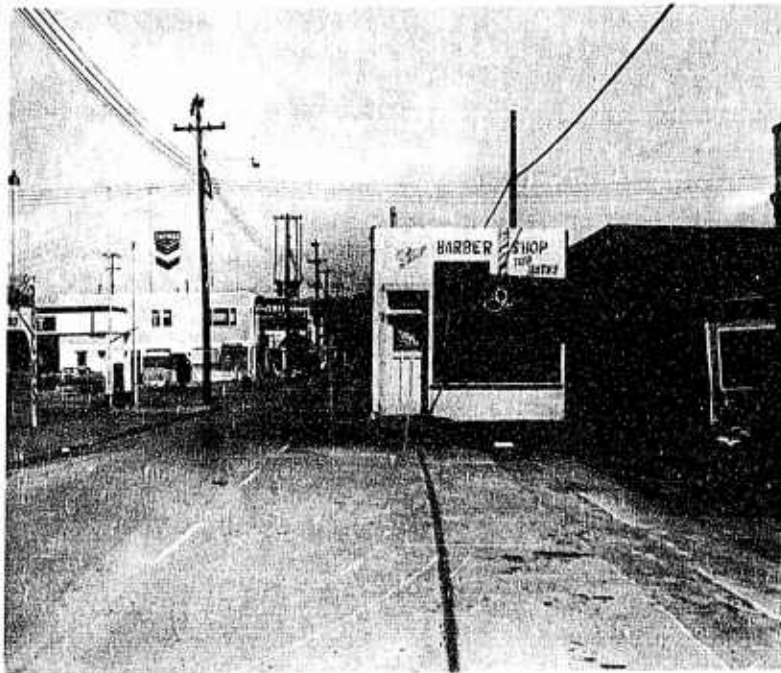
Figure 58. Barber shop was one of many buildings that blocked Second Street by floating across it.

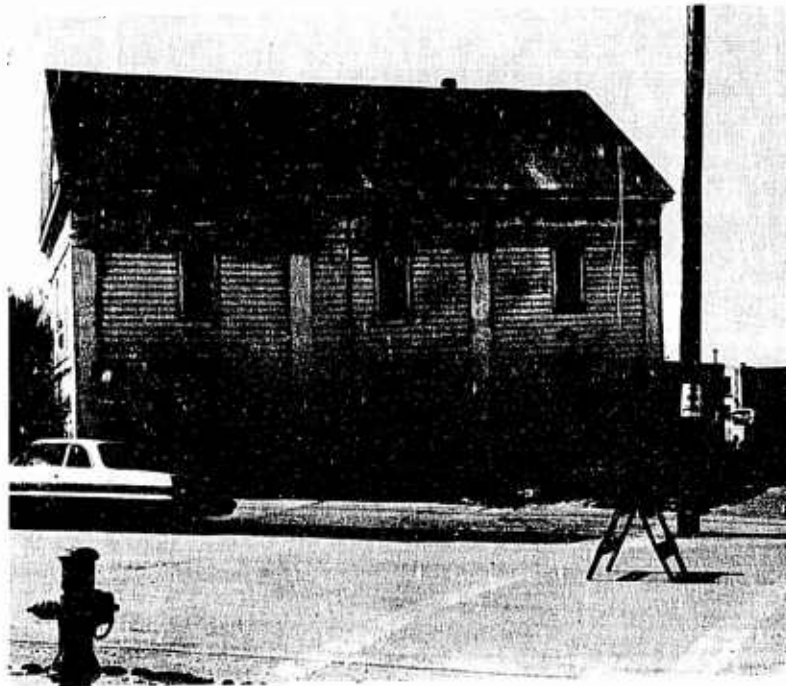
Figure 59. Turbulent waters (5 feet deep) moved two story Odd Fellows Hall 30 feet and rotated it 45°.

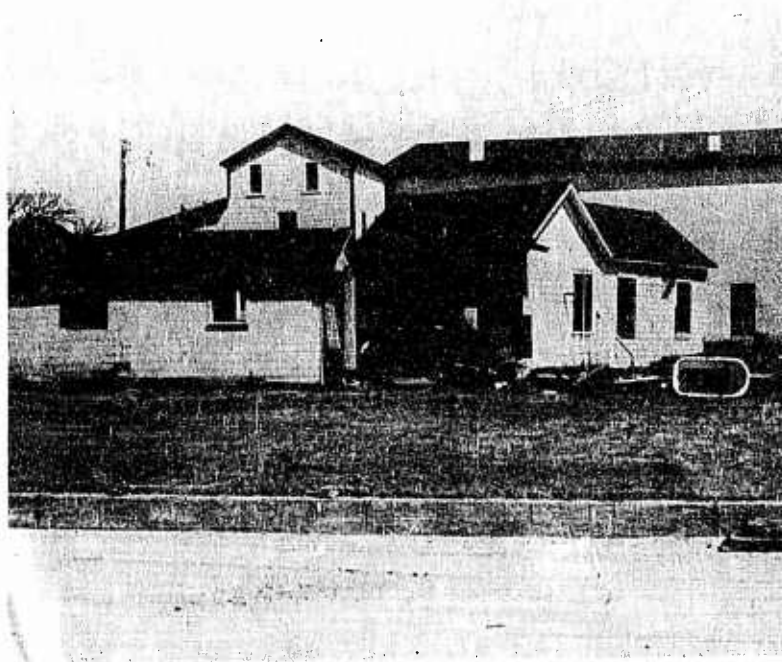
Figure 60. Home on Front Street left its foundation and broke in half. Bathtub still attached to plumbing.

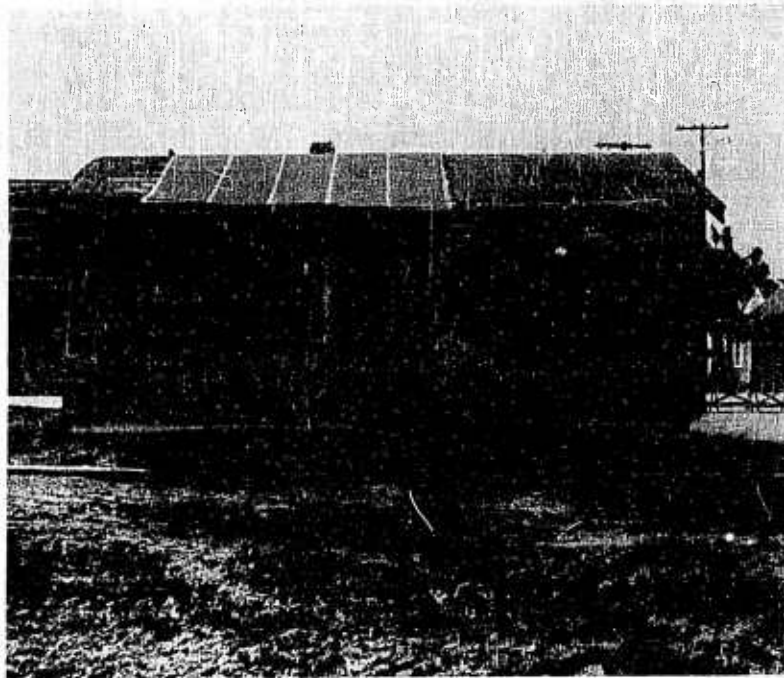
Figure 62. Forces from five feet of flowing water moved housing units up to one block from their foundation.

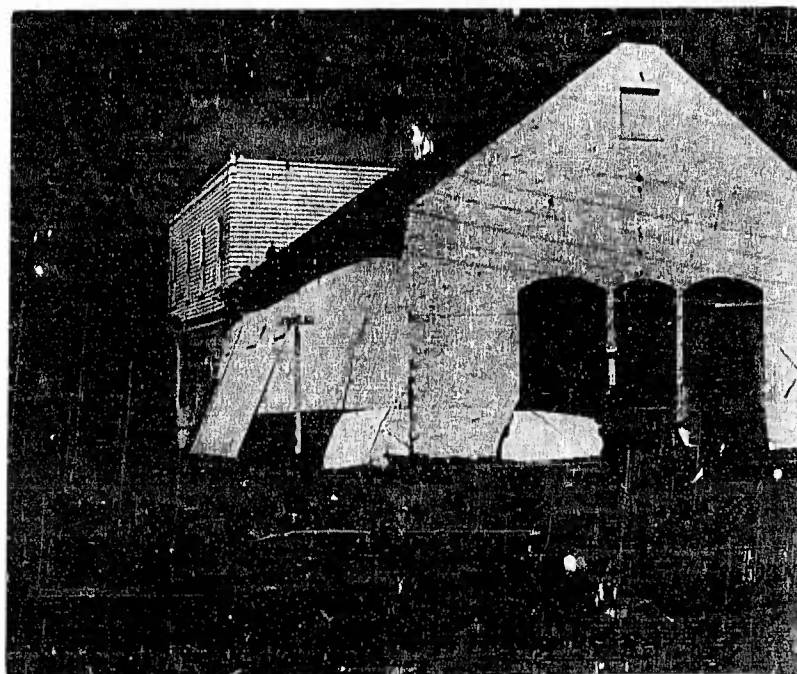
Figure 63. Side wall of Turf Club bulges outward - caused by rapid recession of tsunami waters.

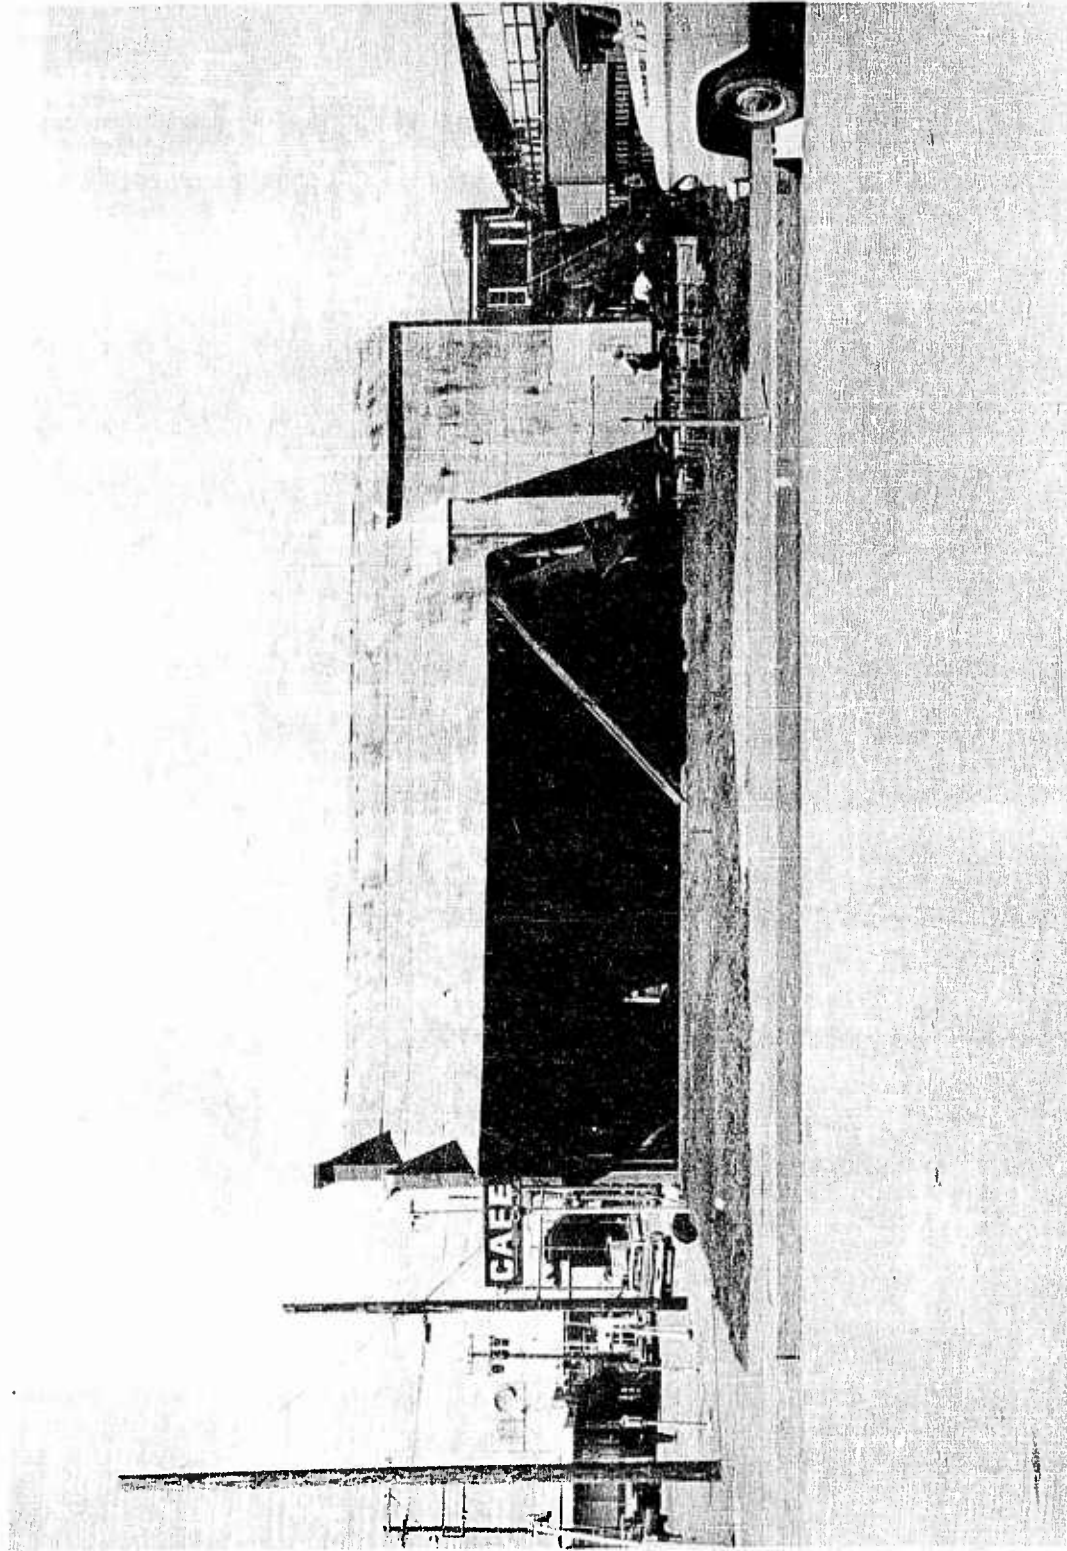
Figure 64. Entire side of corrugated steel transit shed type building along Front Street collapsed.

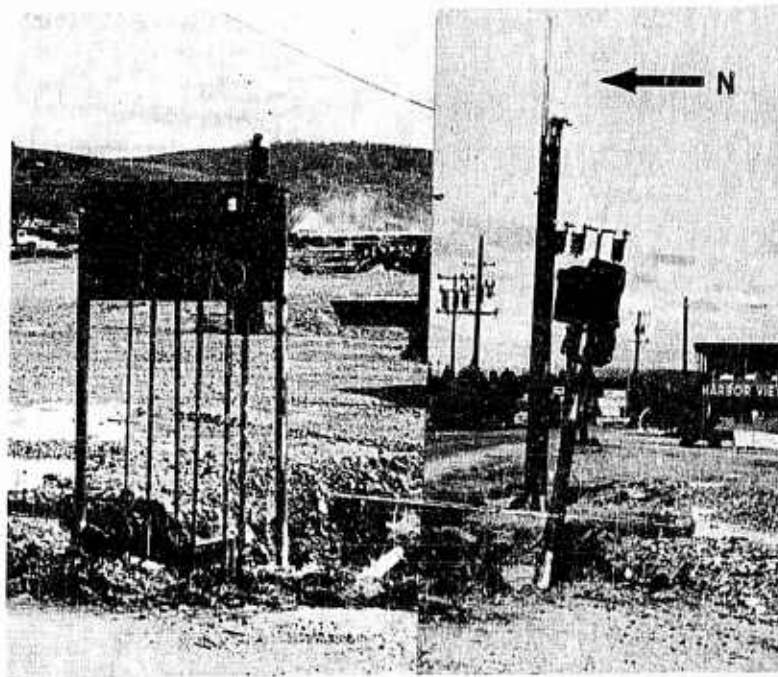
Figure 65 . Wave force and approximate velocity needed to produce yielding of light box at Crescent City Harbor. Bottom photo shows the front and side views of the light box.

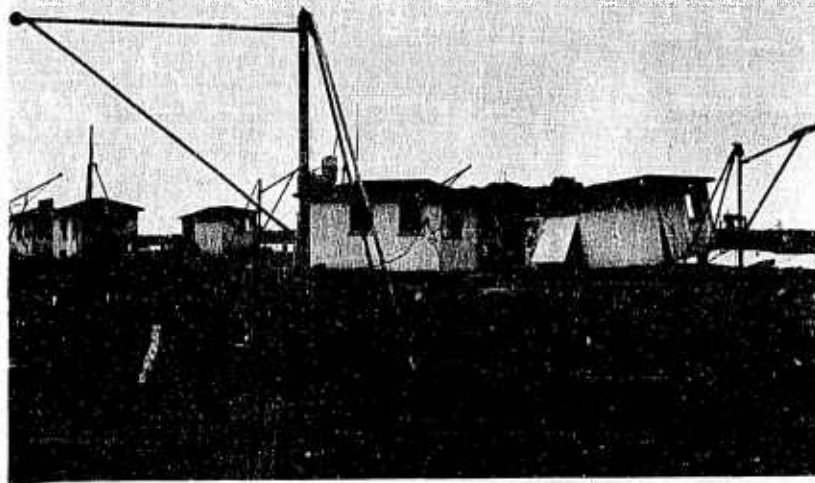
Figure 66A. Commercial fish shacks on Fish Pier arm of Citizens Dock were deflected as tsunami passed.

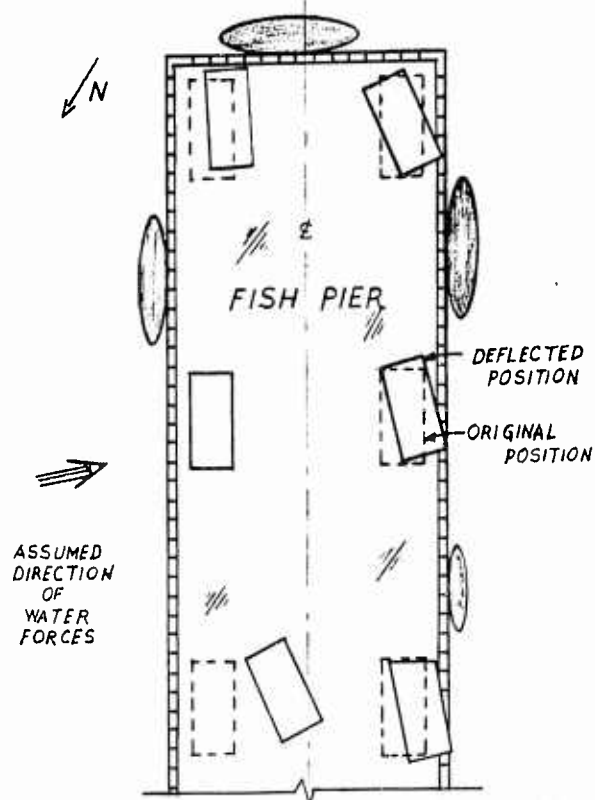
Figure 66B. Fish shacks nailed to decking by 2 X 4's deflected almost inversely proportional to pier corner. Shack that did not move was reinforced and had strong columns at corners.
