CRASH INJURY INVESTIGATION

U. S. ARMY HU-1A

BELL IROQUOIS HELICOPTER ACCIDENT

Fort Carson, Colorado

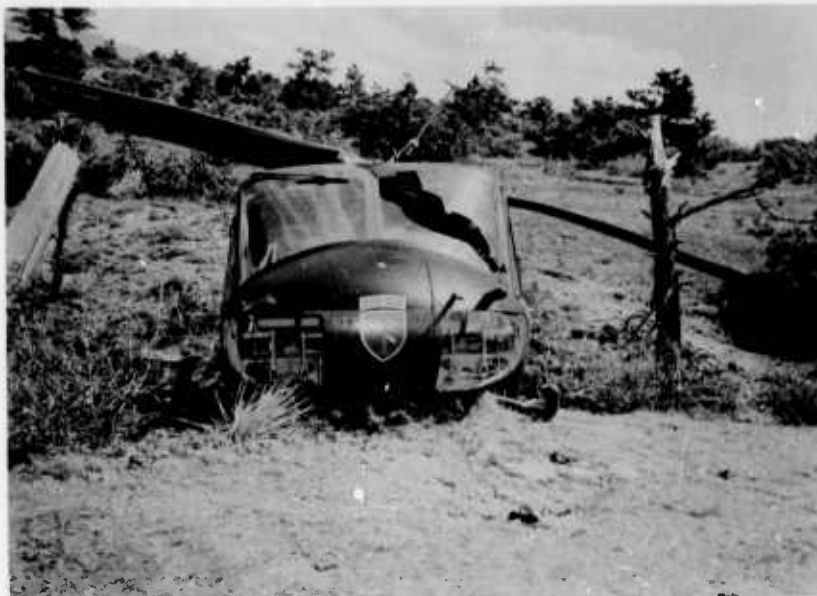
Figure 4. Front view of the helicopter showing broken plexiglas in both pedal wells and left windshield. Destruction of the main rotor is clearly shown.

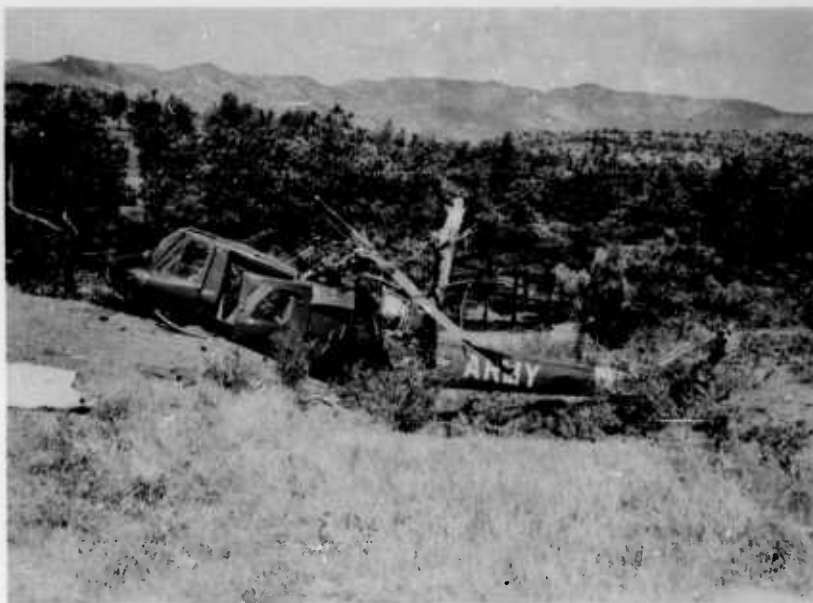
Figure 5. Side view of aircraft showing embankment struck with relative position of pine tree.

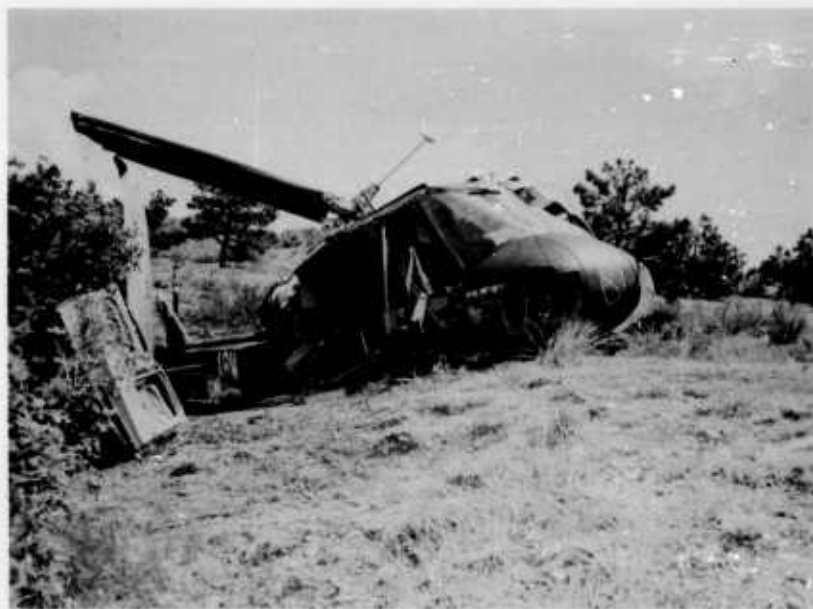
Figure 6. Right front view of the helicopter. Note the distorted right skid.

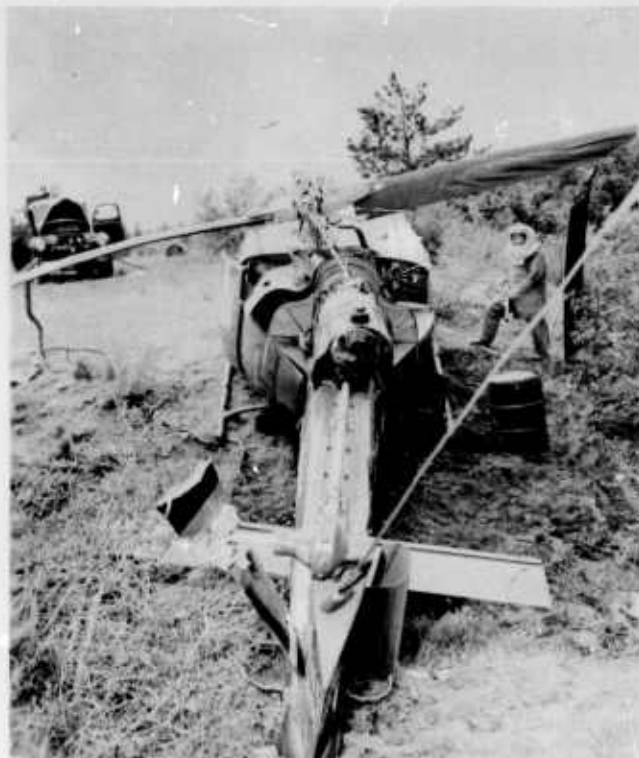
Figure 7. Rear view of helicopter showing demolished rotors and twisted tail boom.

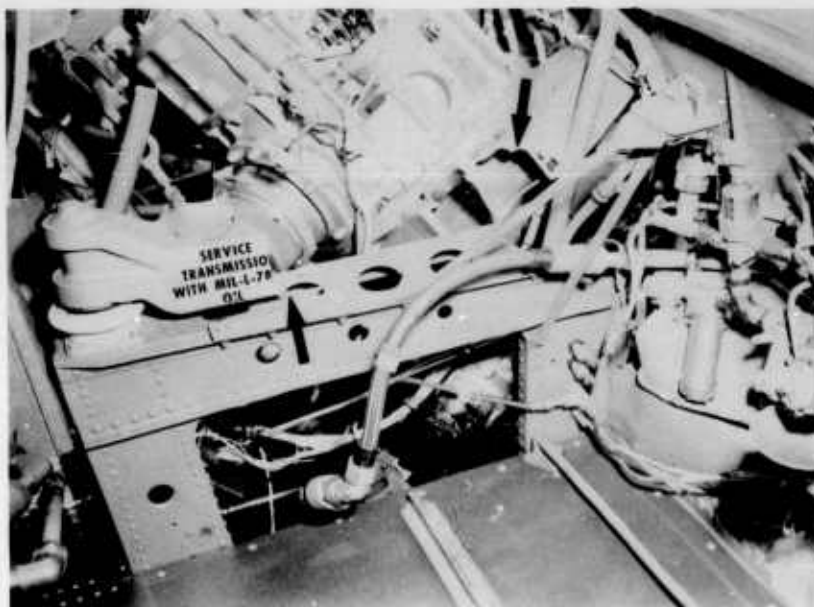
The transmission assembly failed in this accident in the same manner as experienced in previous HU-1A accidents. The significant failure point in all HU-1A accidents is the magnesium casting which serves as a cradle supporting the transmission assembly. In this instance, the transmission moved forward and was, therefore, a contributing factor insofar as injuries are concerned. This is a hazard which has been pointed out on several occasions. During a recent evaluation of the HU-1D helicopter, it was found that Bell Aircraft was providing for a fifth transmission mount to prevent the transmission from moving forward during a crash. It is questionable, however, whether this will resolve the problem because the failures have not occurred at the mounts, but rather in the magnesium casting which serves as a cradle for the transmission assembly. The failure experienced in this accident is shown in Figure 8.

Figure 8. Note the fractures in the magnesium casting (arrows).

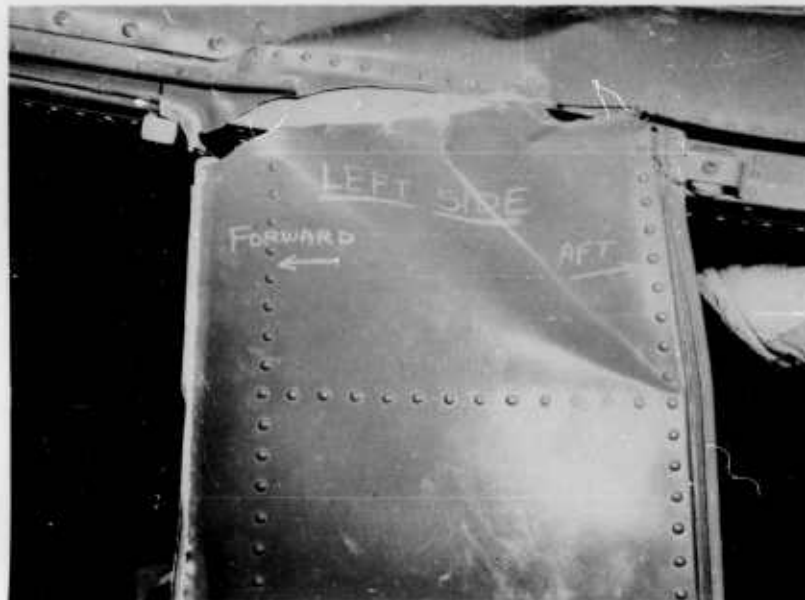
Failure of these support members in this and four other HU-1A accidents reported indicates an inherent structural weakness and stresses the need for redesign to eliminate this potentially dangerous crash injury hazard.

Figure 9. Side view showing failure of left vertical support at upper attachment and shifting of overhead cabin structure.

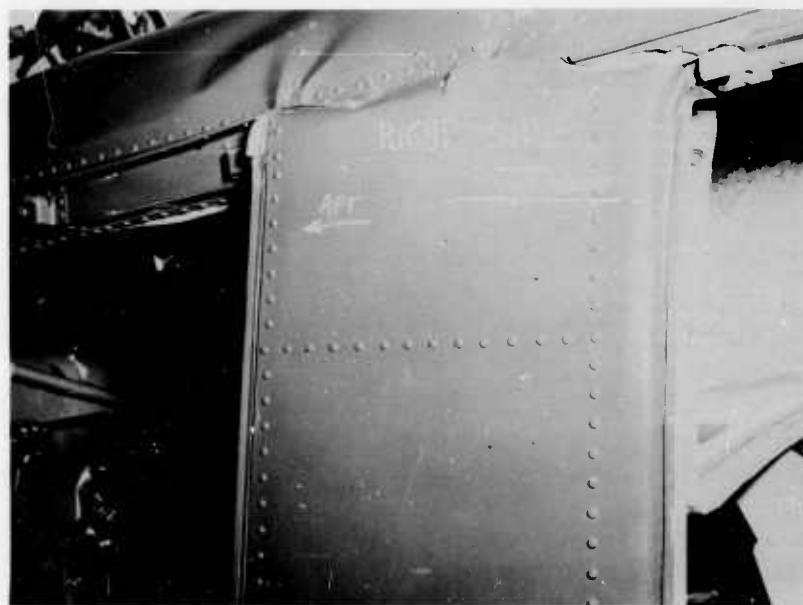
Figure 10. Side view showing failure of right vertical support at upper attachment and shifting of overhead cabin structure.

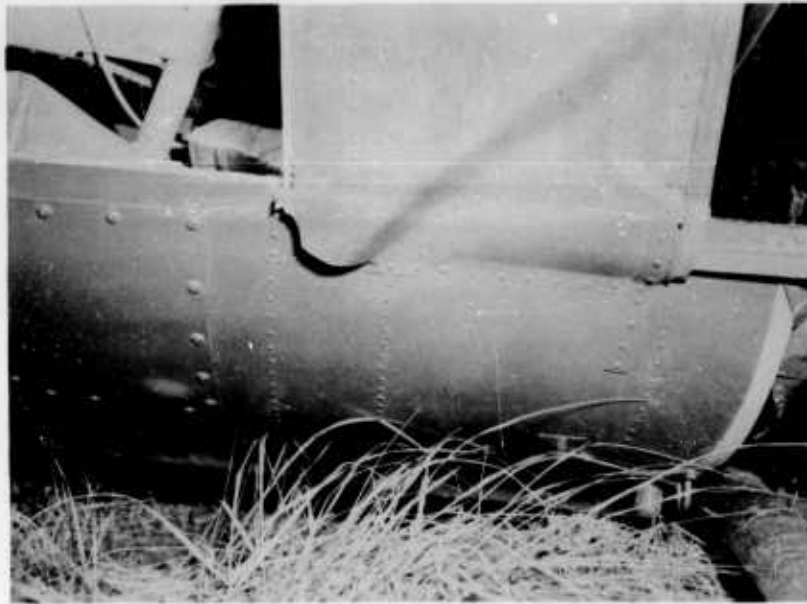
Figure 11. Side view showing distortion and impending separation of left vertical support at lower attachment.

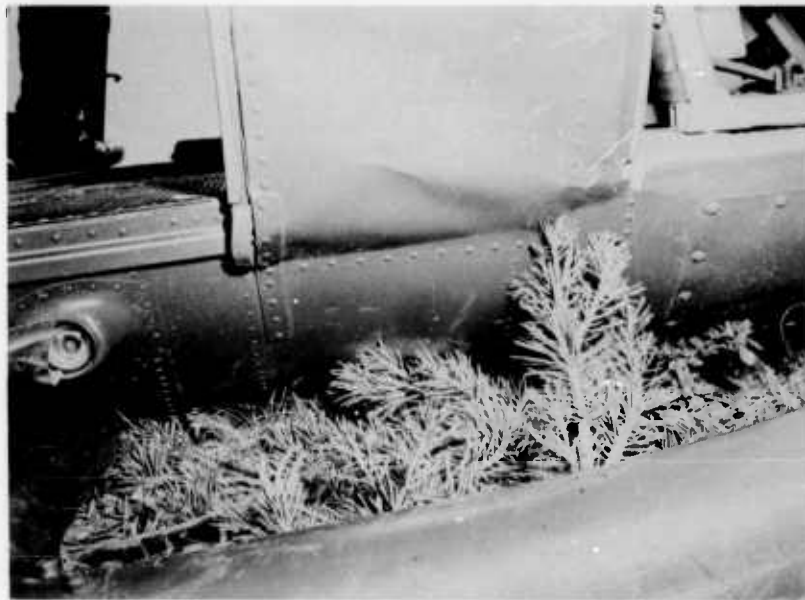
Figure 12. Side view showing distortion and impending separation of right vertical support at lower attachment.

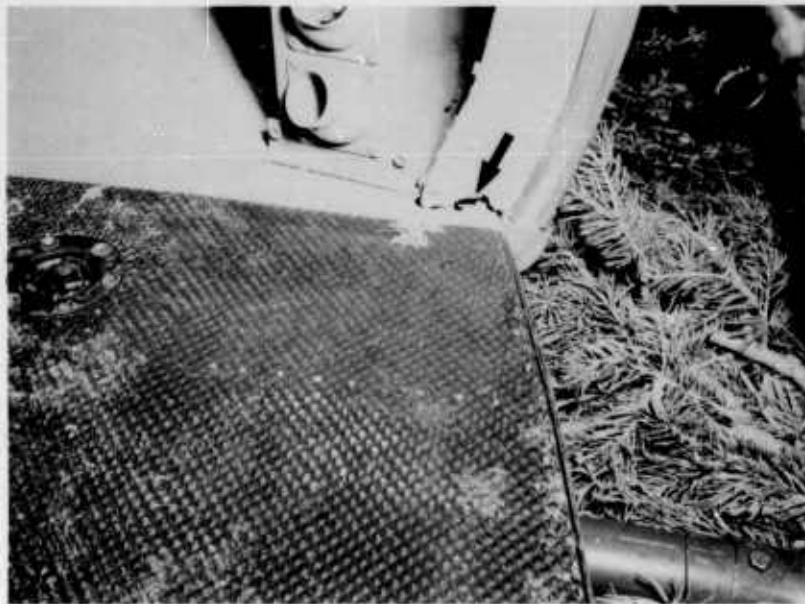
Figure 13. The arrow depicts the separation of the right vertical side support from its attaching point, floor level.

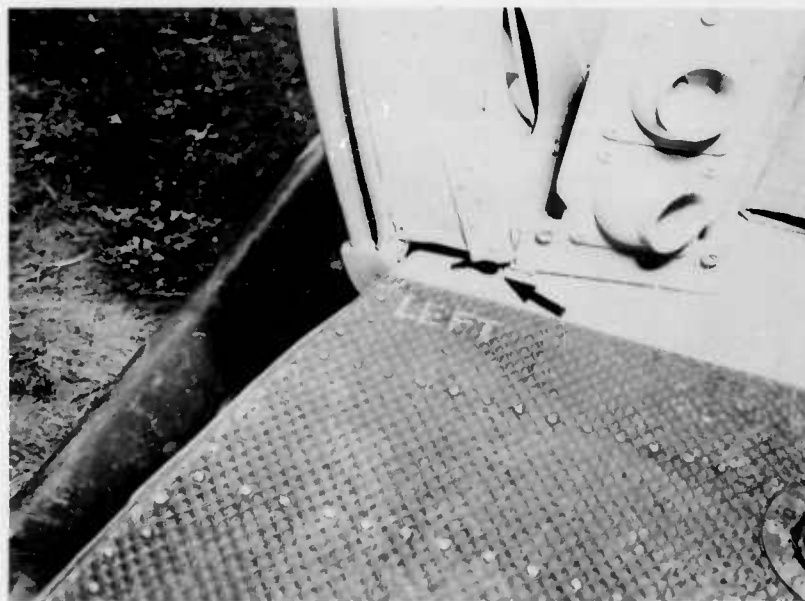
Figure 14. View of left vertical support at floor showing failure and impending separation at attaching point.

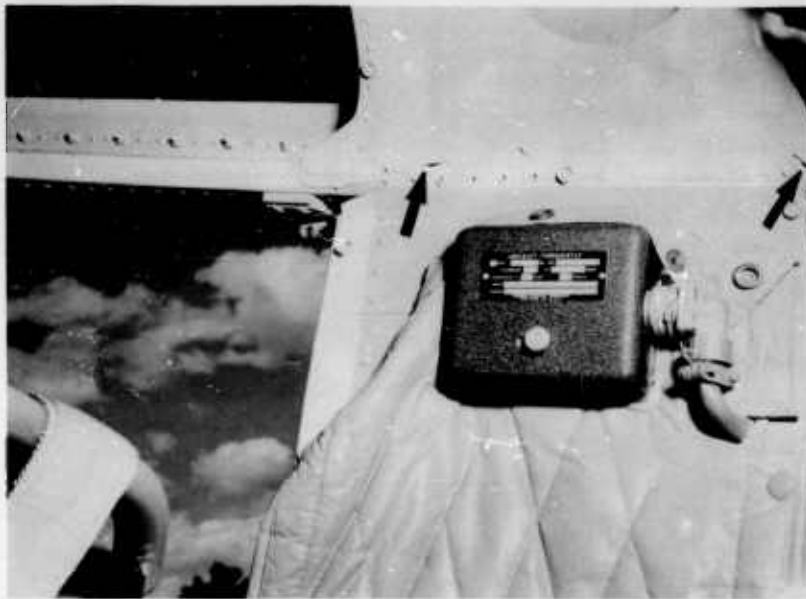
Figure 15. The arrows depicts the failures at the top of the right vertical side support.

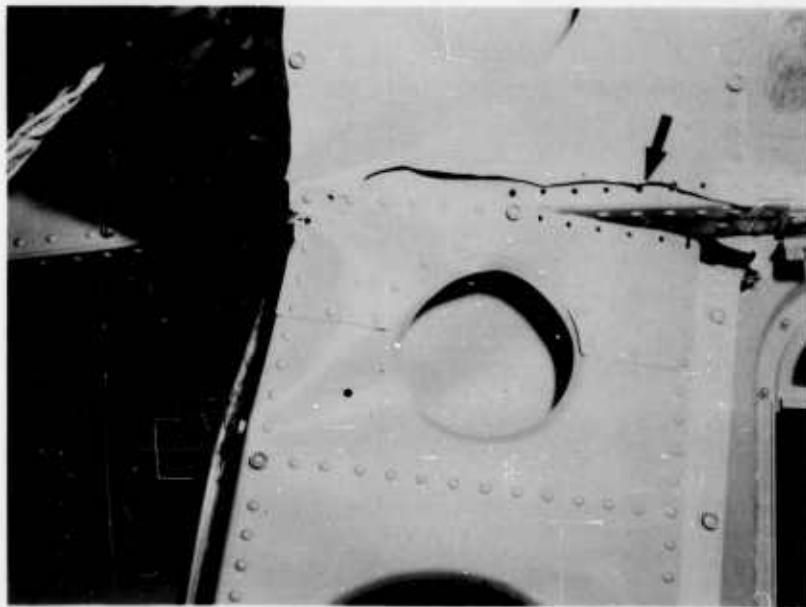
Figure 16. The separation of the left vertical side support and roof structure is denoted by the arrow.

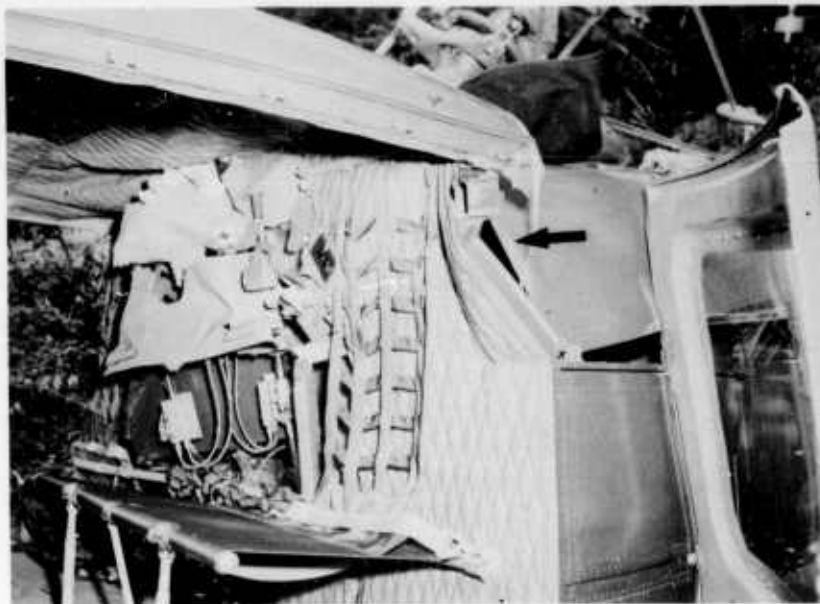
Figure 17. The forward displacement of the firewall, left side, is depicted by the arrow.

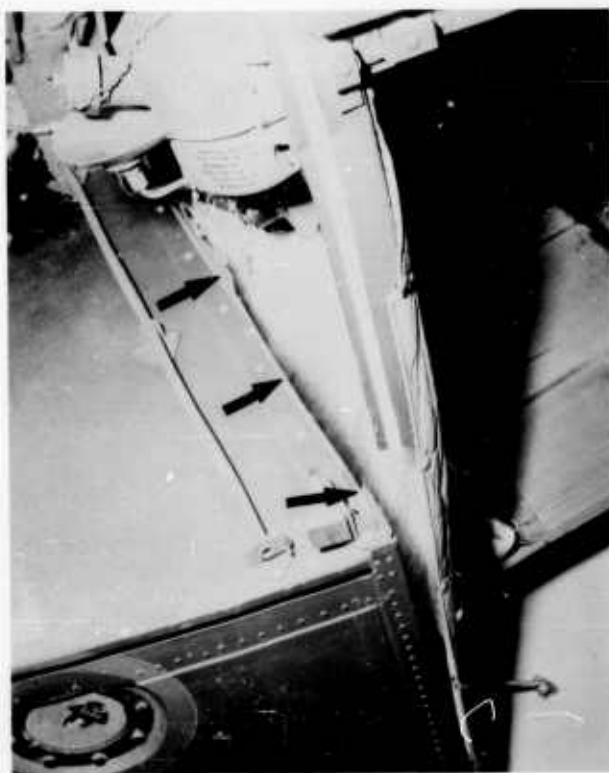
Figure 18. Rear view of the right side showing the fire-wall displacement (arrows). It should be noted that there was very little forward deceleration in this accident.

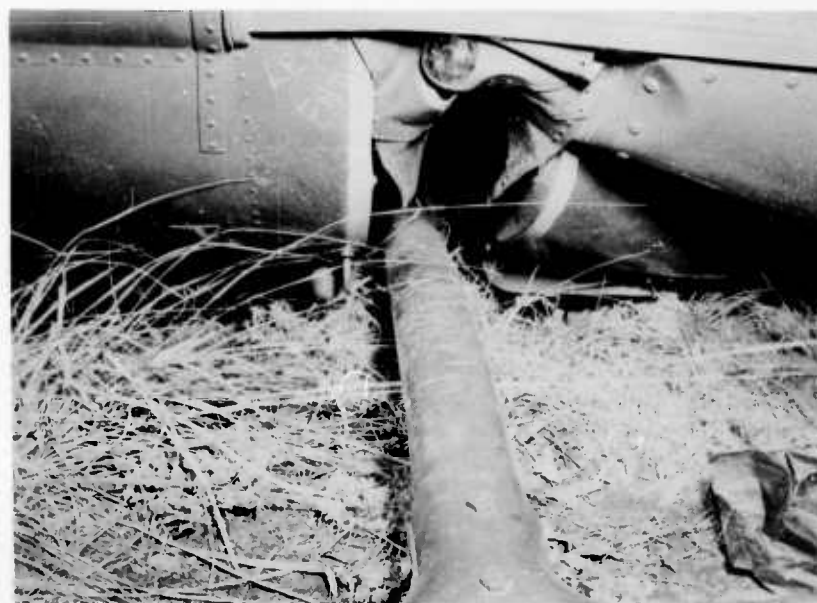
Figure 19. Left side view of aircraft showing displacement of the left forward cross tube and distortion to underside of the main cabin.

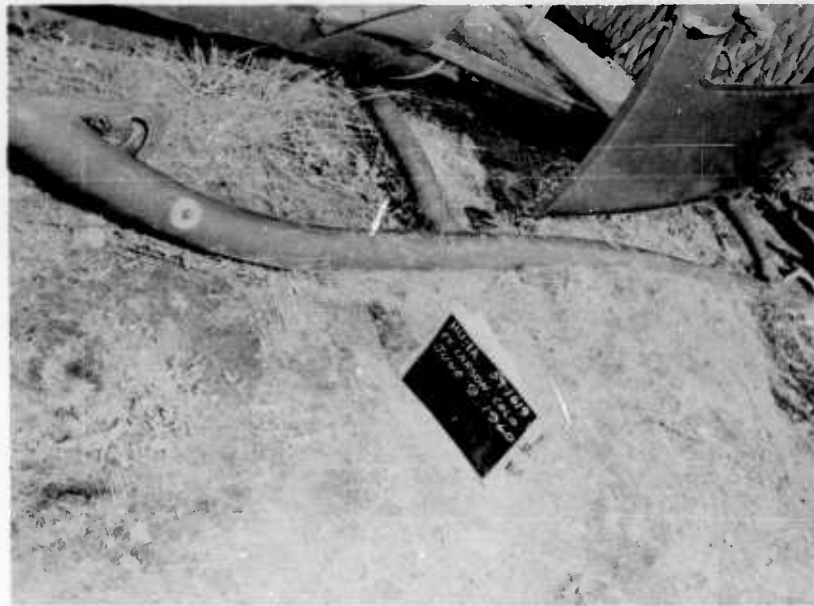
Figure 20. Note the manner in which the landing skid has deformed to fit the contour of the hill.

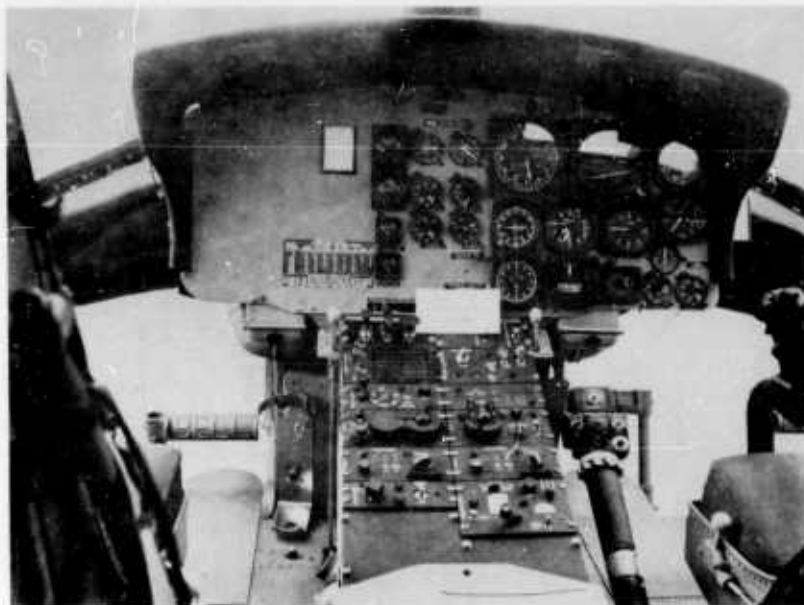
Figure 21. The intactness of the cockpit is depicted in this photo. The fire extinguisher was removed after the accident.

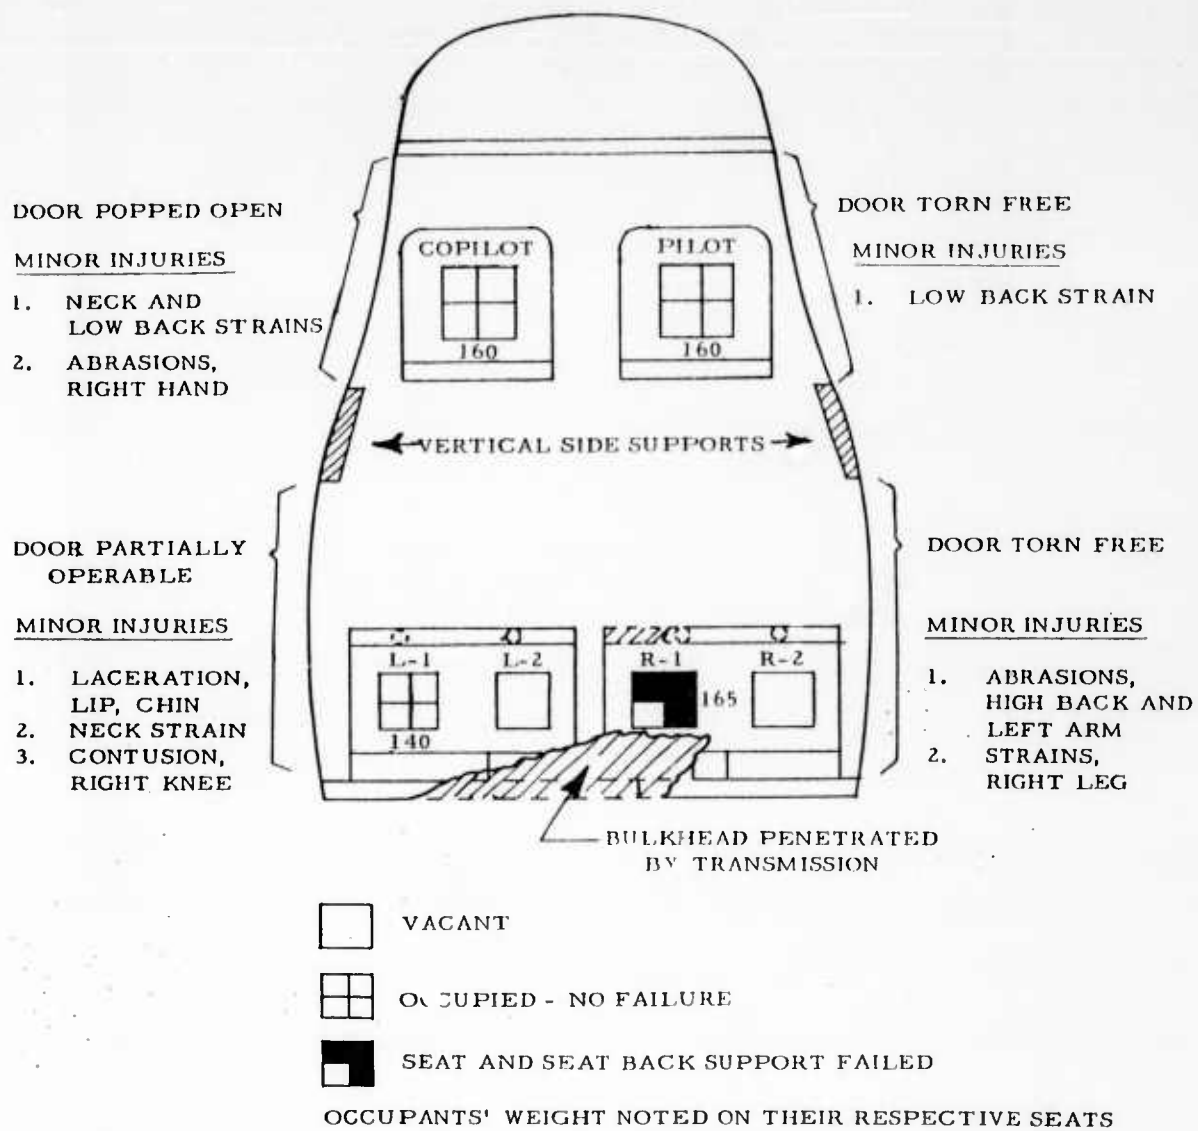
Figure 22. Seating arrangement, seat damage, and injuries.

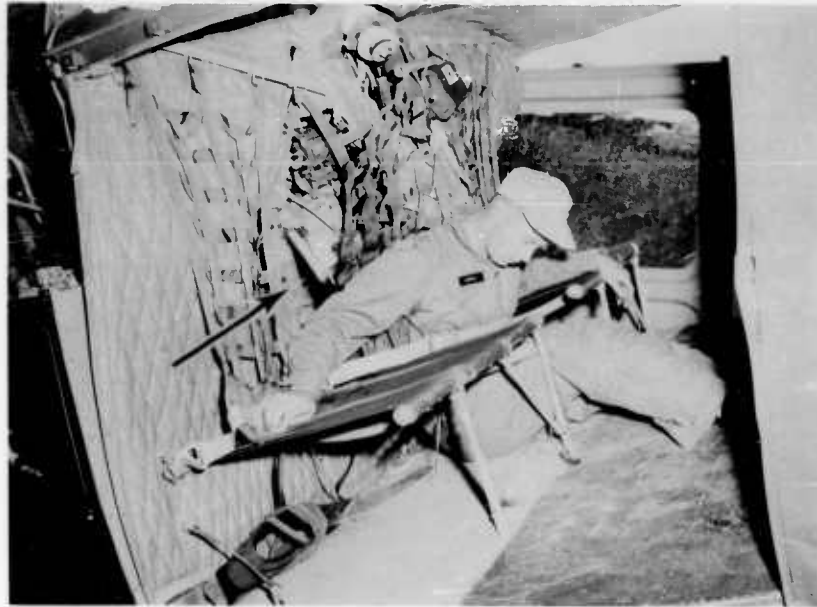
tube coupled with the extreme slack in the occupant's seat belt permitted him to move forward and downward, away from the transmission as shown in Figures 23 and 24. This fortunate coincidence probably prevented dangerous or fatal injuries to the occupant. Jagged and torn metal caused by penetration of the transmission is shown protruding into the cabin area in Figure 25.

Figure 23. Posed photograph from right side of aircraft shows final position of occupant and penetration of aft cabin bulkhead by transmission assembly (see arrow) and its relation to occupant.

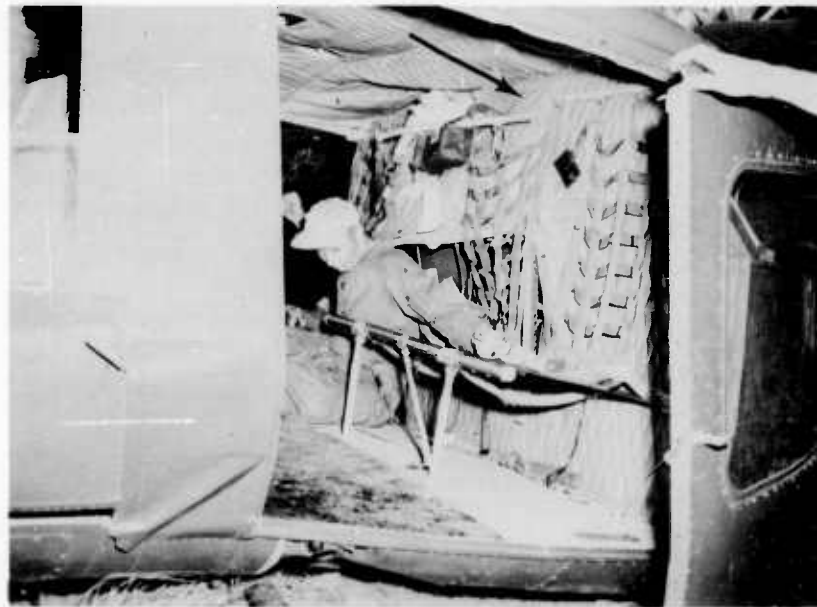
Figure 24. Posed photograph from left side of aircraft shows final position of occupant and broken seat back upper attachment (arrow).

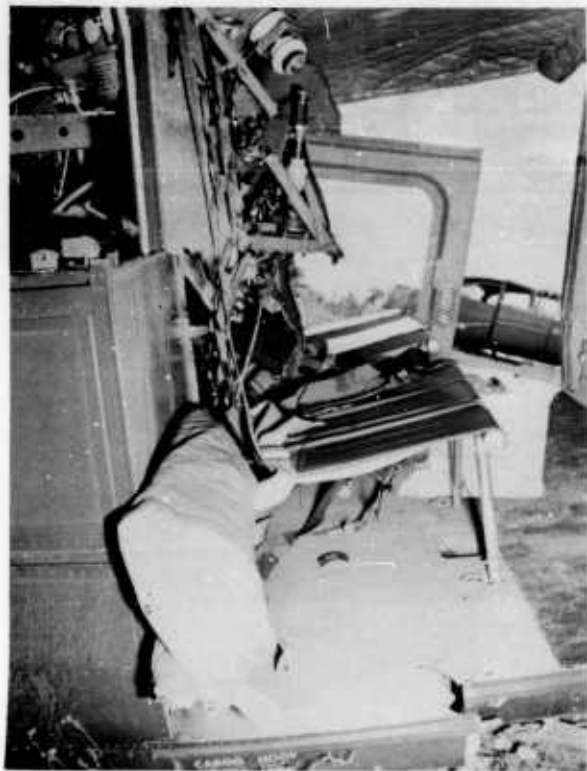
Figure 25. The 17-inch forward displacement of the transmission should be noted in this side view. The forward displacement of the firewall is also visible. The fracture in the floor occurred at the outboard edge.

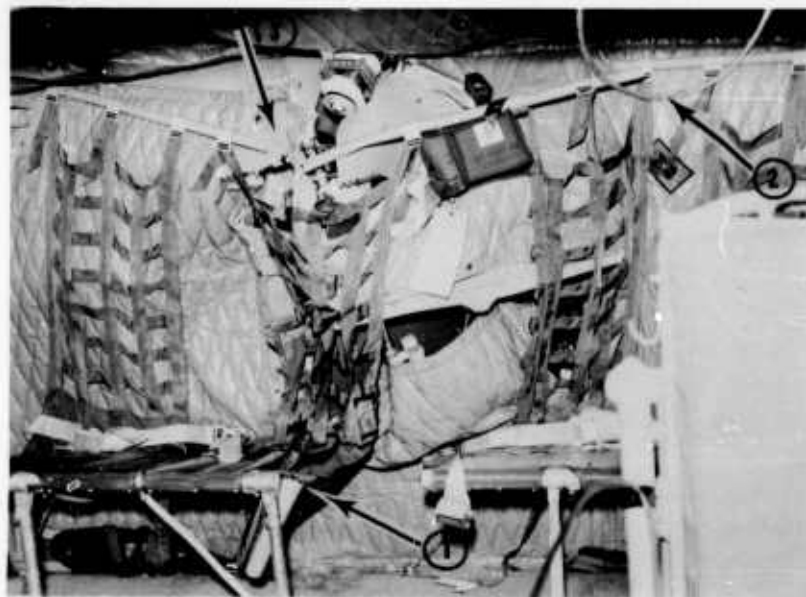
In addition to failure of the front seat support tube, the seat back upper attachment of seat R-1, which is attached to the firewall by means of four bolts inserted through drilled holes in the attachment, also failed, Figure 26. This attachment supports the seat back webbing. Failures frequently occur at these weakened points under relatively low crash forces. It appears that a clamp type attachment similar to that which supports the rear seat support beam in the HU-1A, would be more satisfactory. It is obvious that a considerable load was imposed on this support by the transmission failure; however, numerous failures of this type seat have been noted in other accidents in which the transmission was not a factor.

Figure 26. Arrow 1 depicts the broken front seat tube. This failure permitted the occupant to be thrown onto the cabin floor. Arrows 2 and 3 point out the fractures in the seat back upper attachment.

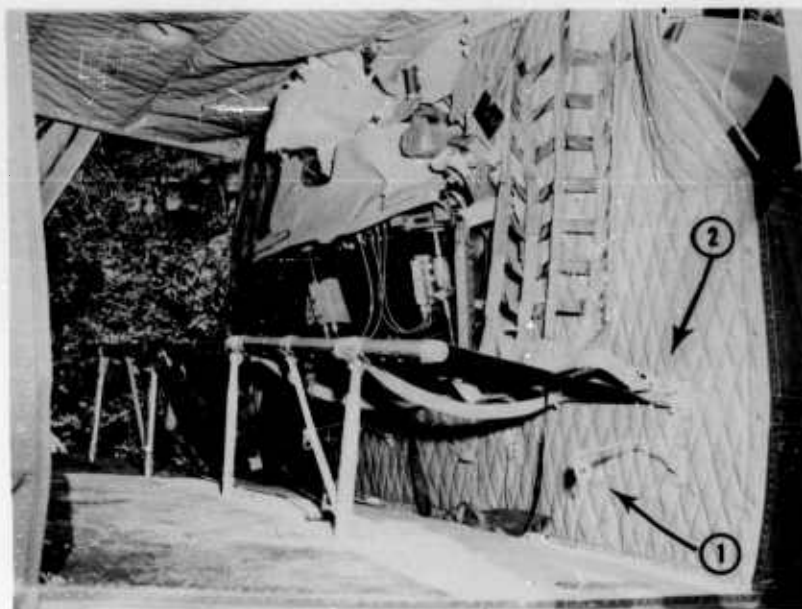
Figure 27. Arrow 1 denotes the desirable safety belt attachment. Arrow 2 depicts the manner of attachment which is normally utilized.

An additional item of interest is depicted in Figure 27. Arrow 1 points out a short length of cable which is anchored to primary structure. These cables are installed at intervals across the aft bulkhead and are intended to serve a two-fold purpose: (1) to anchor the ferry tank when utilized and;(2) to function as a safety belt attachment when transporting troops. The utilization of these cables relieves the rear seat support beam of a considerable load and also properly positions the safety belt across the hips at approximately a 45° angle. This desirable 45° angle places a majority of the load on the hips and forces the spine to flex at the lumbosacral joint. When the safety belt is attached to the "O" ring as shown in Figure 27, Arrow 2, the safety belt crosses the occupant at approximately a 90° angle and forces the spine to flex in a higher area, often causing flexion fractures. It is therefore suggested that all safety belts in the cabin be attached to the cables to afford the occupant maximum protection.*
