# CRASH INJURY INVESTIGATION

U. S. ARMY HU-1A

BELL IROQUOIS HELICOPTER ACCIDENT

Fort Bragg, North Carolina

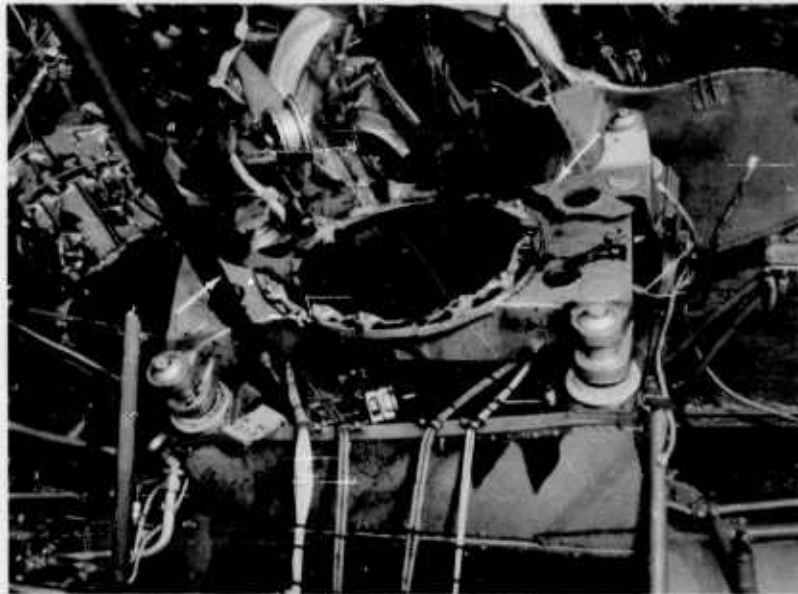
The transmission assembly failed in this accident in the same manner as experienced in previous HU-1A accidents. The significant failure point in all HU-1A accidents is the magnesium casting which serves as a cradle supporting the transmission assembly. In this instance, the transmission

Figure 5. Transmission torn free from its cradle support. Note the fractures in the magnesium casting (arrows).

failed rearward and to the right and was, therefore, not a contributing factor insofar as injuries are concerned in this accident. Had the direction of the crash forces been such that the failed transmission moved forward, it would have penetrated the rear bulkhead of the cabin area, as experienced in a previous HU-1A accident. This is a hazard which has been pointed out on several occasions. During a recent evaluation of the HU-1D helicopter, it was found that Bell Aircraft was providing for a fifth transmission mount to prevent the transmission from moving forward during a crash. It is questionable, however, whether this will resolve the problem because the failures have not occurred at the mounts, but rather in the magnesium casting which serves as a cradle for the transmission assembly. The failure experienced in this accident is shown in Figure 5.

2. Consideration be given to the utilization of a more ductile material to replace the brittle casting presently used to support the transmission;
3. The specifications for both crew and troop seats be revised to provide increased occupant protection under survivable crash force conditions;

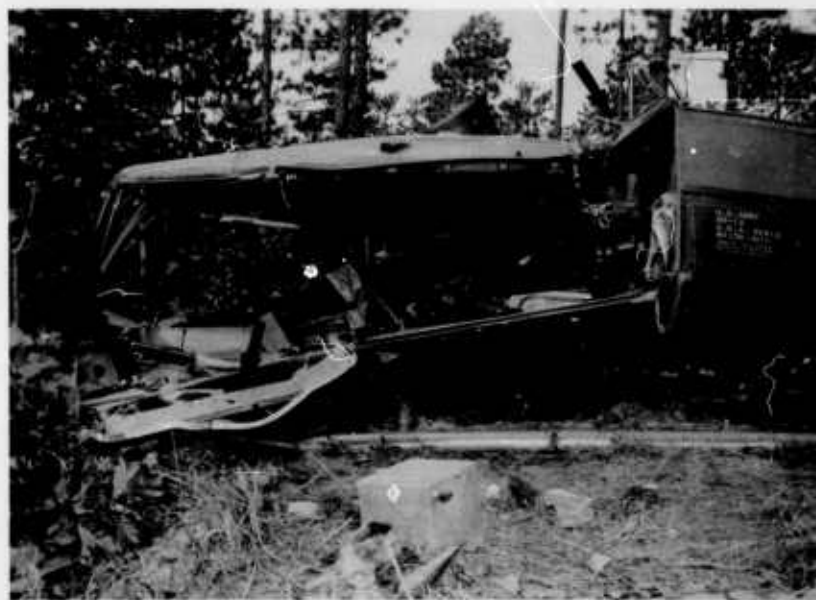
At principal impact, the side roof support members failed completely. This contributed to the failure of the aft roof support member permitting the roof to move forward and downward into the occupiable area of the cabin, reducing the occupiable height within the cabin from 4'8" to 2'8". The failure of these members is shown in Figures 6 through 9.

As the rear roof support member failed, it caused the rear bulkhead to tear and rip, with a jagged point striking the occupant of the rear troop seat at the base of the skull, injuring him critically.

Figure 6. Close-up view of left side of aircraft. The upper arrow depicts the rear bulkhead failure. The broken side supports can also be seen (lower arrows).

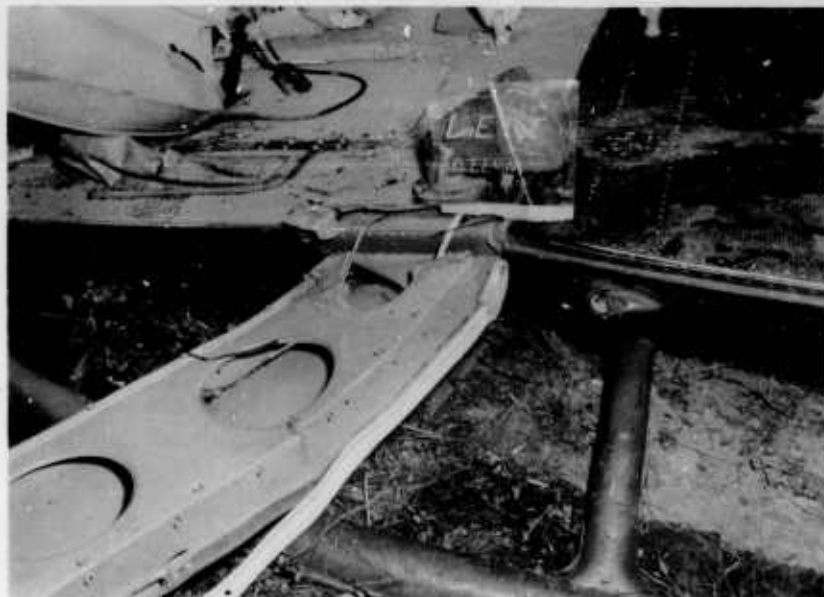
Figure 7. Failure of the left vertical side support at the floor. Cables are holding the support to the floor structure.

Failure of these support members has occurred in every HU-1A accident experienced to date, indicating an inherent weakness in the design of these members. This has been pointed out in previous accident reports and has resulted in "Request for Alteration" studies by the Army. As a result of the requests, Bell Helicopter has conducted the studies and submitted recommended solutions to this problem. The results of the Bell studies are set forth below:

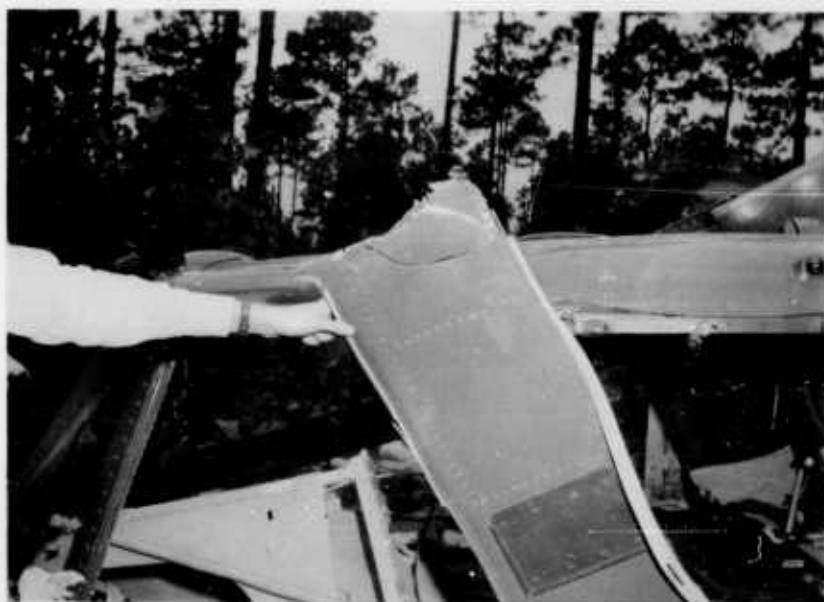
Figure 8. Side view showing failure of left vertical side support at the upper attachment to the roof structure.

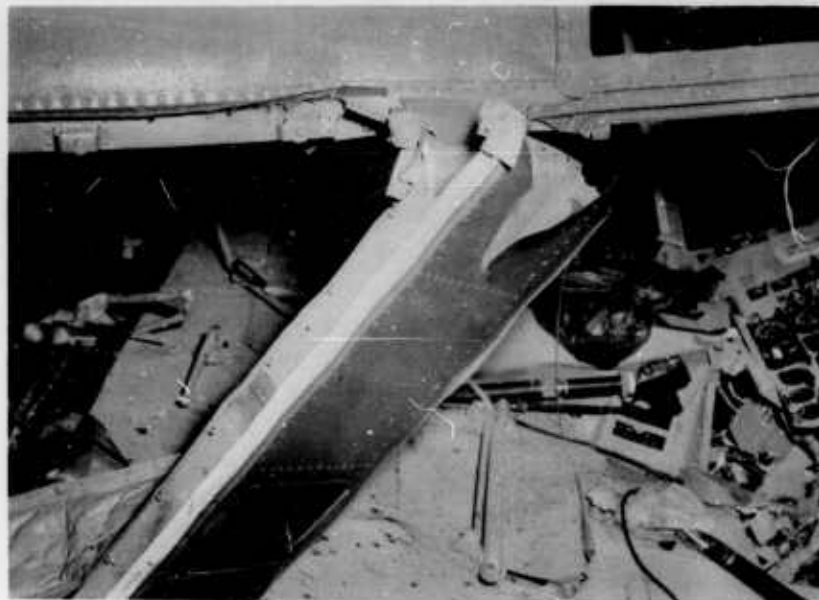
Figure 9. Side view showing failure of right vertical side support at the upper attachment to the roof structure.

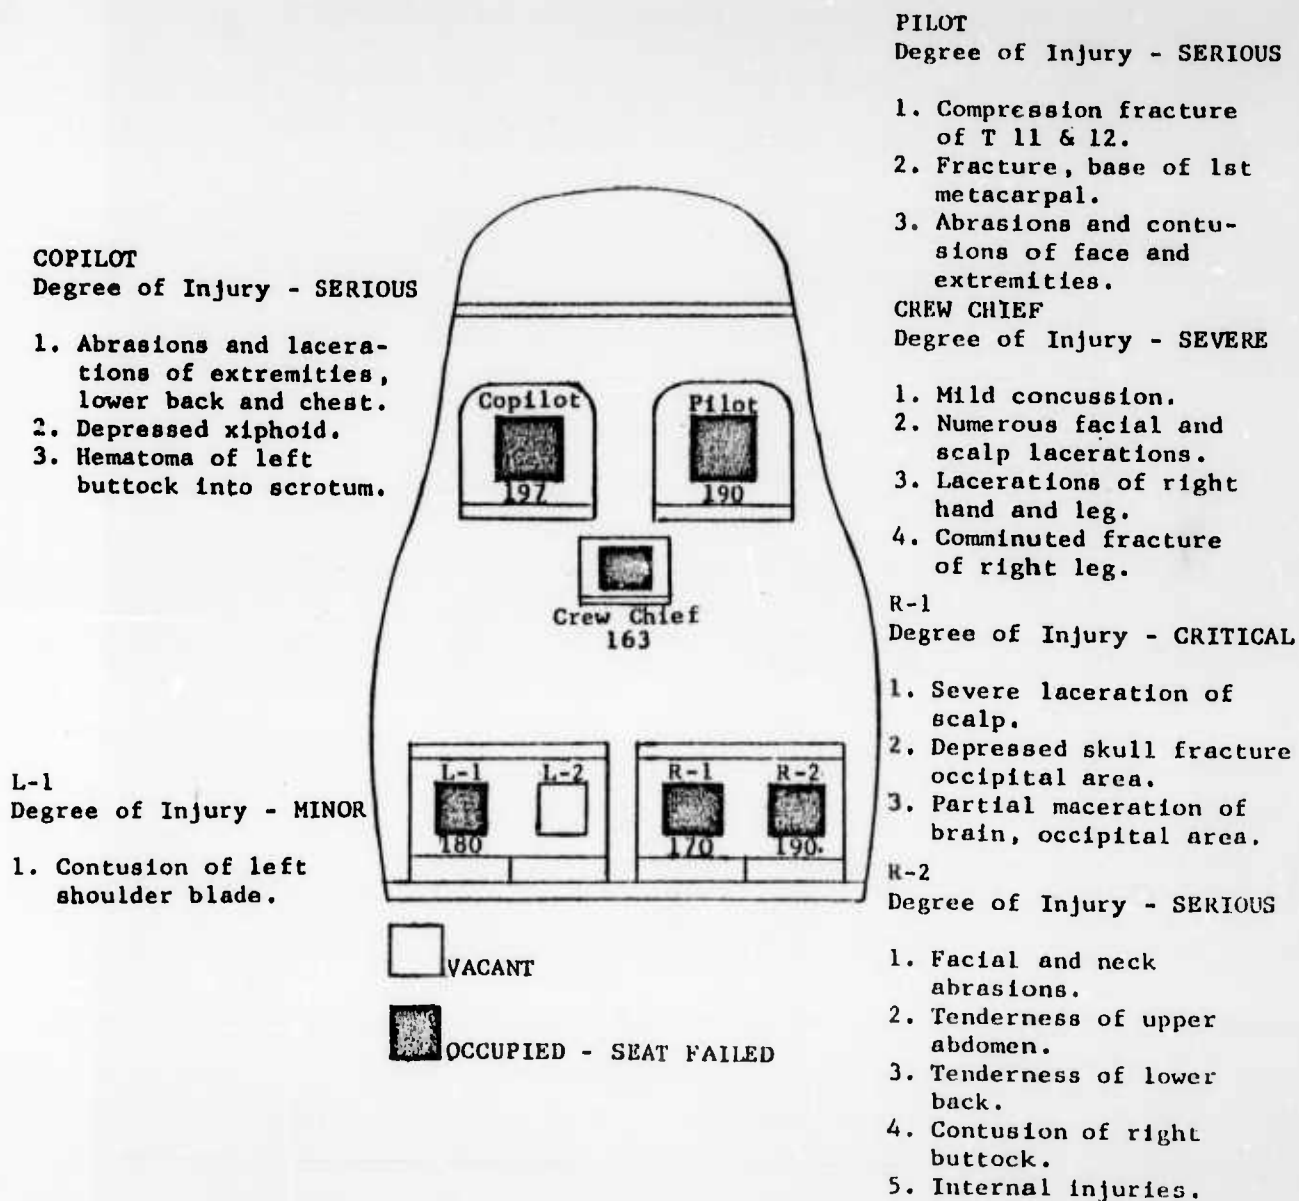
Figure 10. Seating Arrangement - Injury Chart - Seat Failure

of the aircraft at principal impact while still attached to their seats. All other occupied seats failed in place. Figure 10 illustrates the seating arrangement, injuries sustained by each occupant, and the seat failures.

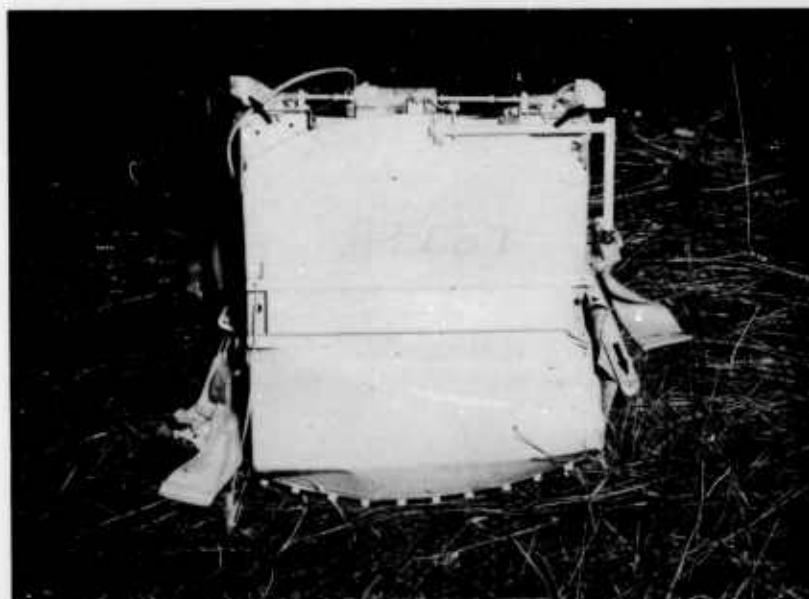
At principal impact the floor and lower seat frame were distorted due to high vertical forces and penetration of the floor by the tree stump. Because of the longitudinal velocity caused by the whipping action of the fuselage, the pilot apparently slid down and forward, deforming the forward lip of the seat pan as illustrated in Figure 11, and popping the rivets along the right side. As a result of the force applied to the seat by the pilot, and the distortion of the lower seat frame, the seat ripped free from the frame and was thrown forward and to the right out of the aircraft. Figure 12 is a view of the lower seat frame still attached to the floor.

Figure 11. Bottom view of seat pan - pilot. The dotted line indicates bent seat pan lip and popped rivets on the right seat. Arrows show locations of seat support failures.

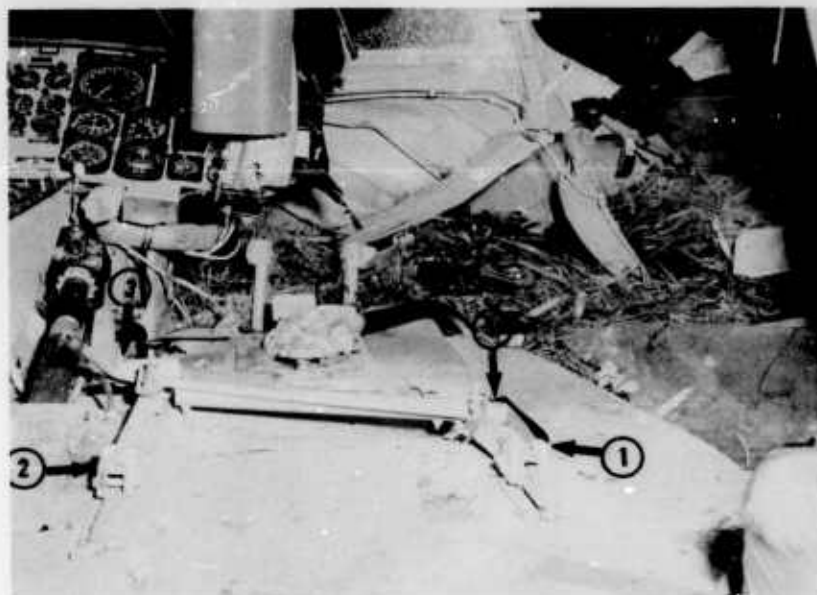
Figure 12. View depicting lower seat frame distortion and floor collapse. Arrows 1 through 4 indicate locations of vertical and diagonal seat frame failure.

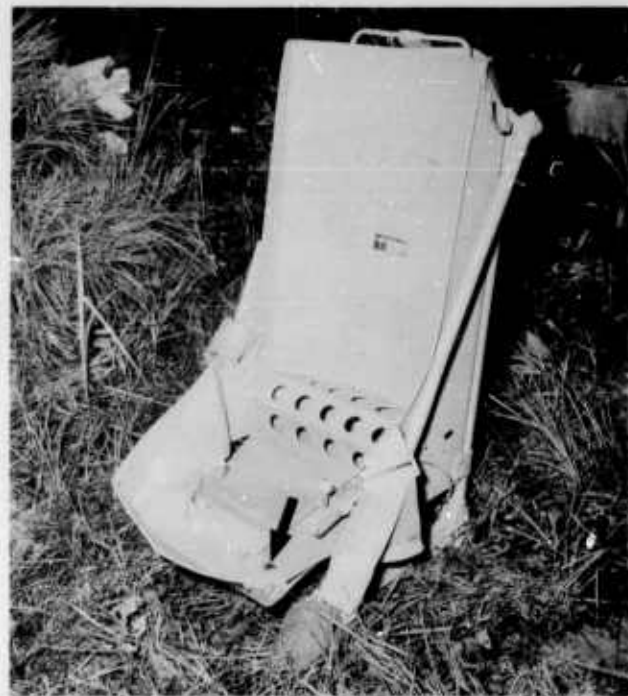
The occupant of the copilot seat apparently also slid downward and forward at principal impact, causing distortion of the forward seat pan lip in the same manner as the pilot's seat (Figure 13). The longitudinal force applied by the occupant of the copilot's seat at principal impact caused the rear seat support members to fail, permitting the seat to pivot forward and wedge the occupant head first in the torque pedal well. Figure 14 illustrates the portion of the copilot's seat frame remaining attached to the floor after removal of the occupant.

Figure 13. View of the broken seat pan - co-pilot. Note the forward and downward bending of the seat pan lip and the tension failure of the left corner of the seat pan (arrow). Also, note excessive width of shoulder harness guide.

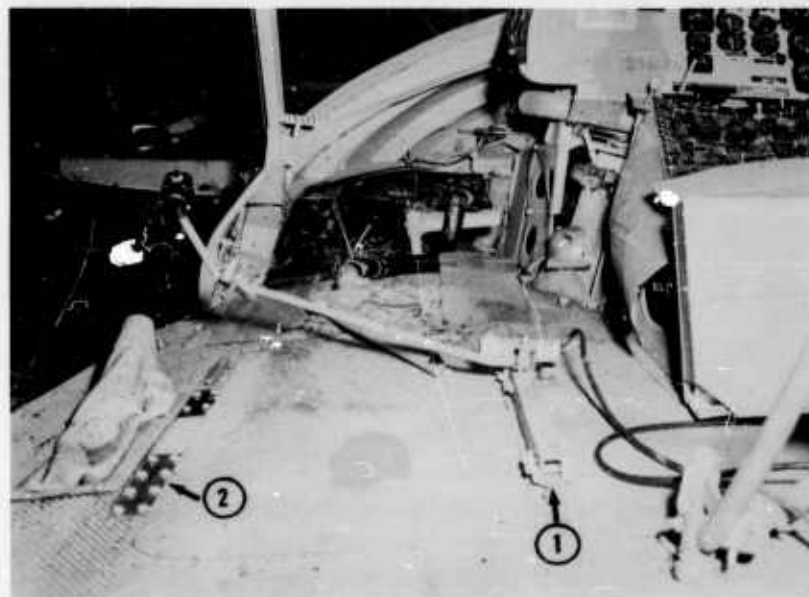
Figure 14. Copilot's seat failure. Removal of the left front occupant necessitated removal of the entire seat and, therefore, is not shown in this photograph. Arrow 1 depicts the manner in which the right rear anchorage failed and Arrow 2 shows how the rear portion of the left seat track pulled free from its floor anchorage.

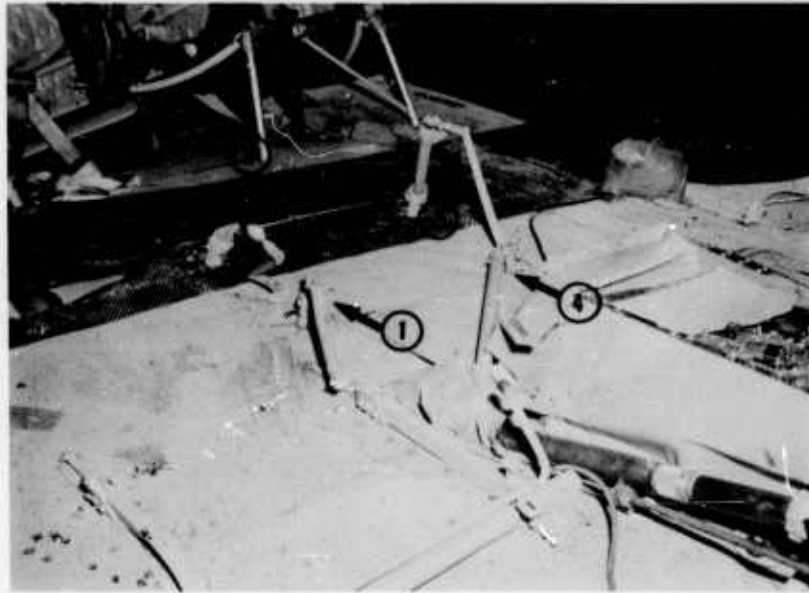
The longitudinal force exerted on the seat by the crew chief at principal impact caused the seat pan to tear free from the seat support. The seat supports apparently absorbed a considerable amount of energy by buckling and distortion before the seat pan tore free, as shown in Figure 15. Additional views of the medical attendant's seat are shown in Figures 16 and 17.

Figure 15. Buckling of the seat supports of the Medical Attendant's seat.  
(Arrows 1 through 4)

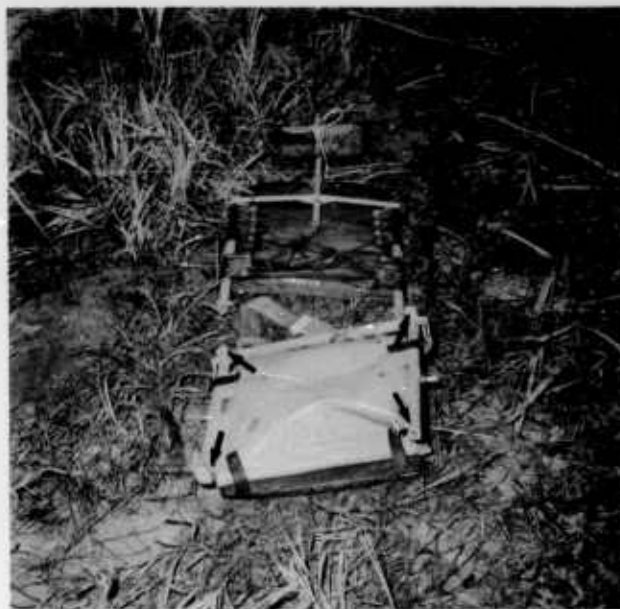
Figure 16. View of broken Medical Attendant's seat. Arrows denote points of support failure.

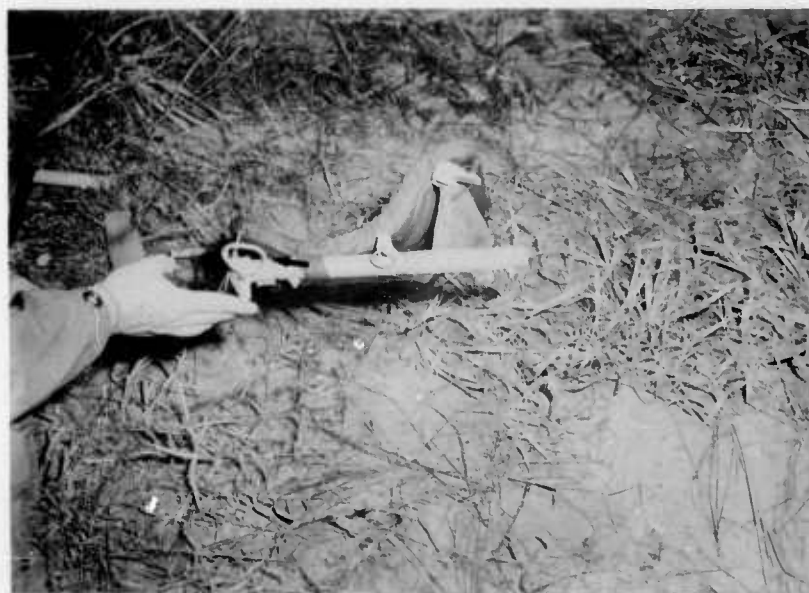
Figure 17. Seat belt attachment of Medical Attendant's seat (arrow). Notice how stress elongated the "O" ring, yet did not fail.

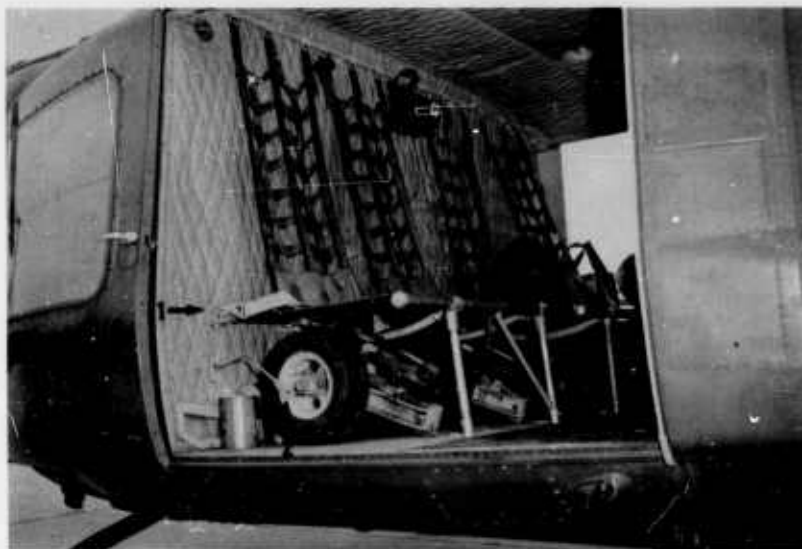
Figure 18. Correct and incorrect belt installation. Over-all view of the cabin area depicting the troop seats and the loose equipment stowed beneath the seats. Arrow 1 denotes the incorrect method of attaching the safety belts. The belts should be attached to the cables which are provided (arrow 2).

With reference to the troop seats, it was noted that the seat belts were attached to clamps of the rear longitudinal seat support member, as shown by Arrow 1 of Figure 18. Attachment of the belts at this point overloads this member and frequently causes failure of the support member. Arrow 2 in Figure 18 shows the cable which is provided in this aircraft for seat belt attachment. These cables are tied directly to primary structure. Attachment of the belts to the cables provided would reduce the crash loads on the seat structure and would eliminate some of the failures experienced in the past. \*

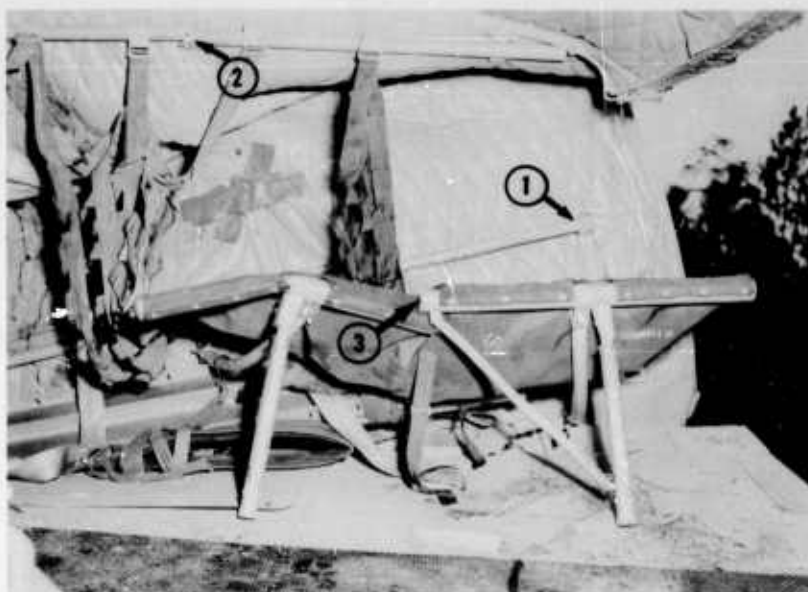
The left rear two-man seat shown in Figure 19 was occupied by one passenger on the outboard side. At impact the seat pan ripped from the rear lateral support tube. This support tube pulled out of the clamp on the left side of the bulkhead and moved two inches to the right, as shown by Arrow 1 of Figure 19. The hooks, which suspend the seat back from the upper support tube tore free from the upper support tube. The upper support tube failed at a drill hole where it is attached to the rear bulkhead, shown by Arrow 2, Figure 19. Failure of the seat pan and the downward force exerted by the occupant caused the front support member to break at a drill hole near the diagonal brace attachment. Failure is shown by

Arrow 3, Figure 19. Both front seat legs were also torn free from their floor attachments.

Figure 19. Failure of left rear troop seat. This seat was set up for photographic purposes. It was originally collapsed on the floor. Arrow 1 shows the clamp where the rear support tube was anchored. Arrow 2 shows the failure of the upper longitudinal tube where the seat backs are attached. Arrow 3 shows the failure of the front support tube at the drill hole.

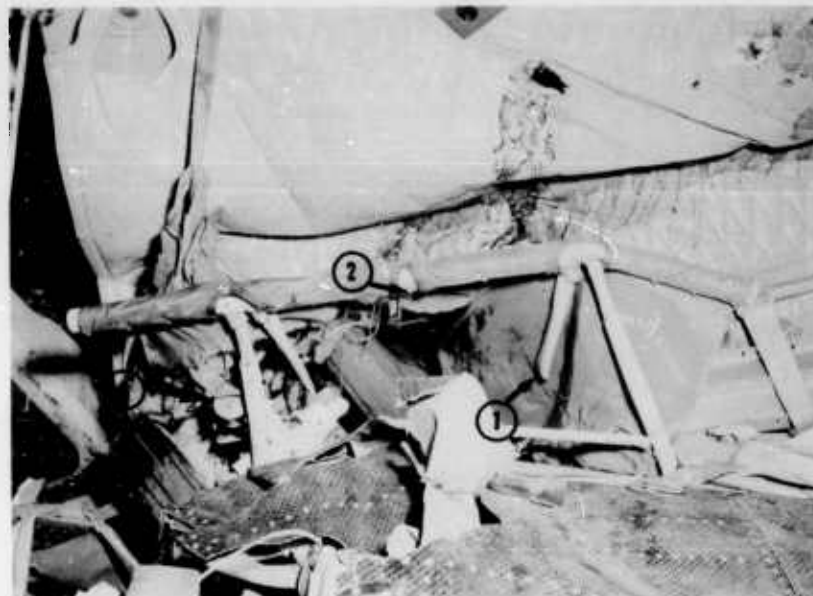
The right rear two-man seat shown in Figure 20 was occupied by two passengers. At impact the floor just ahead of this seat heaved upward as the aircraft impaled itself on the tree stump. The upheaval of the floor, plus the downward force exerted by the two passengers, caused distortion and failure of the vertical seat legs, permitting the seat pan to come into contact with the handle of the hydraulic pump on a set of ground handling wheels stowed under the seat, causing the seat pan to rip longitudinally. The seat spreader under the inboard occupant broke and the diagonal brace failed. The seat back support assembly also failed on this seat.

Figure 20. Failure of right rear troop seat. Note the ground handling wheels under the outboard seat. Arrow 1 indicates the broken seat spreader. Arrow 2 shows the failure of the diagonal brace. Arrow 3 indicates the position of the ground handling wheels.

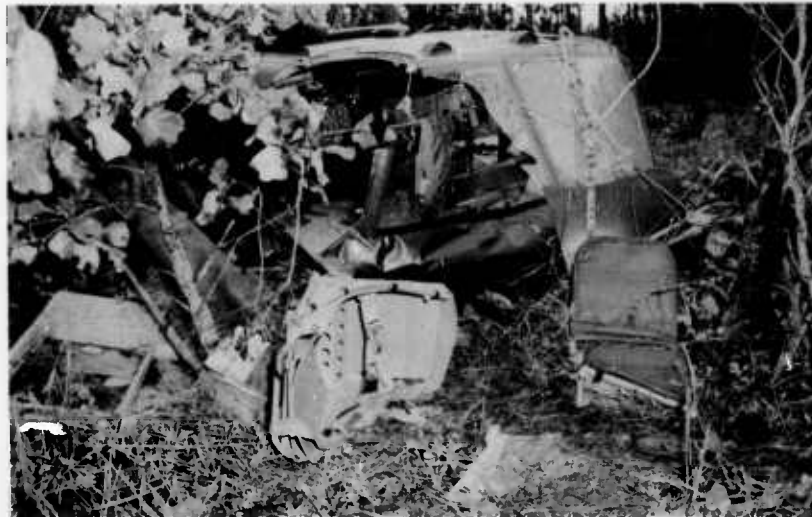
At impact, the pilot's seat failed, permitting the seat and its occupants to be thrown forcibly forward, down, and to the right. The pilot apparently struck the right front door post with his helmet and right side of his body and was then thrown clear of the aircraft (Figure 21).

Figure 21. Front right view of the aircraft showing the door post and the position where pilot and crew chief came to rest.

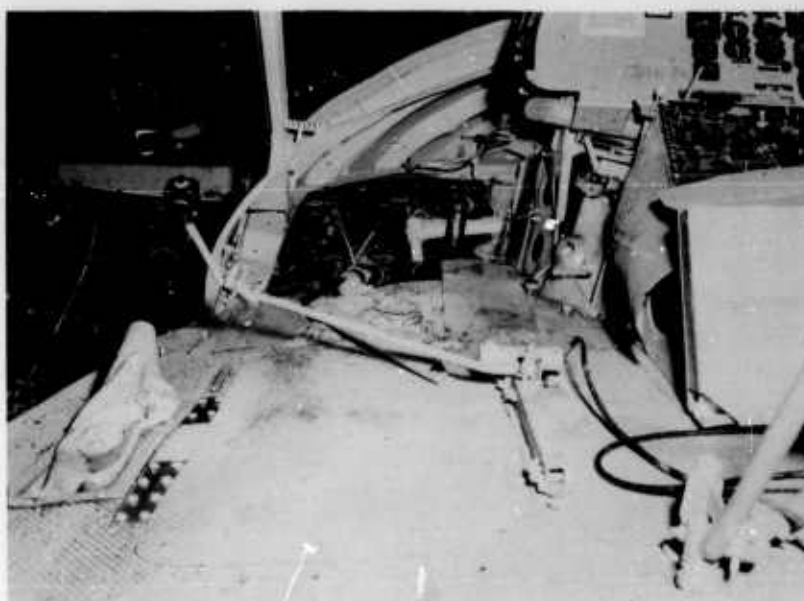
Figure 22. View of the left torque pedal-well after seat was removed. Note the broken cyclic stick.

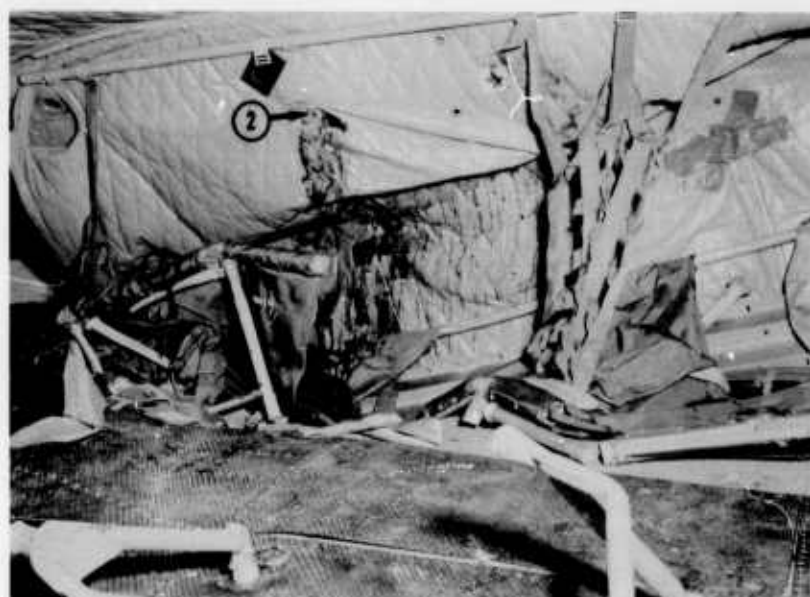
The occupant of this troop seat suffered serious injuries. At impact the nylon seat pan ripped longitudinally in the center. This was caused by the handle of the hydraulic pump equipment on a pair of ground handling wheels that were stowed under his seat (Figure 24, Arrow 1). The occupant received extensive contusions of the right buttock when he fell through the ripped seat pan and contacted these ground handling wheels.\* His safety

Figure 24. View of the right rear troop seat. Arrow 1 shows where the seat pan tore across the ground handling wheels. Arrow 2 indicates the structural member that pierced the bulkhead, injuring the occupant of the inboard seat.
