CRASH INJURY EVALUATION

SUMMARY EVALUATION

FLIGHT SAFETY FOUNDATION, Inc.

AVIATION CRASH INJURY RESEARCH
A Division of Flight Safety Foundation, Inc.
2871 Sky Harbor Blvd., Phoenix, Arizona

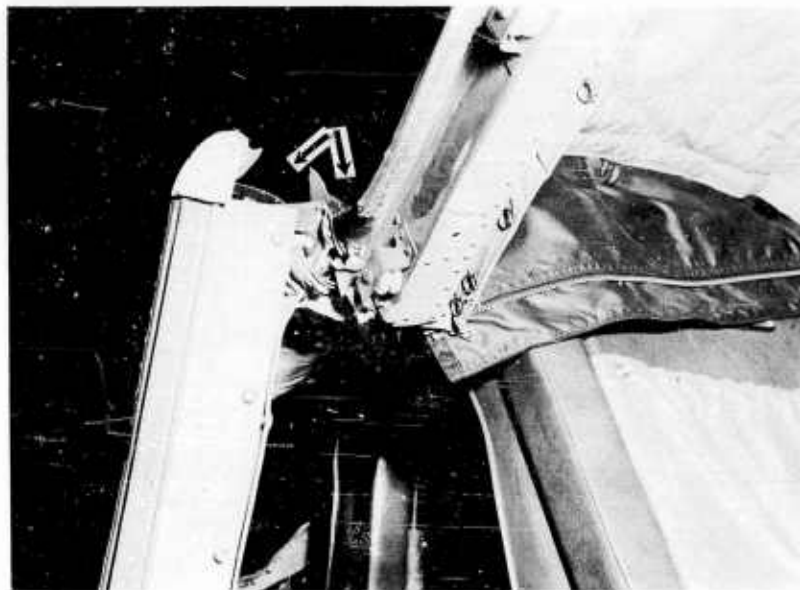
Figure 4. Upper attachment failure of the left vertical side support in Accident "A".

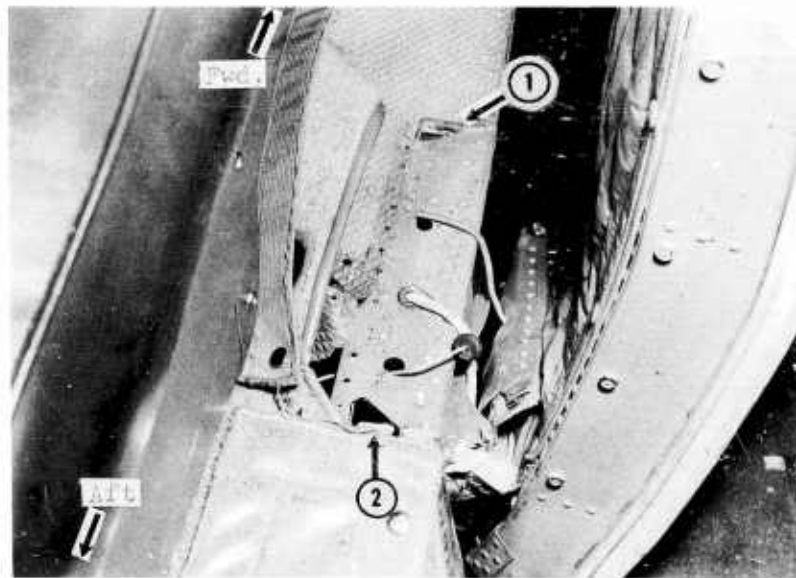
Figure 5. Right vertical support member, lower attachment point, failure in Accident "A". Depth and type of failure of the forward "L" stringer is shown by Arrow 1 (as compared to that of the aft "L" stringer). Arrow 2 indicates some application of force against the upper area of the member in an aft direction during its failure.

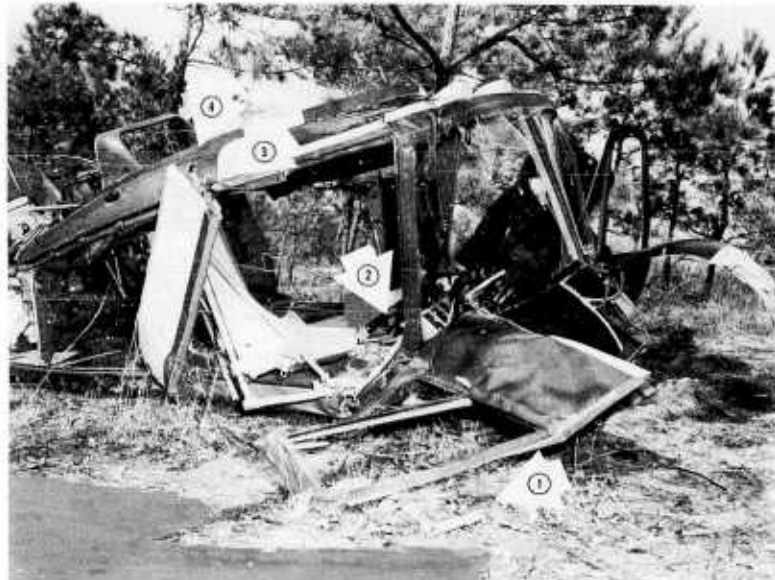
Figure 6. Right side support failure in Accident "B". The upper right side support (arrow 3) was torn free, the bottom also failed. Arrow 1 depicts the pilot's right anti-torque pedal, Arrow 2 damage to collective pitch, while Arrow 4 denotes a hole in the roof caused by the pilot's seat as the roof collapsed.

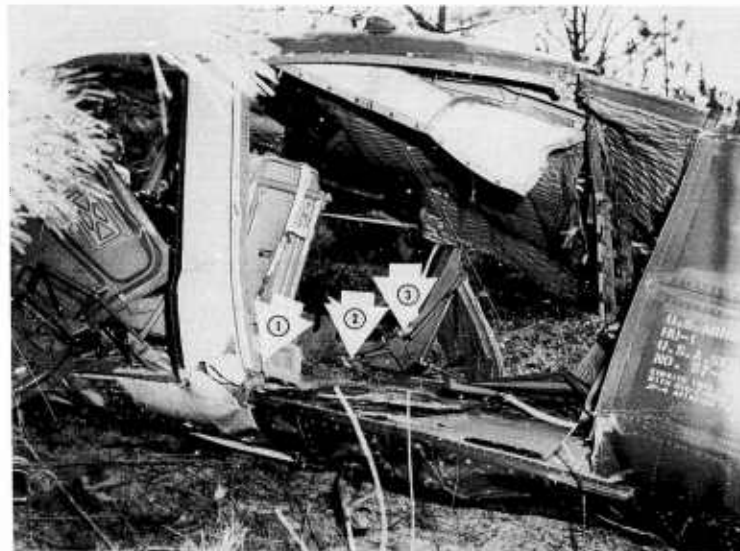
Figure 7. Left side support failure in Accident "B". Arrow 1 depicts the failure on the bottom of the left side support. The top remained attached. Arrow 2 depicts the broken seat attachment, Arrow 3 shows the bent seat tube support.

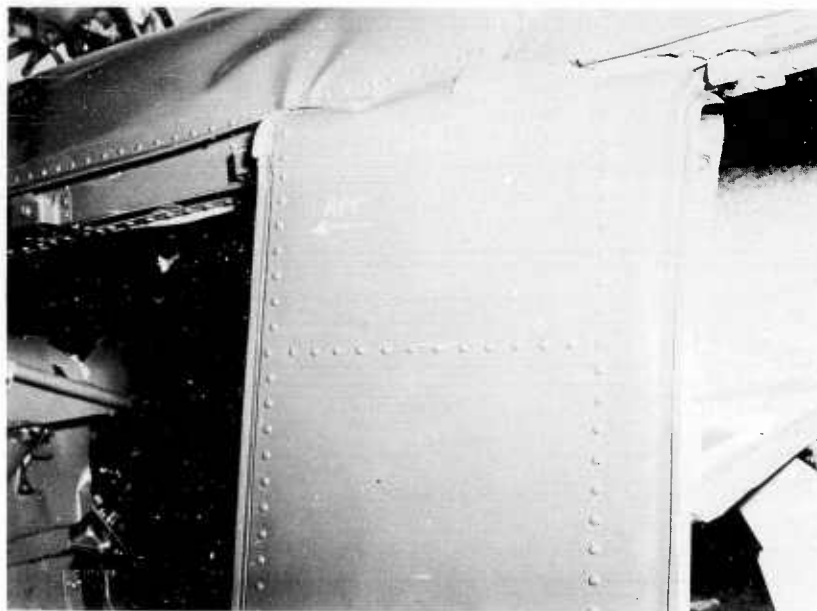
Figure 8. Failure sustained by the top of the right side support in Accident "C".

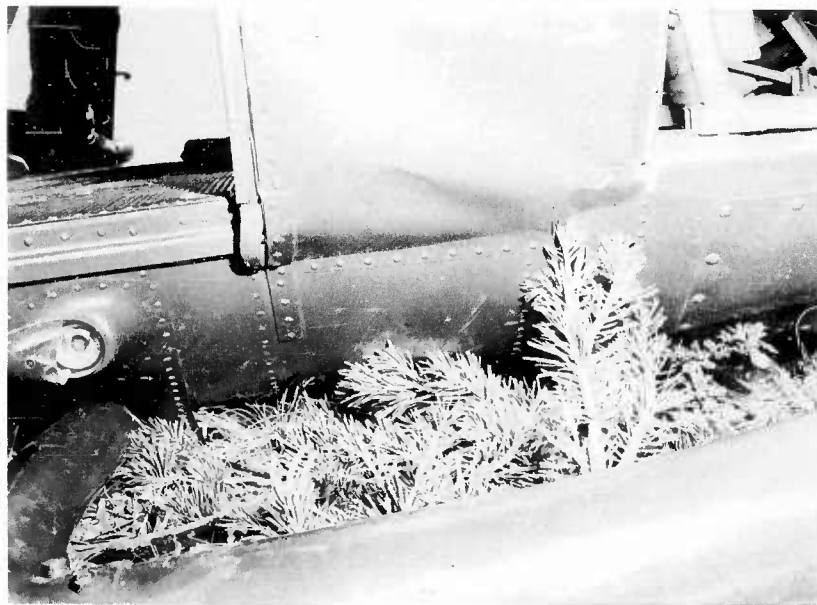
Figure 9. The bottom right side support partially failed in Accident "C".

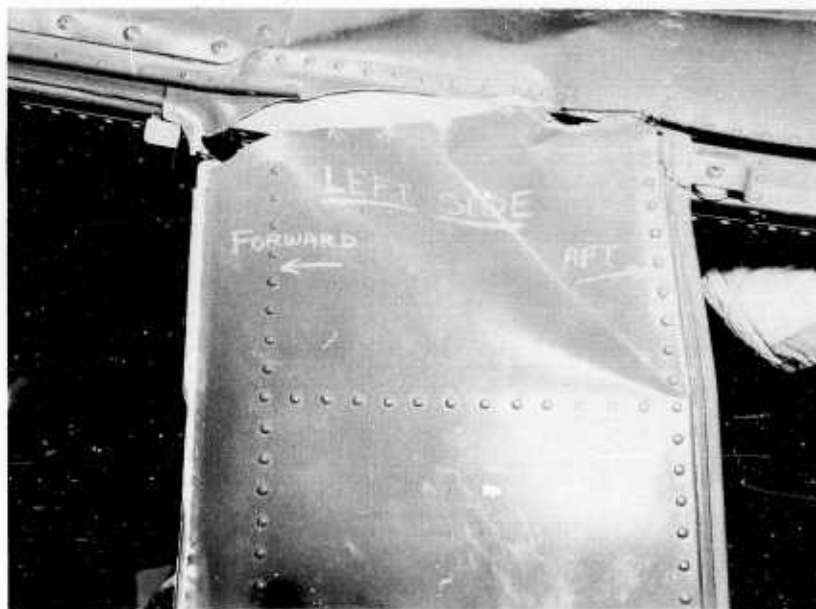
Figure 10. The top of the left side support failed in Accident "C".

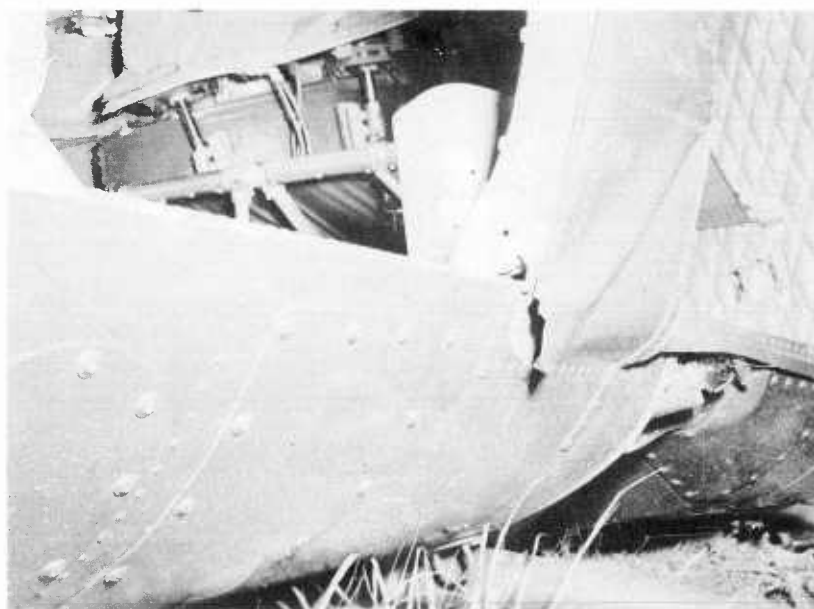
Figure 11. The bottom of the left side in Accident "C" showed signs of failure.

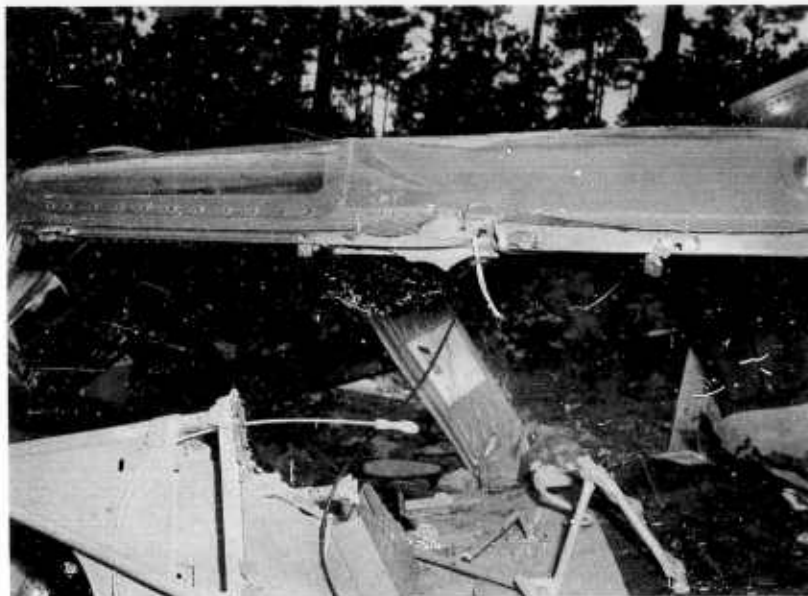
Figure 12. The top left vertical side support was torn completely free in Accident "D".

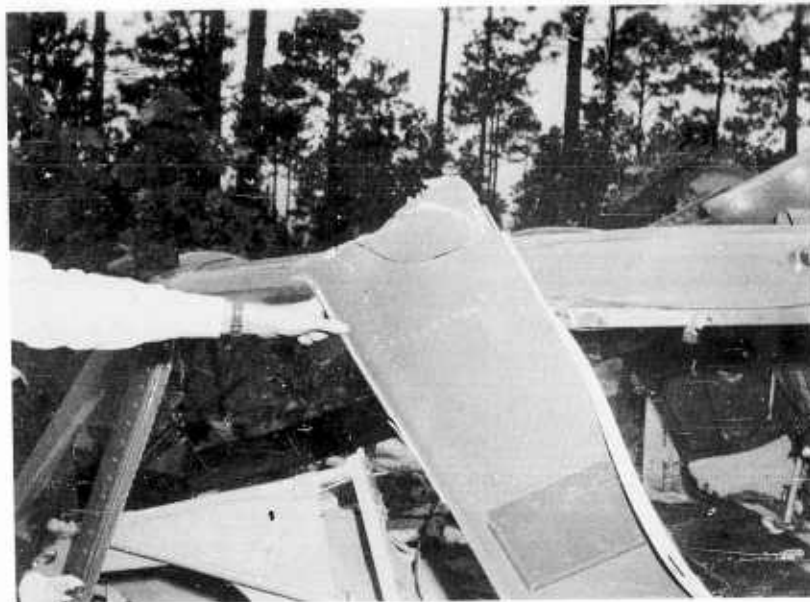
Figure 14. Side view of the torn free support in Accident "D", left side.

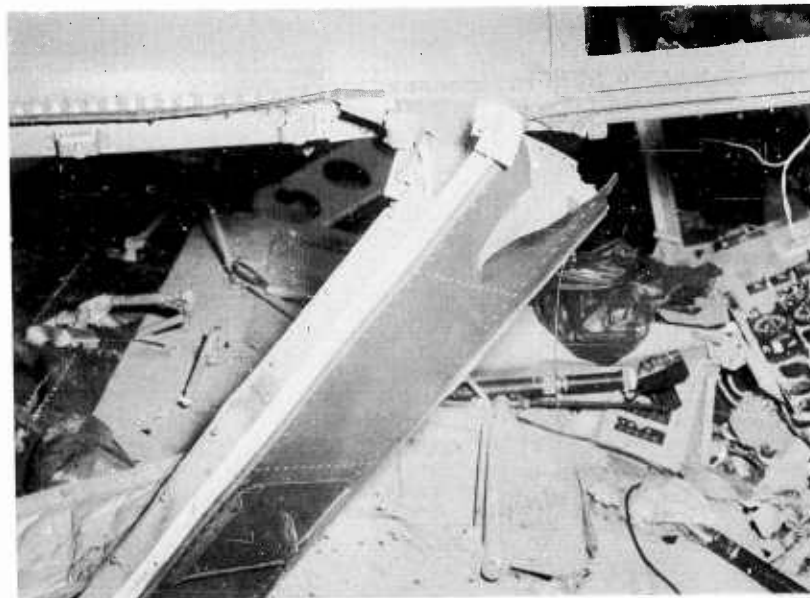
Figure 15. The top of the right side was supported by the wiring, Accident "D".

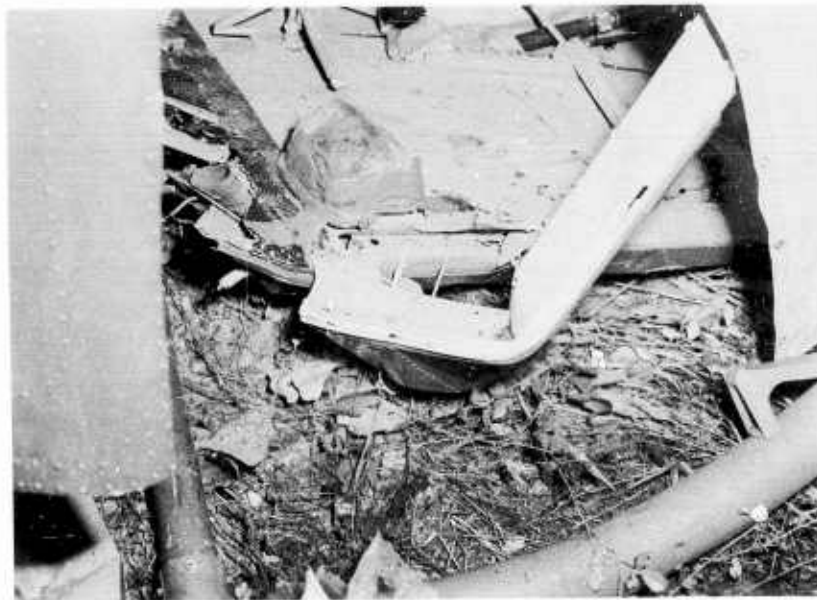
Figure 16. Wiring supported the bottom on the right side support in Accident "D".

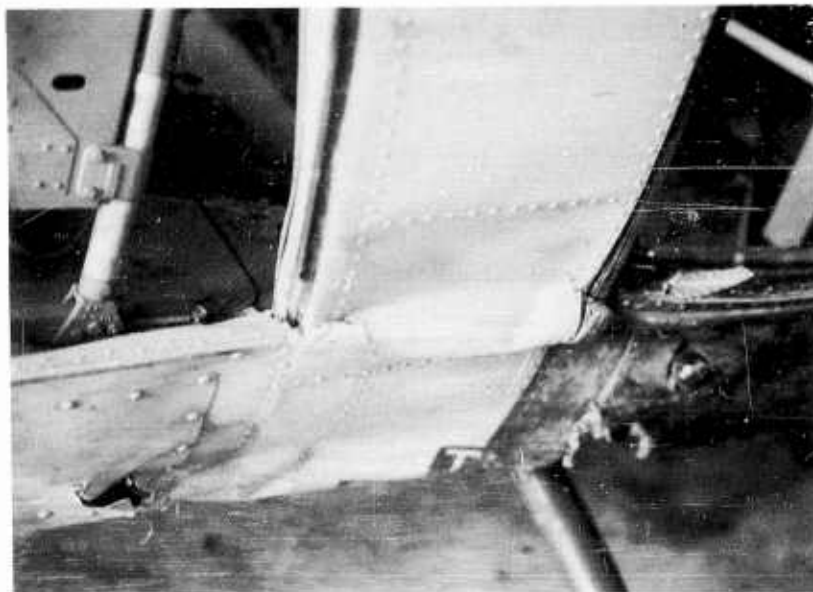
Figure 17. Bottom of the left support in Accident "E" (aircraft fell on its left side). Partial failure may be noted in the side supports.

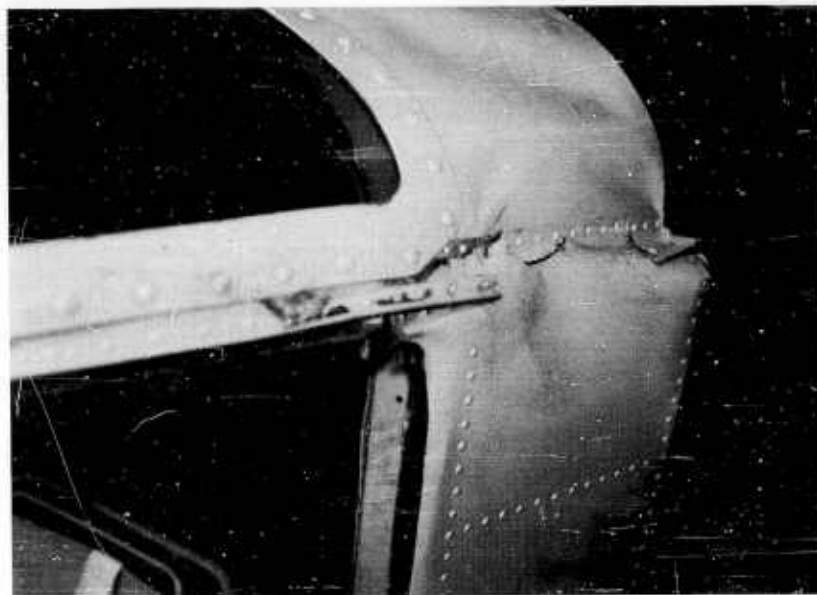
Figure 18. Partial failure occurred on the top of the support, left side, in Accident "E".

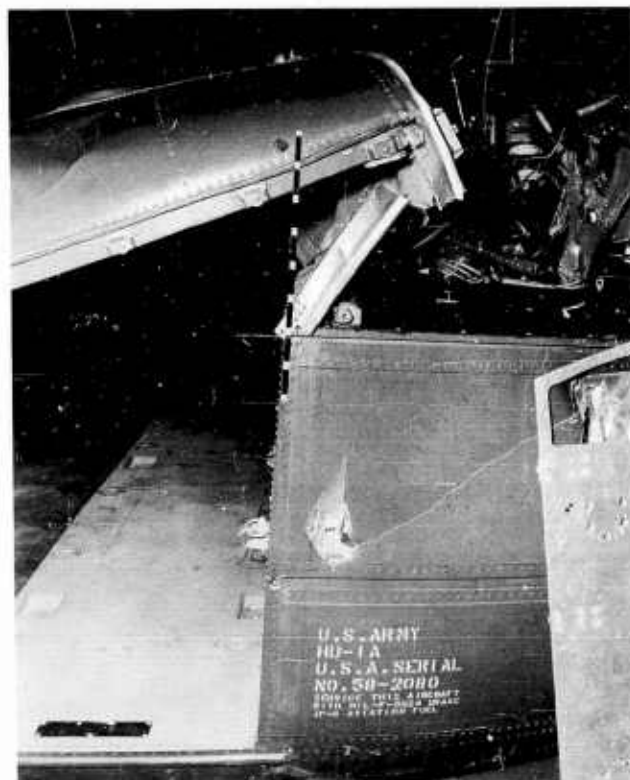
Figure 19. The downward collapse of the roof in Accident "A" is shown. The dotted line depicts the normal position of the fire-wall.

It is evident, therefore, that the strength requirements of both the main side supports and the aft bulkhead support are inadequate. They should be able to withstand impact forces and conditions of a survivable nature without gross failure. This apparently has been recognized recently by both the military and the manufacturer. "Requests for Alteration" have been studied by the Bell Helicopter Corporation on each of these two features.

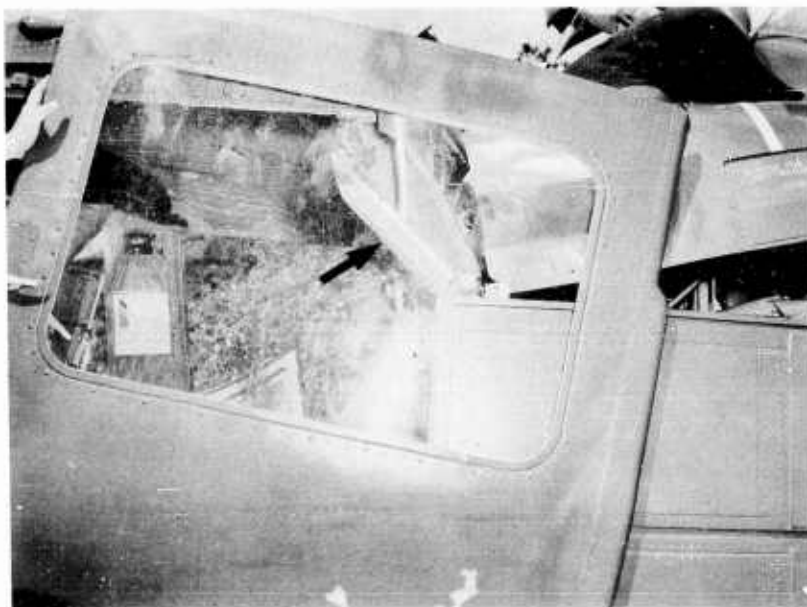
Figure 21. The arrow depicts the forward movement of the aft bulkhead, left side, in Accident "C".

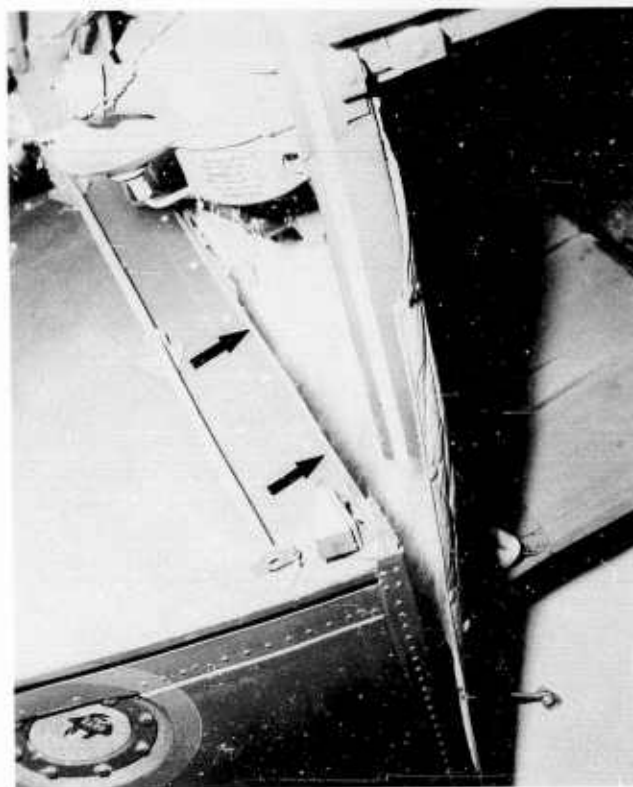
Figure 22. The aft roof structure failed on the right side in Accident "C".

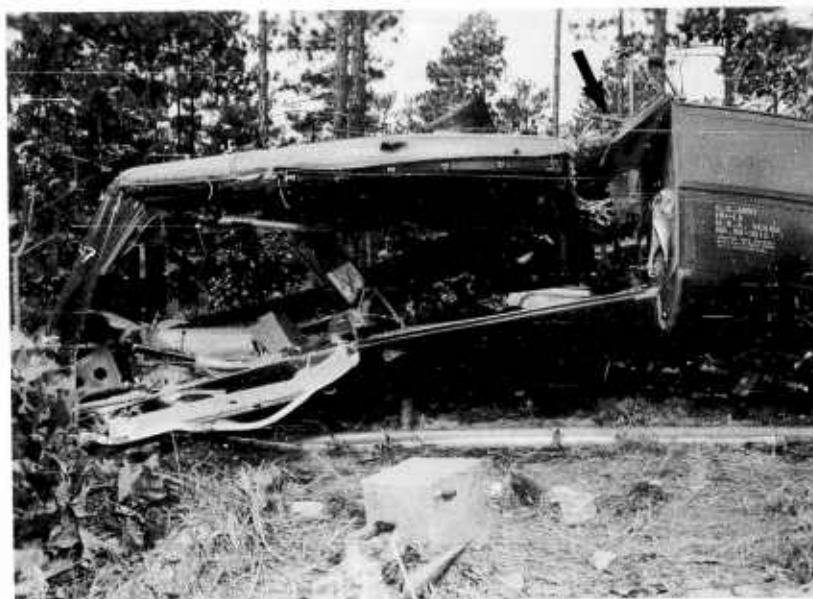
Figure 23. Wiring was the remaining support of the roof structure in Accident "D".

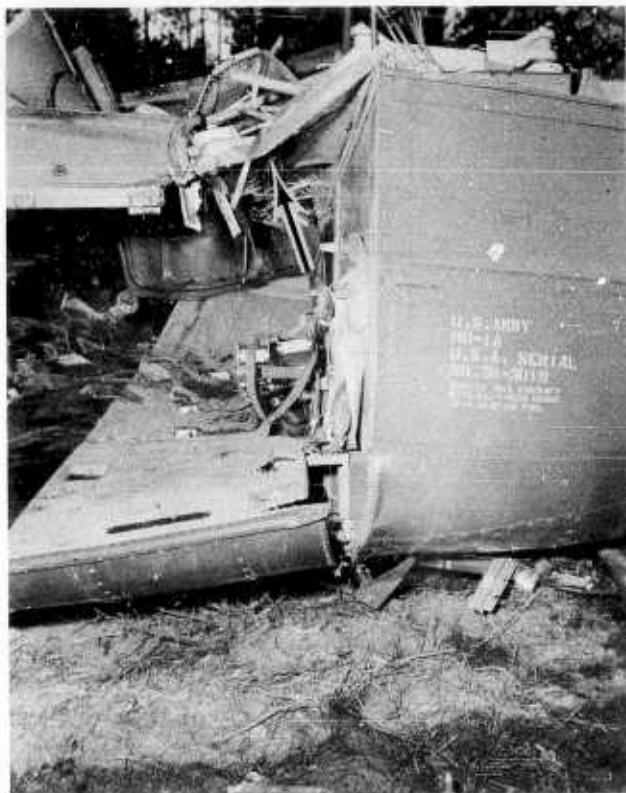
Figure 24. The forward displacement of the aft roof support is depicted by the arrow, Accident "D".

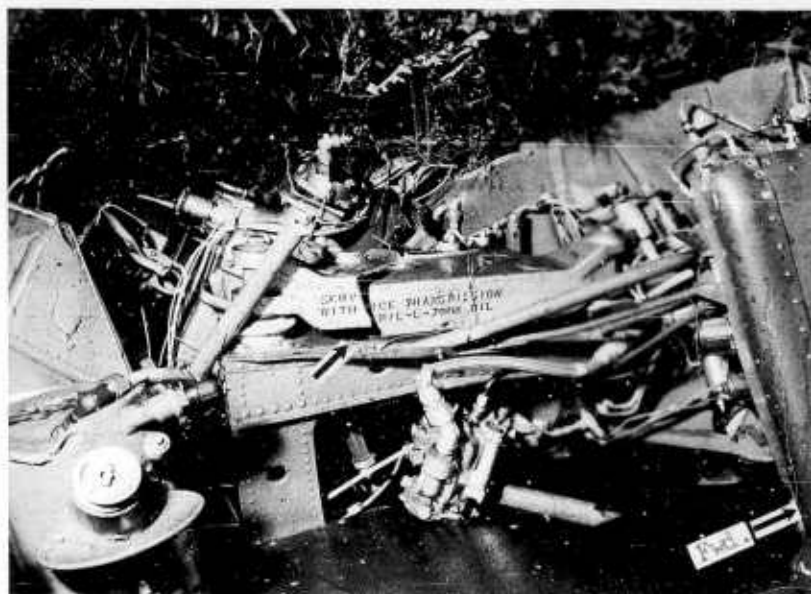
Figure 25. The arrow depicts the failure in the transmission mount which occurred in Accident "A". The transmission, mast, and rotor assembly were partially torn free as a unit.

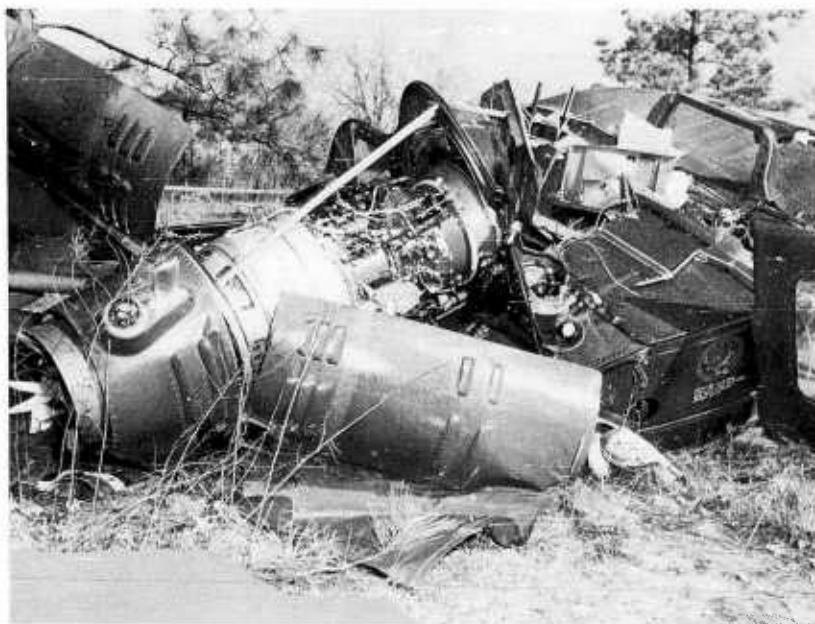
Figure 26. The entire unit was torn free when the blades contacted a tree in Accident "B". The arrow depicts the area normally occupied by the transmission.

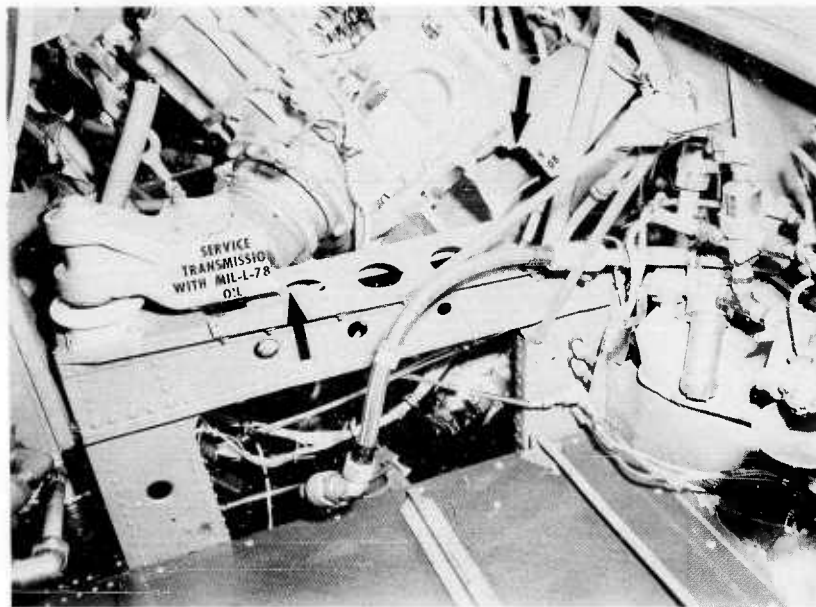
Figure 27. The arrows depict the fractures in the transmission mounts which occurred in Accident "C".

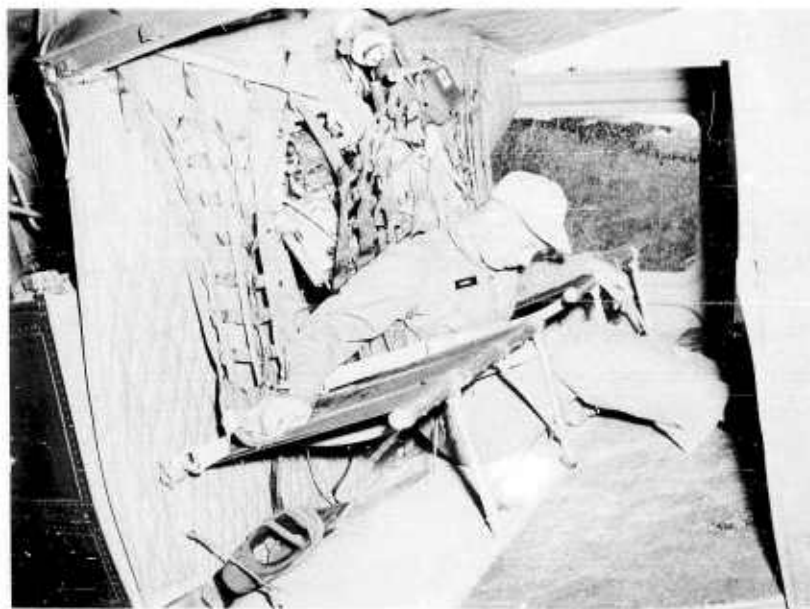
Figure 28. In Accident "C" the transmission penetrated 17 inches into the occupiable area. The loosely worn safety belt plus the failure of the seat permitted the occupant to bottom as depicted in this posed photograph.

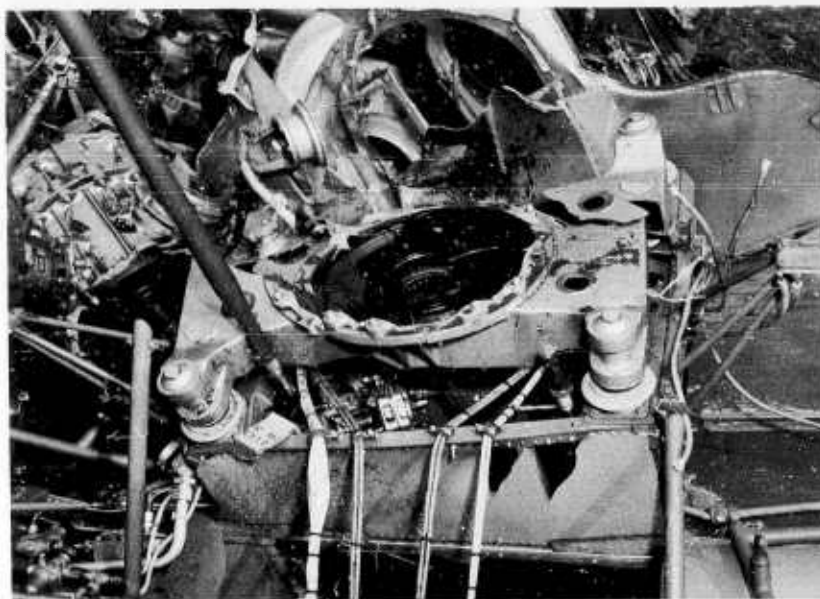
Figure 29. The entire transmission was torn free in Accident "D".

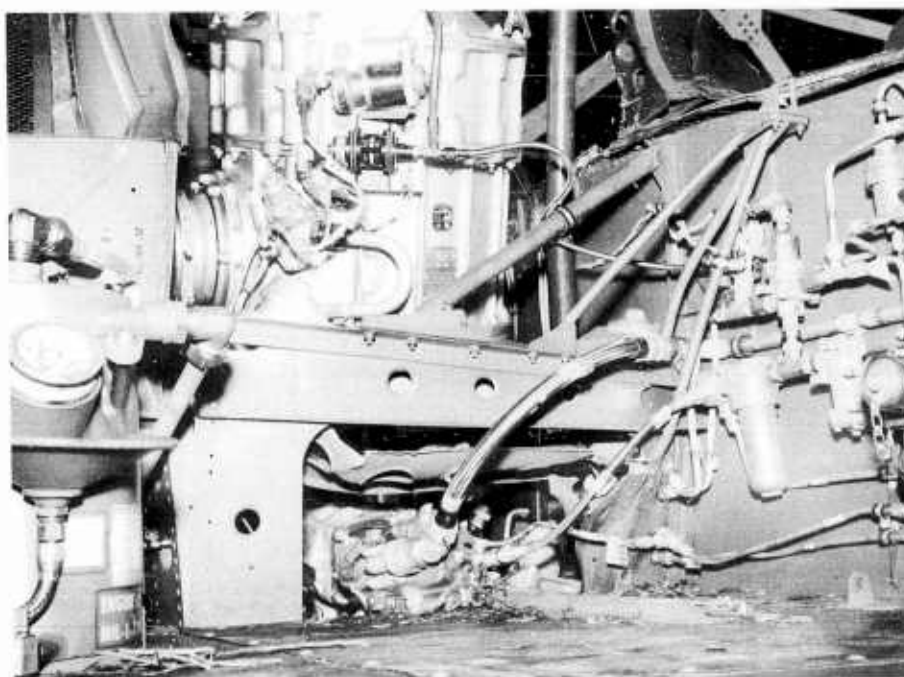
Figure 30. The transmission was displaced in Accident "E".

Considering the loads for which the transmission is stressed and the fact that a failure occurred in every accident including the YH-40 at Fort Rucker, it is believed that an inherent deficiency in structural design exists.

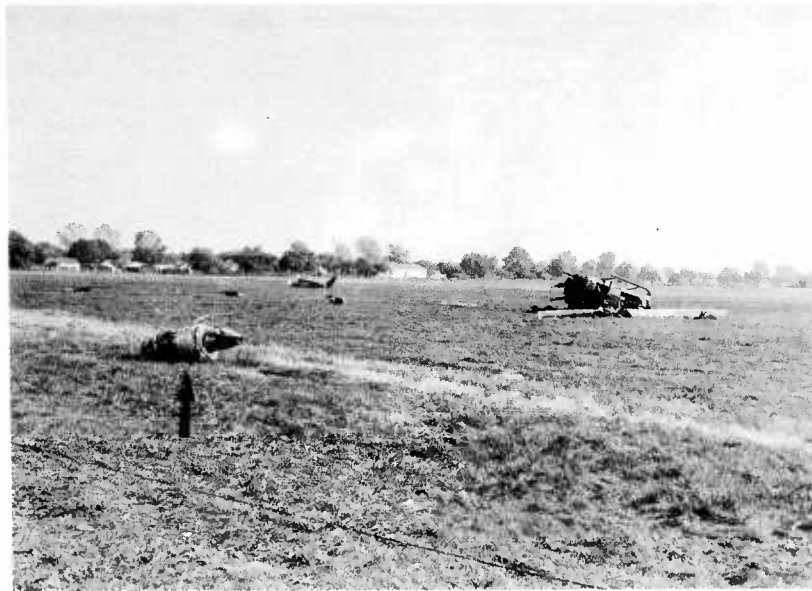
Figure 31. The arrow depicts the engine, torn free, in Accident "A".

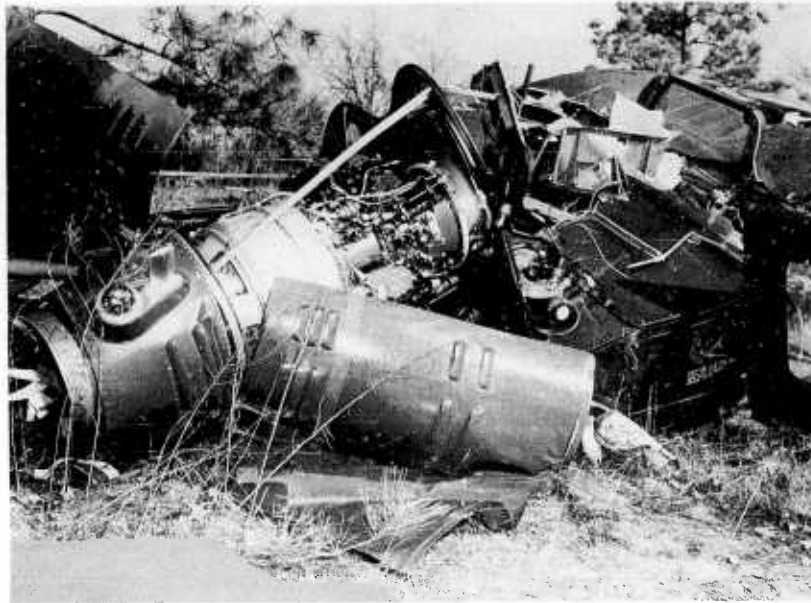
Figure 32. A partial failure in the engine mounts occurred in Accident "B".

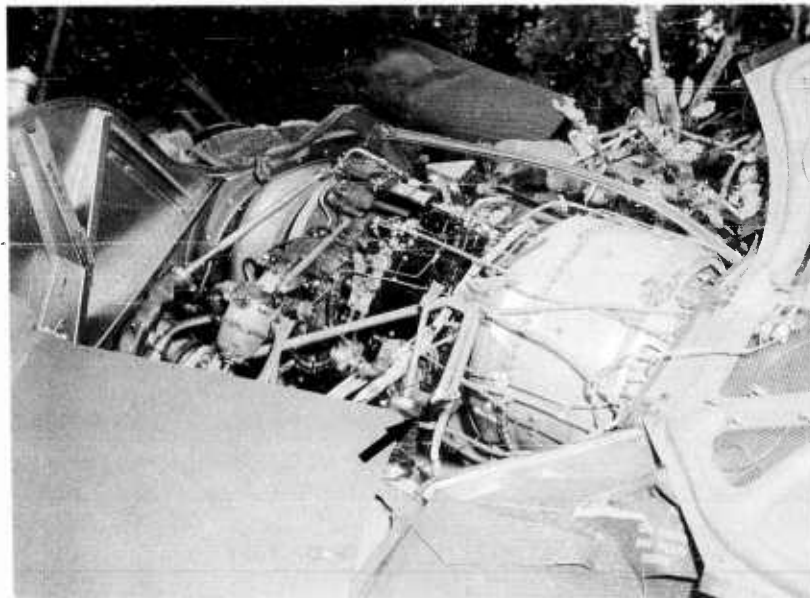
Figure 33. The arrow depicts a partial failure in the engine mounts in Accident "D".

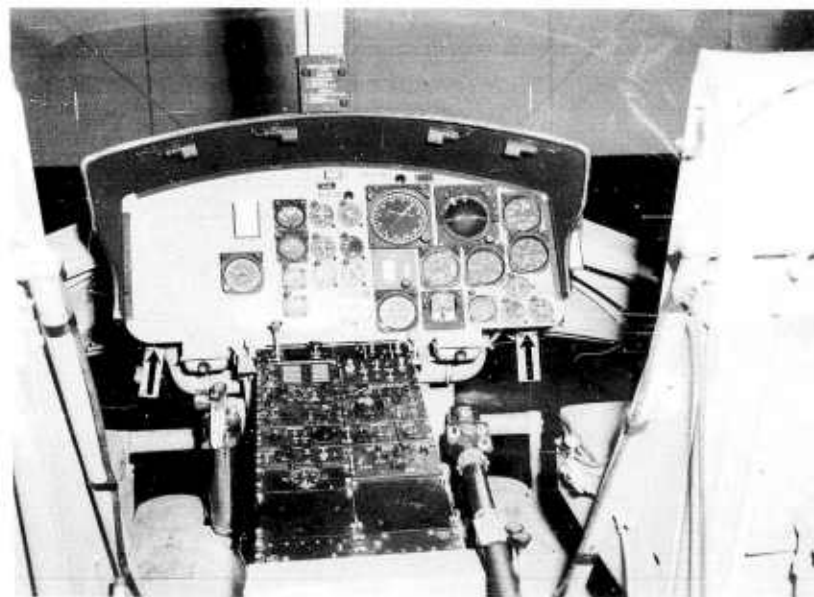
It should be noted that the lower edges of the instrument panel (Figure 34) are quite sharp and unprotected. Statistics reveal that the lower extremities receive the second largest percentage of injuries. The lower edges of the instrument panels should, therefore, be padded with a high energy absorbing material.

Figure 34. Over-all view of the instrument panel in the HU-1 and HU-1A. The arrows denote the sharp unprotected lower edges of the instrument panel.

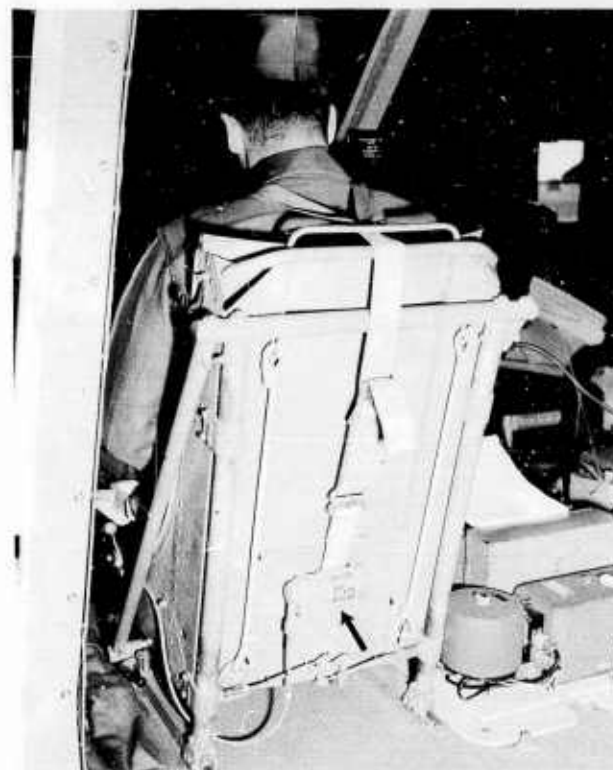
The inertia reel and shoulder harness incorporated on the pilot's and copilot's seats is shown in Figure 37. A manual lock-unlock handle is located on the left side of the seats. When the inertia reel control lever is in the unlocked position, the reel cable will extend to allow the pilot to lean forward; however, the reel will automatically lock when subjected to a 2 to 3G deceleration. Locking of the reel can be accomplished from any position and the reel will automatically take up slack in the harness. To release the lock it is necessary to lean back slightly to release tension on the lock and move the control handle to the locked and then the unlocked position. Manual locking of the reel should be accomplished for all emergency landings.

Figure 37. The arrow depicts the inertia reel attached to the rear of the seat. Note the width of the shoulder harness guide at the top of the seat. This is considered excessive.

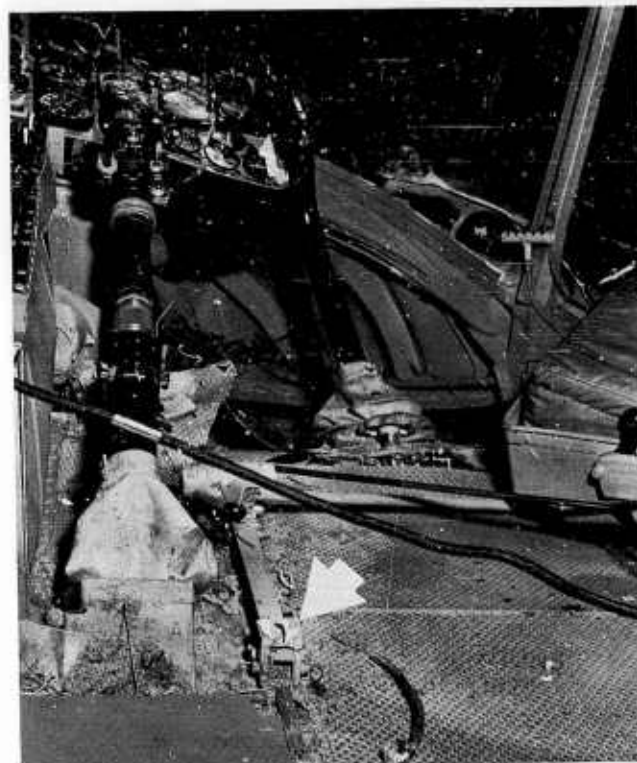
Figure 38. The pilot's seat failed in Accident "B". The arrow points out the failure which occurred at the casting.

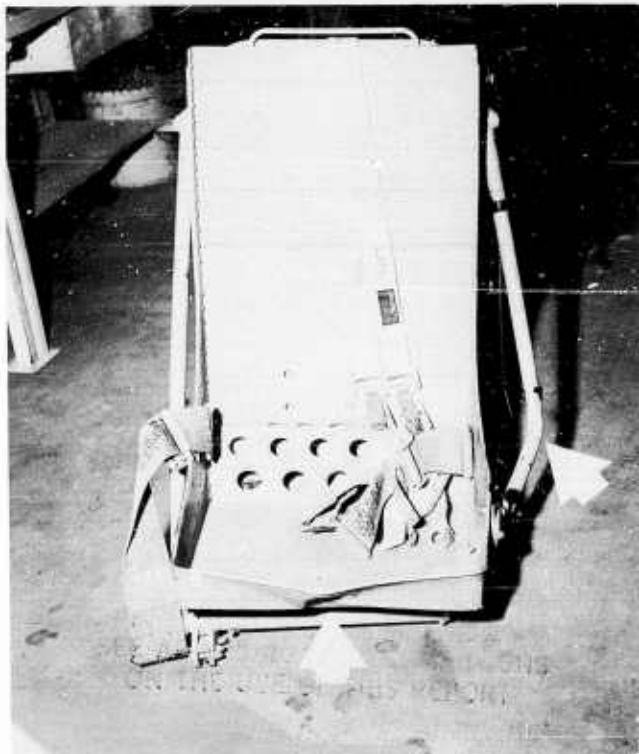
Figure 40. Damage to the pilot's seat pan in Accident "B". The bottom arrow depicts the distortion sustained by the seat pan. The side arrow points out the distortion to the seat tube, Accident "B".

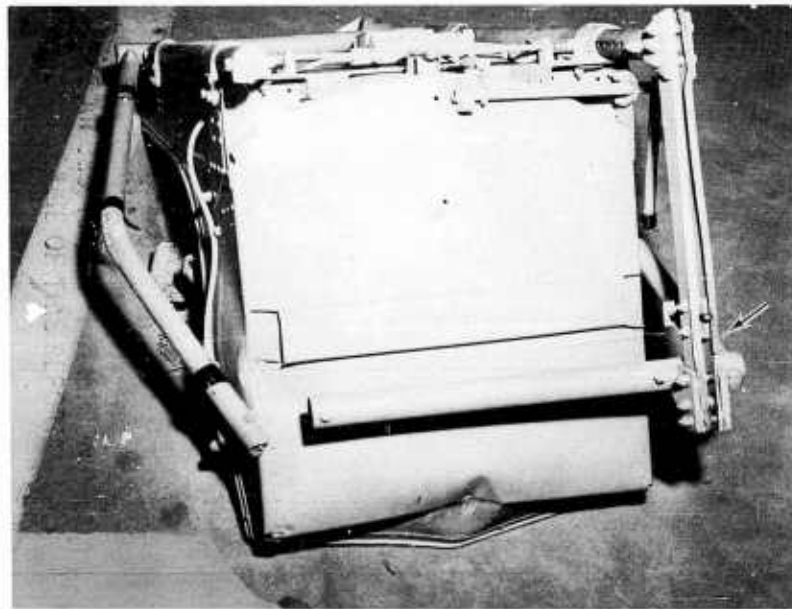
Figure 41. Seat carriage in Accident "B". The arrow depicts the spreading of the seat carriage permitting the seat to separate from the track.

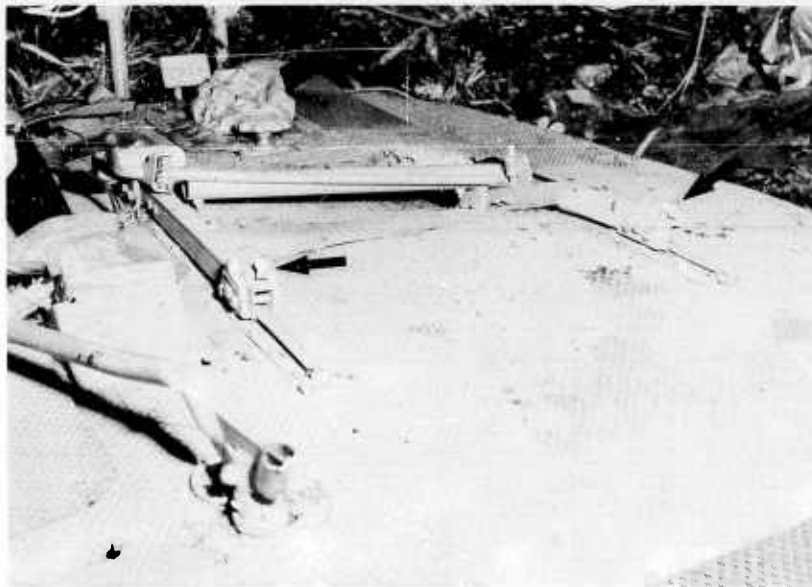
Figure 42. The arrows denote the failures in the leg castings in Accident "D" (right seat). Note the similarity in the failures in this accident with those in Accident "B".

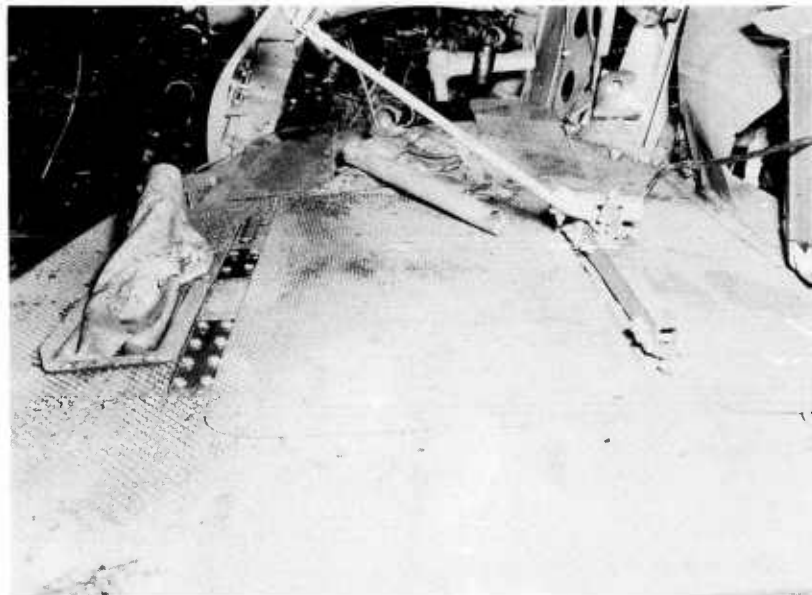
Figure 43. Left seat failure in Accident "D". The right rear leg tore free from the carriage while the left rear leg ripped the track from the floor, permitting the seat to pivot forward. The front attachments were torn free by rescue personnel.

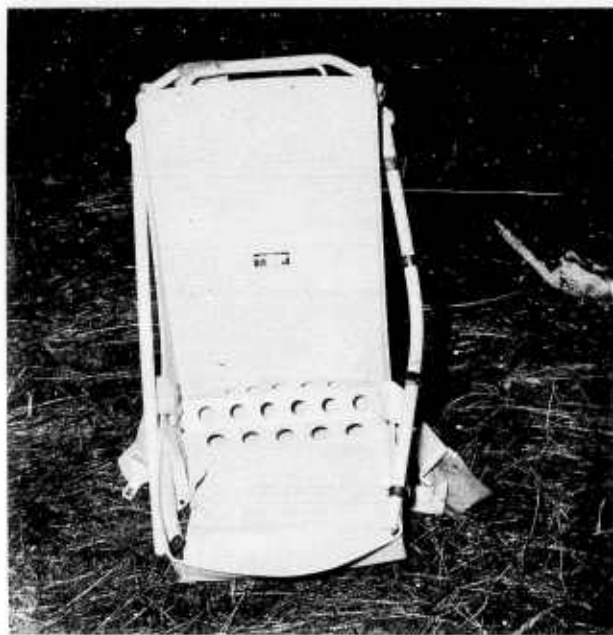
Figure 44. The pilot's seat, right side, in Accident "D". Note the similarity in the damage with the seat in Accident "B".

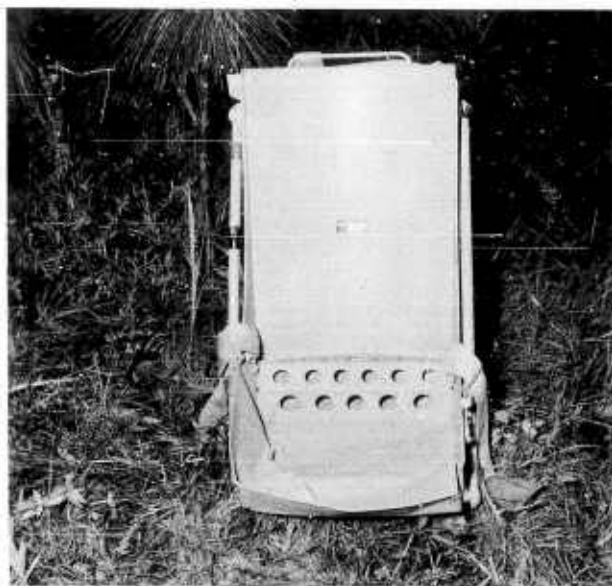
Figure 45. Damage to copilot's seat, left side, in Accident "D".

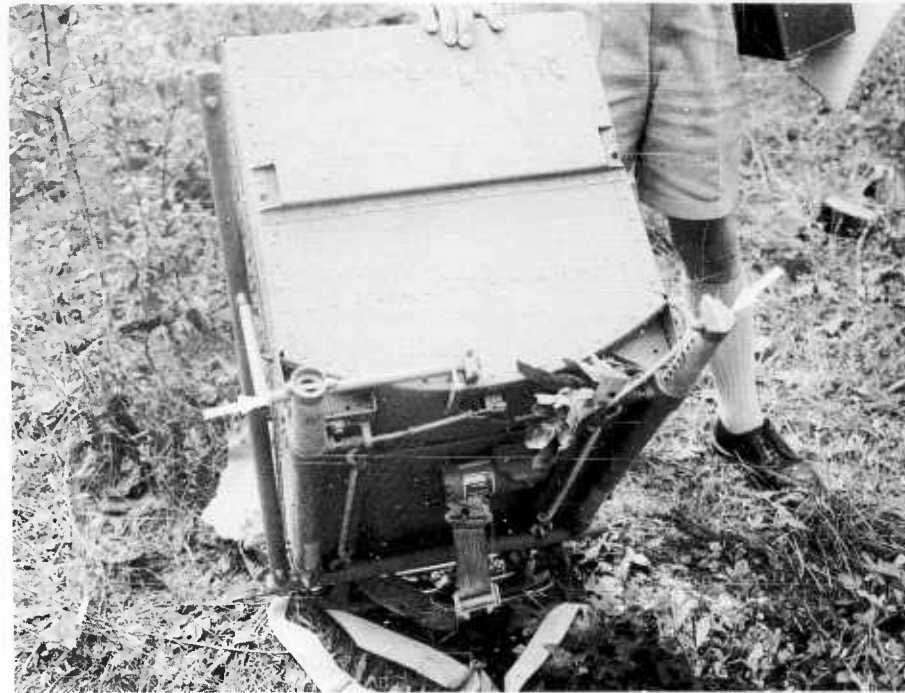
Figure 46. In Accident "E", failures occurred in the leg casting and also at a drilled point (arrows).

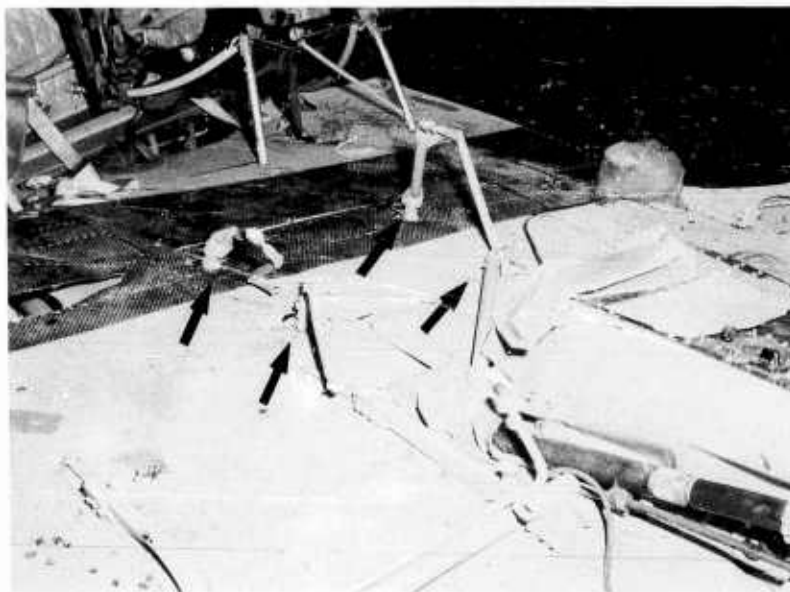
Figure 48. Crew chief seat failure in Accident "D". The arrows depict failures of the leg structure.

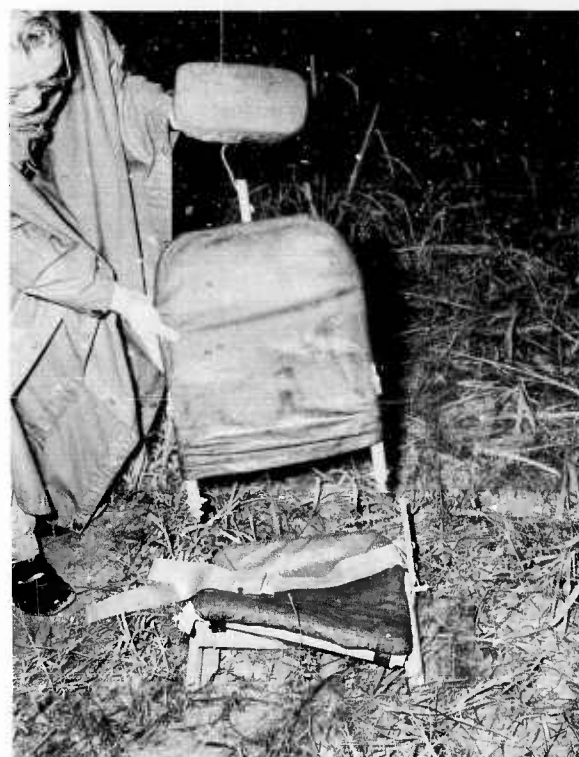
Figure 49. Damaged crew chief's seat.

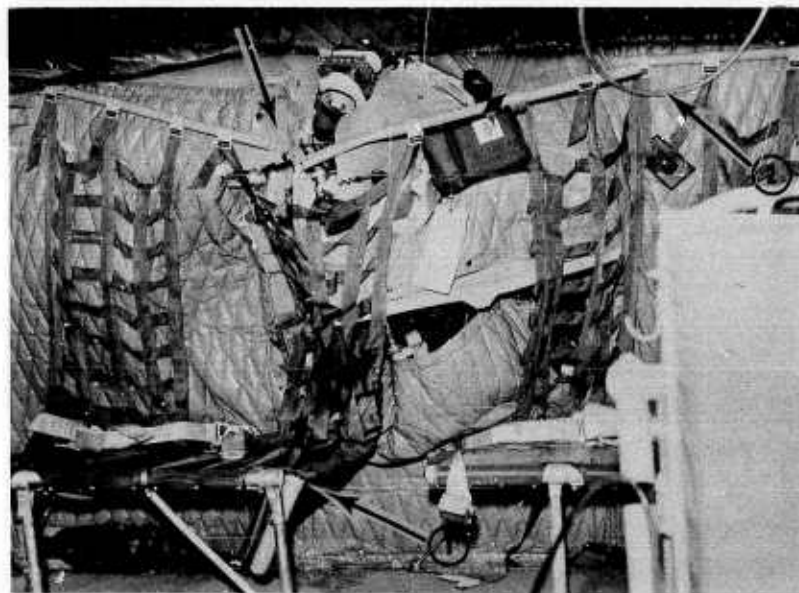
Figure 50. Cabin seat failure in Accident "C". Arrow (1) denotes the failure in the forward cross-tube. Failures also occurred in the cross-tube which supports the seat back due to the penetration of the transmission (arrows 2, 3).

Accident experience has proven that MIL-S-5804A requires revision to provide strength requirements compatible with survivable crash force magnitudes, directions, and time duration. Furthermore, the troop seat should be subjected to dynamic testing in order to obtain a more realistic appraisal. The cabin area in Accidents "A" and "B" was unoccupied; therefore, no seat failures occurred. In Accident "E" the seats were folded and replaced with a ferry tank.

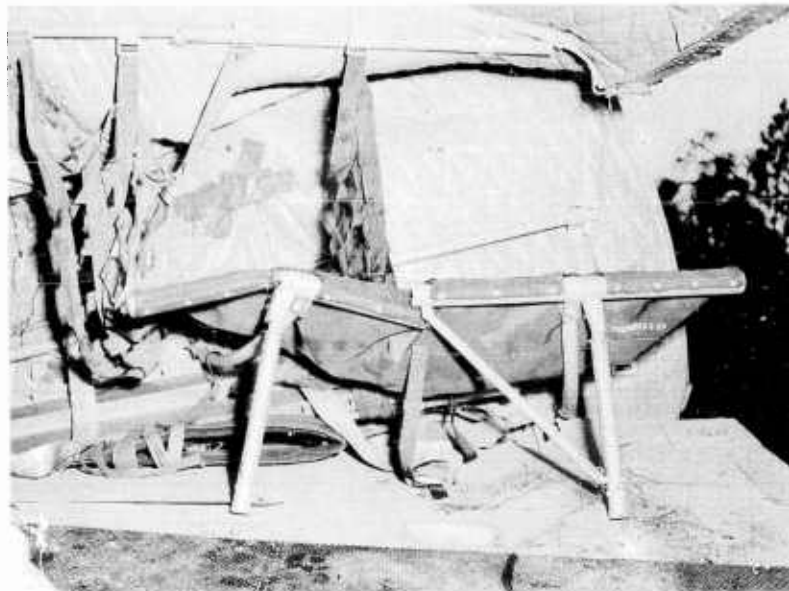
Figure 51. In Accident "D" both seats on the left side were completely collapsed and broken. The seat was set up for photographic purposes.

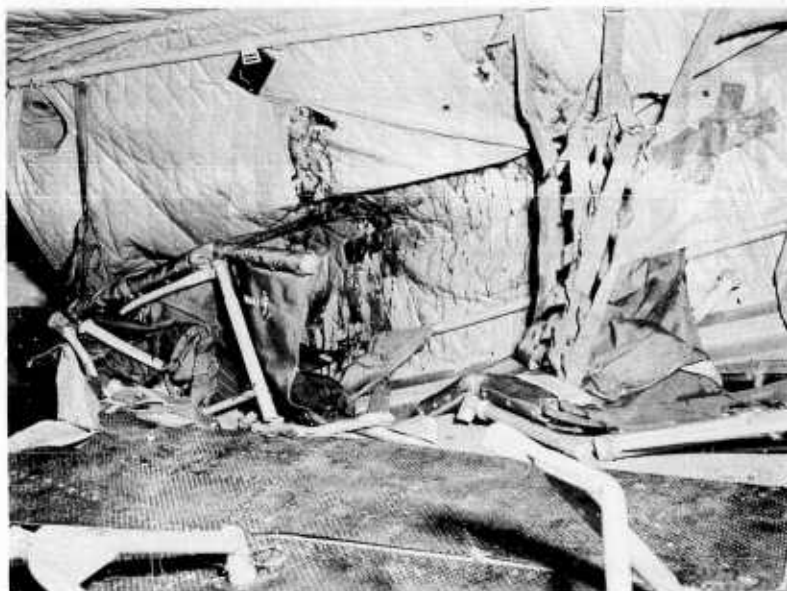
Figure 52. The right side cabin seats in Accident "D" were broken.
