CRASH INJURY EVALUATION

SUMMARY EVALUATION

FLIGHT SAFETY FOUNDATION, Inc.

AVIATION CRASH INJURY RESEARCH
A Division of Flight Safety Foundation, Inc.
2871 Sky Harbor Blvd., Phoenix, Arizona

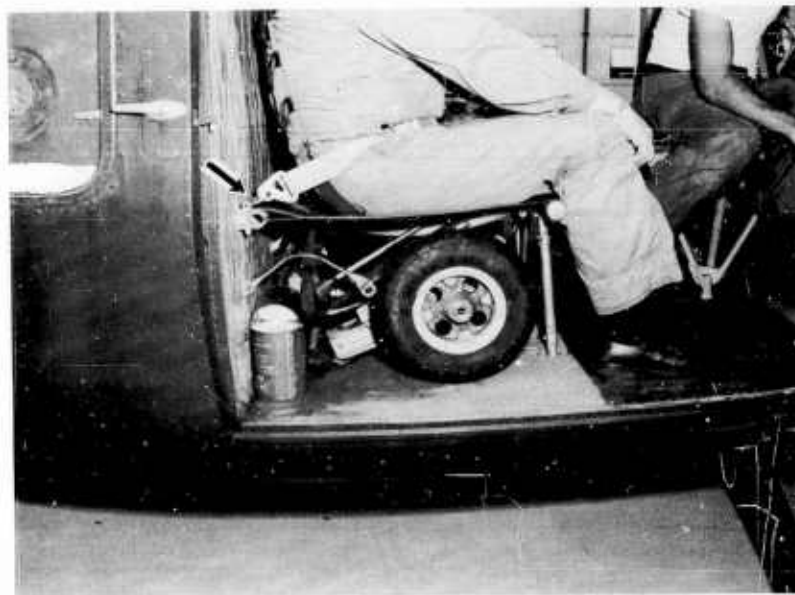
The incorrect belt installation also permits the seat belt to "ride up" and could cause rib and/or chest injuries due to flexing over the belt buckle, in addition to possible spinal injuries.

Figure 53. The incorrect method of attaching the safety belt to the "O" ring is depicted by the arrow. Note that the belt crosses the occupant at approximately 90°.

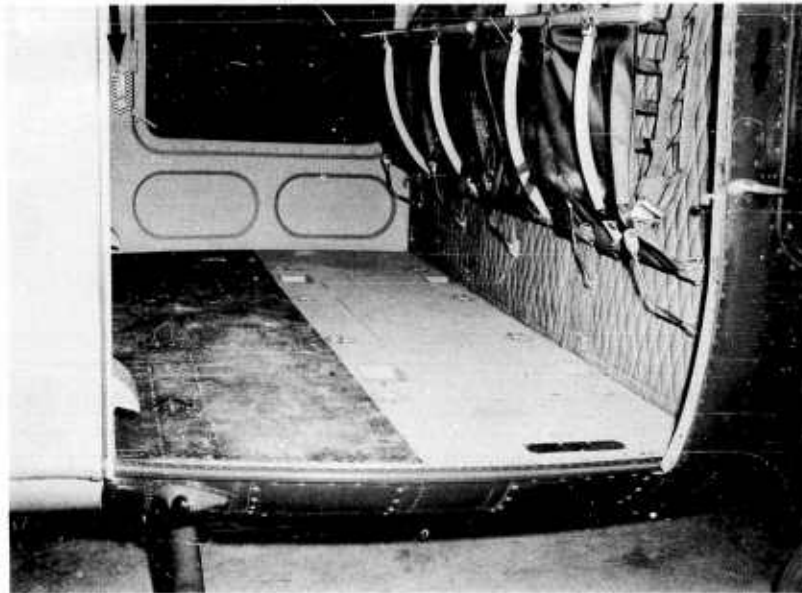
Figure 56. Absence of exterior door operating instructions. The arrow on the left depicts the interior operating instructions. The arrow on the right denotes the absence of exterior door operating instructions.
