U.S. COAST GUARD

REPORT NO. 407

CORROSION TEST OF GASOLINE SAFETY CANS

Date: 12 FEB 1965

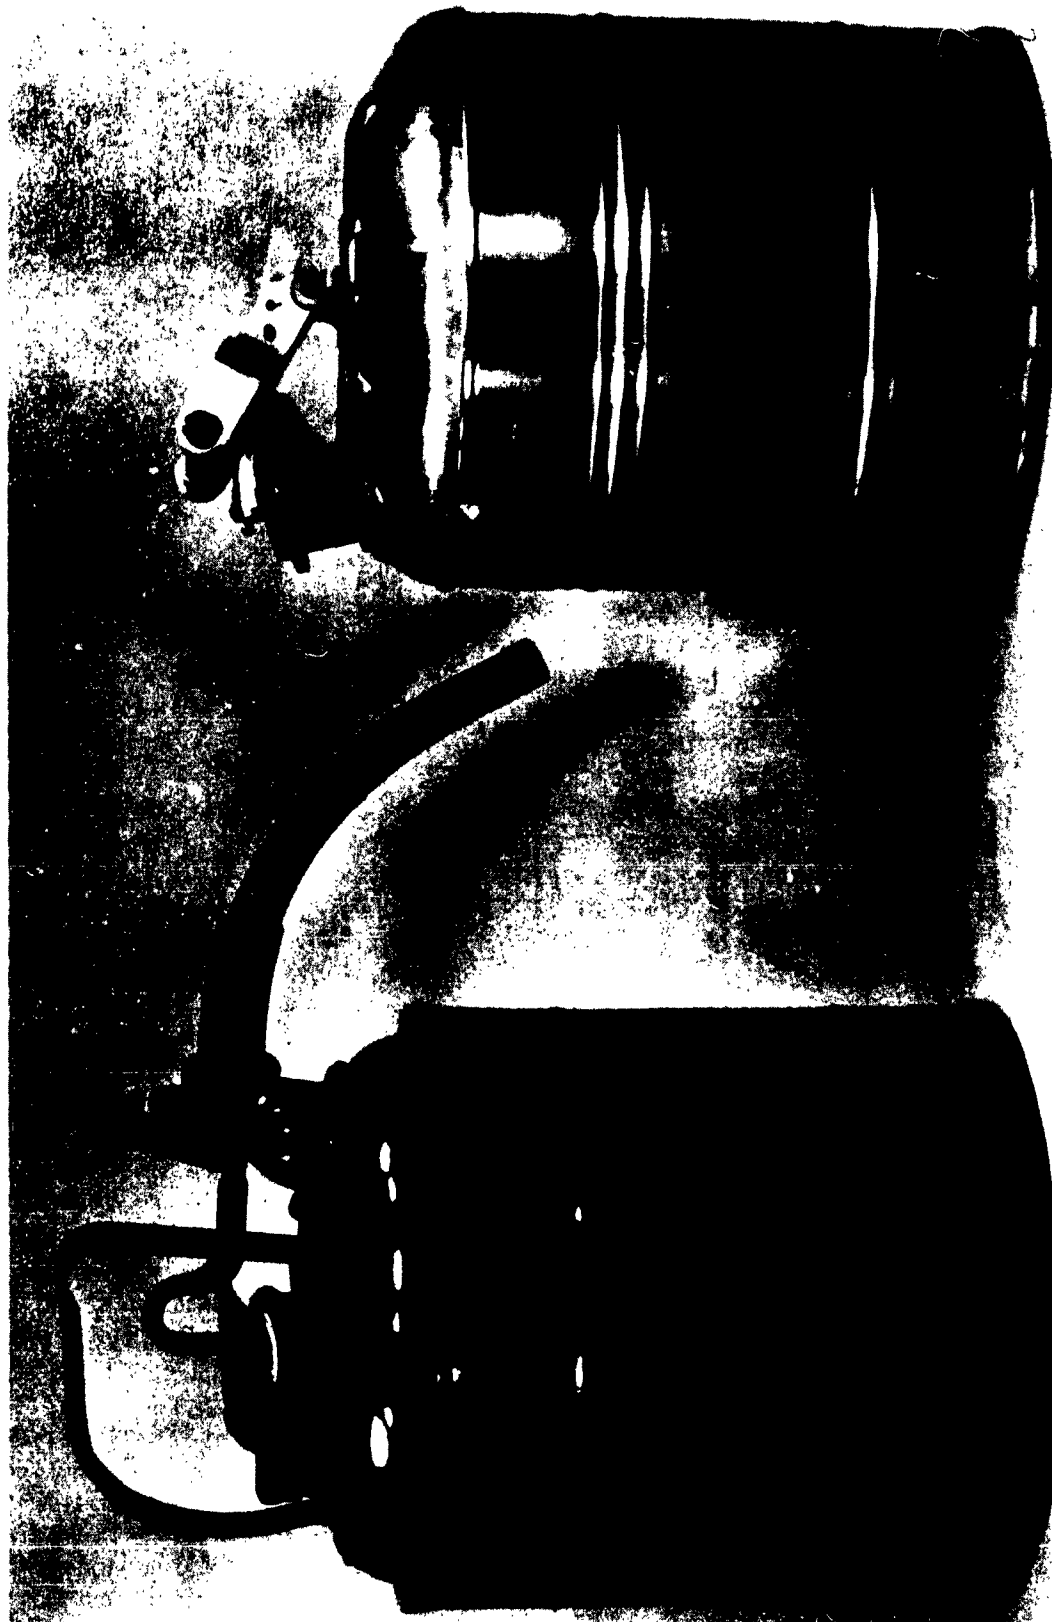
FIGURE 2

CAN D - This is a 5-gallon safety can manufactured by Protectoseal Company, Chicago, Illinois. This is a hot tin dipped can described as having one coat of gasoline resistant red enamel over one coat of zinc chromate primer. There are two top openings, one fill and one pour - both spring loaded and gasketed. This can is fitted with a brass flexible spout and brass fire baffle. The body of the can is rolled with a vertical welded seam and circumferential welded seam at the top. The bottom section is recessed, flanged down and rolled up with body. A heavy gauge supporting ring is spot soldered to the bottom of the can. The UL label is soldered on and the FM diamond is embossed. This can was forwarded to FT&DC from Coast Guard Headquarters and its cost is unknown. Can D is shown on the left in Figure 2.

CAN E - This can was procured from the Just-Rite Manufacturing Company, Chicago, Illinois. It is a 5-gallon safety can with body of non-magnetic stainless steel. The can body is rolled up with a vertical seam and circumferential seams at top and bottom, all soldered on the outside. The single fill and pour spout, the base support ring and handle are of steel, not stainless. There is no paint or other finish applied to this can. The UL label is soldered on and the FM diamond is embossed. The cost of this can was \$27.72. The spout is fitted with a fine mesh woven wire screen, non removable, which appears to be made from stainless steel wire. This screen extends into the can body approximately three inches. This can is shown on the right in Figure 2.

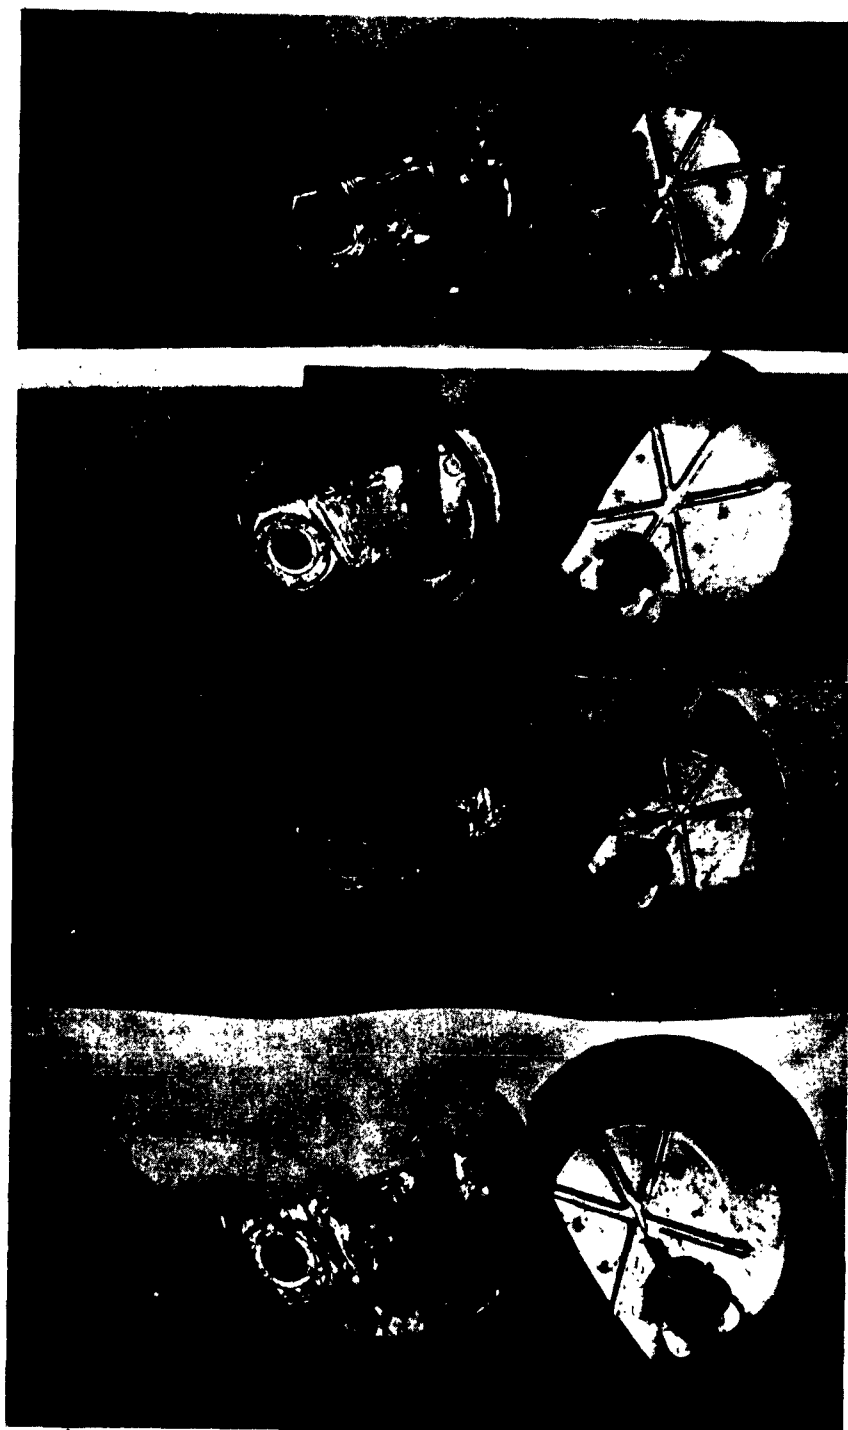
CAN D - Extensive corrosion at seams and cut edges. Working parts are now inoperable and coated with white deposit. Green corrosion products on brass and copper parts. Exterior paint remains unbroken and glossy.

CAN E - Handle, pour spout, spring, base ring all badly rusted. White corrosion product on exterior seams. Interior shows slight stain in a few places.

FIGURE B-1 - Showing progressive corrosion during test period -  
Cans D and E.

top - before exposure  
2nd from top - after 24 hours  
3rd from top - after 138 hours  
bottom - after 240 hours
