OCTOBER 1964

# QUARTERLY TECHNICAL PROGRESS REPORT No. 1

XV-5A LIFT FAN  
FLIGHT RESEARCH AIRCRAFT.

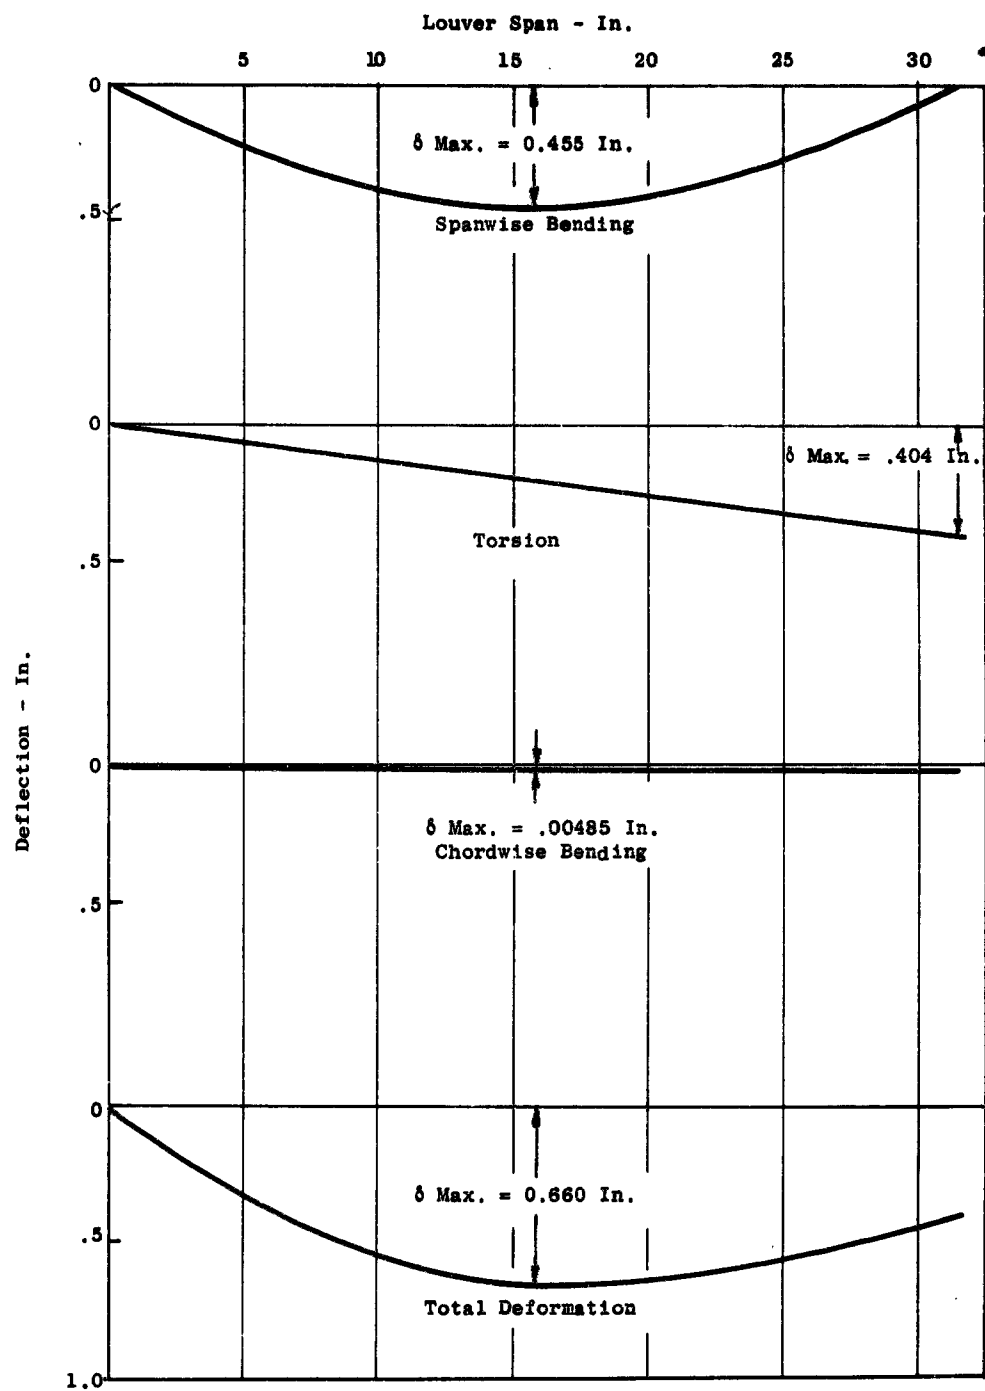
Figure 1. XV-5A Unmodified No. 20 Exit Louver Deformation at 20° Stagger Angle 100% Fan Speed.

During the portion of the ground testing when the push rods were firmly held by the load links, significant deflections were observed in the aluminum louvers. Tests to measure these deflections show that for a stagger angle of  $39^\circ$  and 100% fan speed, the angle of twist of the louver is  $5.3^\circ$  and at a vector angle of  $13^\circ$  the untwist is less than  $1^\circ$ . Although these deflections are not detrimental to the structural integrity of the louvers nor do they affect the roll acceleration obtained during flightworthiness testing, their reduction or elimination would increase thrust control effectiveness to either add a margin of control reserve or compensate for deficiencies elsewhere in the control system.

As a result of mechanical and aerodynamic analysis (results as per Figure 1), it was decided that the best way to modify the louvers would be to increase the effective skin thickness by putting another skin over the outside. Accordingly, the bow and twist would be reduced by more than half of the previous values. The method used was to take a formed outer skin of the same stock thickness and material as the louver and adhesively bond and rivet it to the louvers.

By using the same material and thickness, the existing louver skin dies could be utilized, saving both time and expense. Although an exact fit was not obtained between the contact surfaces of the louver and outer shell, it was sufficiently close to obtain a satisfactory bond. Both surfaces were chemically cleaned to remove any contaminants and pre-heated to 150°F prior to the application of resin.

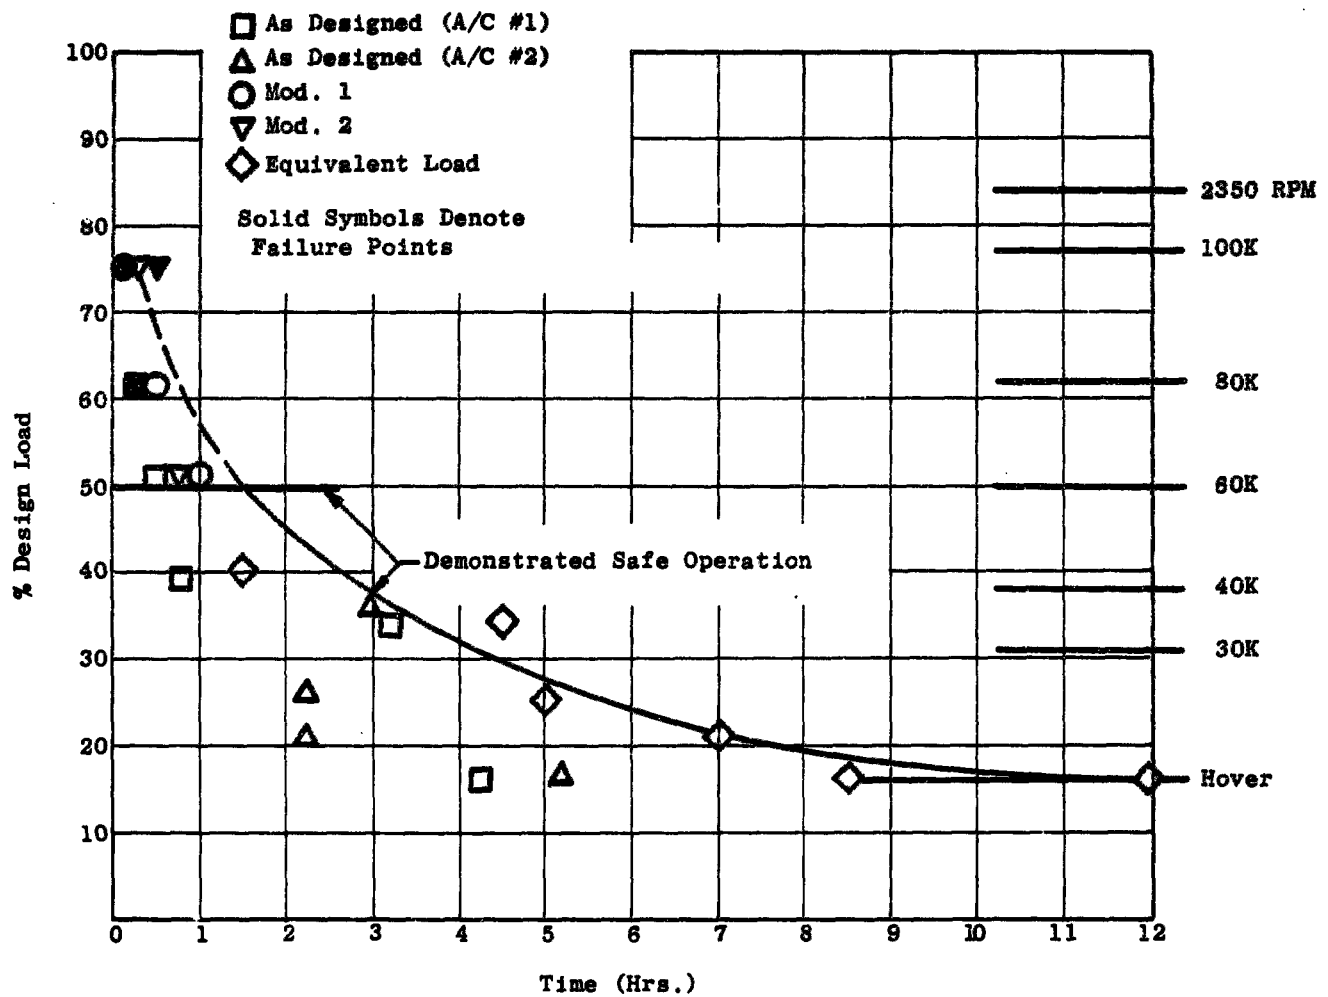
Figure 4. Safe Operational Limit - Inlet Vanes.

The vane operation performance in the wind tunnel was analyzed to establish a safe flight test limit (Figure 3). All the combinations of fan speed and tunnel velocity were analytically reduced to a per cent of design load basis and plotted against time of no failure operation (Figure 4). It was concluded that the aircraft could fly to 60 knots in the VTOL mode without the incidence of vane failure.

There was no attempt during the tunnel test program to conduct sustained continuous loading for significant times. Consequently, the load-life analysis is not a measure of maximum vane capacity as the data are based on conditions accumulated as a result of the wind tunnel test schedule. It can be noted that the only significant time accumulation occurred on the original, as-designed vanes, and the improvements realized as a result of Modifications I and II changes are used only as a safety factor to assure a safe flight test program with the 60 knots flight speed limit.
