**XC-142A  
V/STOL TRANSPORT  
TRI-SERVICE  
LIMITED CATEGORY I  
EVALUATION**

**TECHNICAL REPORT No. 65-27  
JANUARY 1966**

**AIR FORCE FLIGHT TEST CENTER  
EDWARDS AIR FORCE BASE, CALIFORNIA  
AIR FORCE SYSTEMS COMMAND  
UNITED STATES AIR FORCE**

FTC-TR-65-27

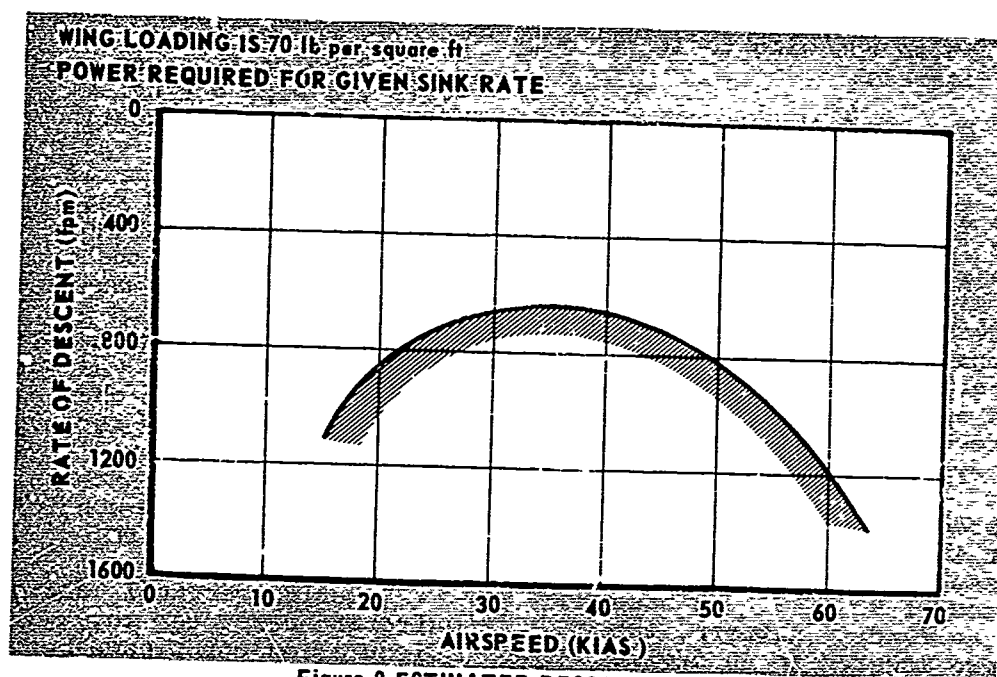
Figure 2 ESTIMATED DESCENT BOUNDARY

Descent boundary investigations were performed by the contractor to verify the predicted buffet onset speeds and maximum sink rates. Buffet onset speeds and maximum sink rates were demonstrated during military crew checkouts. Buffet onset and buildup characteristics were similar for all configurations observed. Buffet onset was very light but distinct. It intensified as the sink rate was increased by power reduction. The maximum sink rate was defined by moderate airframe buffet and a slight decrease in stability and controllability, primarily about the lateral axis.

The buffet onset speeds agreed closely with predictions, and the region of light buffet at higher sink rates was more than sufficient for pilot warning. This buffet region is discussed in greater

detail in the Stall Approaches section. The predicted descent boundary is shown in figure 2,

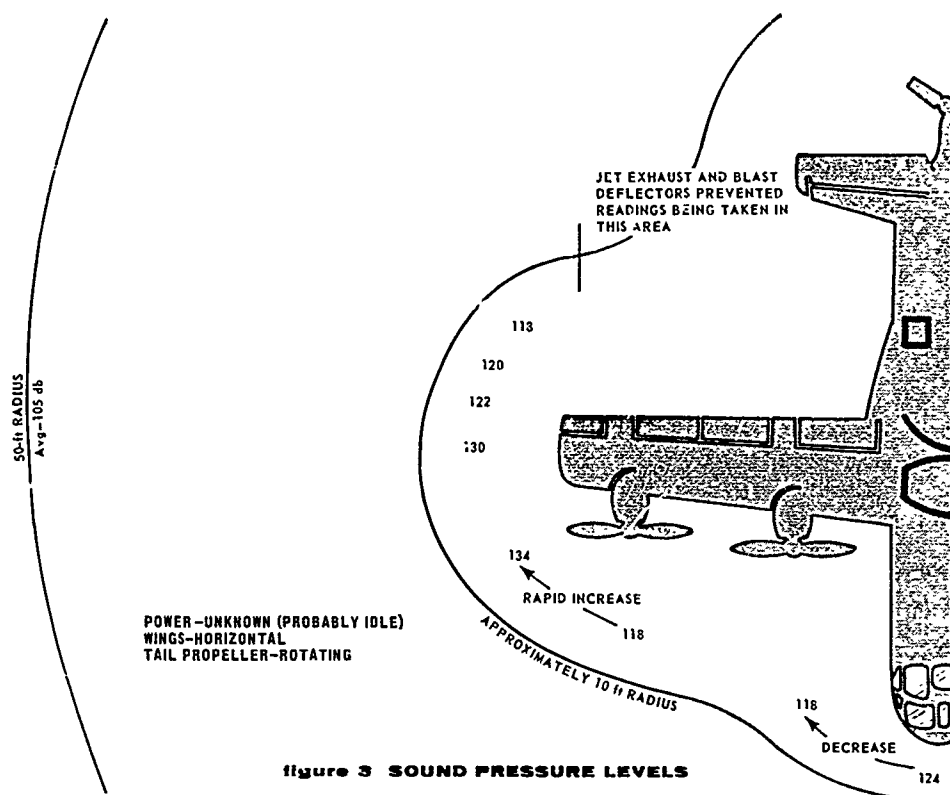
figure 3 SOUND PRESSURE LEVELS

Sound levels were measured adjacent to the runway during the STOL tests. During these tests the wind speeds were 2 to 3 knots. The results are shown in table XIV. The data are not definitive due to a large amount of scatter. The noises were high and could present a problem in an occupied area.

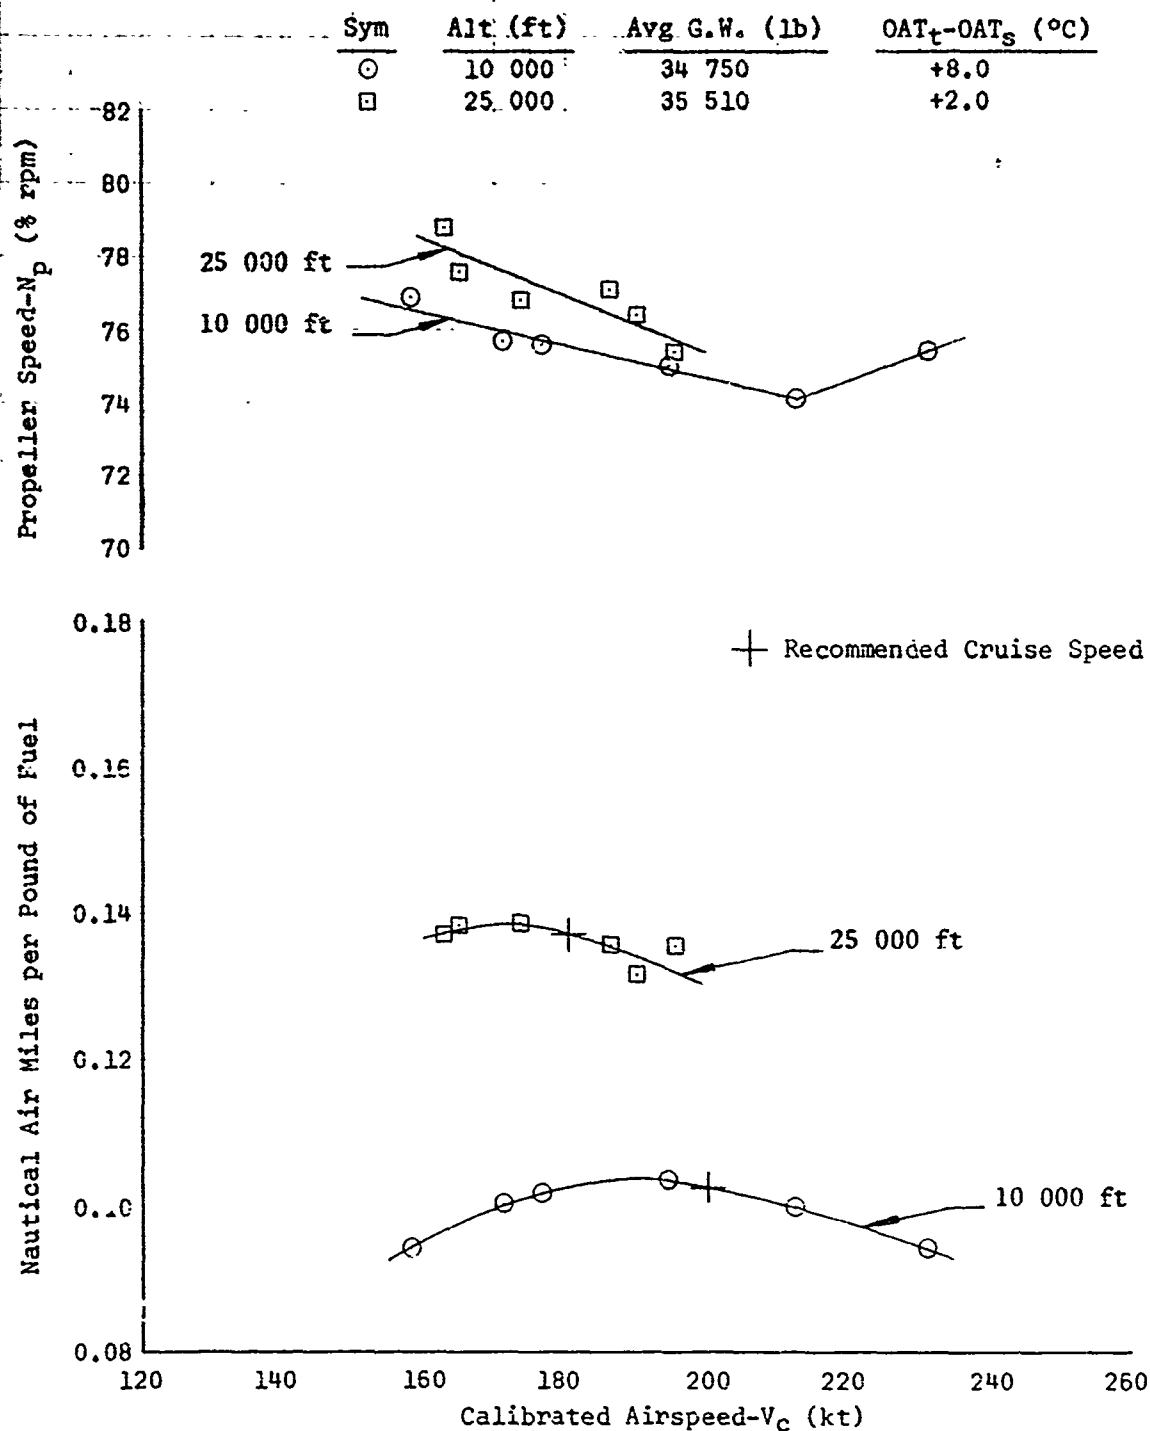
Figure 9. Specific Range

The 4-engine cruise data were obtained simultaneously with the airspeed calibration at 10 000 and 25 000 feet altitude. There were no 4-engine cruise data in the Flight Manual for comparison to the test data since the recommended cruise was with two engines operating. The 4-engine data were obtained mainly for comparison with the 2-engine data. The highest recommended 4-engine cruise speed was 265 KTAS at 25 000 feet.

ating and at the recommended 4-engine cruise speed the specific range was 17 percent less. At high altitude, the comparison was made with 4-engine data at 25 000 feet (the operational ceiling) and 2-engine data at 20 000 feet. The 4-engine best cruise speed of 254 KTAS was 17.5 percent higher than the best 2-engine cruise speed but the specific range was 9 percent lower. The 4-engine cruise performance is presented in figure 9, appendix I.

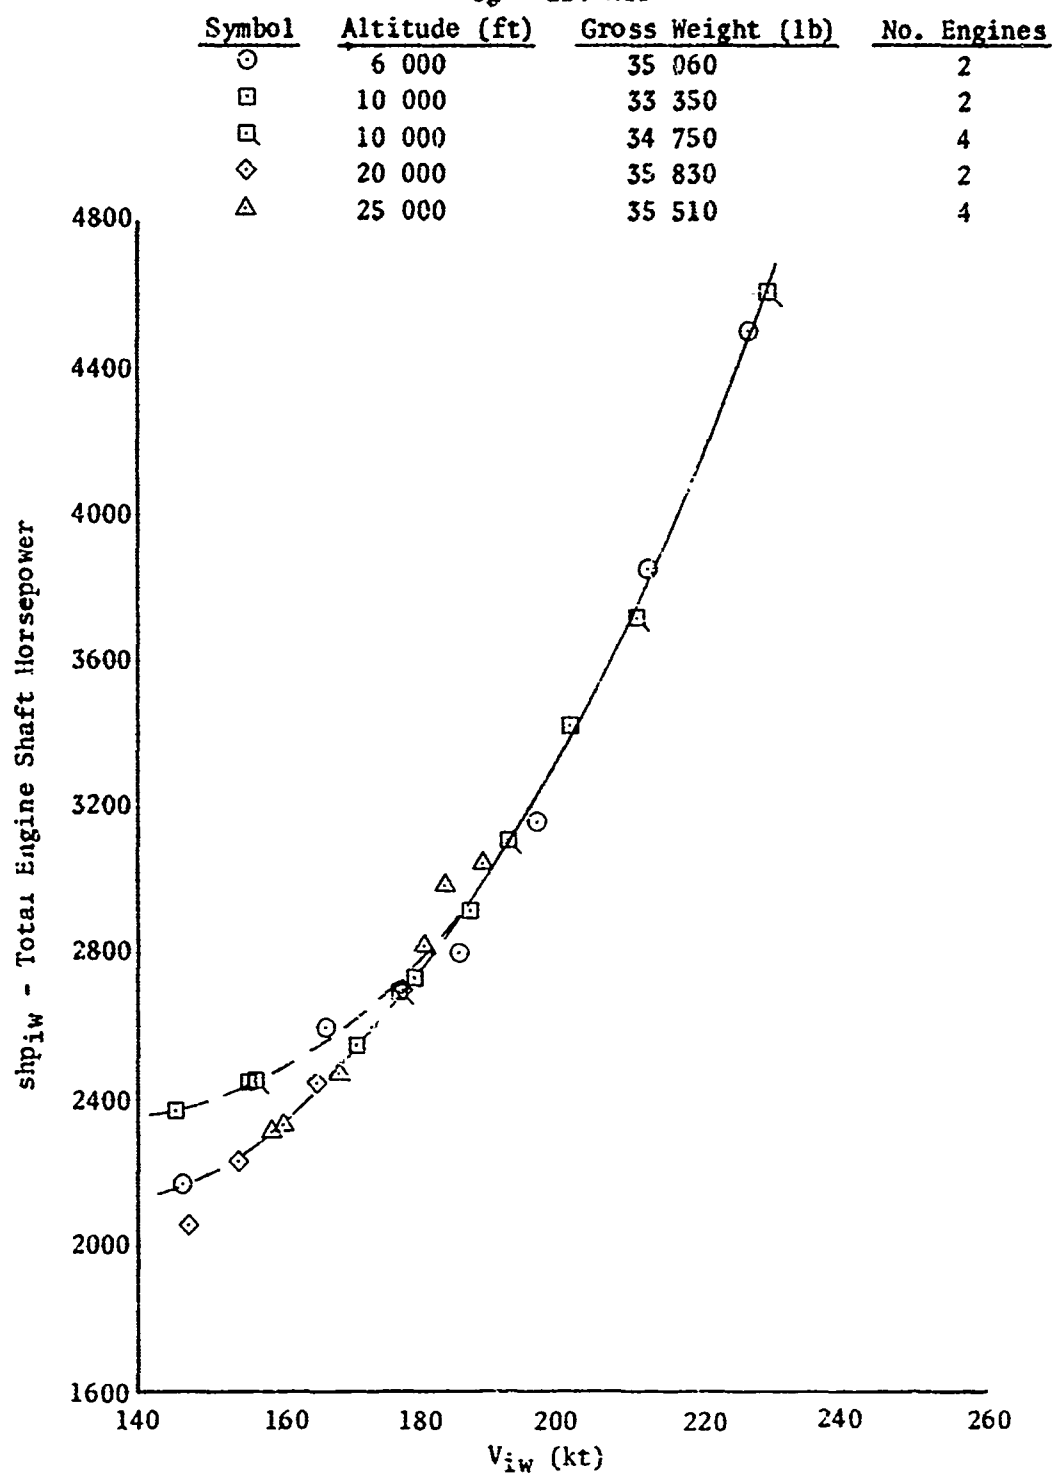
Figure 10.  $shp_{iw}$  vs  $V_{iw}$

A plot of  $shp_{iw}$  versus  $V_{iw}$  is shown in figure 10, appendix I. It shows no noticeable difference in total power required between 2- and 4-engine cruise at the same conditions. This plot shows some characteristics at low speed that cannot be explained or verified with the limited data available.
