# ARMY AVIATION SAFETY

- CRASH INJURY
- CRASHWORTHINESS

Final Report  
U. S. ARMY  
TRECOM Contract  
DA 44 177 TC 624  
TREC Technical Report  
60 77  
AvCIR 70 0 128  
30 December 1960

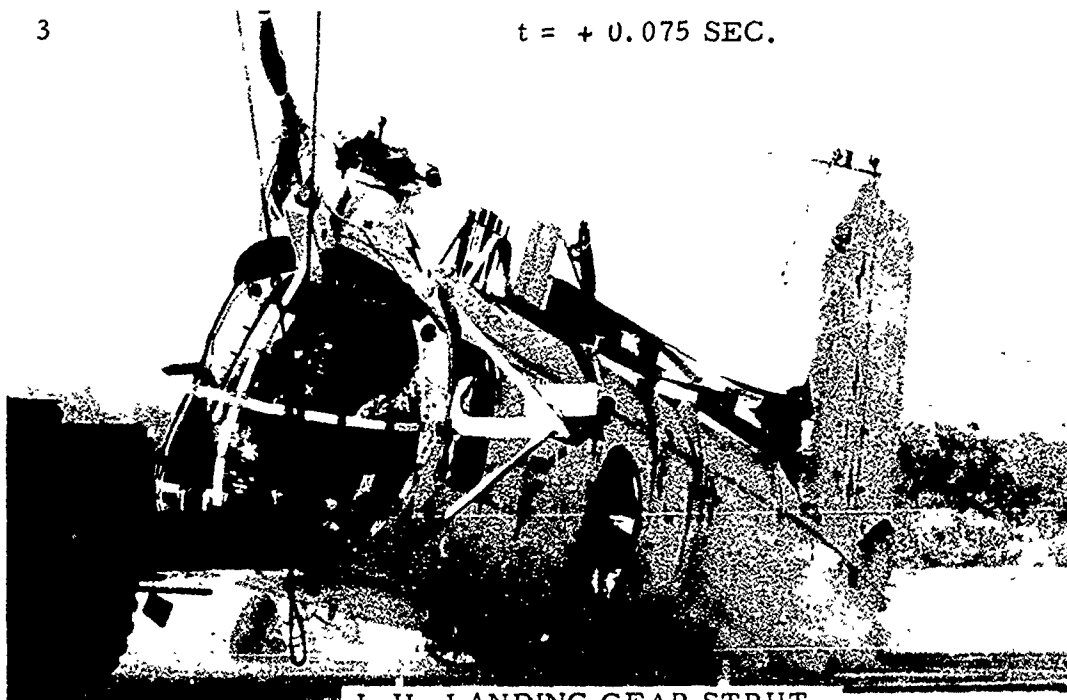
L. H. LANDING GEAR STRUT  
PUSHES THROUGH FUSELAGE
