INFORMAL  
MANUSCRIPT  
REPORT  
NO. O-55-65

MARINE FOULING AND CORROSION OF  
INSTRUMENTATION AT ARGUS ISLAND

C. F. BECKNER, JR.  
OCEANOGRAPHIC PREDICTION DIVISION

JANUARY 1966

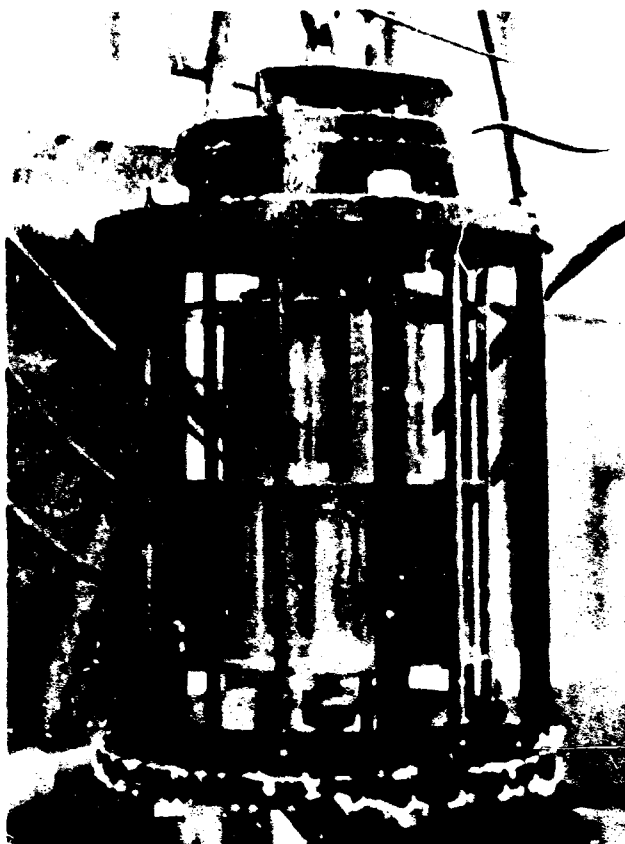
FIGURE 1b. SAVONIUS ROTOR PLACED AT 45-FOOT DEPTH, 30 JUNE - 7 AUGUST 1964

A Savonius rotor was placed at a depth of 45 feet between 30 June and 7 August 1964, and three Roberts meters were placed at depths of 15, 75, and 135 feet. The top and bottom structural plates of the Savonius rotor contained evidence of salt deposits (figure 1b); however, the deposits were not as heavy as those on the rotor placed at 165 feet. The sensor was free of goose barnacles; very little algae were present. The Roberts meters showed no evidence of fouling or corrosion.

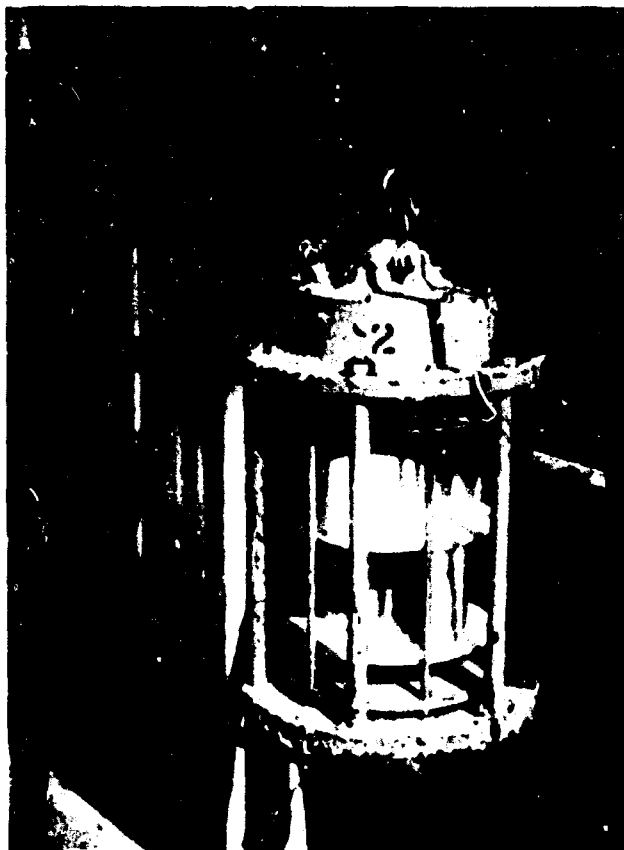
FIGURE 1c. SAVONIUS ROTOR PLACED AT 85-FOOT DEPTH, 24 AUGUST - 25 SEPTEMBER 1964

On 24 August 1964, a Savonius rotor was installed at a depth of 85 feet. Recovered on 25 September, this rotor showed fairly heavy deposits of salt, serious pitting around the edges of the top and bottom structural plates, and very few goose barnacles (figure 1c). A thin layer of algae covered the metallic surfaces, but the plastic rotor was completely free of fouling.

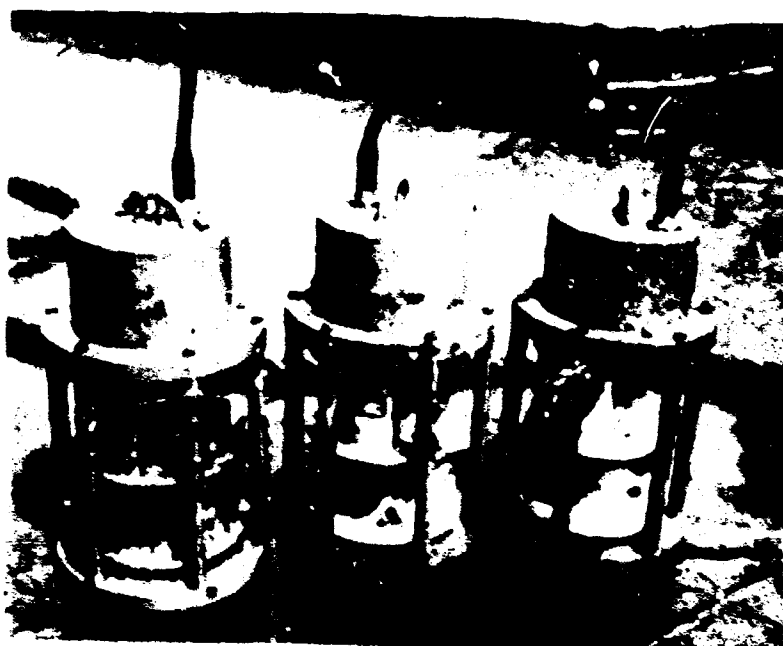
Fouling consisted primarily of goose barnacles and green algae, the latter being predominant. Algal growth, which appeared to increase rapidly with depth, was of sufficient severity on the Savonius rotor located at 137 feet to effect a calibration change. A large barnacle was attached to the rotor of the meter at the 55-foot depth. This barnacle was large enough to cause sufficient drag to interfere with accurate data measurements. The Hytech current direction finders were heavily covered with algae and numerous goose barnacles. Algal growth was greater on the plastic vanes than it was on the metallic cases. Barnacles and algae on the vanes of the direction finder located at 91 feet rendered it incapable of responding to changes in current direction after several weeks of operation.

FIGURE 4. SAVONIUS ROTORS PLACED AT DEPTHS OF 137, 96, AND 55 FEET  
17 AUGUST - 14 OCTOBER 1964
