U. S. NAVAL AIR TEST FACILITY (SI)

Report NATF-EN-1086

DEVELOPMENT AND EVALUATION
OF THE
TC13 MOD 1 STEAM CATAPULT
(30 Jan 1964 to 19 Oct 1965)

Periodic Report No. 1
22 March 1966

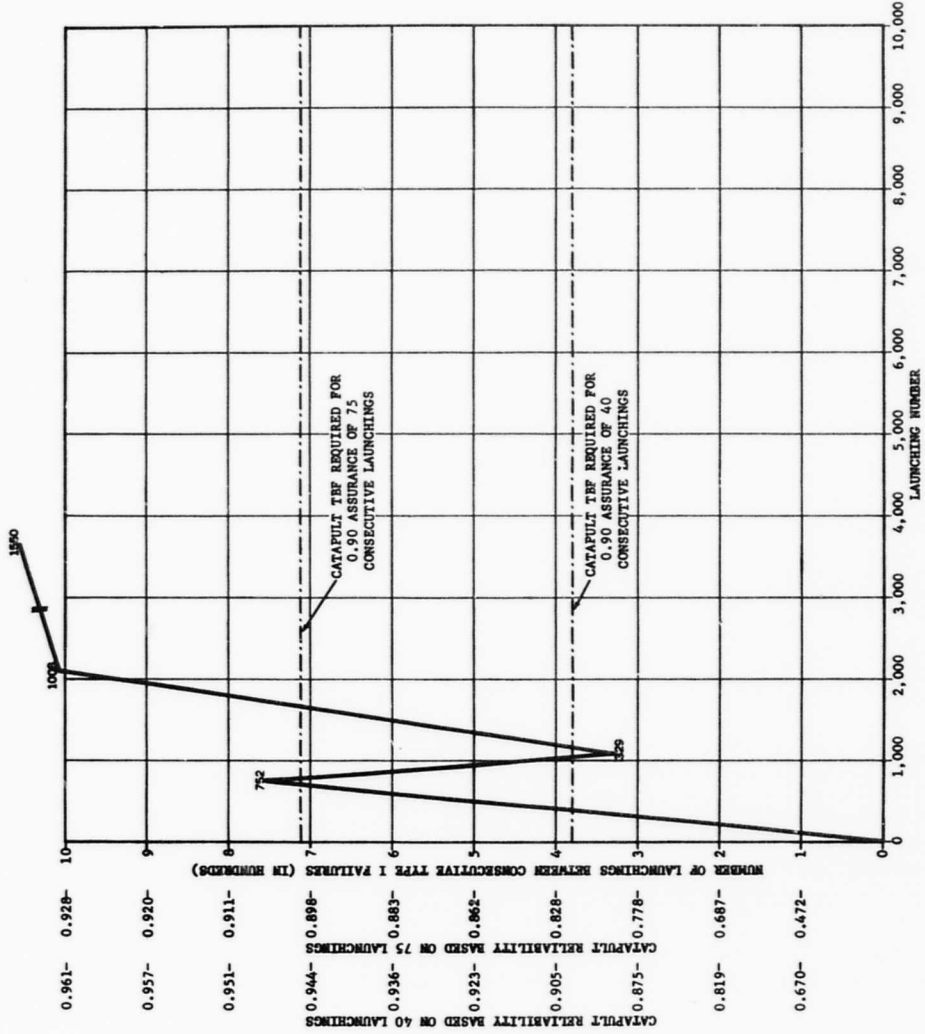
Figure 5 - Number of Launchings Between Consecutive Type I Failures versus Launching Number (TC13 Mod 1 Steam Catapult)

<u>Event No.</u>	<u>Failure</u>
752	Tailpiece, cracked
1,081	Silbrazed joint, cracked
2,089	Retraction-engine piston rod, bent
3,639	Shuttle wheel, broke

These four Type I failures yielded a mean-time-between-failure (MTBF) of 909 launchings for a reliability of 95.5 percent with respect to 40 consecutive launchings. This is an excellent reliability; however, it is undoubtedly somewhat inflated because nearly 75 percent of the launchings were no-loads. The four Type I failures are plotted in Figure 5, a continuous plot of reliability.
