AIRCRAFT GROUND-FLOTATION INVESTIGATION
PART III. DATA REPORT ON TEST SECTION 2

U. S. ARMY ENGINEER WATERWAYS EXPERIMENT STATION

TECHNICAL REPORT AFFDL-TR-66-43, PART III

APRIL 1966

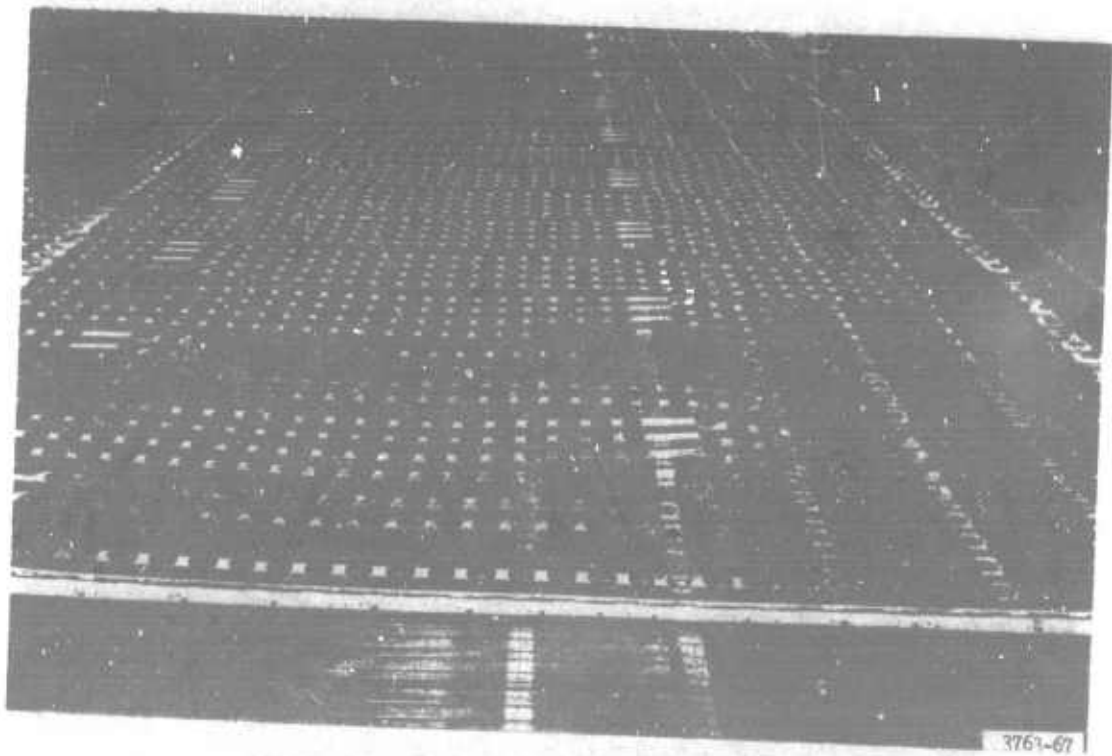
Figure 9. Lane 3, item 2, at 122 coverages
(2 postfailure coverages)

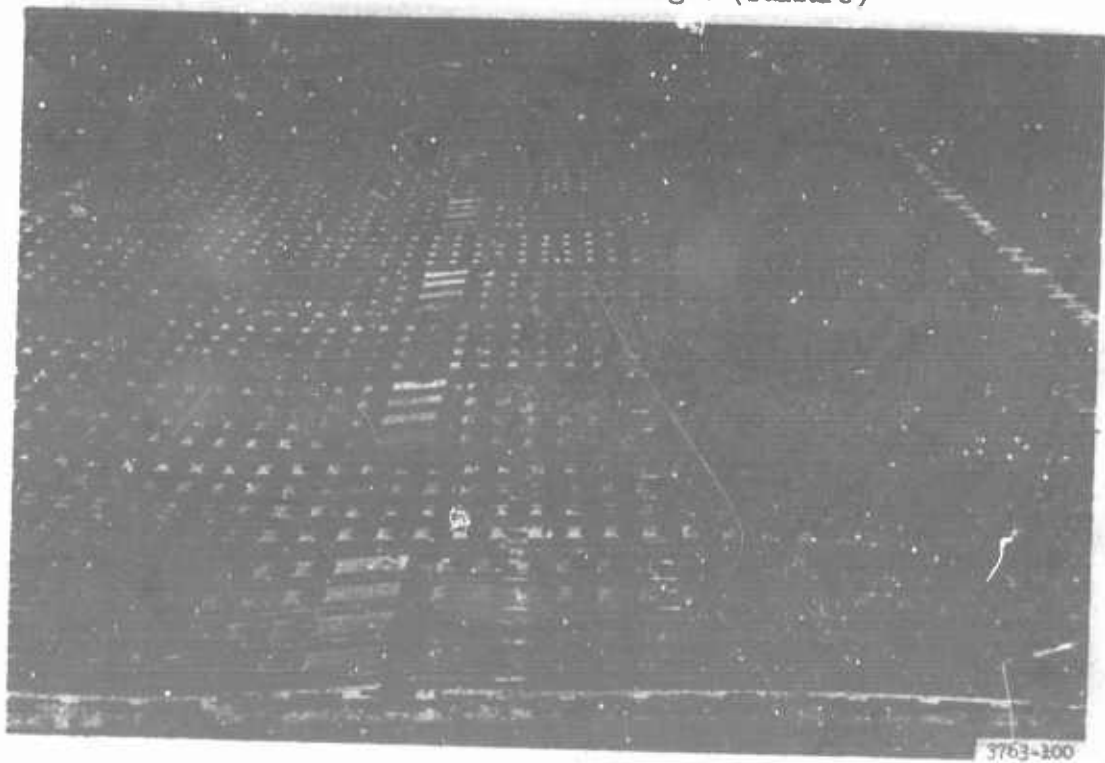
considered failed due to the large amount of subgrade extrusion which caused surface roughness and mat deformations (Figures 21 and 22). No mat breakage was found at failure. Figure 23 shows the deformed mat surface after removal of the extruded soil. The rated CBR of the item was 3.6.

Figure 23. Lane 4, item 2, at 20 coverages (failure) after removal of extruded soil

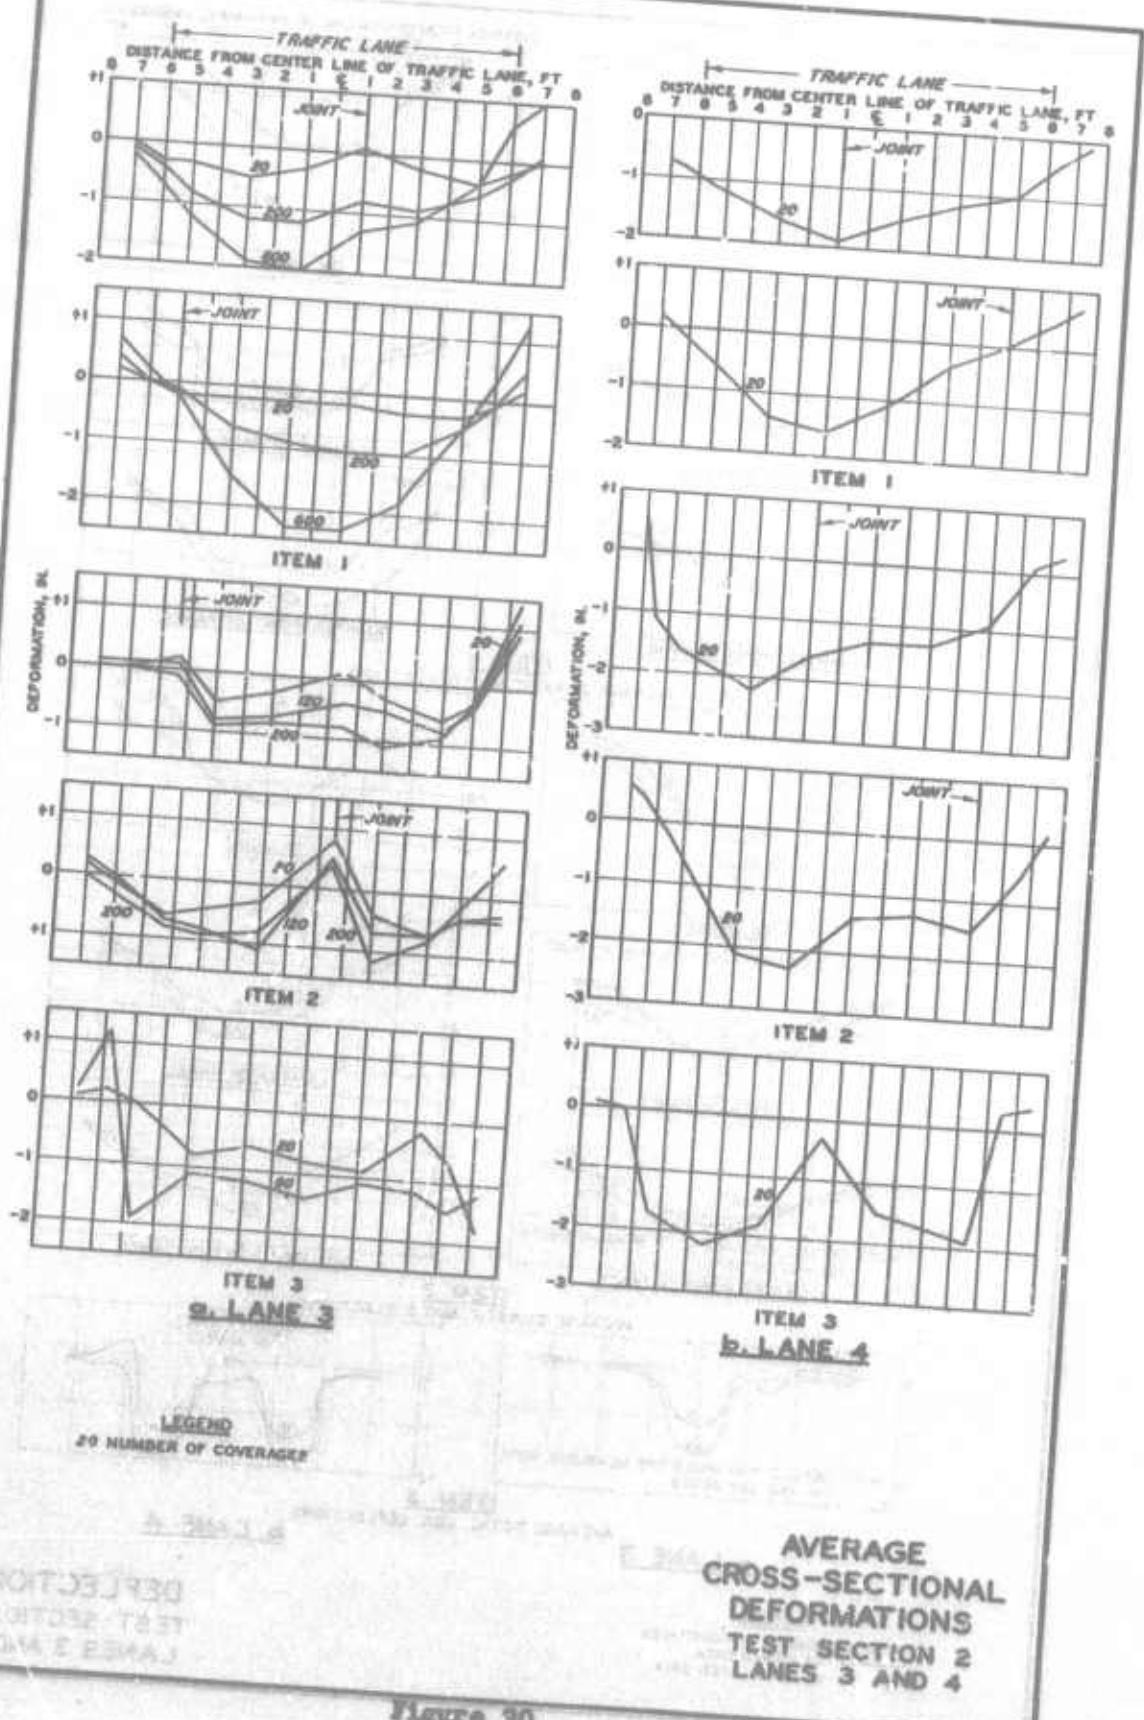
Figure 30

- b. Deformation. Average profile and cross-section deformation plots are shown in plates 4 and 5, respectively, for several coverage levels. General subsidence of the traffic lane is evident in each of the plots. A maximum average cross-section deformation of 2.3 in. was measured at failure (Fig 30).

AVERAGE
CROSS-SECTIONAL
DEFORMATIONS
TEST SECTION 2
LANES 3 AND 4

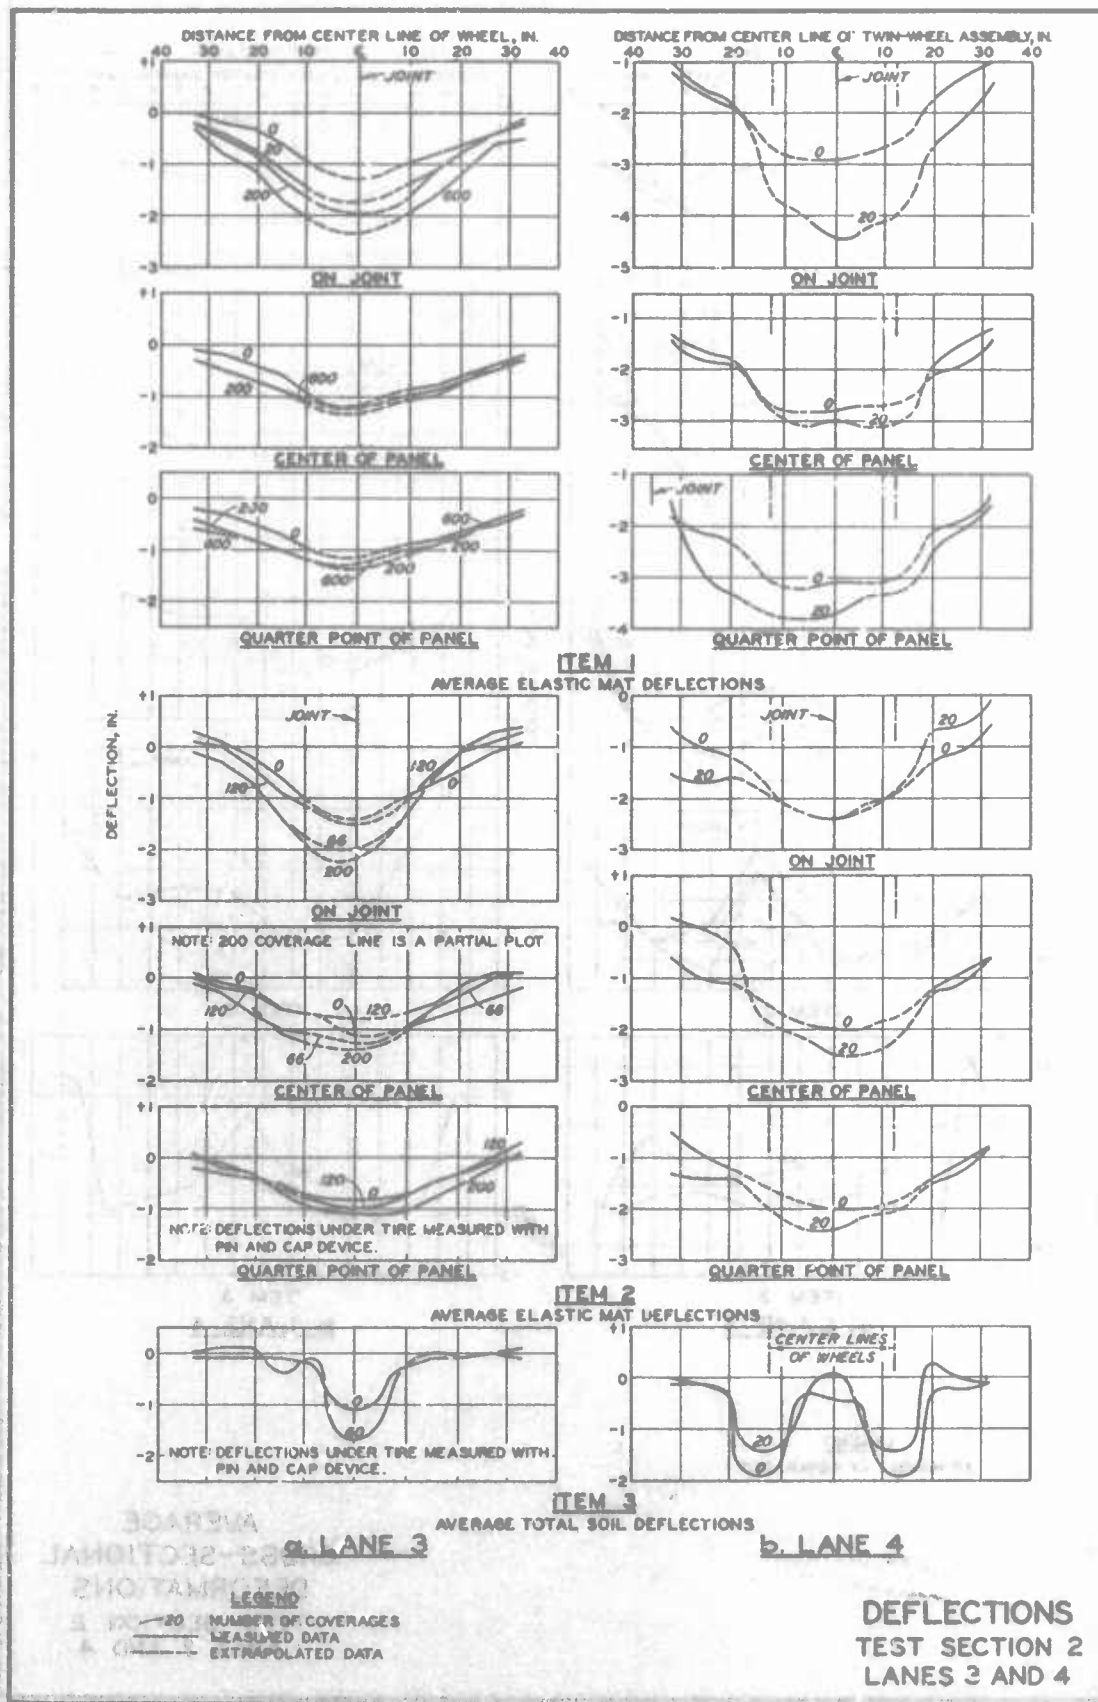
Figure 31

- c. Deflection. Fig 31 illustrates the mat deflection under static load of the wheel assembly at various coverage levels with center line of the assembly located at different points relative to panel joints. The largest deflection (2.3 in.) was recorded with the load wheel resting on a panel end joint at 600 coverages. At the same coverage level, the pin and cap device showed the elastic subgrade deflection to be 1.5 in. directly beneath the load wheel at the midpoint of a panel.

- c. Deflection. Elastic mat deflections under the static load of the test cart are represented in Fig 31. Mat and subgrade deflections are tabulated in table 1. Plots in Fig 31 show mat configuration with load wheels in various positions relative to panel end joints. In each instance, the mat deflections were significantly greater at the 20-coverage level than those measured prior to trafficking. The elastic subgrade deflection measured at failure was 1.9 in.
