20 June 1966

Subject: Final Report Investigation and Recovery Program for Nozzle Port  
Flange Snap Ring Groove Cracking Problem of the Minuteman Stage III  
Motor, Report No. MTO-752-50

FINAL REPORT  
INVESTIGATION AND RECOVERY PROGRAM  
FOR  
NOZZLE PORT FLANGE SNAP RING GROOVE CRACKING PROBLEM  
OF THE  
MINUTEMAN STAGE III MOTOR

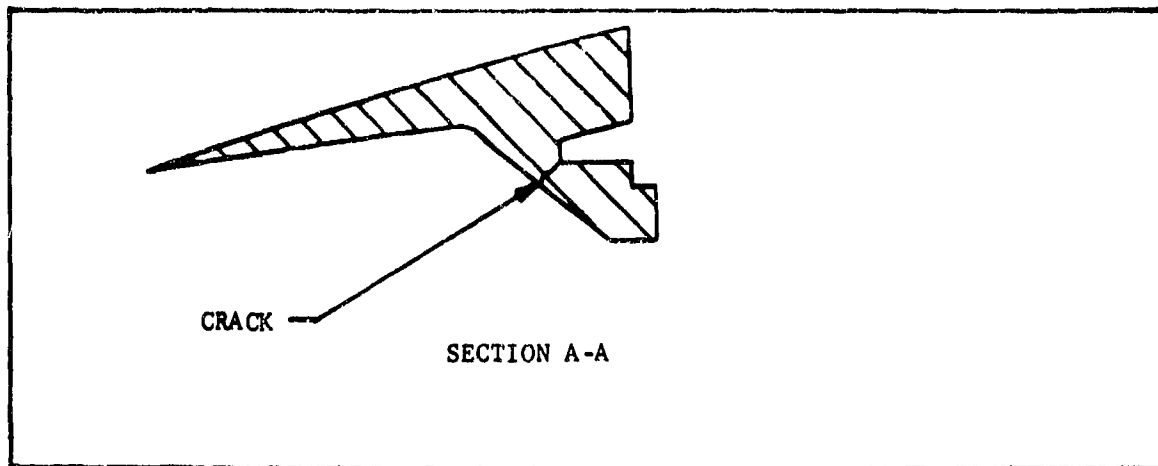
Each instance of flange cracking was found to be in the forward radius area of the snap-ring groove at the keyway and/or 180 degrees from the keyway as shown in Figures 1 and 2. These cracks were found to be a maximum of ten inches in circumferential length.
