## **AIRCRAFT GROUND-FLOTATION INVESTIGATION**

### **PART IV. DATA REPORT ON TEST SECTION 3**

**TECHNICAL REPORT AFFDL-TR-66-43, PART IV**

**APRIL 1966**

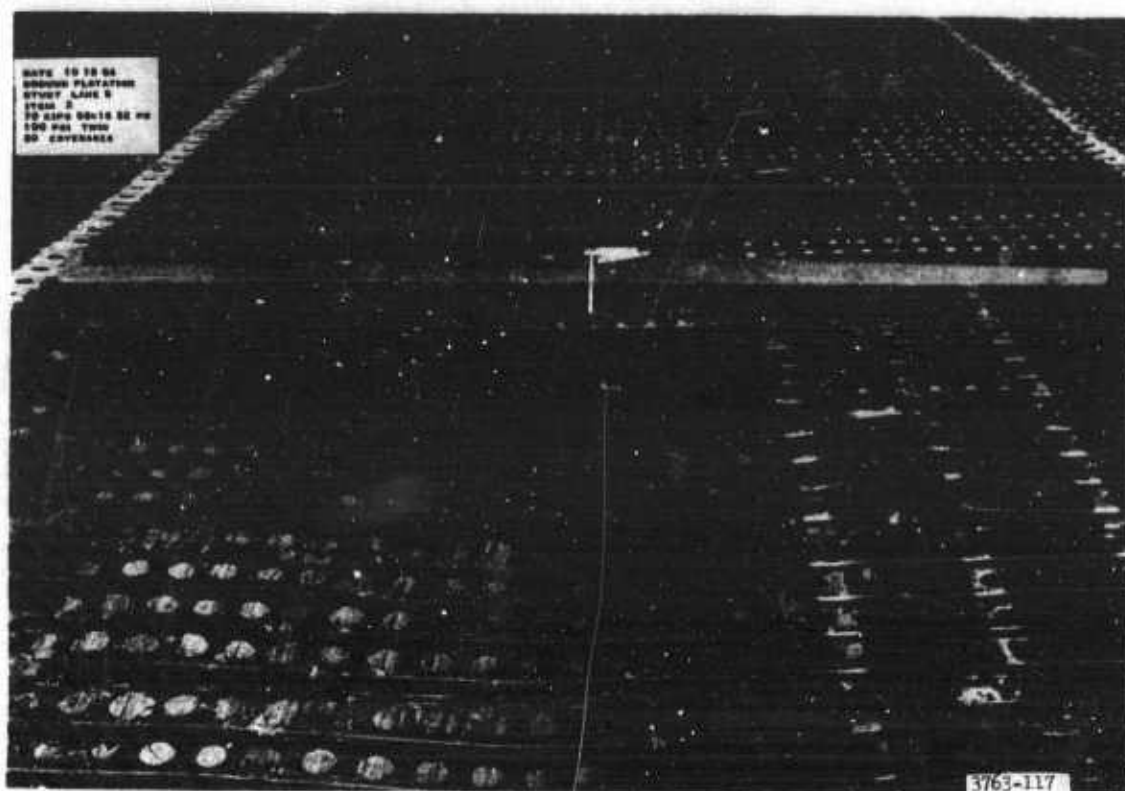
Item 2. Item 2 prior to traffic is shown in **Figure 5**. The item was considered failed due to roughness at 28 coverages. Two postfailure coverages were applied. **Figure 6** shows the item at the 30-coverage level. As the item approached failure (28 coverages), the subgrade became less resistant to displacement and the resulting plastic deformation conformed to the impression made by the last pass of the tracking vehicle. The M8 steel landing mat was flexible enough to follow the contours of the deformed subgrade without breaking. The rated CBR for the item was 3.8.

- a. Roughness. Differential deformations were subject to large changes with each pass of the load wheels as the item approached a failure condition. The great increase in differential deformations between 28 and 30 coverages reflects the plastic condition of the subgrade. The differential deformation values show the concurrent development of roughness with number of traffic coverages (table 1).

**Figure 6.** Lane 5, item 2. Transverse straightedge shows roughness at 30 coverages (2 postfailure coverages)

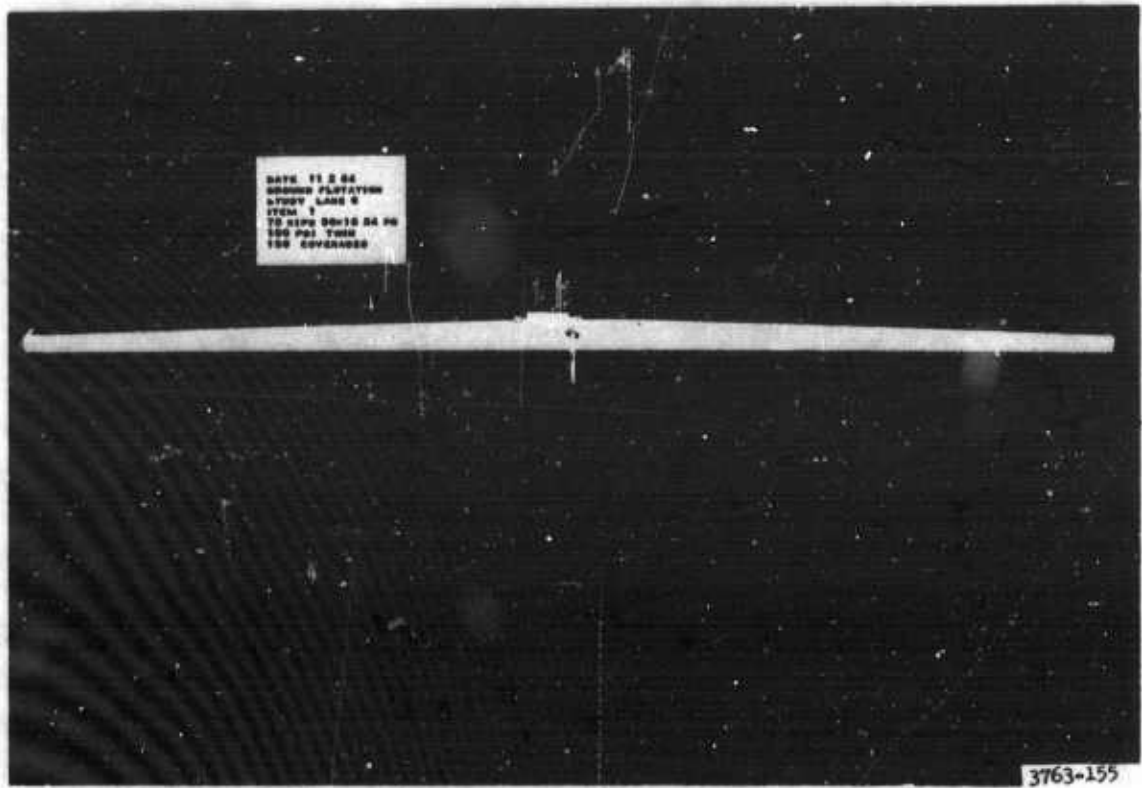
Item 1. **Figure 9** shows item 1 prior to traffic. After the first 20 coverages, the rate of mat deterioration (breakage) increased. Displacement of the subgrade away from the center toward the outside of the traffic lane created a concave cross section. The item was considered failed due to roughness and mat deterioration at 130 traffic coverages. Traffic was continued to 156 coverages (**Figure 10**). The rated CBR was 2.0.

- a. Roughness. Average differential deformations (table 1) were approximately 3.0 in. and 2.3 in. for the transverse and diagonal positions, respectively, at 130 coverages. At 156 coverages an average transverse differential deformation of 3.9 in. was measured. Average dishing of individual mat panels was 0.38 in. at failure.

**Figure 10.** Lane 6, item 1. Transverse straightedge shows roughness at 156 coverages (26 postfailure coverages)

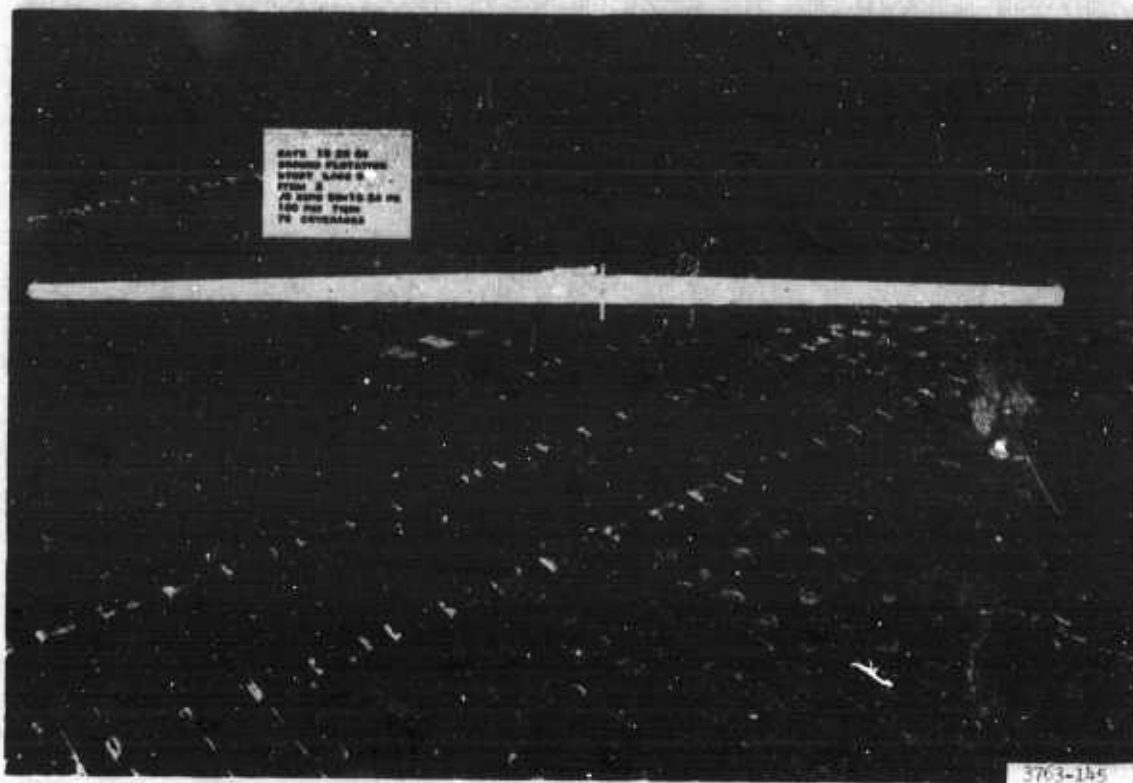
Item 2. **Figure 11** shows item 2 prior to traffic. At 50 coverages no mat breaks were observed and differential deformations were within the allowable range for serviceable surfaces. The item was considered failed due to roughness at 76 coverages (**Figure 12**). The rated CBR was 3.6.

- a. Roughness. Differential deformation measurements for various coverage levels up through 76 coverages (failure) are presented in table 1. At failure the average transverse and diagonal differential deformations exceeded 2 in.
- b. Deformation. Plots in **Fig 21** represent the average

**Figure 12.** Lane 6, item 2. Diagonal straightedge shows roughness at 76 coverages (failure)

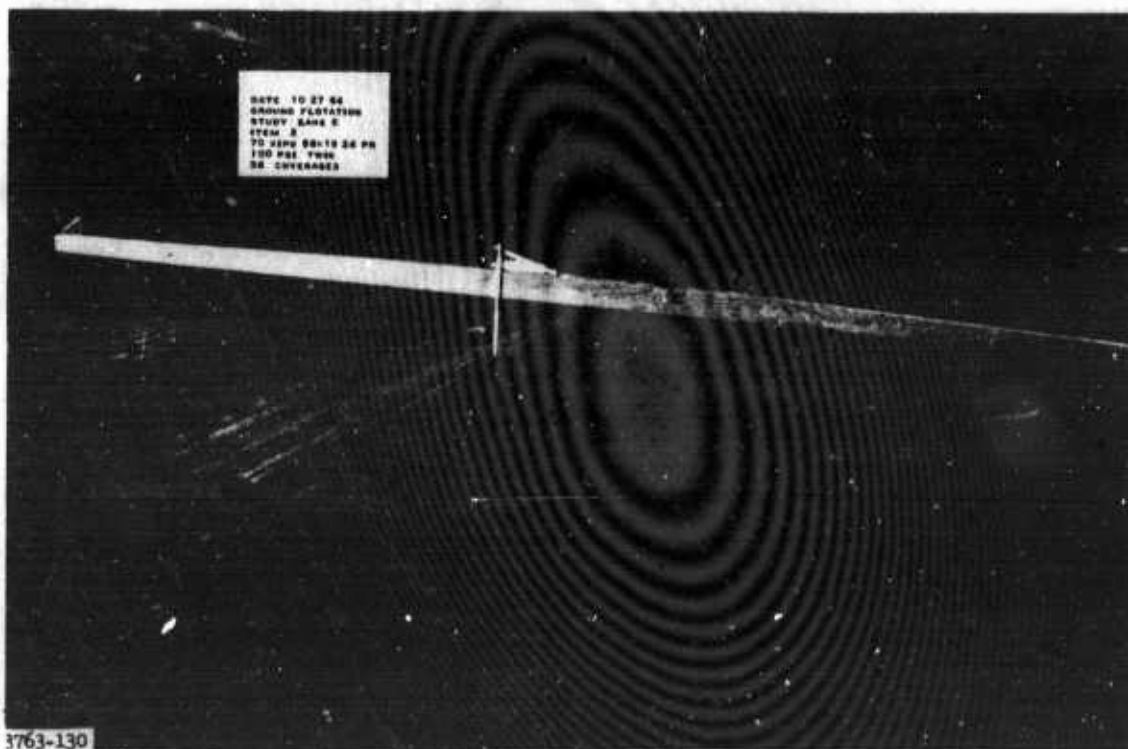
Item 3. Item 3 is shown prior to traffic in **Figure 13**. At 36 coverages a localized failure was evidenced by rutting at one end of the item from sta 0+80 to sta 0+90 (**Figures 14 and 15**). The 10-ft failed segment of the item was designated 3a, and the still serviceable segment was designated 3b. After the ruts in 3a were repaired, traffic was resumed

**Figure 15.** Lane 6, item 3. Diagonal straightedge shows rutting in segment 3a at 36 coverages (failure)

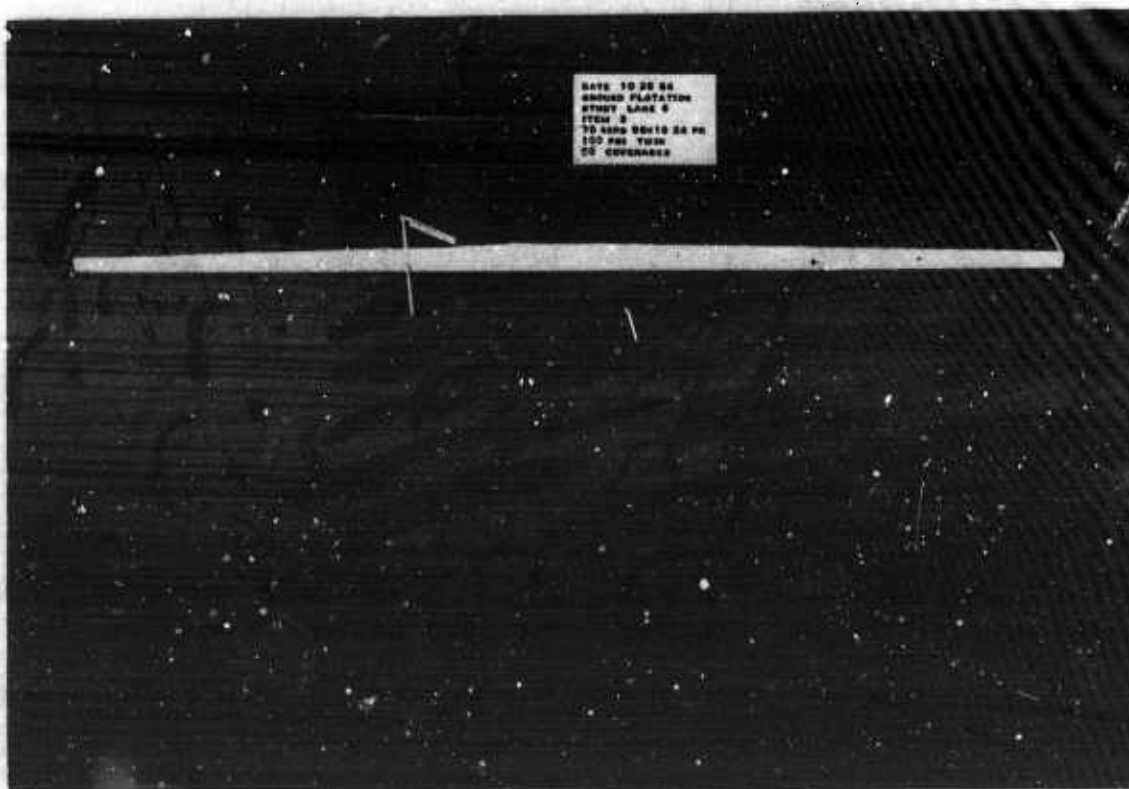
over the entire item which was considered failed due to rutting at 50 coverages (**Figures 16 and 17**). Segments 3a and 3b were assigned rated CBR's of 9 and 10, respectively.

**Figure 17.** Lane 6, item 3. Diagonal straightedge shows rutting in segment 3b at 50 coverages (failure)
