Technical Report

FOAMGLAS INSULATION FOR  
BURIED HOT PIPES

June 1966

Technical Report R-451

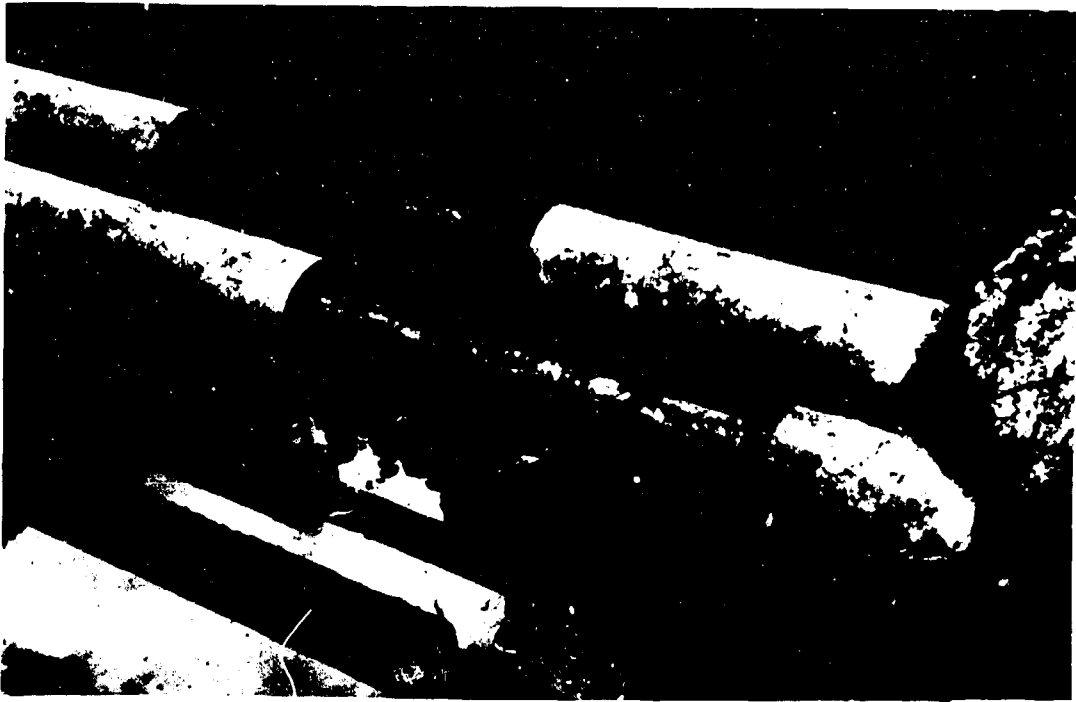
Of the three systems, the Foamglas was in the best condition in Seattle and in the worst condition in New Orleans (see Appendix E for illustrations). Most of the Foamglas in Seattle was relatively intact, but there were isolated broken areas through which ground water had intruded to the pipe. At St. Louis, Foamglas had severely abraded because of pipe movement, and was badly broken up at most excavations. Water had intruded through the Foamglas to the pipe. At New Orleans the Foamglas system had been shut down and disconnected for approximately 2 weeks. The Foamglas at that site was relatively intact on portions of the condensate line but was completely disintegrated inside the pipeline felt along portions of the steam line.

At Seattle there was very little corrosion damage to the pipes. At St. Louis there was severe general corrosion damage on the original steel pipe. At New Orleans there was very little corrosion damage of either the steam or condensate lines.

Figure E-1. Seattle. The insulation has been removed from the pipe revealing that both pipe and insulation are in good condition.

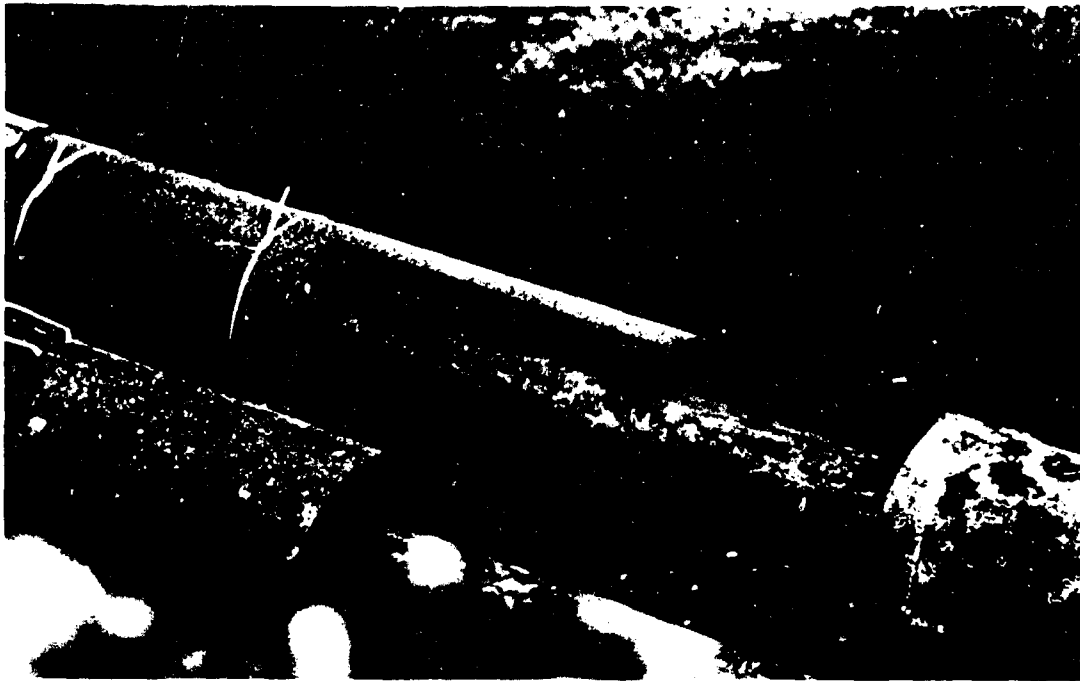
Figure E-3. Seattle. The pipe is being recovered with half sections of Foamglas which are being secured to the pipe with stainless steel wire.

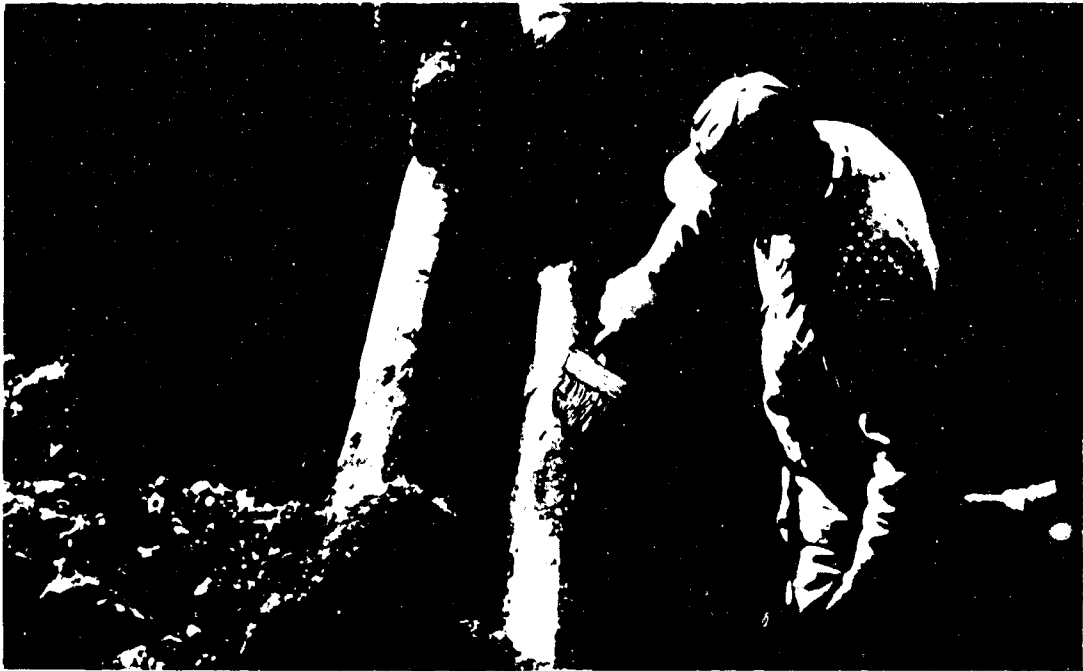
Figure E-5. St. Louis. Coating new Foamglas section with mastic; contractor thinned mastic with gasoline so that it could be applied with brush, thus ignoring Foamglas Manufacturer's recommendation that mastic be gloved on.

1. The use of Foamglas should be permitted in dry, underground environments (type B sites); however, the Foamglas must be installed in strict accordance with the manufacturer's recommended procedure.
2. Hot pipes should be located above ground where practical.

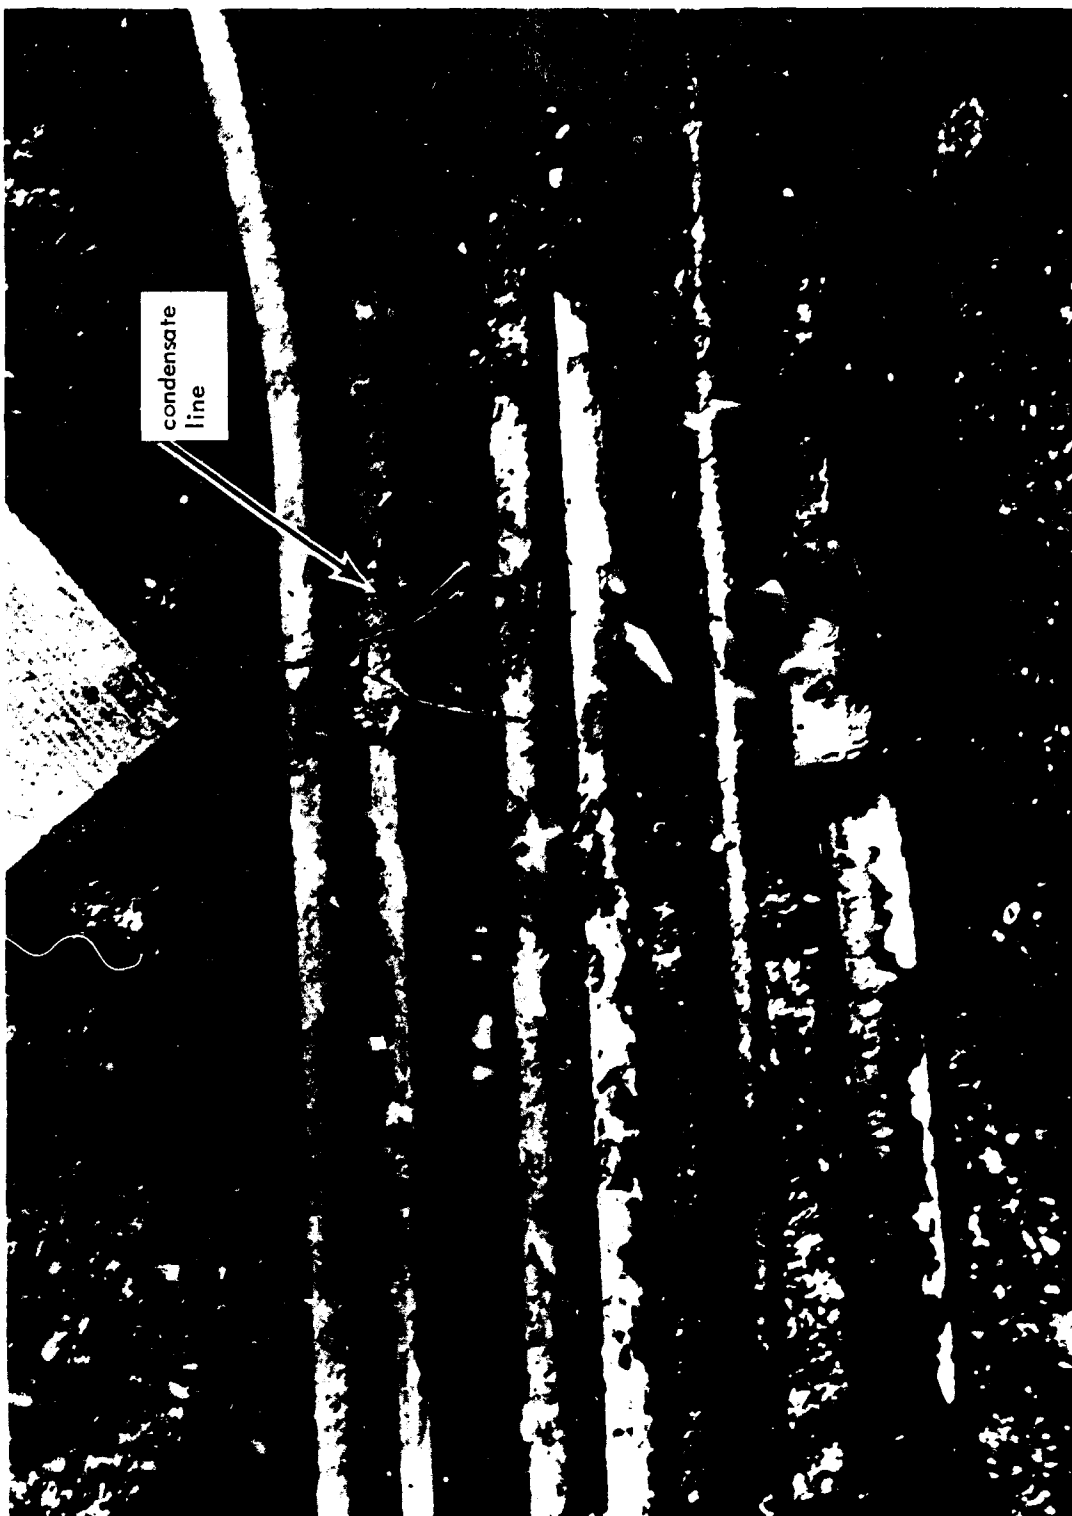
4. The failure at New Orleans was characterized by disintegration of the Foamglas; this did not occur at the other two sites. This disintegration probably resulted from pressures exerted by external steam which was generated when water intrusion reached the outer surface of the pipe. As mentioned previously, water intrusion could not be attributed to soil properties.

Figure E-9. New Orleans. Typical excavation after water was pumped from the hole. Note condition of Foamglas on condensate line.
