REPORT NO. RS-TR-66-5

**METALLURGICAL EXAMINATION OF BULLPUP "A"  
PROPULSION UNIT S/N 4800 AFTER THREE YEARS OF STORAGE**

April 1966

**Materials Engineering and Development Branch  
Structures and Mechanics Laboratory  
Research and Development Directorate  
U. S. Army Missile Command  
Redstone Arsenal, Alabama 35809**

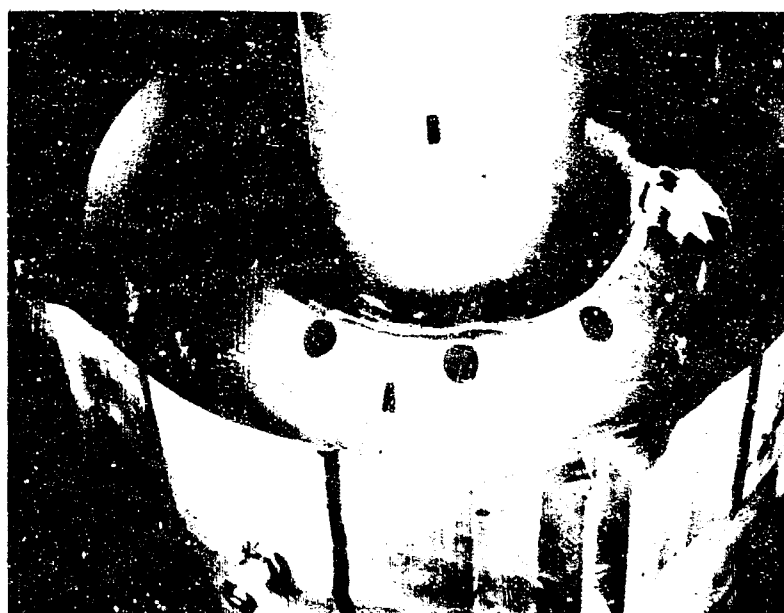
Figure 10. Deposits on Interior of Oxidizer Tank

The internal surfaces of the oxidizer tank were examined for deposits, and two types of deposits were observed: an amber deposit on the tank walls, and a heavier, thicker, green deposit adhering loosely to the gas diffuser and deflector assembly. These deposits were collected separately and subjected to chemical analysis.

Examination of the interior surfaces of the oxidizer tank revealed, in addition to the amber colored deposit, a slight etch condition over all surfaces. This etch was slightly more apparent at the weld heat affected zone (HAZ). The surface of the stainless steel SPGG diffuser and deflector was etched fairly heavily under the green flaky deposit.

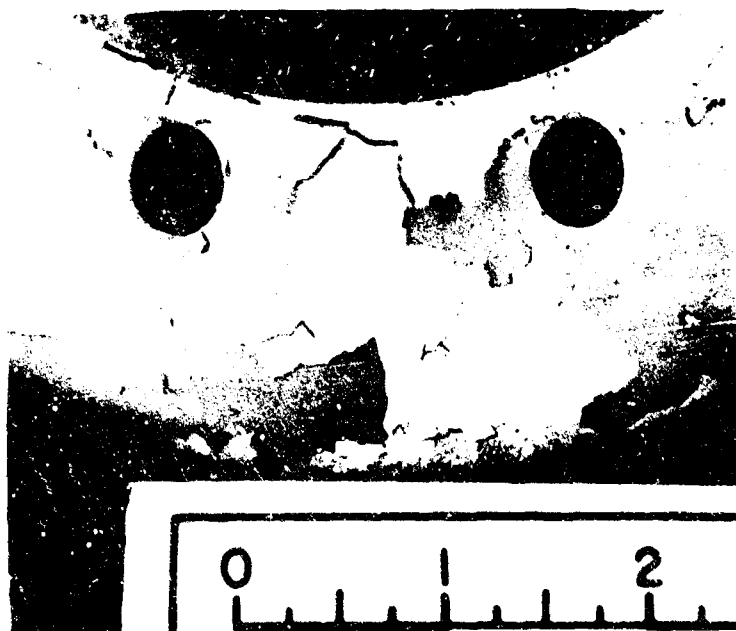
Figure 12. Deposit on Oxidizer Tank Solid  
Propellant Gas Diffuser and Deflector

Residue found in the oxidizer tank was caused by a reaction between the stainless steel SPGG diffuser and deflector assembly and the IRFNA.

Deposit was lightly attached.

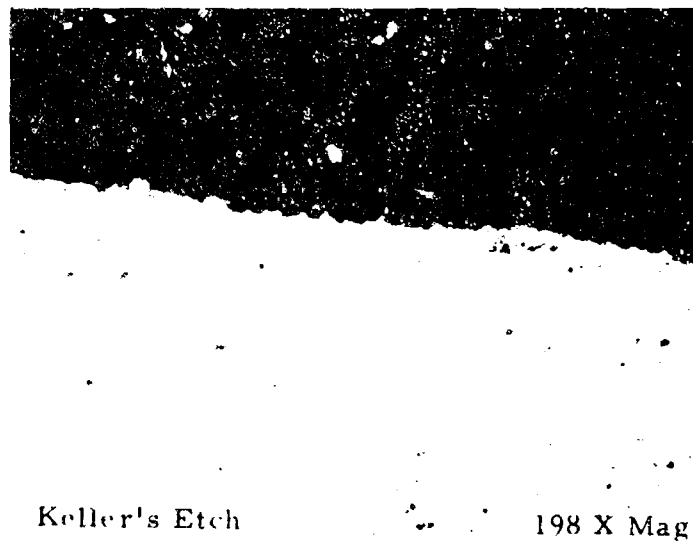
Figure 28. IRFNA Contact Surface of SPGG Tube HAZ at Oxidizer Baffle Weld

IRFNA corrosion was most severe at the HAZ surfaces.

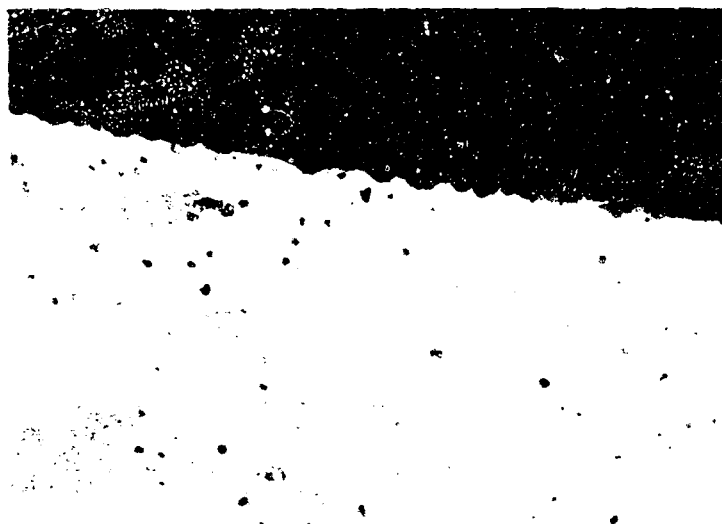
Figure 30. IRFNA Contact Surface of Aluminum Baffle HAZ at Stainless Steel SPGG Tube Weld

Degree of corrosion is the same in the HAZ of other aluminum components. Angularity of exposed grains does not appear to influence the amount of corrosion.

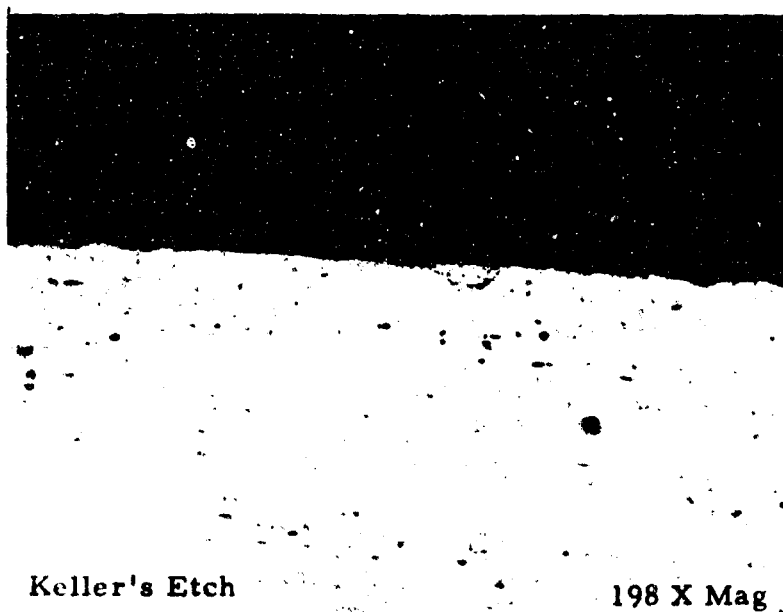
**Figure 32. Interior Surface of Aluminum SPGG Tube That Had No IRFNA Contact**

**Surface generally free of attack.**

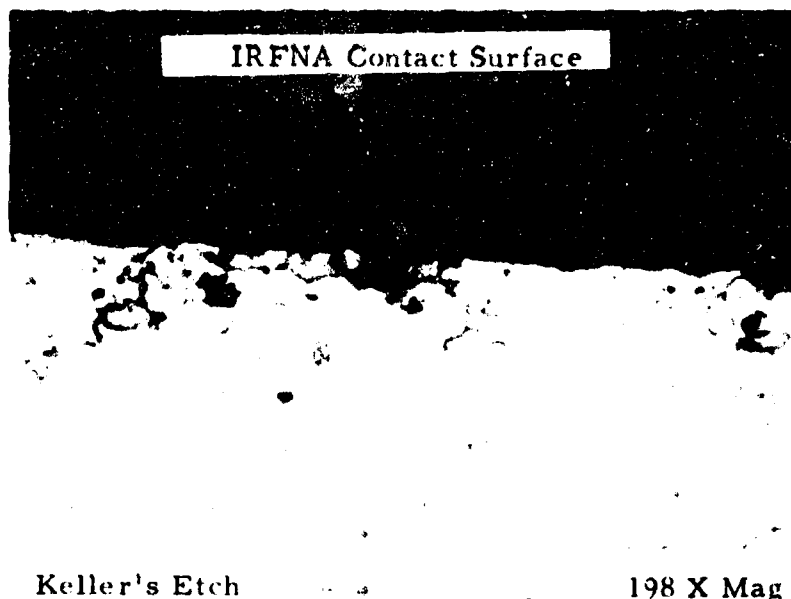
Figure 33. Same Surface as Shown in Figure 32  
After Three Months of Exposure to Laboratory  
Atmosphere

Intergranular attack and general surface dissolution corrosion have progressed further than any nitric-induced corrosion did during the 3.3 years of storage.

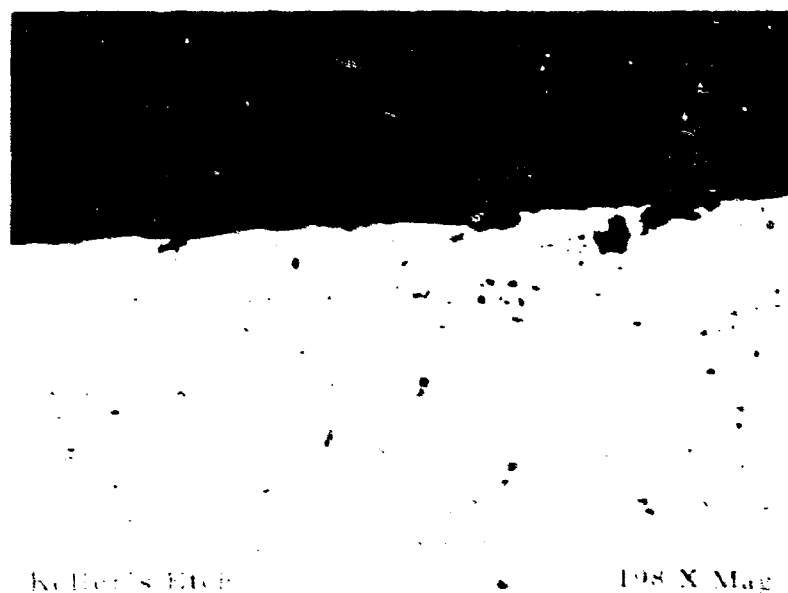
**Figure 46. Atmosphere Surface, Center Bulkhead**

Corrosion is more advanced on this surface than on the IRFNA contact surfaces.

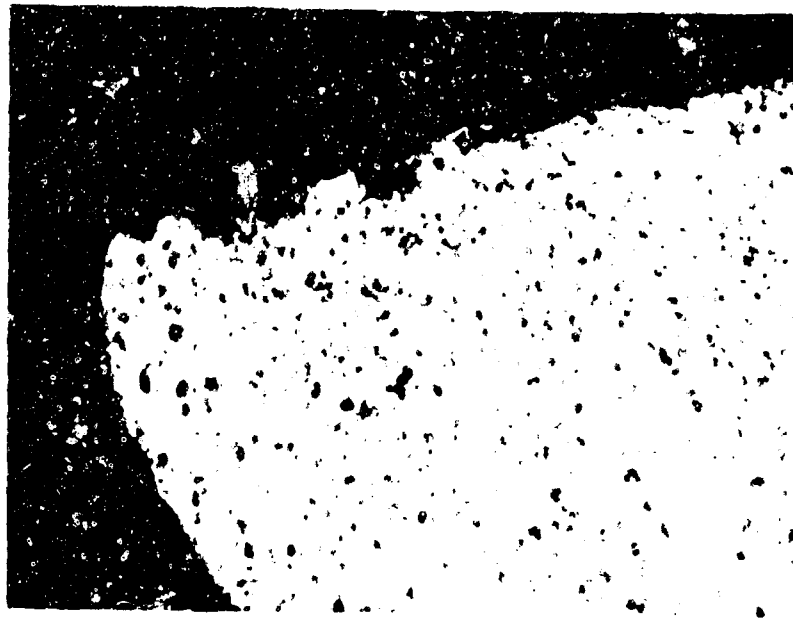
Figure 51. Corrosion on "Bucked" End of Rivet,  
Oxidizer Director and Screen Assembly

Slight IRFNA attack apparent on heavily worked rivet [A].

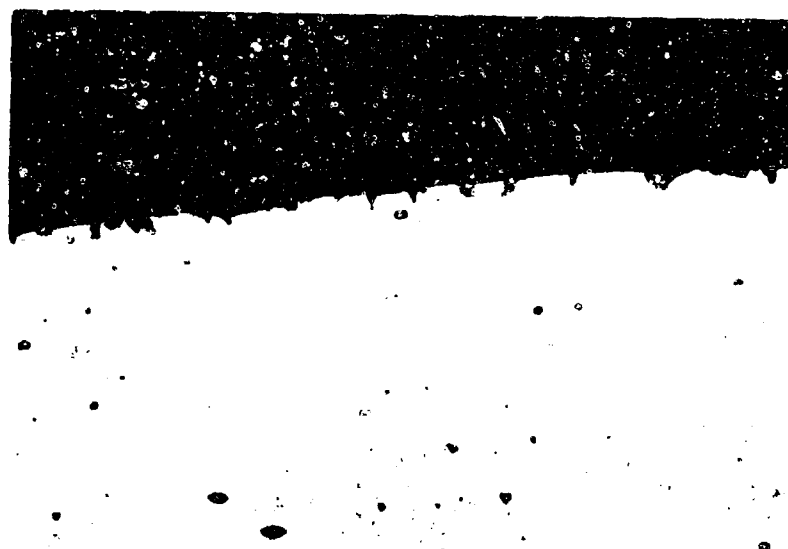
Figure 52. IRFNA Contact Surface, Stainless Steel  
Screen

Electrolytic Oxalic Acid Etch 198 X Mag  
Slight IRFNA attack is evident.

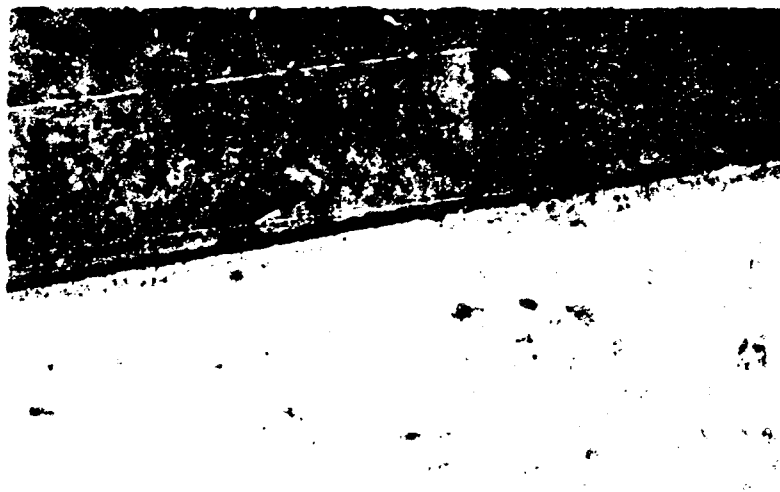
Figure 53. IRFNA Contact Surface, Stainless Steel  
Outer Screen Retainer Ring

No IRFNA surface attack is evident.

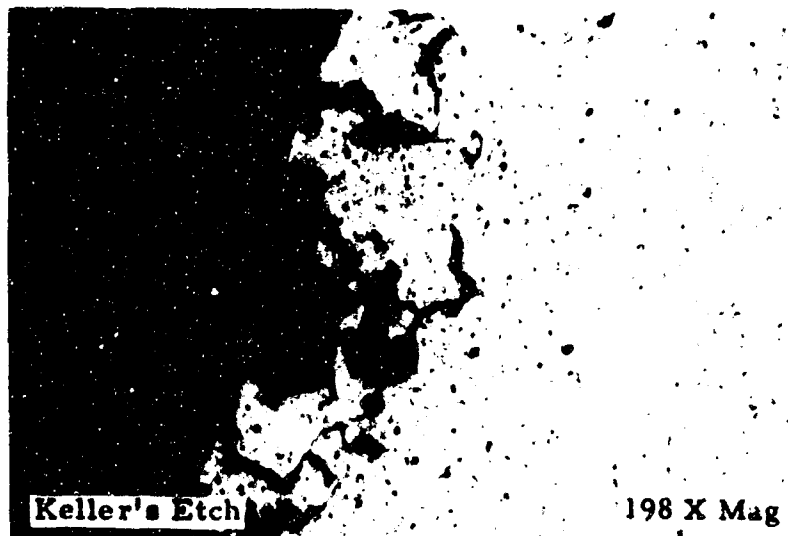
**Figure 55. Corrosion Site on Retainer Ring  
Where Aluminum Ring Contacted Stainless  
Steel Screen**

Corrosion has been advanced by exposure to laboratory environment.

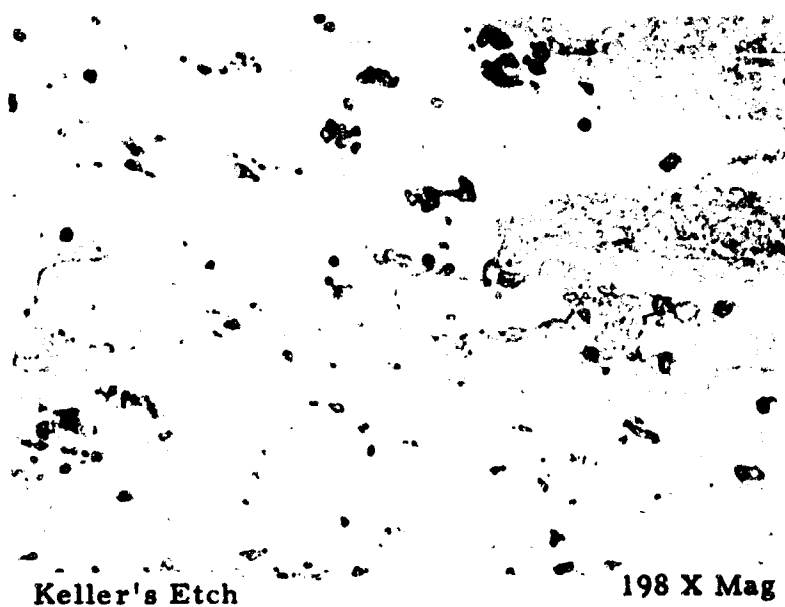
Figure 57. Oxidizer Tank Wall Microstructure  
12 Inches from Center Bulkhead Weld

Hardness, Rockwell "B" 80

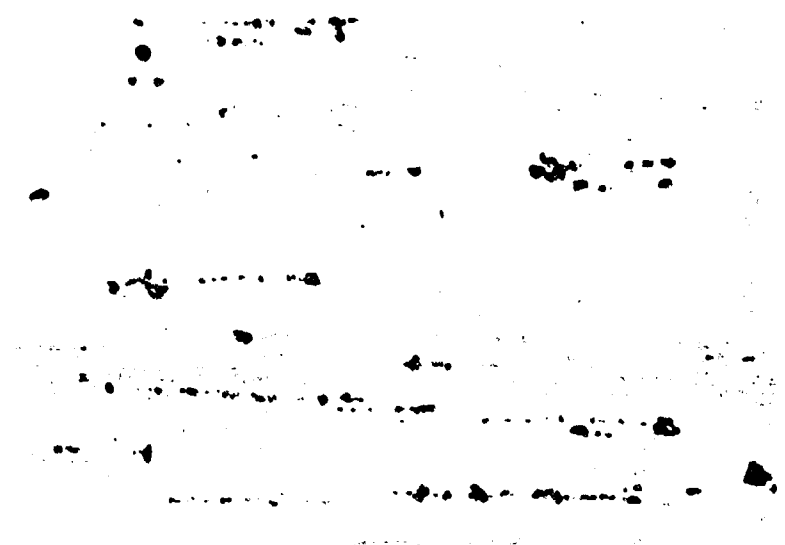
Figure 58. Oxidizer Tank Wall Microstructure  
0.660 Inch from Center Bulkhead Weld

Hardness, Rockwell "B" 73.0

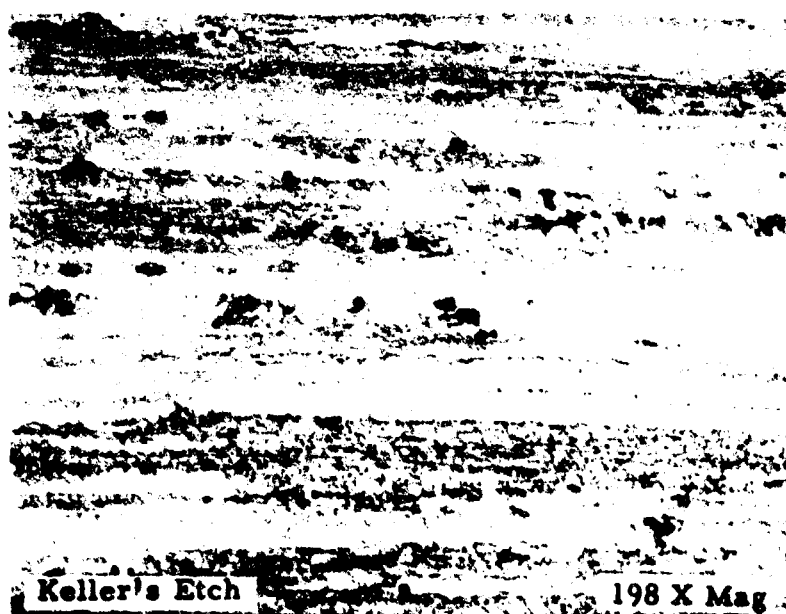
Figure 60. Oxidizer Tank Wall Microstructure  
0.050 Inch from Center Bulkhead Weld

Hardness, Rockwell "B" 60

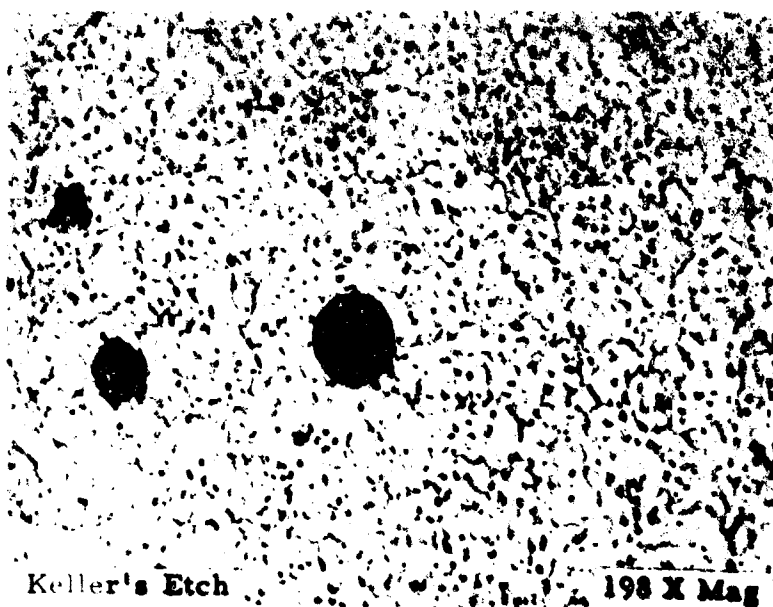
Figure 62. Weld Metal at Oxidizer Tank to Center Bulkhead Weld

Hardness, Rockwell "B" 47.0

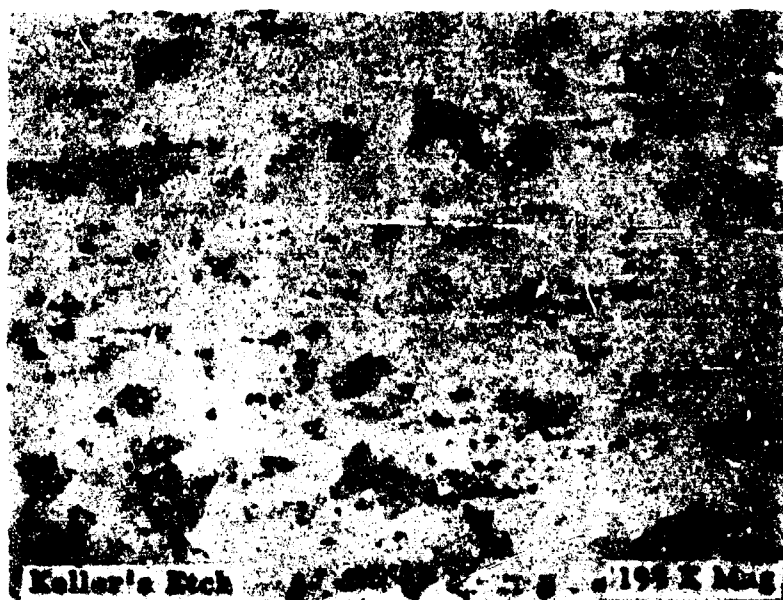
Figure 65. Center Bulkhead Microstructure 0.500  
Inch from Weld

Hardness, Rockwell "B" 53.0

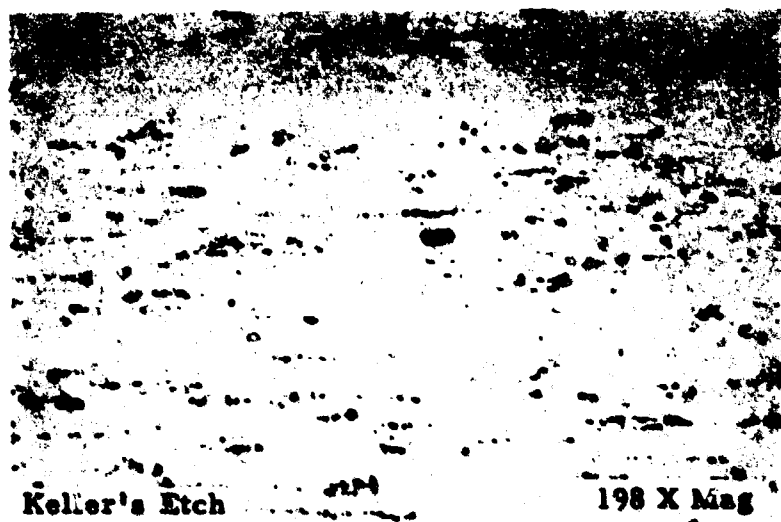
Figure 66. Center Bulkhead Microstructure 0.75  
Inch from Weld

Hardness, Rockwell "B" 71.8

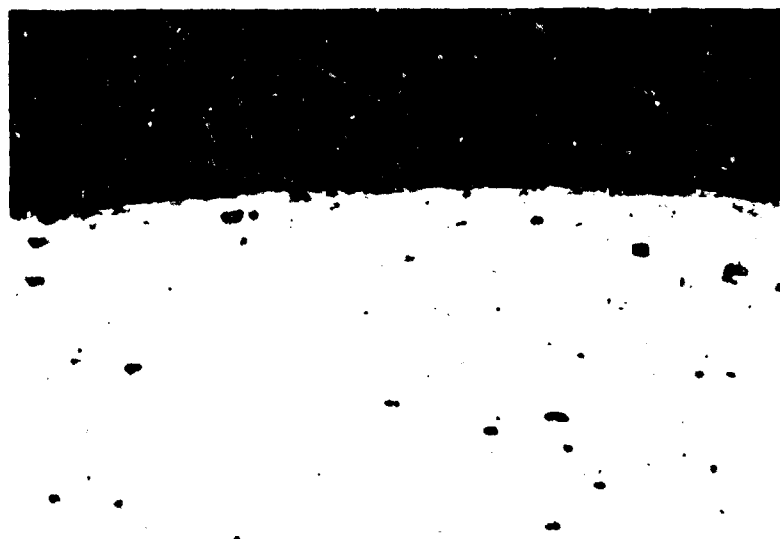
Figure 68. Stainless Steel Solid Propellant Gas Diffuser and Deflector, Microstructure

No corrosive attack is evident.
