TECHNICAL DIAGNOSTIC ANALYSIS  
OF LRAPP TEST BED PROGRAM  
FAILURE (U)

2 August 1971

BKD-CN-667

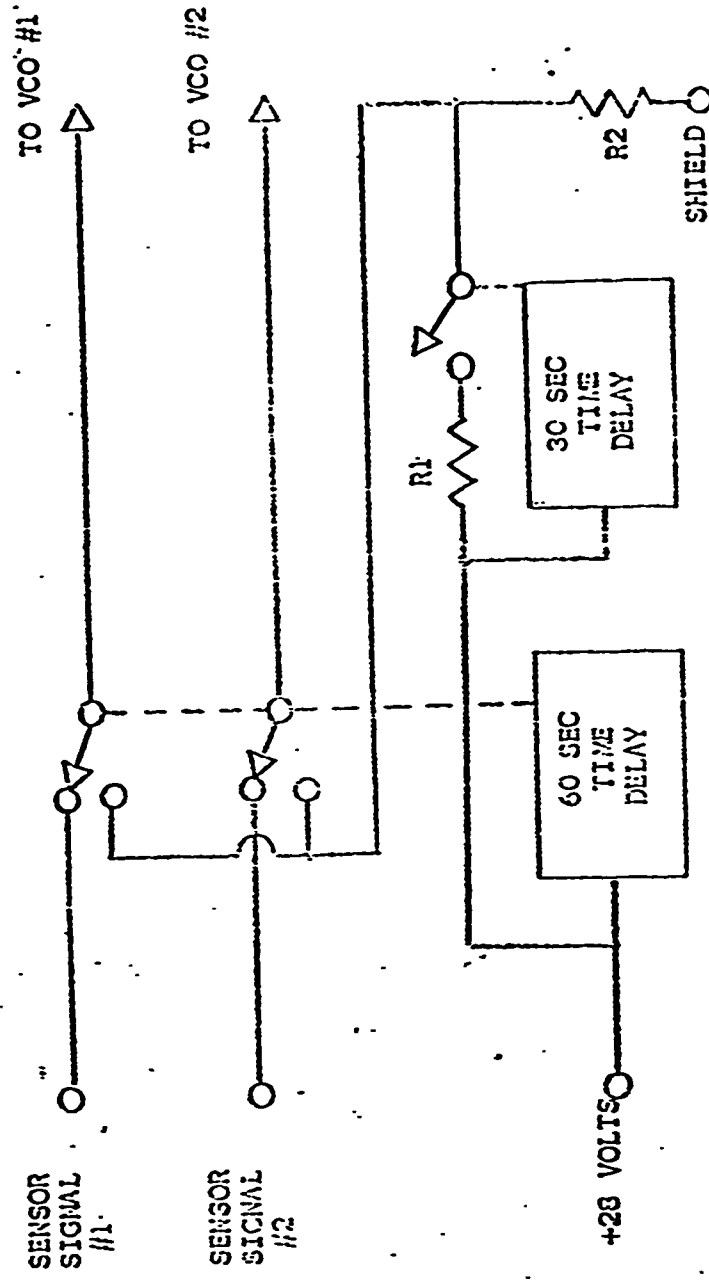
FIGURE 5. CALIBRATION BOARD AND RELAYS

reliability. Two major weak points exist within this unit. First, the relays that were used required high current, were selected from on-hand relays at NUSC, and were not of sufficient reliability or quality to be used in a system with a projected 3-5 year life. The second weak area was the selection of the ceramic filters for command tone detection. These filters are extremely critical to shock and vibration which causes mechanical failure, have very broad bandwidth skirts in their frequency response which require a very delicate control of the amplitude of the command tone, and are not as selective to frequency as they should be for adequate command response. NUSC, forced by critical implantment timing, did not elect to replace these ceramic filters with more reliable products that are on the market. Since the implantment, NUSC has investigated a tuning fork driven reed relay that both replaces the ceramic filter for tone detection and the heavy current relays with a highly reliable, very accurate and sensitive decode capability. In future implantments, these new relays should be considered for use over the filters and relays used for the TEST BED.

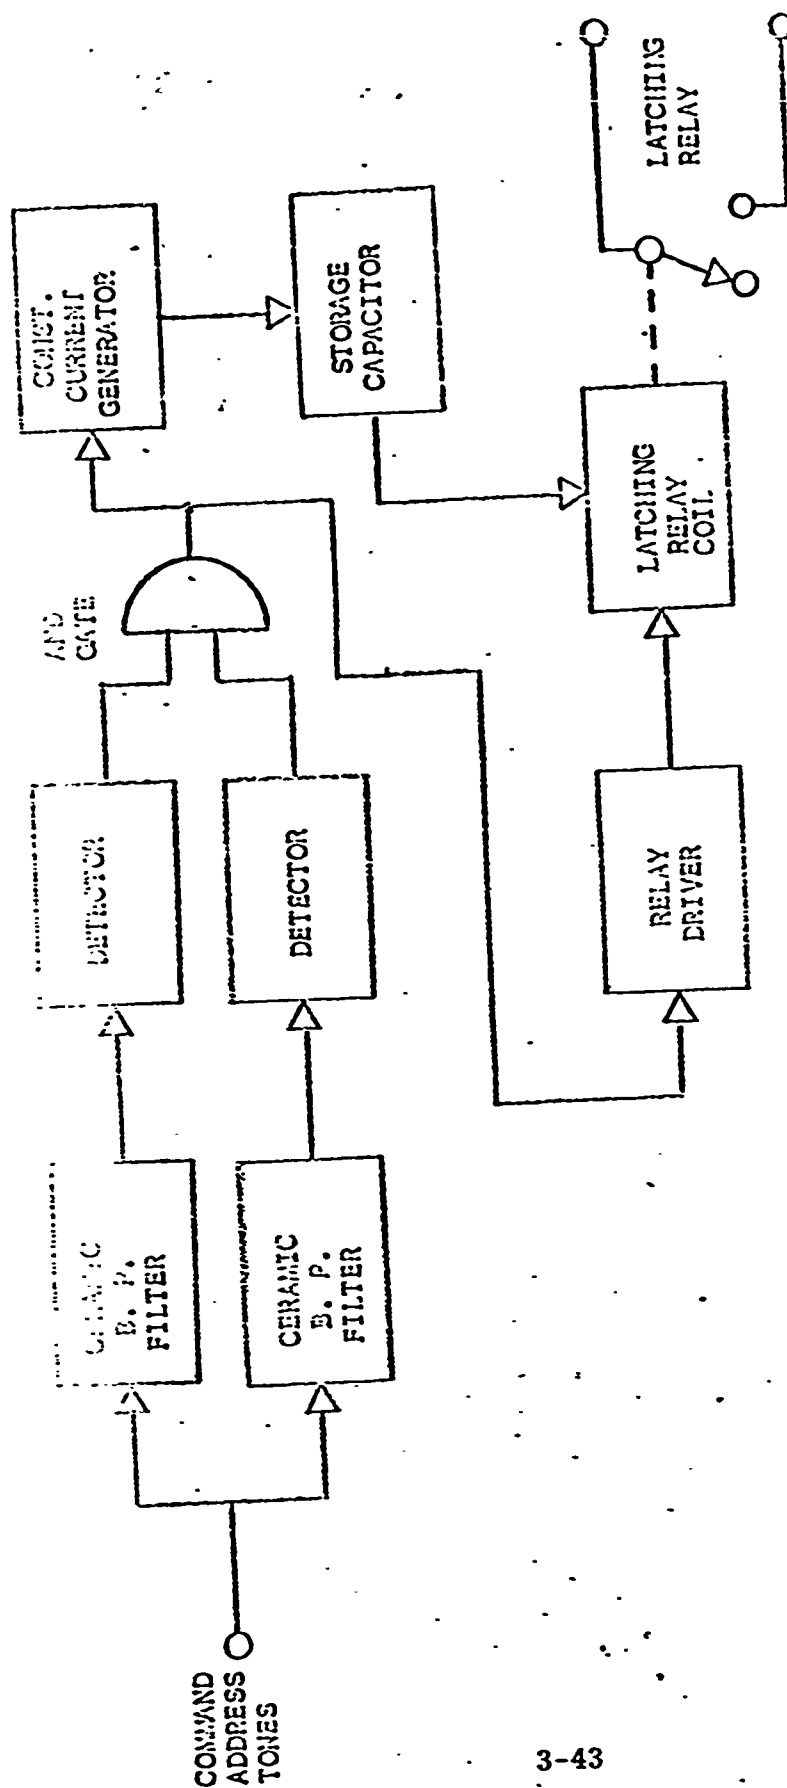
FIGURE 7. COMMAND ADDRESS TONE DECODER BOARD

(U) The decoder card causes the + 28 volt power relay contacts to open or close when the card's particular pair of address tones are present at 25 volts peak to peak. Figure 7 shows the address signal flow through this board and USL Dwg. E-01318C6 shows schematic detail. There are 12 possible address frequencies between 11. kHz and 13.75 kHz, spaced 250 Hz apart. Each decoder board has two ceramic narrow band filters installed to only pass a particular pair of address tones to the detectors. If both tones are simultaneously present, the AND gate causes a constant current to flow into a storage capacitor. The address tones normally have a duration of 1.0 seconds
