WOOD  
STRUCTURE  
PERFORMANCE  
IN AN  
EARTHQUAKE  
IN ANCHORAGE, ALASKA

# WOOD STRUCTURE PERFORMANCE IN AN EARTHQUAKE<sup>1</sup>

IN ANCHORAGE, ALASKA MARCH 27, 1964

FOREST PRODUCTS LABORATORY<sup>2</sup> FOREST SERVICE

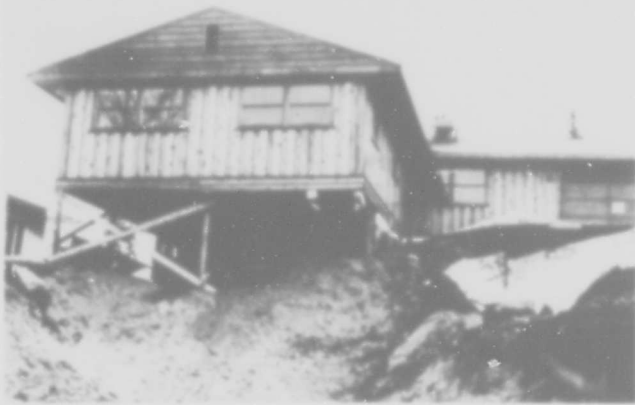
Figure 3.--Wood frame home in Turnagain bluff area. Earth subsidence destroyed a portion of the basement but caused little harm to house. Temporary bracing has been placed under the left portion.

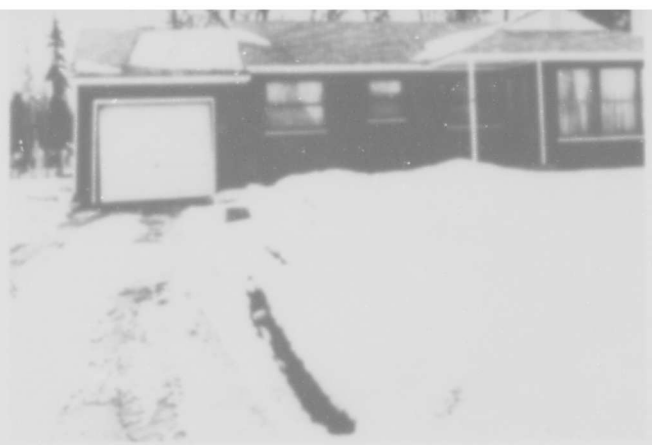
Figure 5.--Fissure in earth (center, foreground) caused slight movement of floor slab and twisting of garage door. This home is near the Turnagain housing area where severe earth slides occurred.

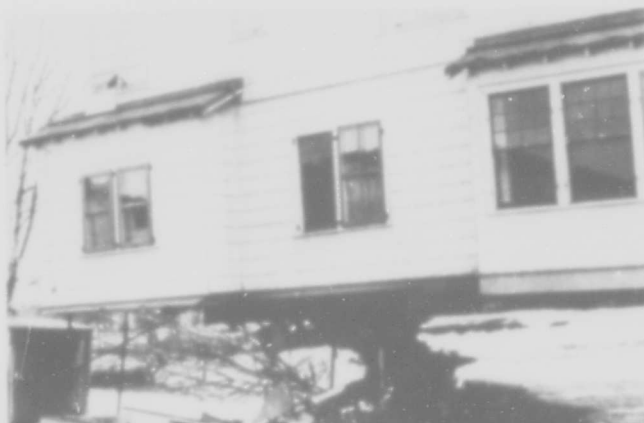
Figure 6.--Inadequate fastening of wall to floor system caused some floor damage. Little racking of the house was apparent though one end had fallen into an earth fault.

Wood frame floor systems performed well with relatively little damage even though basements or foundation walls had been destroyed. There were several instances, however, where wall-to-floor fastenings were insufficient and the floor had pulled away from the wood frame wall (fig. 6). Metal straps similar to those often used

in hurricane areas or diagonal wood or plywood sheathing nailed to both floor and wall framing would probably have prevented this type of failure. The wood floor and wall systems were usually sufficiently strong to support the weight of the house even though most of the foundations had failed (fig. 7).

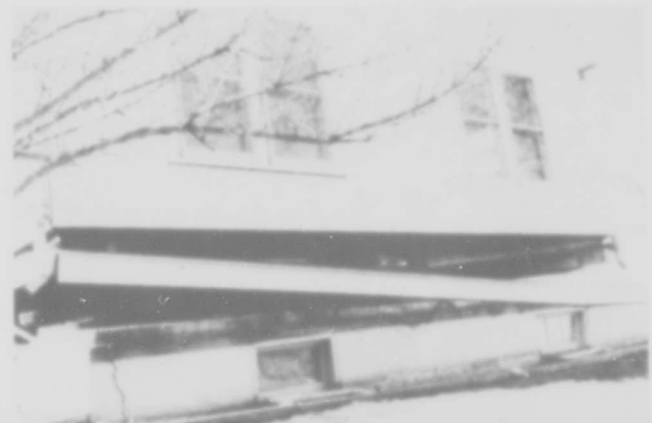
Figure 7.--Although the porch is somewhat awry, this small wood frame house was rigid enough to span the hole caused by earth subsidence.

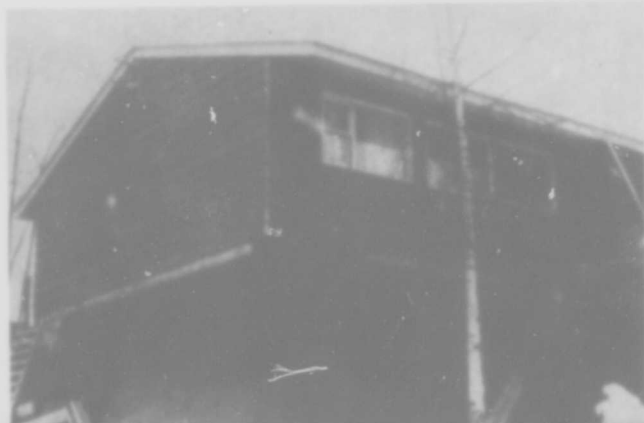
Figure 8.--Earth collapse caused failure of the concrete block foundation wall of this crawl space house. A portion of the top course of the block is still attached to the floor plate. The rigidity of the wood-framed walls prevented deflection and damage to the house proper.

There were several instances where concrete block foundation walls had collapsed in the earth drop areas, leaving a row of blocks or a few blocks attached to the floor framing because of the wood plate-to-foundation anchor bolts (fig. 8). In this instance, the separation of floor and foundation was an advantage. If the bolts had been spaced closer together and extended down into the masonry wall a greater distance, it is possible that greater damage would have occurred to the house because of the suspended weight of the masonry.

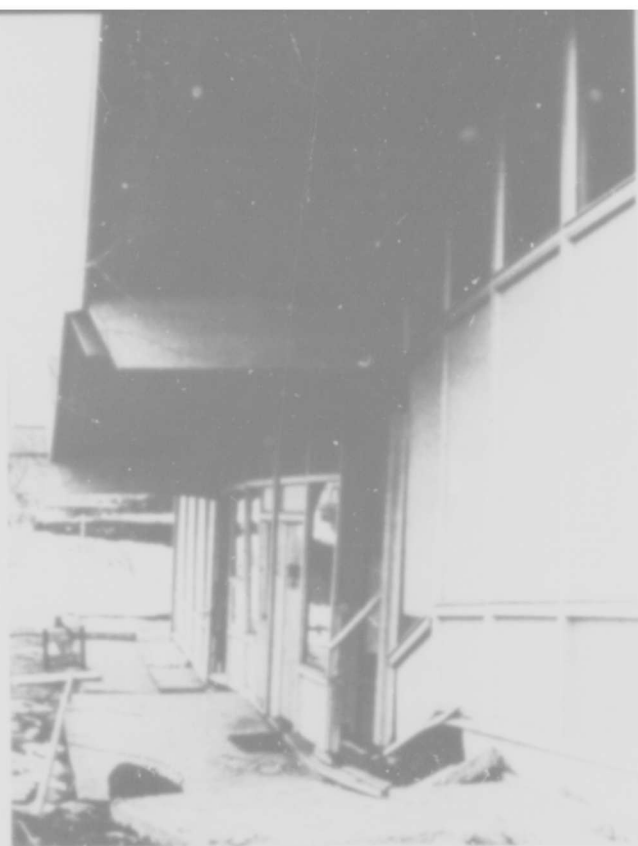
Figure 9.--This one-story office building constructed on a concrete slab was racked and badly damaged in an earth subsidence area, primarily because of slab failure. Wood roof decking and laminated beams are practically undamaged.

Concrete slab floors were usually destroyed in the earth drop areas. Because frame walls were anchored to the slabs or to perimeter foundations, they too were generally racked or damaged (fig. 9).

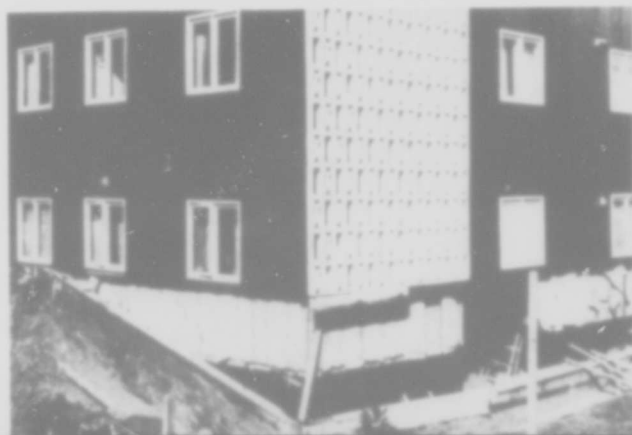
Figure 13.--Plywood sheathing over wood framing was responsible, in part, for the durability of this house.

Of the sheet materials commonly used for sheathing, plywood did an outstanding job in the houses examined (fig. 13). In the majority of cases, it was applied with the 4- by 8-foot sheets placed vertically, with perimeter nailing. Fiberboard

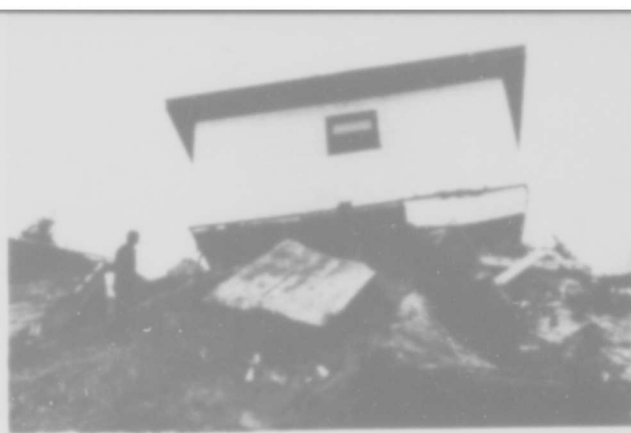
Figure 14.--The impact of the sudden earth subsidence was sufficient to cause shearing of the fiberboard sheathing.

sheathing in 25/32-inch thickness, when used properly, seemed to perform satisfactorily except where high stresses had caused shear failures between studs (fig. 14). However, not all fiberboard sheathing was applied properly with good nailing. Often 4- by 8-foot sheets were placed horizontally without edge nailing between studs. Some 2- by 8-foot fiberboard sheathing was also noted. Generally, failures of this type of sheathing consisted of nailhead pullthrough or shearing out at the nails due, in part, to inadequate nailing. These walls were usually racked beyond repair.

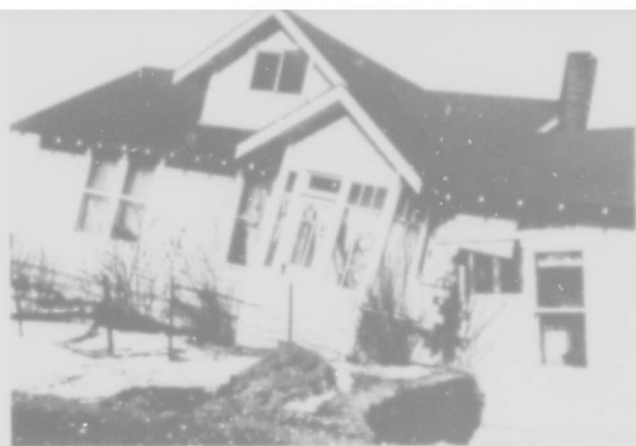
Figure 19.--The drop siding without use of sheathing did not provide enough rigidity to prevent damage to this house.

wall. Wood-sided walls performed well, as did panelized walls finished with plywood or paper-overlaid plywood (figs. 16 and 17). A number of houses, both old and new, with wood sheathing and a stucco (over wire lath) finish also appeared resistant to the forces of the earthquake and earth drops (fig. 18). Such finishes were also used on several wood-frame apartments with little or no evident damage. The use of a single covering material such as drop siding without benefit of sheathing did not supply sufficient strength (fig. 19). In

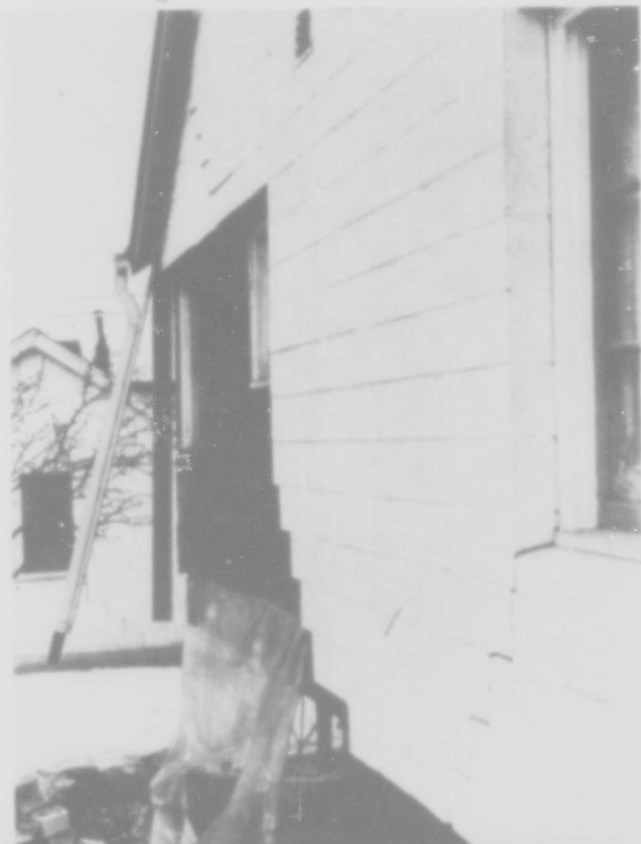
Figure 20.--The nonflexible facing of masonry failed but the more flexible wood wall framing remained undamaged.

The failure of masonry veneer such as concrete block or brick was noted in a number of cases (figs. 20 and 21). In the wood-frame house (fig. 20), the rigid, brittle facings had fallen away, revealing the undisturbed wood frame wall and sheathing behind them. Even brick or other masonry veneer with the normal amount of metal ties to the wood

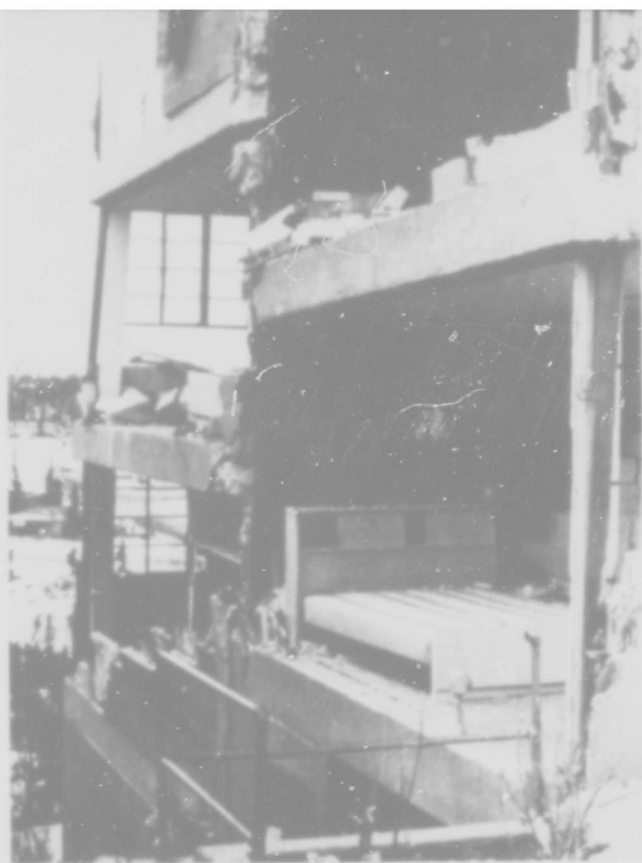
Figure 21.--This apartment house was finished with a facing of brick backed by concrete block. Corner windows provided little shear resistance to the walls.

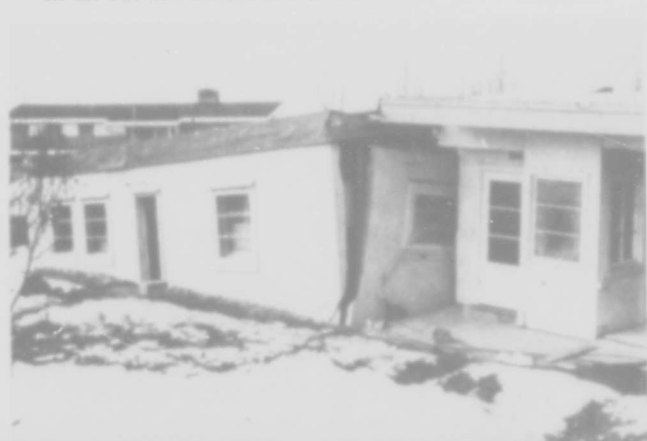
Figure 22.--Poor corner reinforcing is evident in this house with poured concrete walls damaged in an earth subsidence area.

There was evidence, in some of the more highly stressed houses such as those dropping or sinking into holes caused by earth failures in the Turnagain area, that improved fastening systems would be desirable for interior partitions intersecting exterior walls. Normally, these walls are fastened to exterior walls by nailing along the stud joining the wall and by the crossing top plate. The interior finish does little to tie the two walls together. These interior walls are important, as they serve to reduce the span of outside walls and act much as the partitions in a box to supply additional rigidity and strength. One poured concrete house failed in part because of poor corner reinforcing (fig. 22).

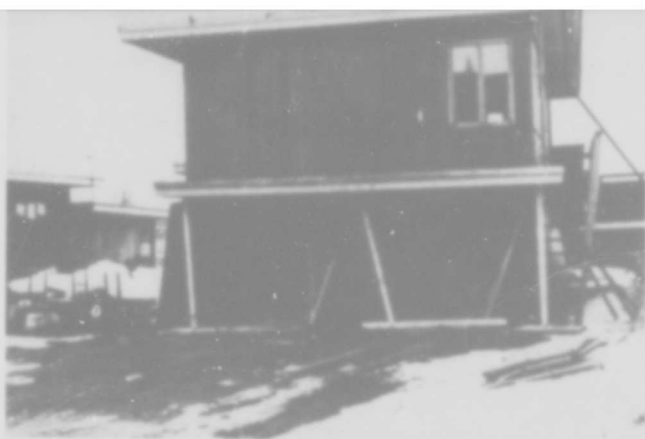
Figure 23. The narrow front walls of this double garage provided little resistance to racking stresses. Living area on upper floor is relatively undisturbed. Note temporary posts and bracing.

panels on each side of the garage door openings provided little racking strength (fig. 23). This was apparent by the failure of this section of the house.

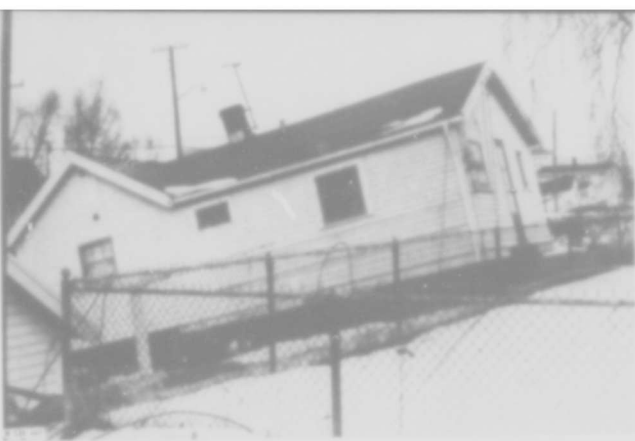
house constructed in this manner was located in the Turnagain area where severe earth subsidence and movement had occurred. However, the ridge beam, made up of three nail-laminated 2- by 12-inch members, failed by nail withdrawal and subsequent opening and failure at the ridge line (fig. 28). This type of beam should normally be a glue-laminated or solid beam or members should be securely bolted together.

Figure 28.--Nail-laminated ridge beam separated, causing roof failure of this attached garage.

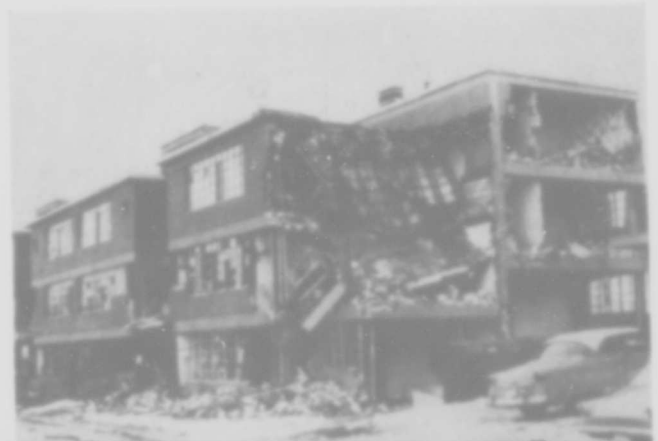
Figure 30.--Resistance to racking forces of the earthquake was lacking in this apartment building.

The need for good corner connections in exterior walls was apparent in most types of structures. In addition, openings at or near the corners reduced the racking resistance of the walls (fig. 30) and were partly responsible for damage to many buildings. Buildings with continuous openings or panels along the sides offered little resistance to racking forces (fig. 31).

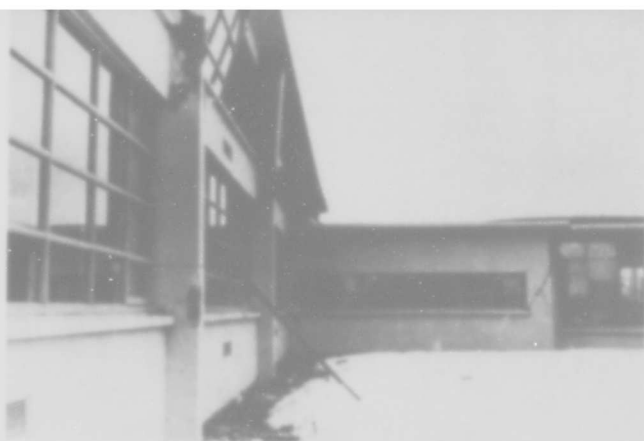
Figure 31.--The widely spaced columns of this school offered little resistance and failed at points of fixity at floors and roof line.

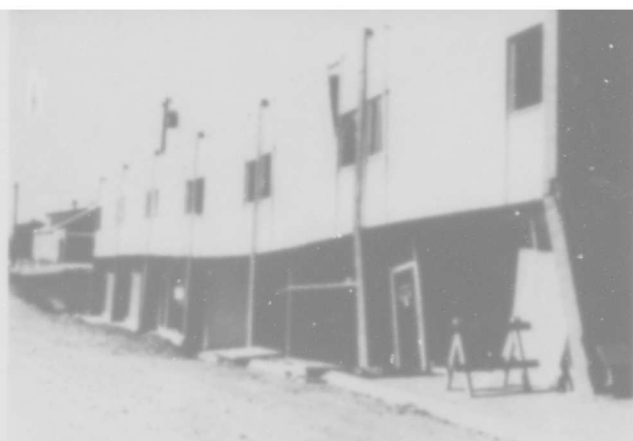
Figure 32.--The wall of the second floor offered some resistance to racking forces; not so the open first floor, which lacked enough reinforcement to resist lateral movement.

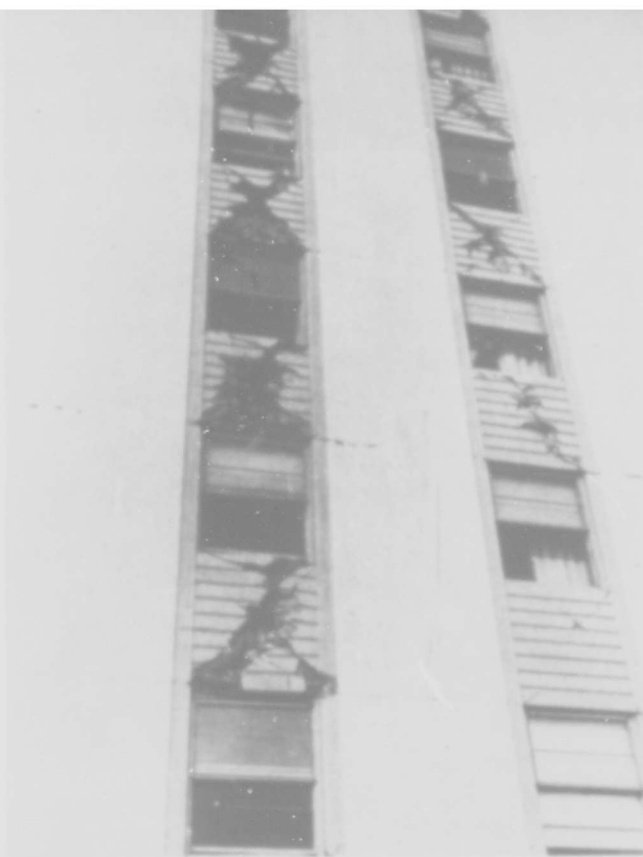
Figure 33.--The reinforced spandrel panels over the windows failed in shear. Shear failures at each floor line are also visible.

Buildings in earthquake areas should be designed so that all exterior faces have sufficient diagonal reinforcing to resist lateral movement. Several new two-story commercial buildings were designed with masonry end walls and long open or paneled sides which offered little or no resistance to racking stresses (fig. 32). Failure of the end walls because of little or no longitudinal resistance to racking had caused severe damage to the buildings. In two 14-story reinforced concrete apartment buildings, the shear forces damaged the spandrel panels over window openings (fig. 33) as the buildings swayed.

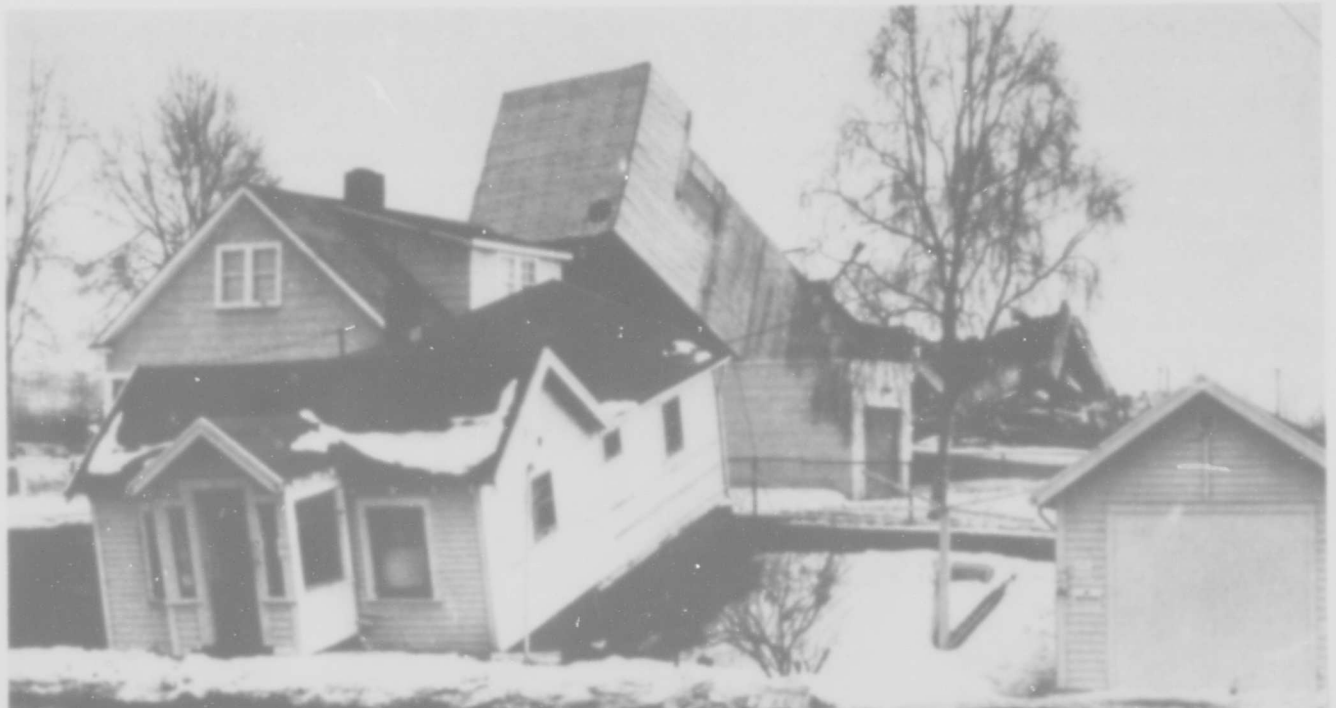
Figure 34.--The small frame house and garage in the foreground suffered only minor damage though being dropped into an earth slide area, but the shock destroyed the lift-slab reinforced concrete building in the background.
