8p  
SEA-SPACE SYSTEMS, INC.  
1754 So. Crenshaw Boulevard  
Torrance, California

FINAL REPORT SKYHOOK BALLOON RESEARCH

CONTRACT NUMBER Nonr 4395(00)

PERIOD OF PERFORMANCE  
COVERED Feb. 24, '64 thru Aug. 31, '64

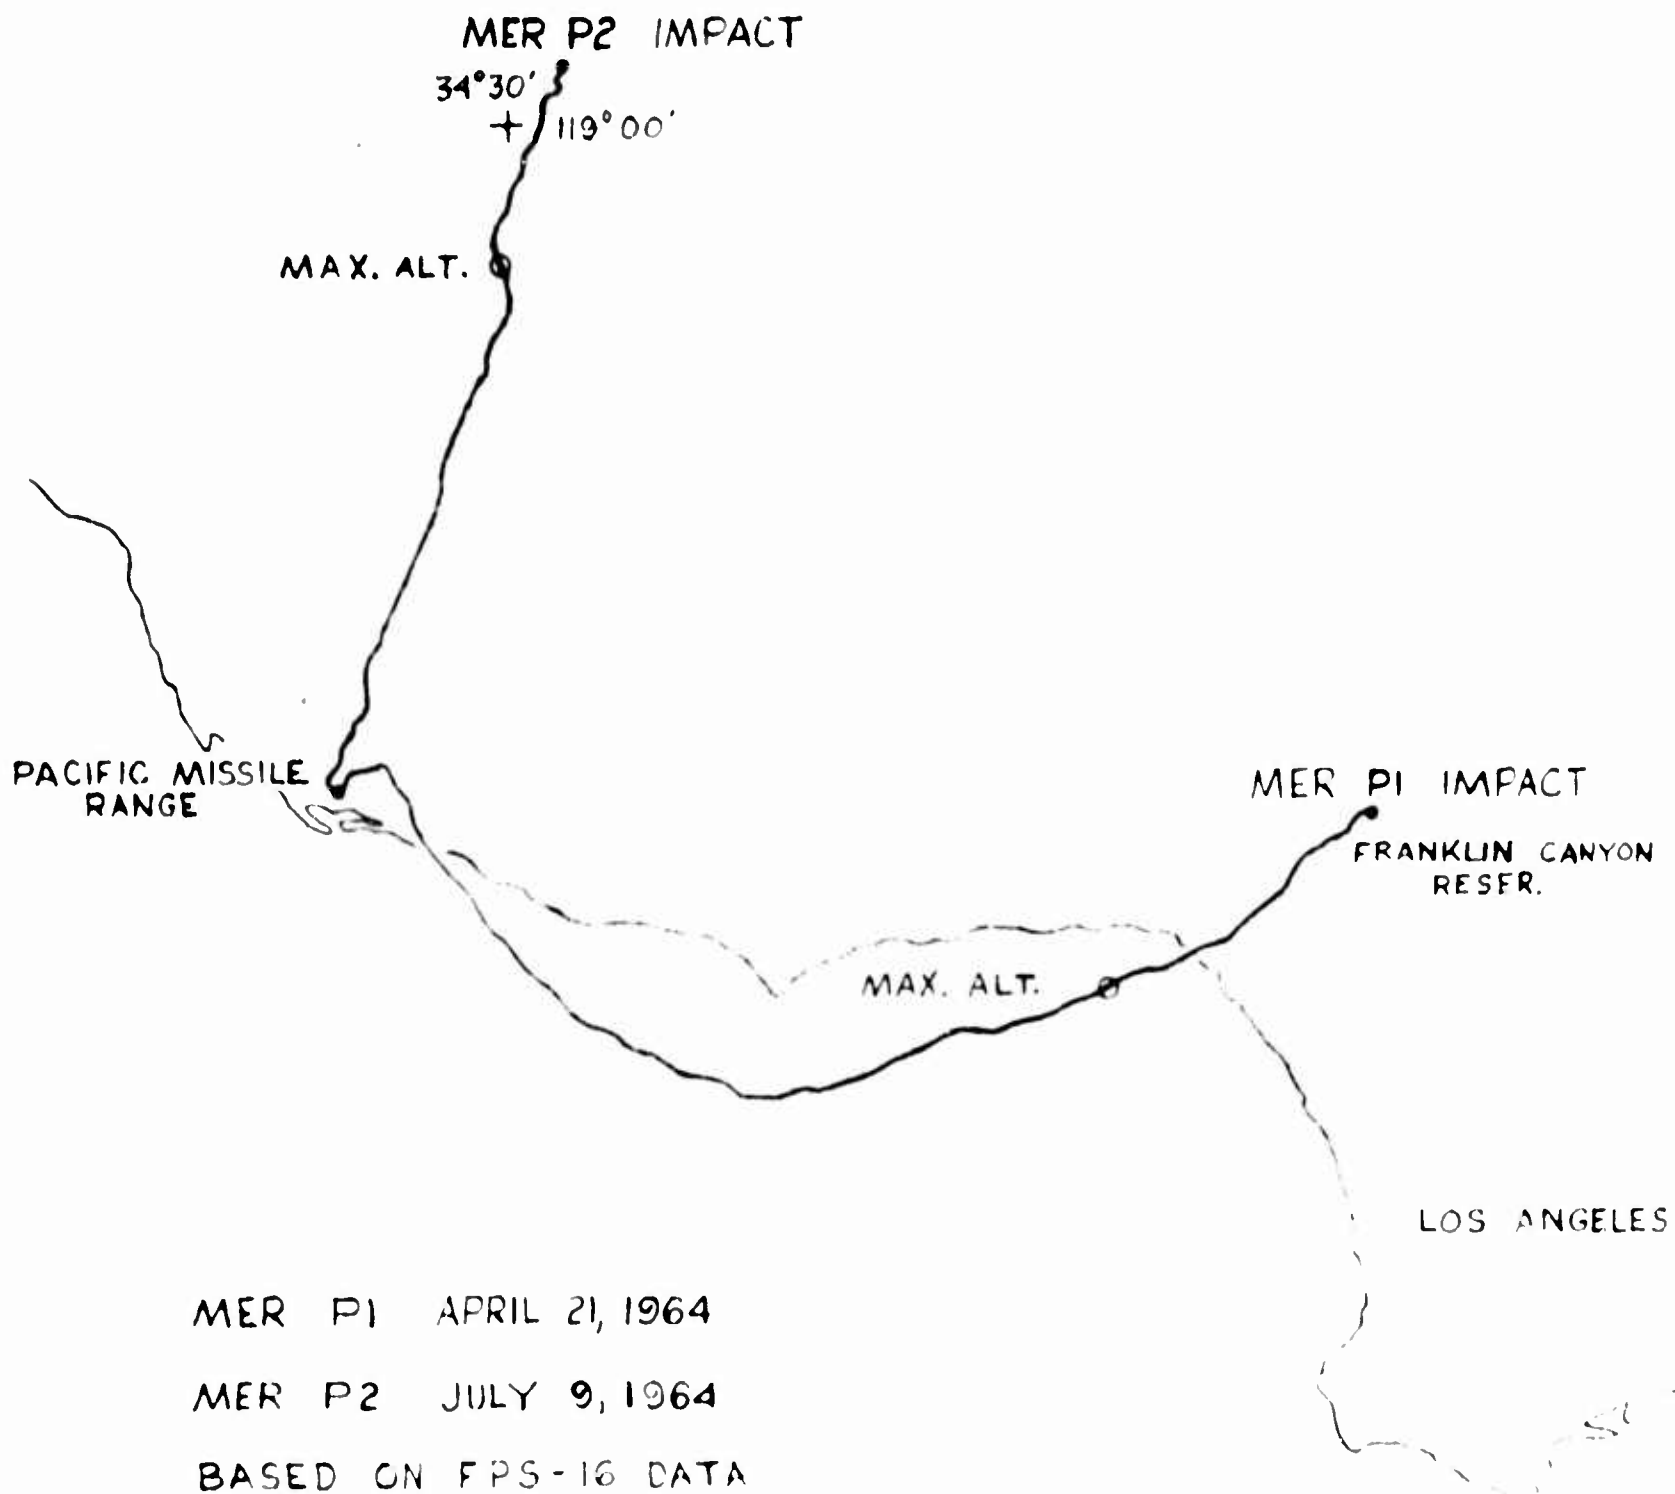
MER P1 AND MER P2 FLIGHT PROFILES

The MER P balloon is unstable without a payload greater than 13 lbs. Consequently, the balloon reached approximately forty-five thousand feet altitude, where, it is reasonable to assume, it turned over, dumping its helium. It then descended abruptly.

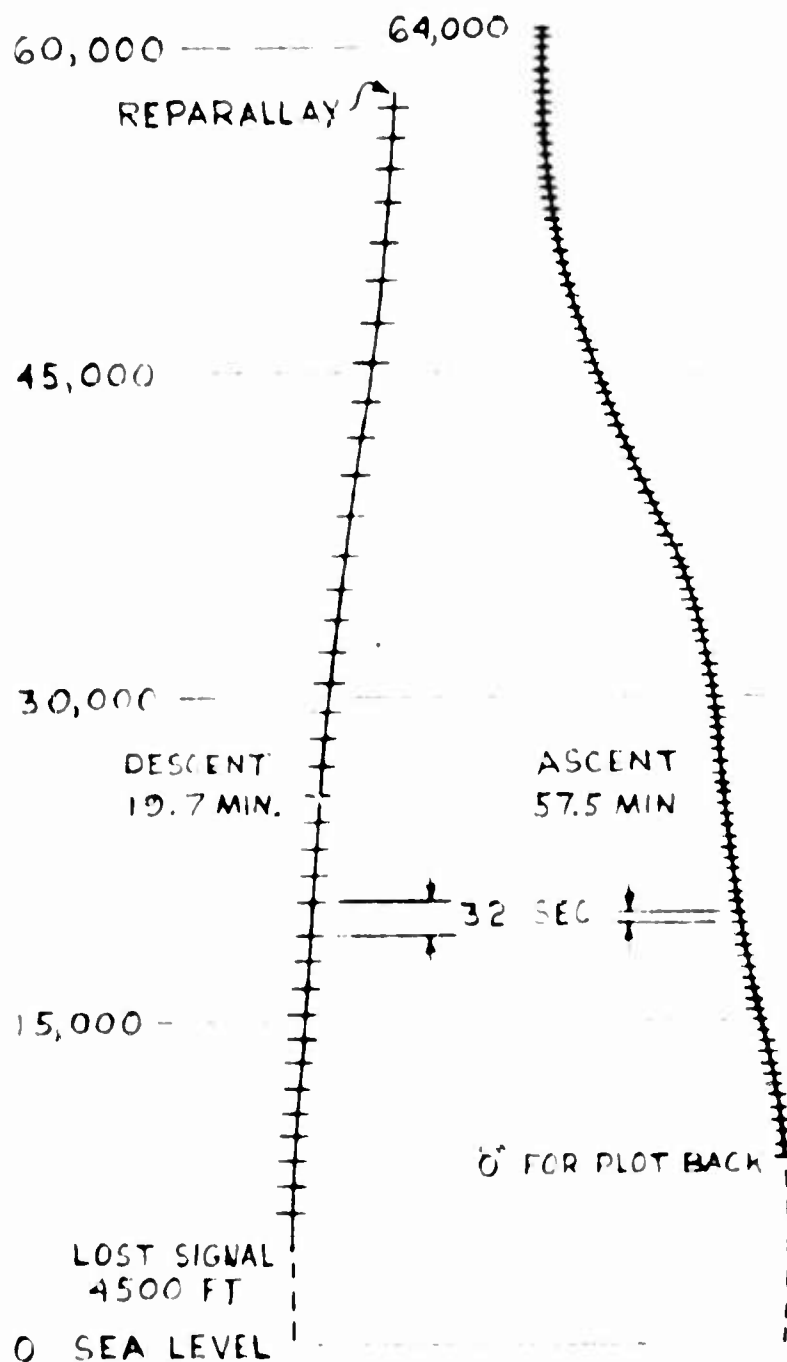
MER P2

Postflight investigation showed slight damage to the launcher from the payload line. It is believed the line hung up in a "bight" of plastic film, the first such occurrence of this kind in 18 launches with this type launcher. As shown by the MER P I flight, the MER P balloon is unstable without an adequate payload, and can turn over when it becomes inflated sufficiently.

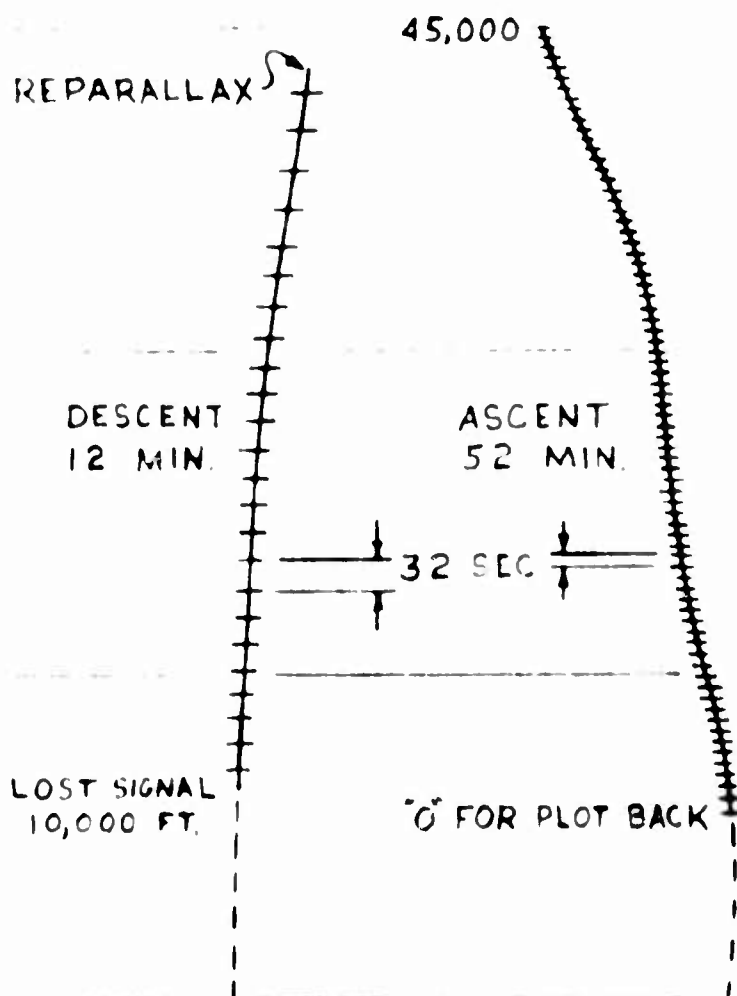
MER P1

Postflight analysis showed the heavy PE launcher film had ripped circumferentially at its base, the rip initiating at an upwind point. The payload attachment line sheared through the heavy, reinforced bottom fitting of the balloon, when wind forces, estimated to be at least 500 lbs, acted on the balloon.
