VUF-1010
FINAL REPORT

VELA UNIFORM PROJECT **SHOAL**

STRUCTURAL SURVEY OF PRIVATE MINING PROPERTIES

U.S. BUREAU OF MINES

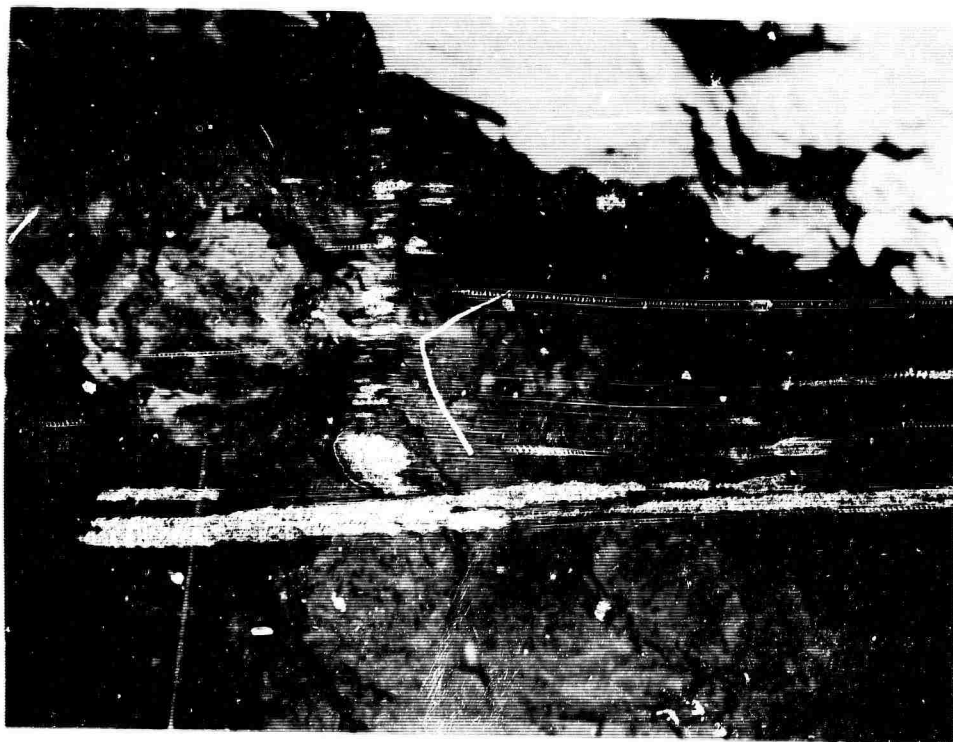
Photo 4-3-13. Preshot. September 30, 1963.

Photo No. 4-3-13. Rock along back at 150-foot level shaft station. The rock is in a generally loosened condition.

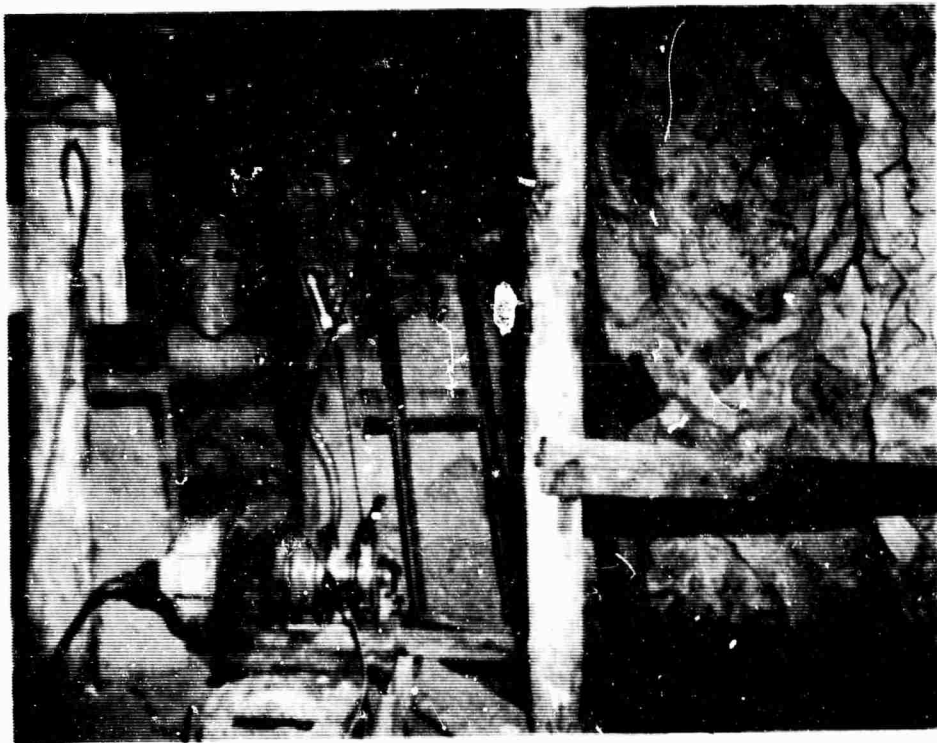
Photo 11-11-54. Preshot. October 2, 1963.

Photo No. 11-11-54. Station for 1000-winze on 400-foot level. Inclination of winze is 72 degrees. Random round 8-inch timbers are used for support. A large amount of mining equipment was found at this winze station.

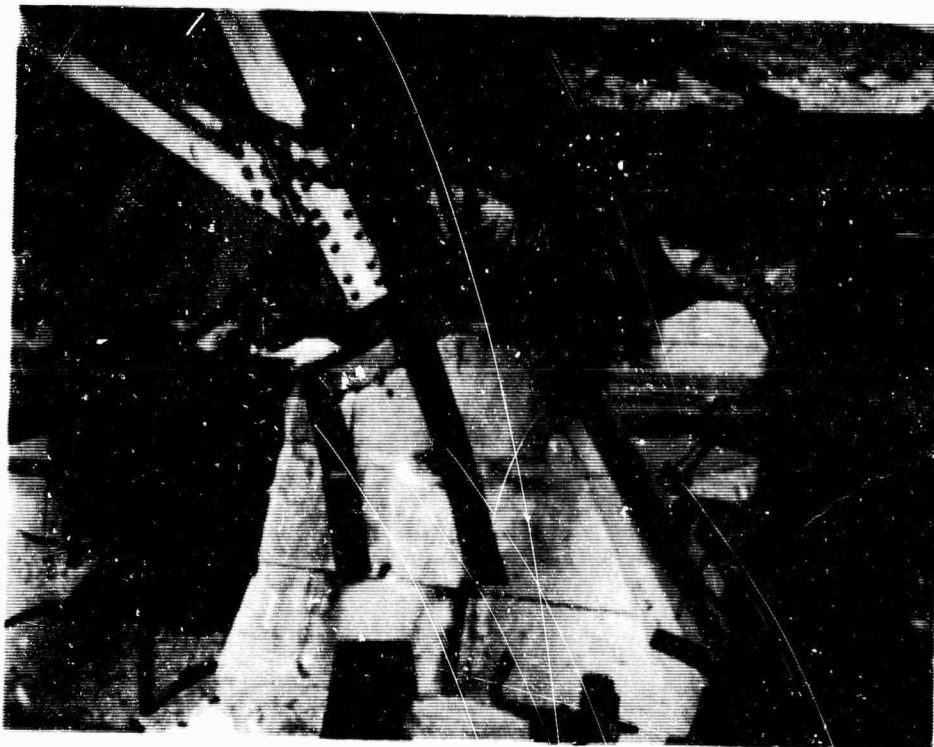
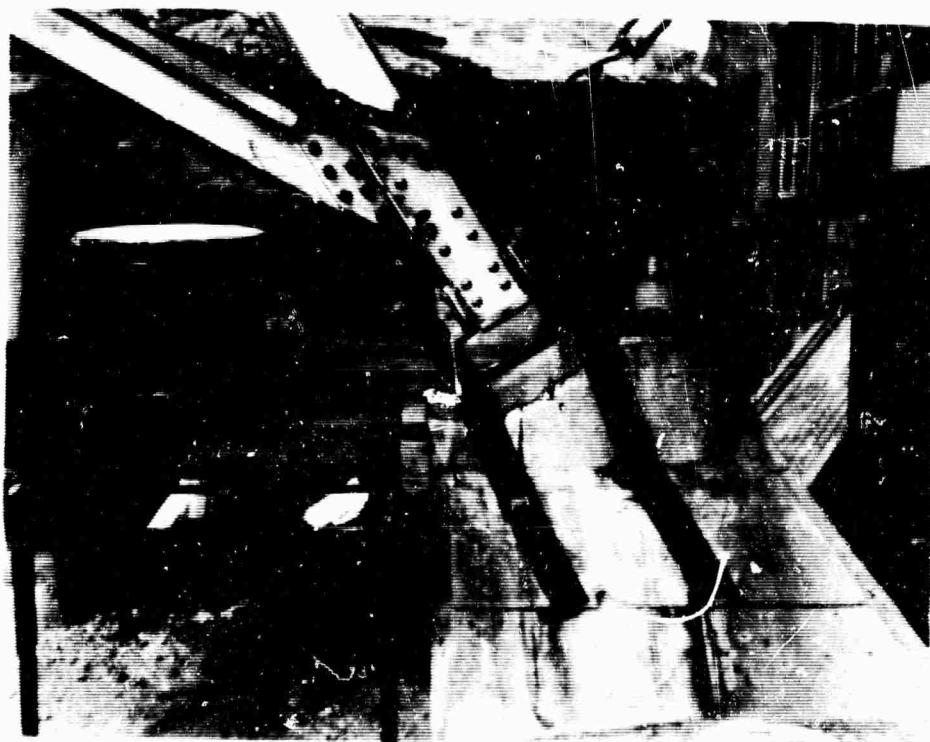
Photo 11-14-57. Preshot. October 2, 1963.

Photo No. 11-14-57. Subsidence by undermining from the 250 stope has caused separation between the steel leg and concrete pier of left rear post of headframe. Reference mark measured 6.05 inches separation both pre- and postshot. The 1/4 x 3-inch steel straps holding the headframe leg to the concrete pier do not form a rigid connection and the steel straps can be deflected by hand pressure.

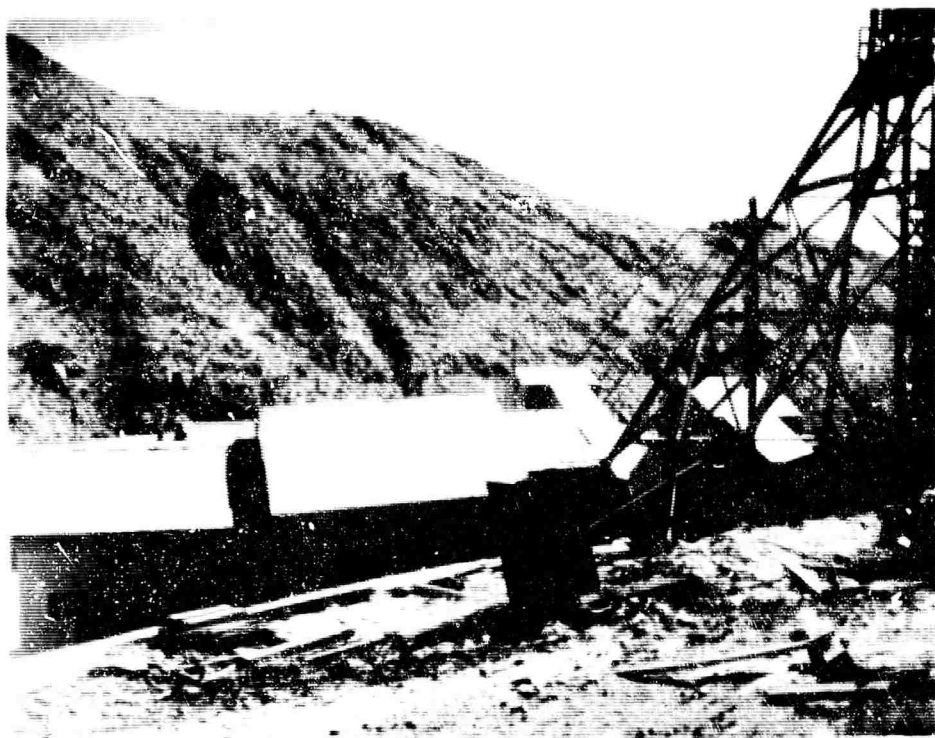
Photo 11-15-58. Preshot. October 2, 1963.

Photo No. 11-15-58. Subsidence by undermining from the 250 stope has caused a four degree northward tilt to hoist house. The concrete foundation for the hoisting equipment has a large crosswise crack immediately behind the main drum. The hoist consists of a cylindrical double drum electric powered system mounted on a steel frame.
