# VELA UNIFORM PROJECT **SHOAL**

**PRESHOT AND POSTSHOT STRUCTURE SURVEY**  
Holmes & Narver, Inc.

December 1963

# **PRESHOT AND POSTSHOT STRUCTURE SURVEY**

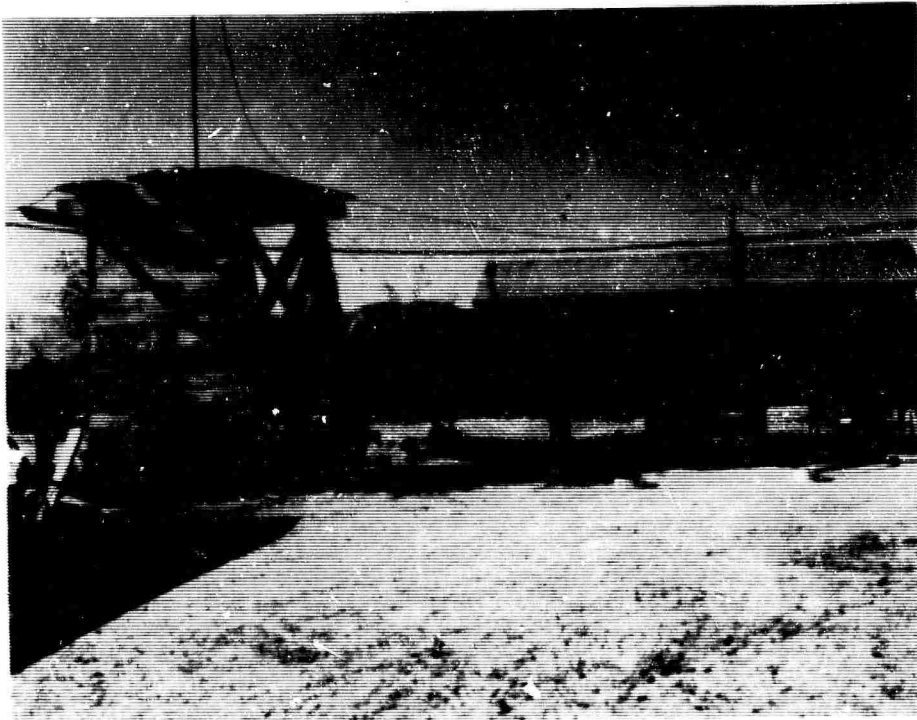
Photo No. 3-2 (2) - Preshot - October 8, 1963

- 3-2 Garage (See photos 3-2(1) and 3-2(2)) 24 x 30-foot concrete block structure built about 1953. There are three gasoline pumps. There is a wood tower or platform structure supporting the T.V. antenna. This structure is roughly built of planks and boards. See photo 3-2(2). No damage was noted as a result of the postshot survey.

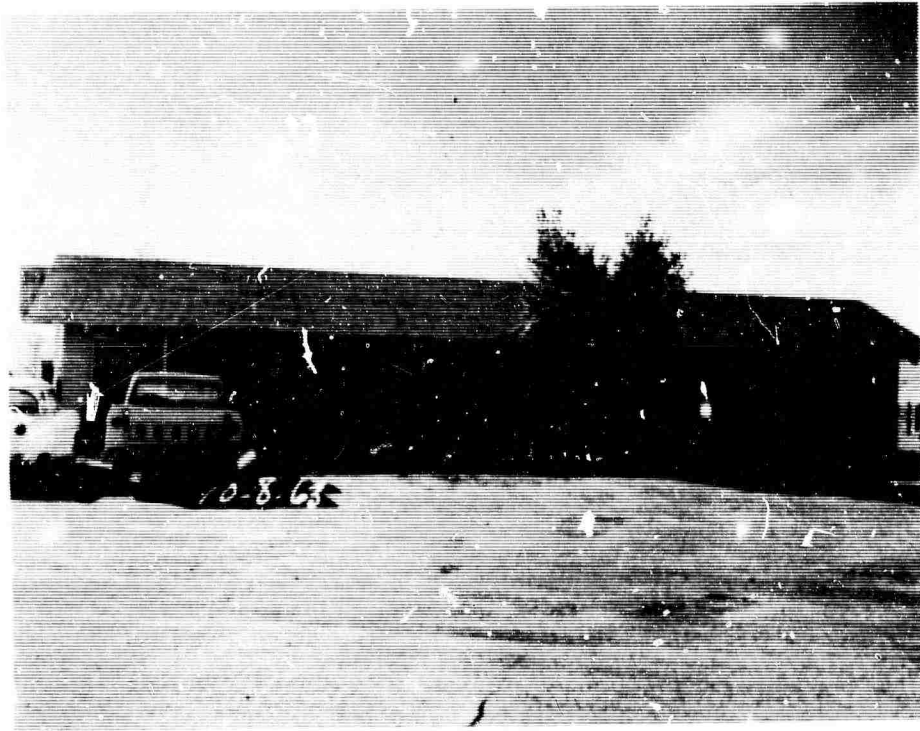
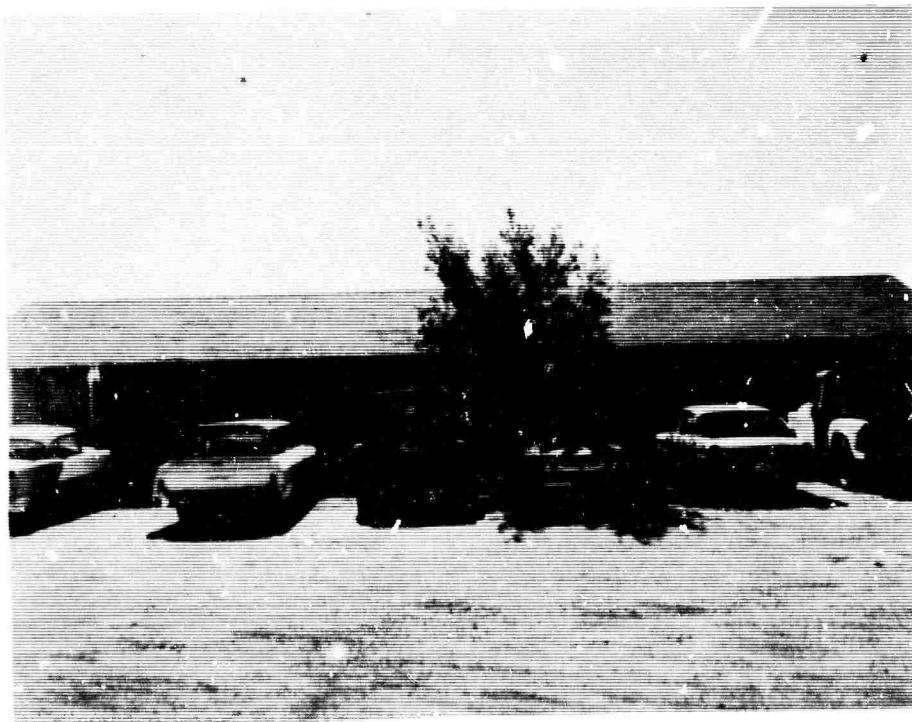
Photo No. 3-3 (3) - Preshot - October 8, 1963

- 3-3 Motel (See photos 3-3(1) through 3-3(8)) This is a 30 x 60-foot concrete masonry structure built in 1955 and is in good condition except for several cracks in front concrete slab. AZ 157° clockwise from magnetic north. No damage was noted as a result of the postshot survey.

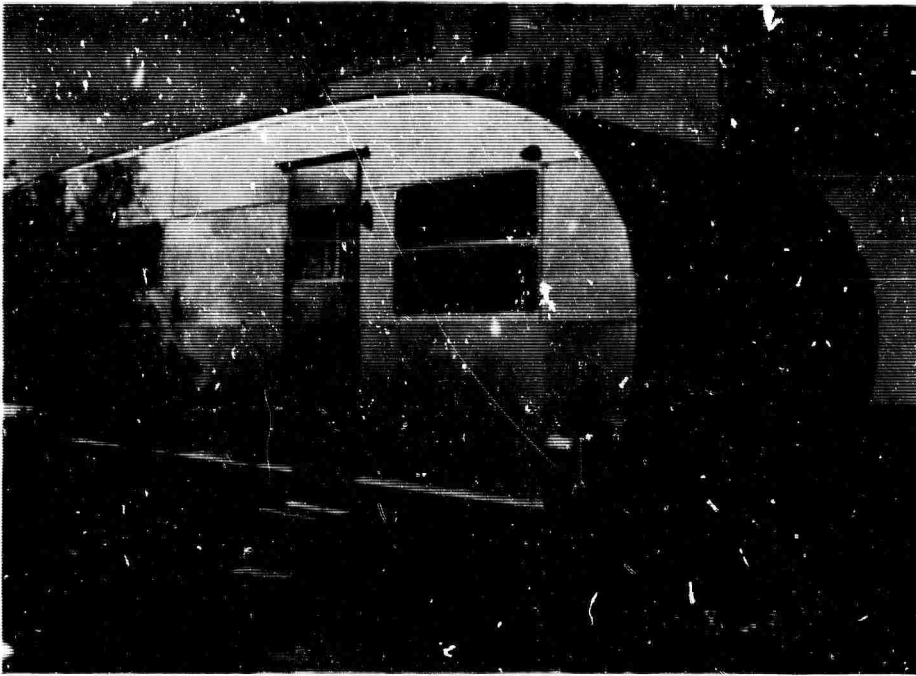
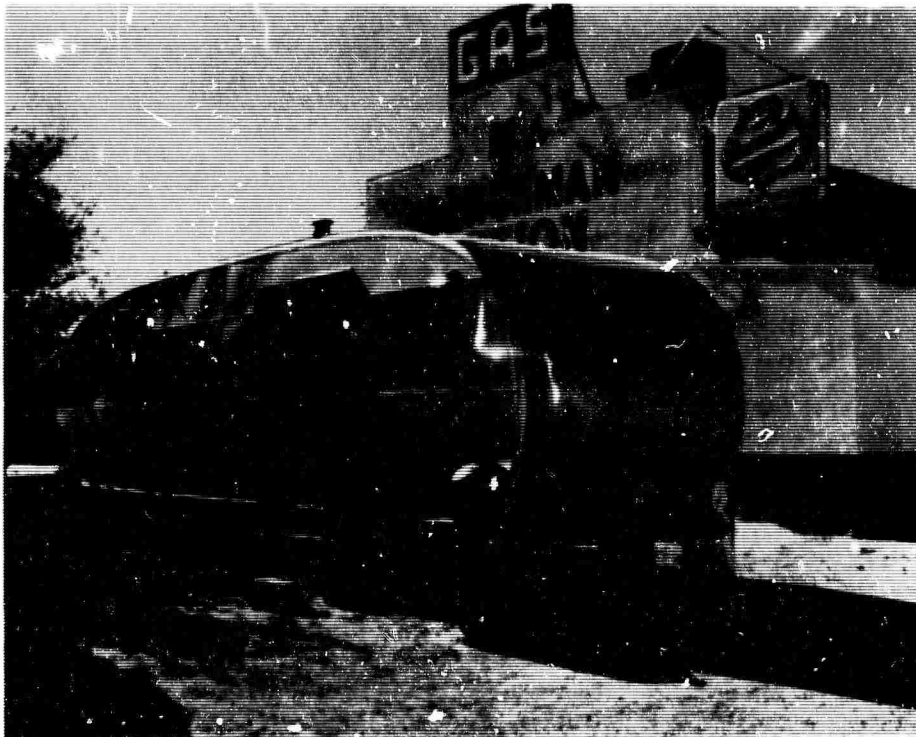
Photo No. 3-4 (2) - Preshot - October 8, 1963

- 3-4 Trailer (See photos 3-4(1) and 3-4(2)) This is a 25-foot long metal covered trailer. No damage was noted as a result of the postshot survey.

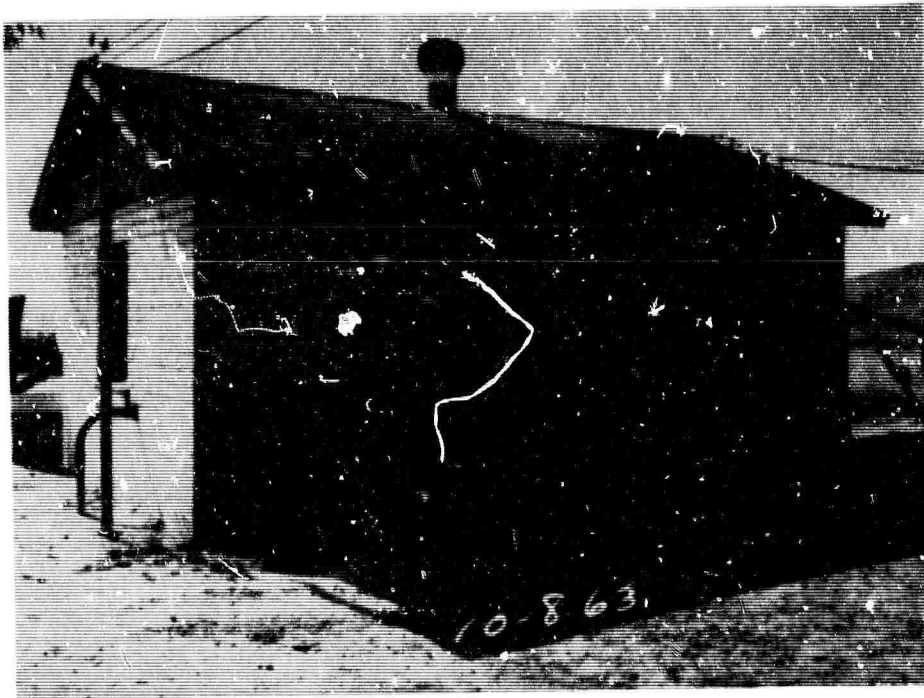
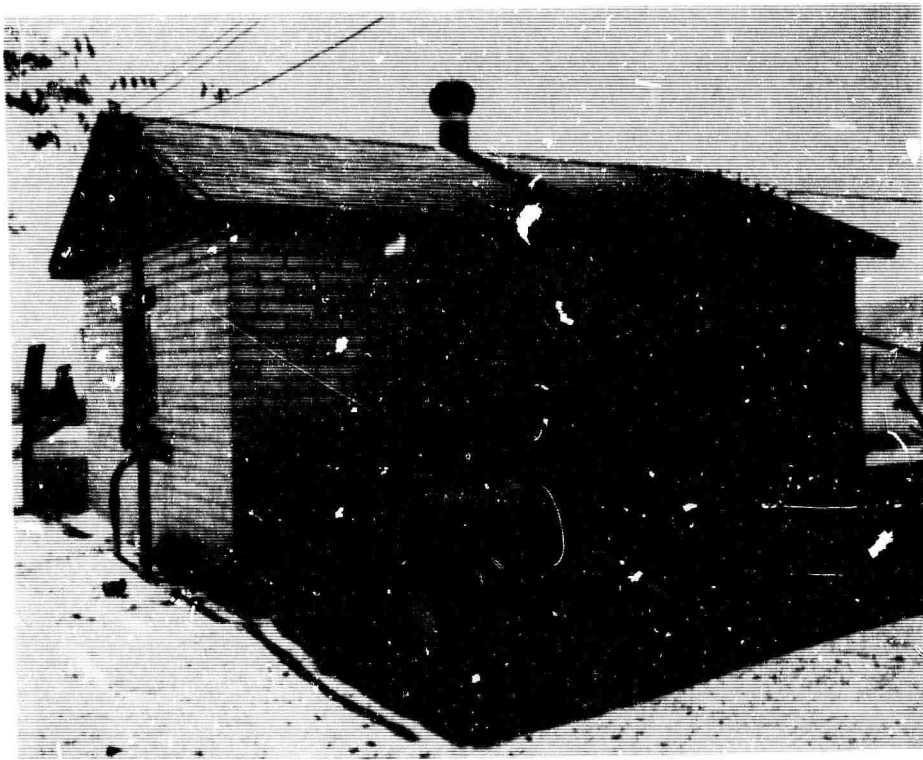
Photo No. 3-5 (2) - Preshot - October 8, 1963

- 3-5 Pump house (See photos 3-5(1) through 3-5(4)) This is a 15 x 20-foot concrete masonry pump house built about 1953. AZ 254° clockwise from magnetic north. No damage was noted as a result of the postshot survey.

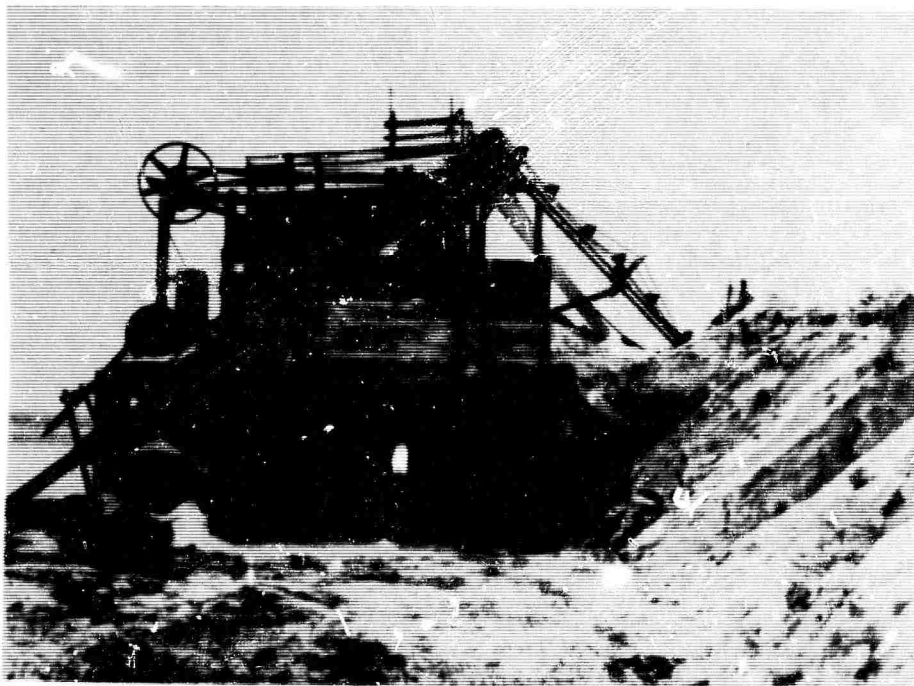
Photo No. 5-1 (1) - Postshot - November 4, 1963

- 5-1 Loading Bins and Ramp (See photos 5-1(1) and 5-1(2)) Consists of loading bins and ramp of wood construction. No damage was noted as a result of the postshot survey.

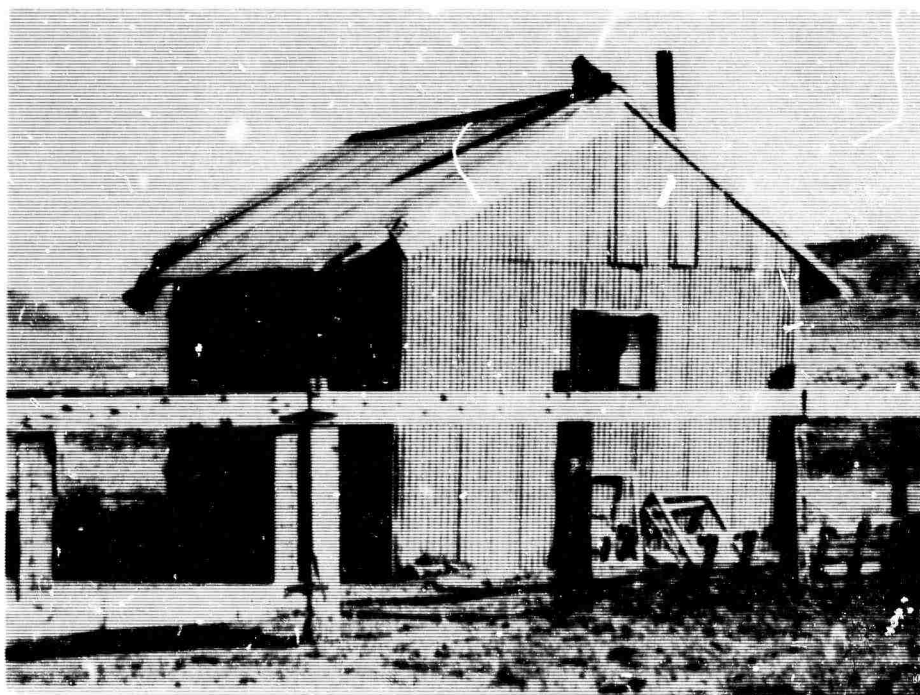
Photo No. 6-1 - Preshot - October 30, 1963

- 6-1 Shack (See photo 6-1) This structure is a 16 x 16-foot wood frame, corrugated sheet metal-covered shack. Roofing and siding are damaged and all windows have been removed. No damage was noted as a result of the postshot survey.
- 6-2 Shack (See photo 6-2) This shack is a 16 x 16-foot wood structure. It is unpainted and the boards of the siding are warped and badly weathered. No damage was noted as a result of the postshot survey.

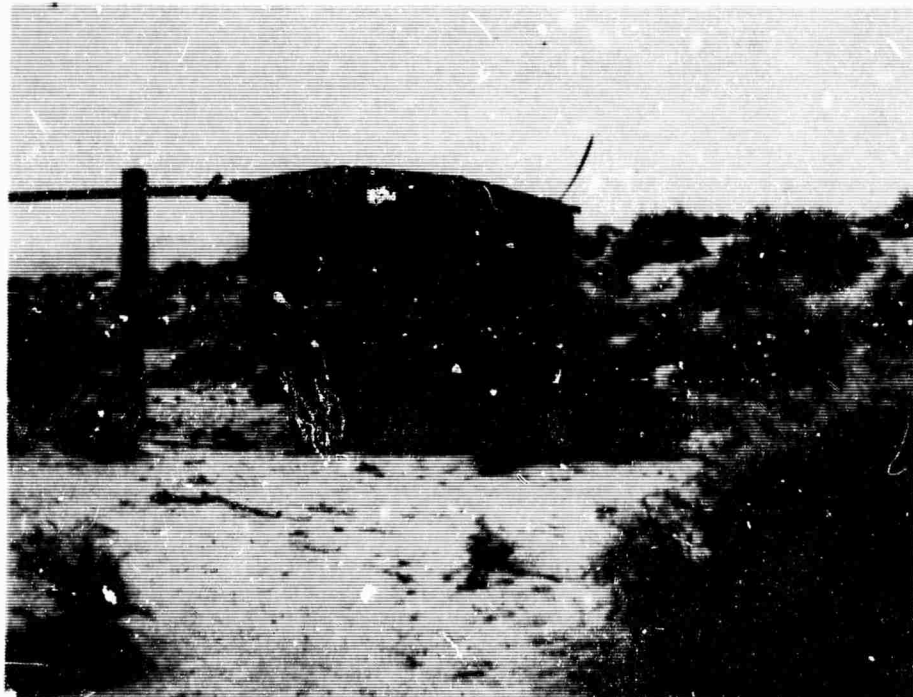
Photo No. 9-1 - Postshot - November 4, 1963

- 9-1 Shack (See photo 9-1) This 8 x 15-foot wood shack is about 40 years old and abandoned. Siding is unpainted, badly weathered and warped. Windows are all missing. Interior is completely gutted and floor is covered with trash. No damage was noted as a result of the postshot survey.

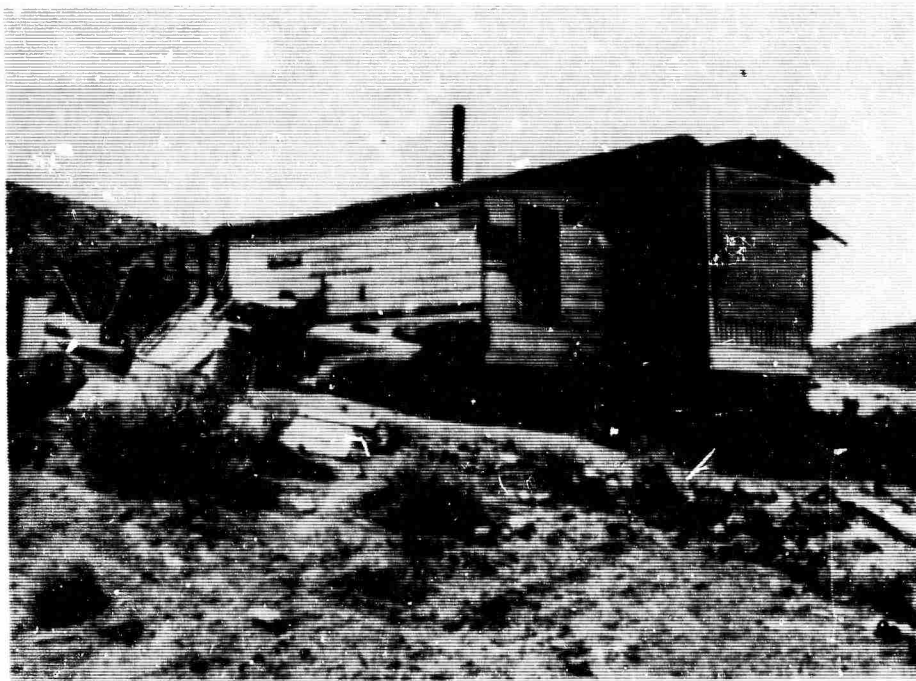
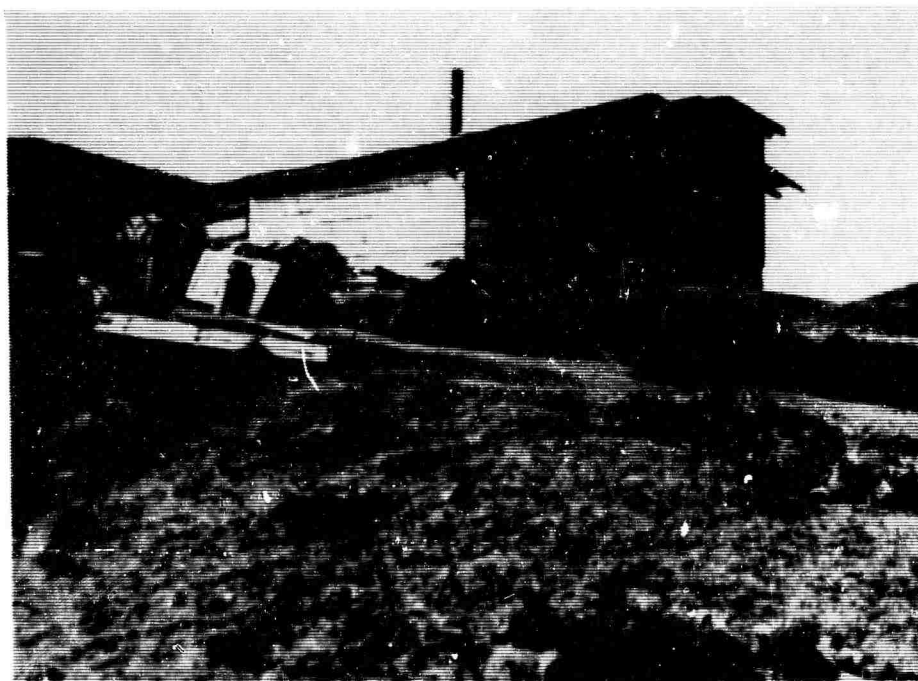
Photo No. 12-1 - Preshot - September 30, 1963

- 12-1 Cabin (See photo 12-1) This is a 24 x 24-foot wood frame and wood siding occupied cabin. AZ 170° clockwise from magnetic north. No damage was noted as a result of the postshot survey.

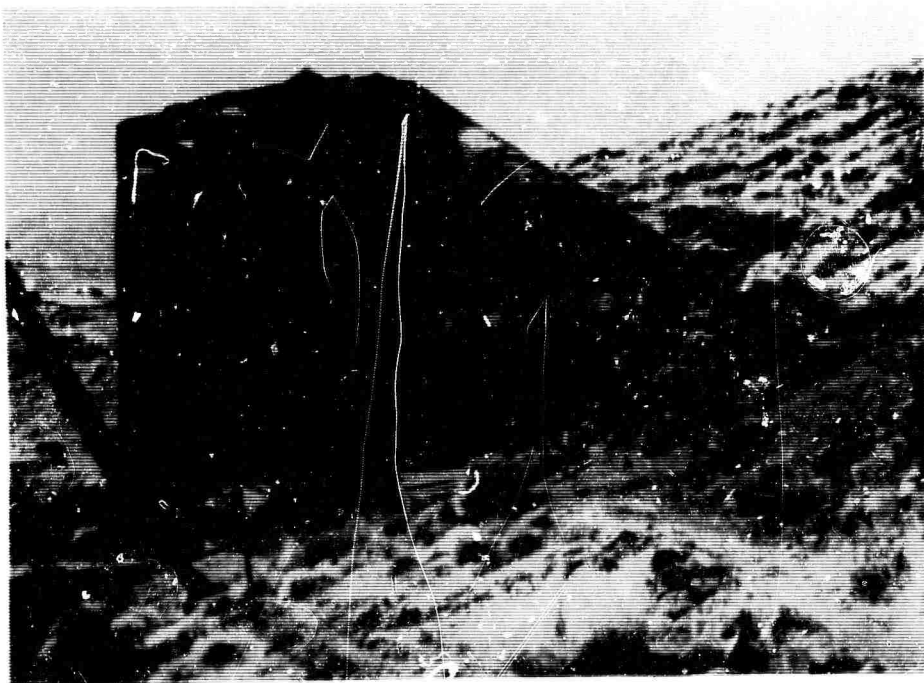
Photo No. 20-5 - Postshot - October 30, 1963

- 20-5 Hoist House (See photo 20-5) Upper level hoist house. 15 x 30-foot wood structure with corrugated metal roof partly missing. Doors and windows missing. No damage was noted as a result of the postshot survey.

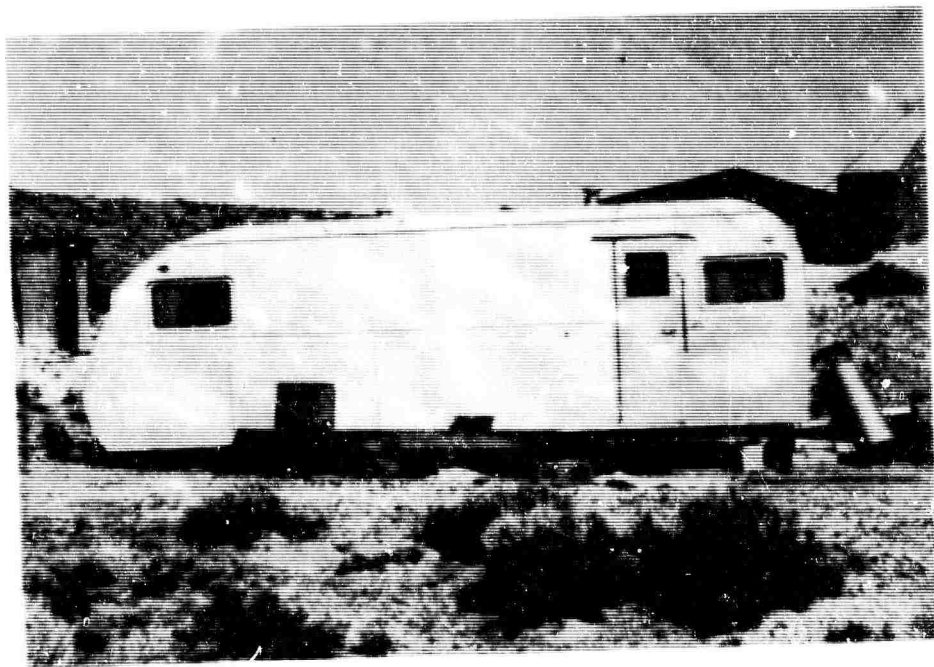
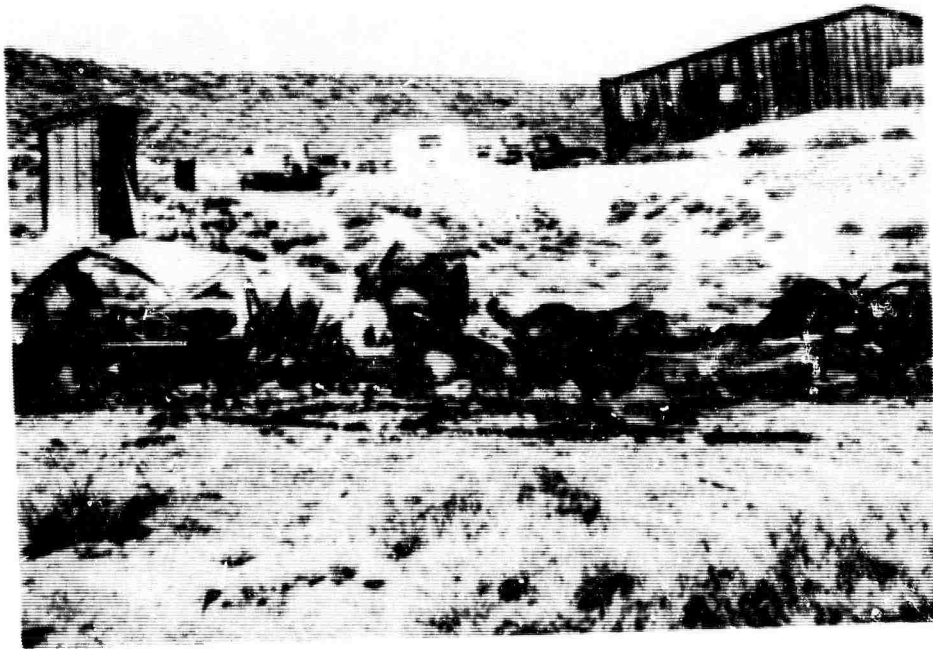
Photo No. 22-5 - Preshot - October 3, 1963

A trailer identified by Serial No. 2-4 had been removed from the location and was not present at shot time; therefore, no postshot photograph was taken. Another trailer which is identified by Serial No. 22-5 was burned down during the weekend of October 19, 1963, according to the owners. A detailed report of these changes is included in Appendix A. No other physical changes were observed.
