# VELA UNIFORM PROJECT **SHOAL**

## TEST OF DRIBBLE-TYPE STRUCTURES

Holmes & Narver, Inc.

January 1964

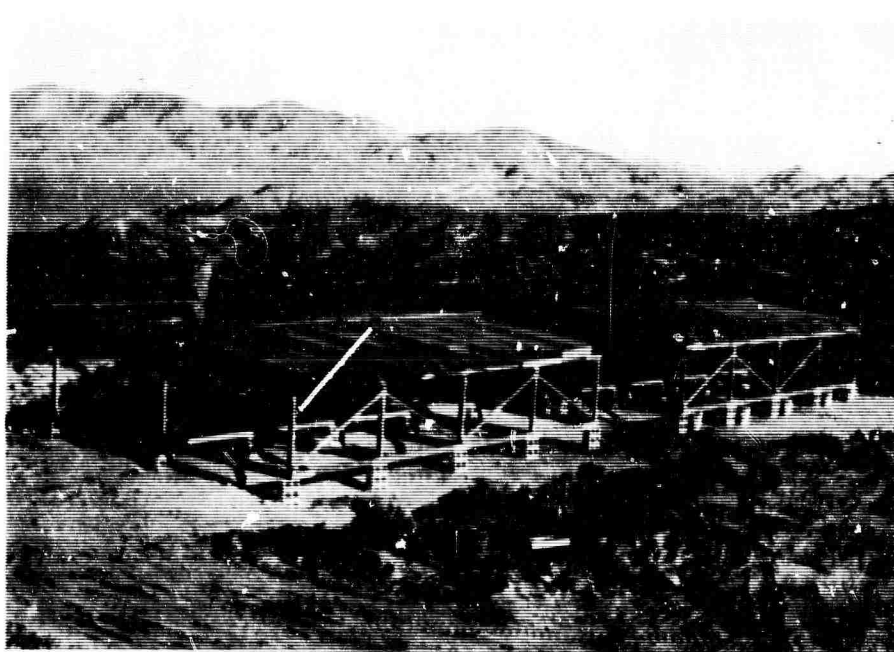
Figure 12 Postshot Station A, Rear View  
Looking SE, SZ to Left

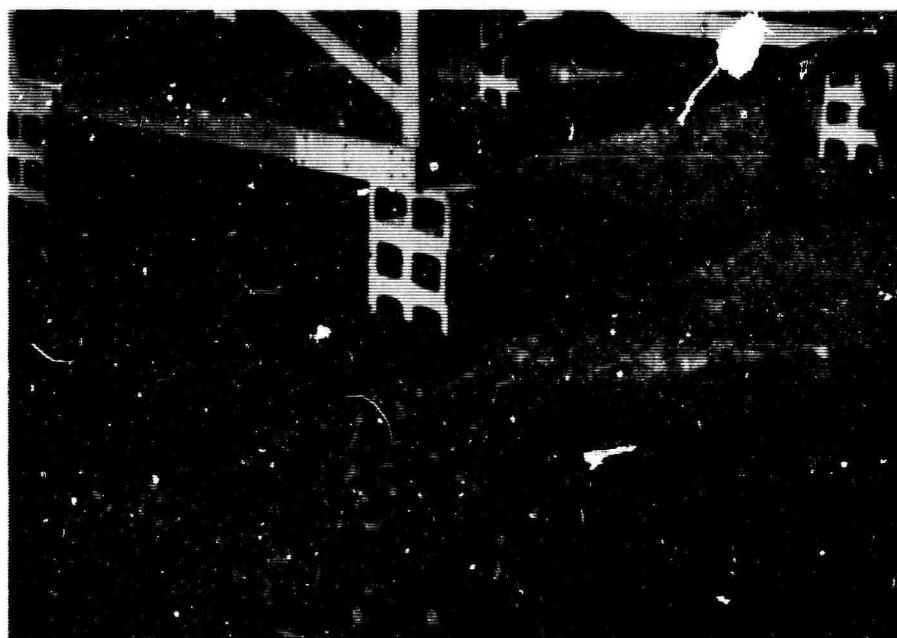
Figure 15 Postshot Station A Unbraced,  
Rear-Right Pier  
Note Crack in Ground, Foreground

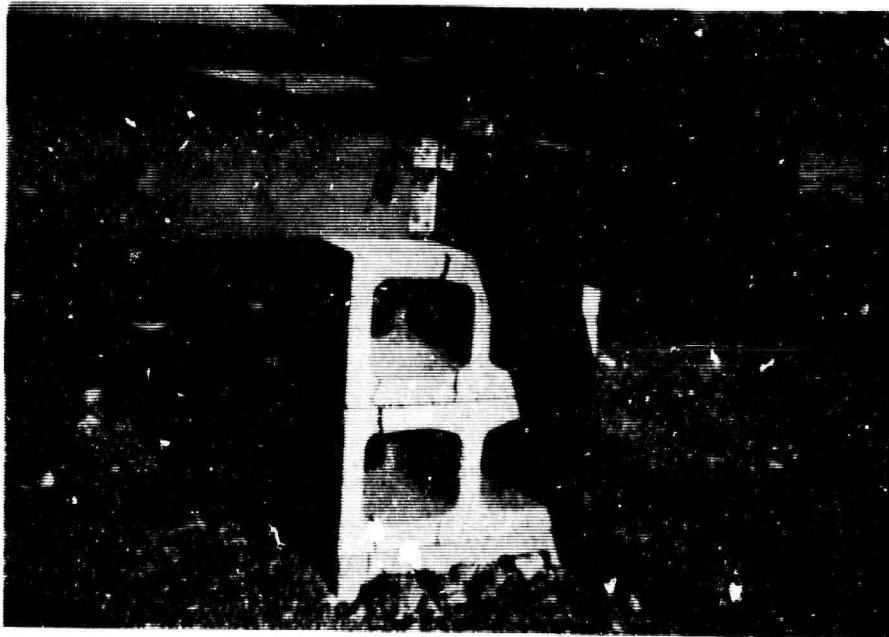
Figure 16      Postshot Station A Unbraced,  
Center-Center Pier

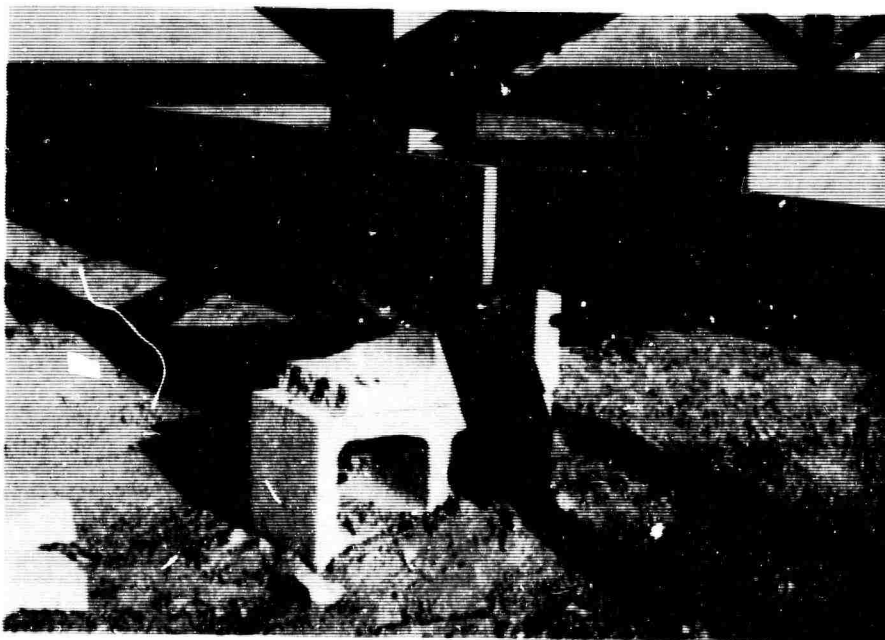
At the Station A unbraced building damage was confined to the concrete blocks in the center row of piers. See Figure 11. Four piers in that row were cracked (all but the inner-right pier, facing SZ), and all three of the blocks were cracked in the center and center-left piers; see Figure 16. In the extreme right and extreme left piers of the center row, only the upper blocks were cracked. See Figure 17.

Figure 17      Postshot Station A Unbraced,  
Center-Left Pier

The pier damage appears to have resulted primarily from vertical motion. In the unbraced buildings, the maximum computed static pier reaction (on the two inboard piers of the center row) was 2760 lbs., causing a unit stress of about 100 psi in the vertical "webs" of the blocks. During the motion, this stress could have been momentarily increased, at Station A, to  $100 + 1.3(100) = 230$  psi, which is well below the compressive strength of any structural concrete. However, most of the damage is seen to have occurred in the horizontal flanges of the blocks in a manner indicating a shear failure, see Figures 14, 17, and 21.

Further inspection of Figures 14, 17 and 21 shows that the damage is without exception either on one side or the other of the center webs of the pier blocks, but not on both sides. This circumstance indicates uneven bearing of the sill timber on the pier, which is probably to be expected whenever the sill timber is not continuous over a pier. If we assume that the sill is bearing on only half of the top block, the shear stress on flange sections near the webs was over 300 psi, which could result in failure. In fact, a condition of line bearing of the end of a sill timber on the pier might be expected, particularly when the structure slams back down on the pier after the

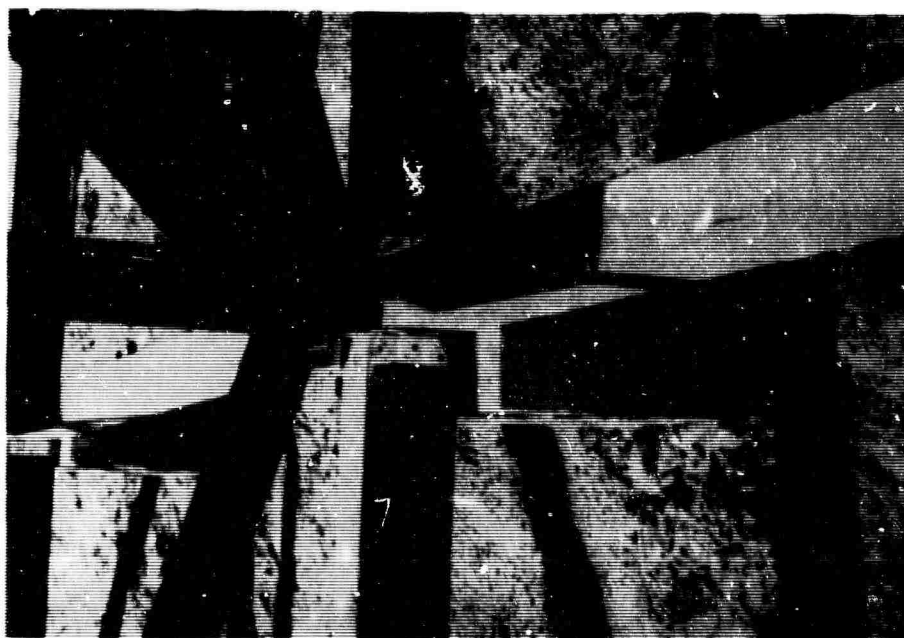
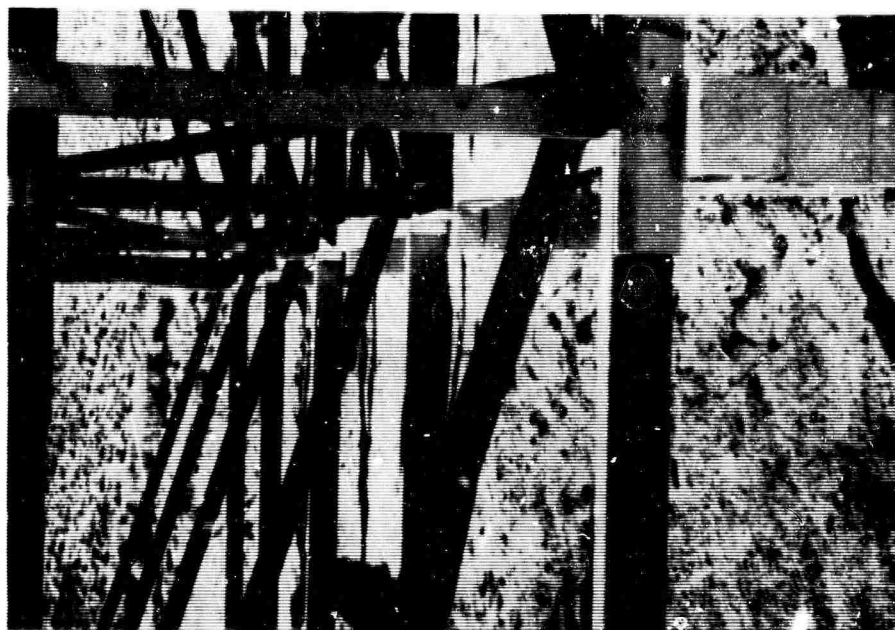
In the center row, the tops of the piers were displaced away from SZ with respect to the frame, but the piers were still plumb. See Figures 18 and 19. No horizontal differential displacement was observed in the other rows, although the row toward SZ showed a slight deviation from plumb, Figure 20.

Figure 18 Postshot Station A  
Unbraced, Center-Center  
Pier, SZ to Right

Figure 19 Postshot Station A  
Unbraced, Center Row  
of Piers, SZ to Right

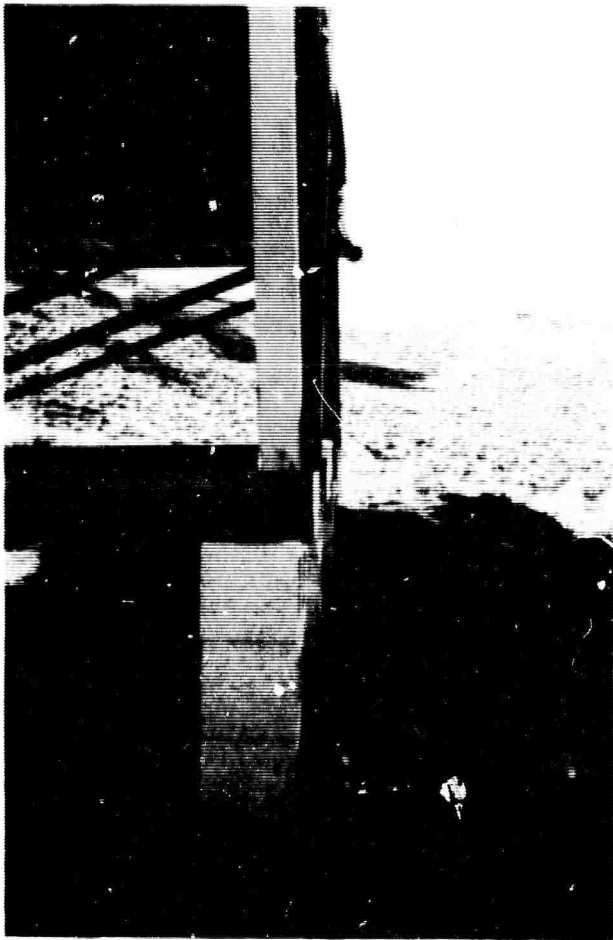
Figure 20

Postshot Station A  
Unbraced, Front  
Row of Piers, SZ  
to Right
