OPERATION PLUMBBOB

EVALUATION OF BURIED CORRUGATED-STEEL ARCH
STRUCTURES AND ASSOCIATED COMPONENTS

Issuance Date: February 22, 1961

OPERATION PLUMBBOB—PROJECT 3.3

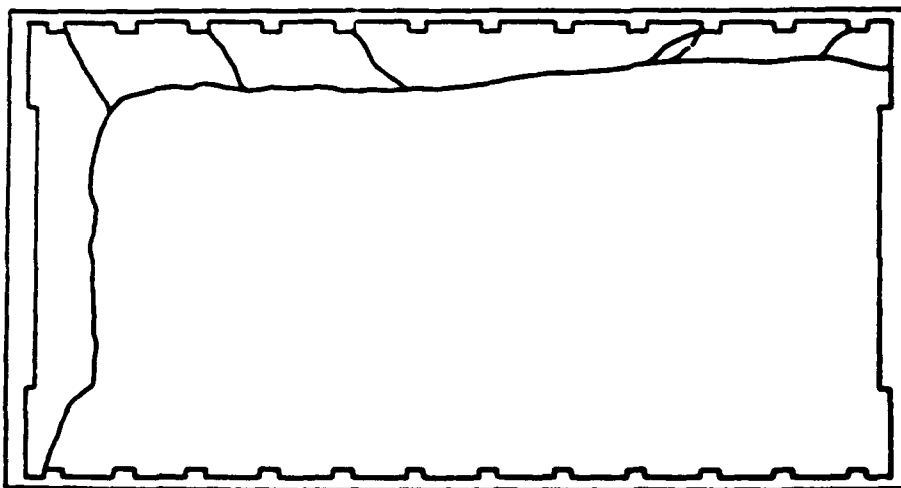
Only in Structure 3.3a was cracking of the floor evident. A sketch of the crack pattern is shown in Figure 2.38.

Figure 2.38 Crack pattern of floor, Structure 3.3a.
